# **Bearspaw South Feeder Main Pipe Investigation Findings**

IP2024-1237

December 11, 2024

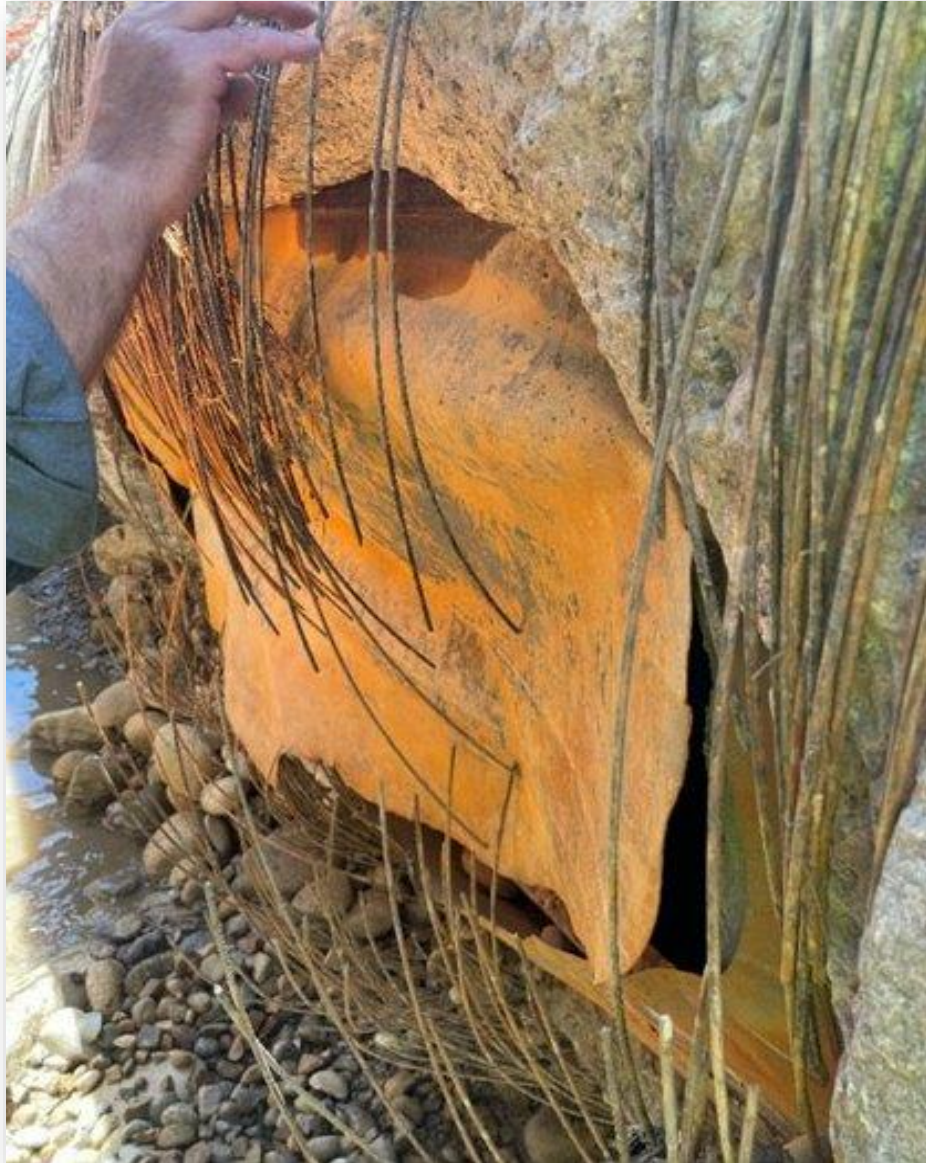
"The cause of the June 5 failure was the **breakage of a sufficient number of prestress wires** in a pipe segment causing loss of pressure resisting capability in the pipe."

"...the ruptured pipe experienced **microcracking or previous mortar damage** allowing soil interaction with the prestress wires. The compromised mortar allowed **Stress Corrosion Cracking and/or Hydrogen Embrittlement** of the prestress wires resulting in brittle wire failures/fractures."

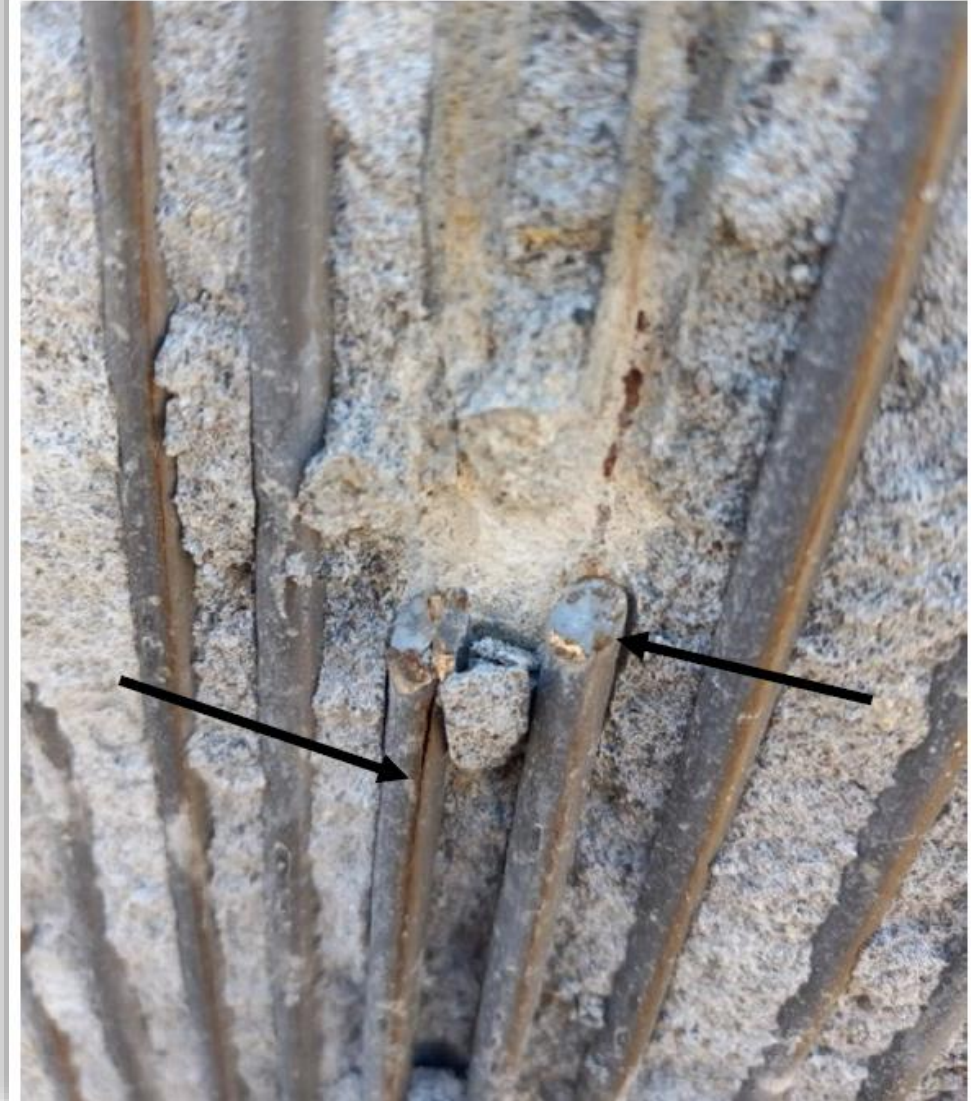
Figure 3-22 Pipe 20202 - Evidence of Brittle Failures

The investigation report yielded the following observations relative to the ruptured and distressed portions of pipe:

- Some pipes showed visible **mortar cracking**, while other pipe had intact mortar.
- Some distressed pipes did have **chlorides penetrate** the mortar, while others showed none.
- Soil testing showed **high chloride soils** in certain areas.
- Severe **pitting and corrosion of the prestress wires** was present, as well as significant quantities of **brittle wire failure**.
- Evidence of **Hydrogen Embrittlement and Stress Corrosion Cracking** due to chloride penetration of the mortar and/or microcracking.

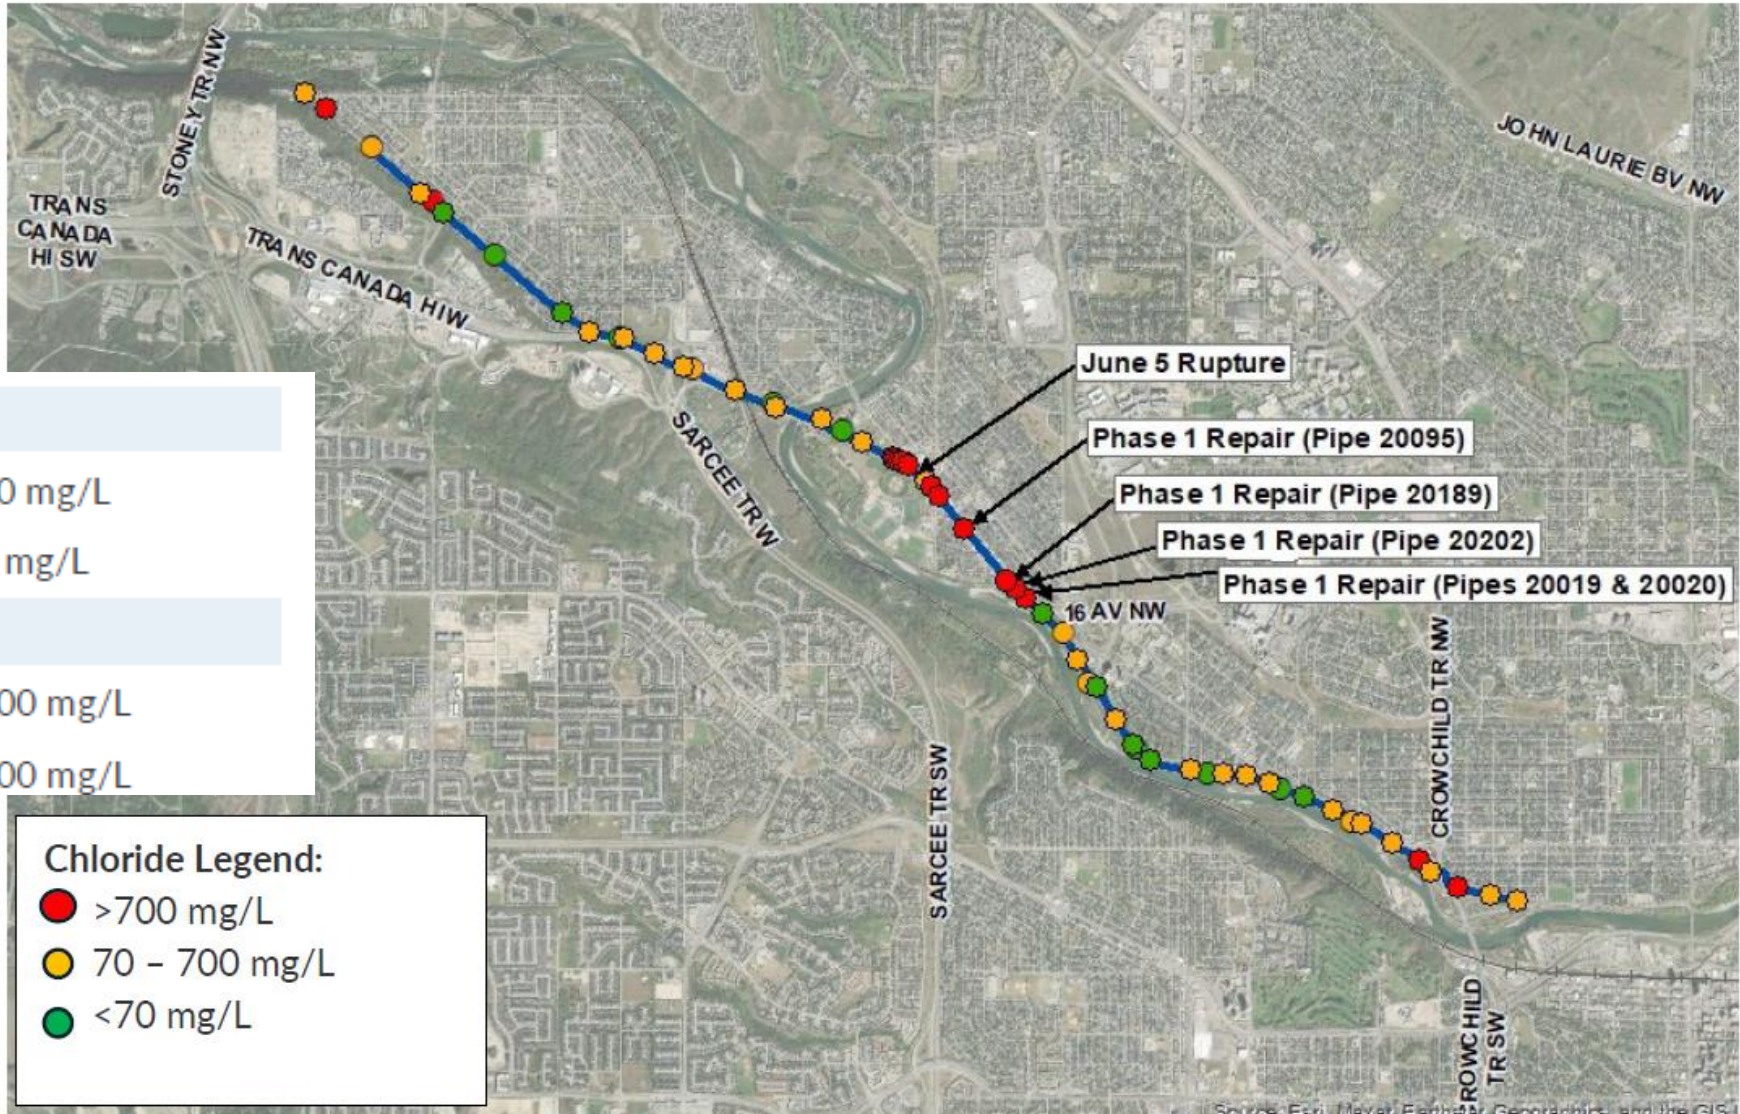
Figure 8-1 Chloride Levels- mg/L

**Strong correlation between distress and chlorides.**

**Chlorides**

- Corrosive > 700 mg/L
- Moderately Corrosive > 70 mg/L

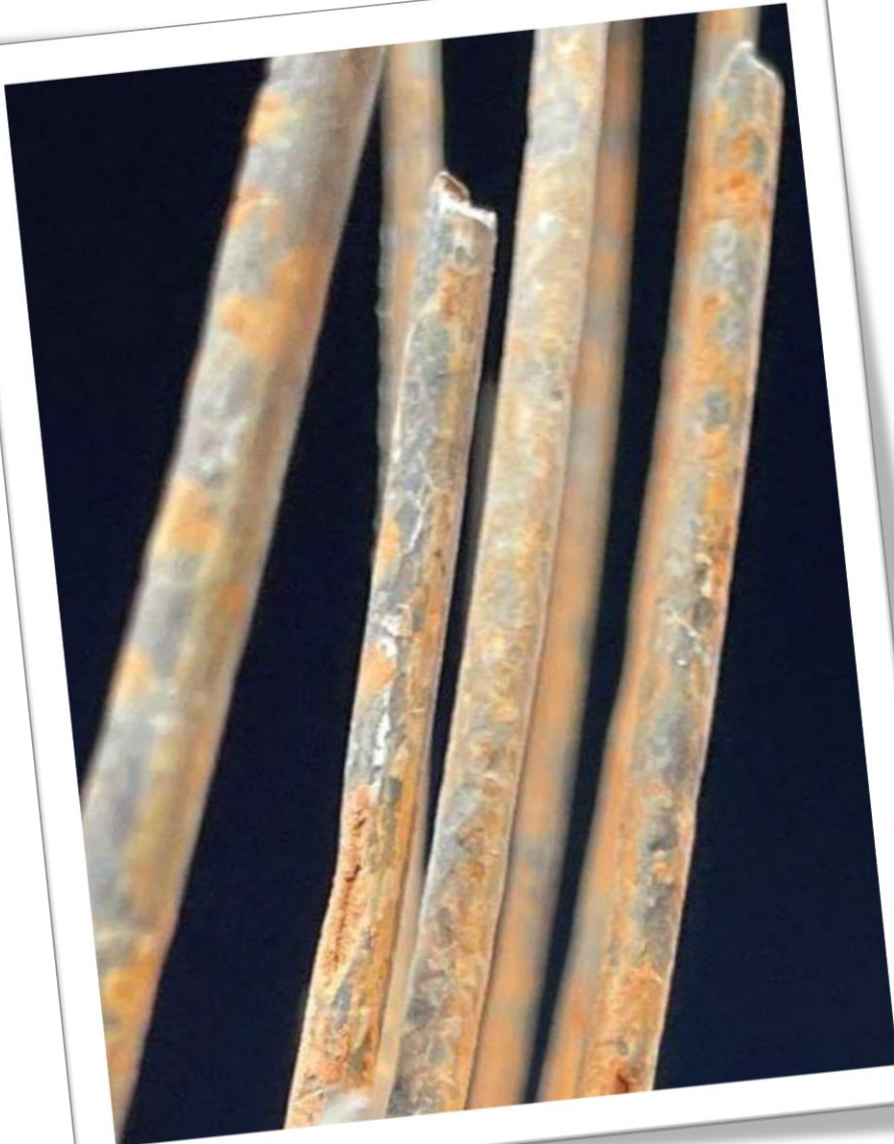
**Strong correlation between distress and chlorides, and likelihood of de-icers contributing to elevated chlorides.**

- The **steel cylinder and wires met standards** at the time of manufacturing.
- The **prestress wires had poor torsional ductility** - not a requirement at the time.
- Some had **longitudinal splits**.
- The wire used in the **pipe that failed had hydrogen embrittlement sensitivity**.
- The wire used in the **5 hot spot pipe had some sensitivity to hydrogen embrittlement**.

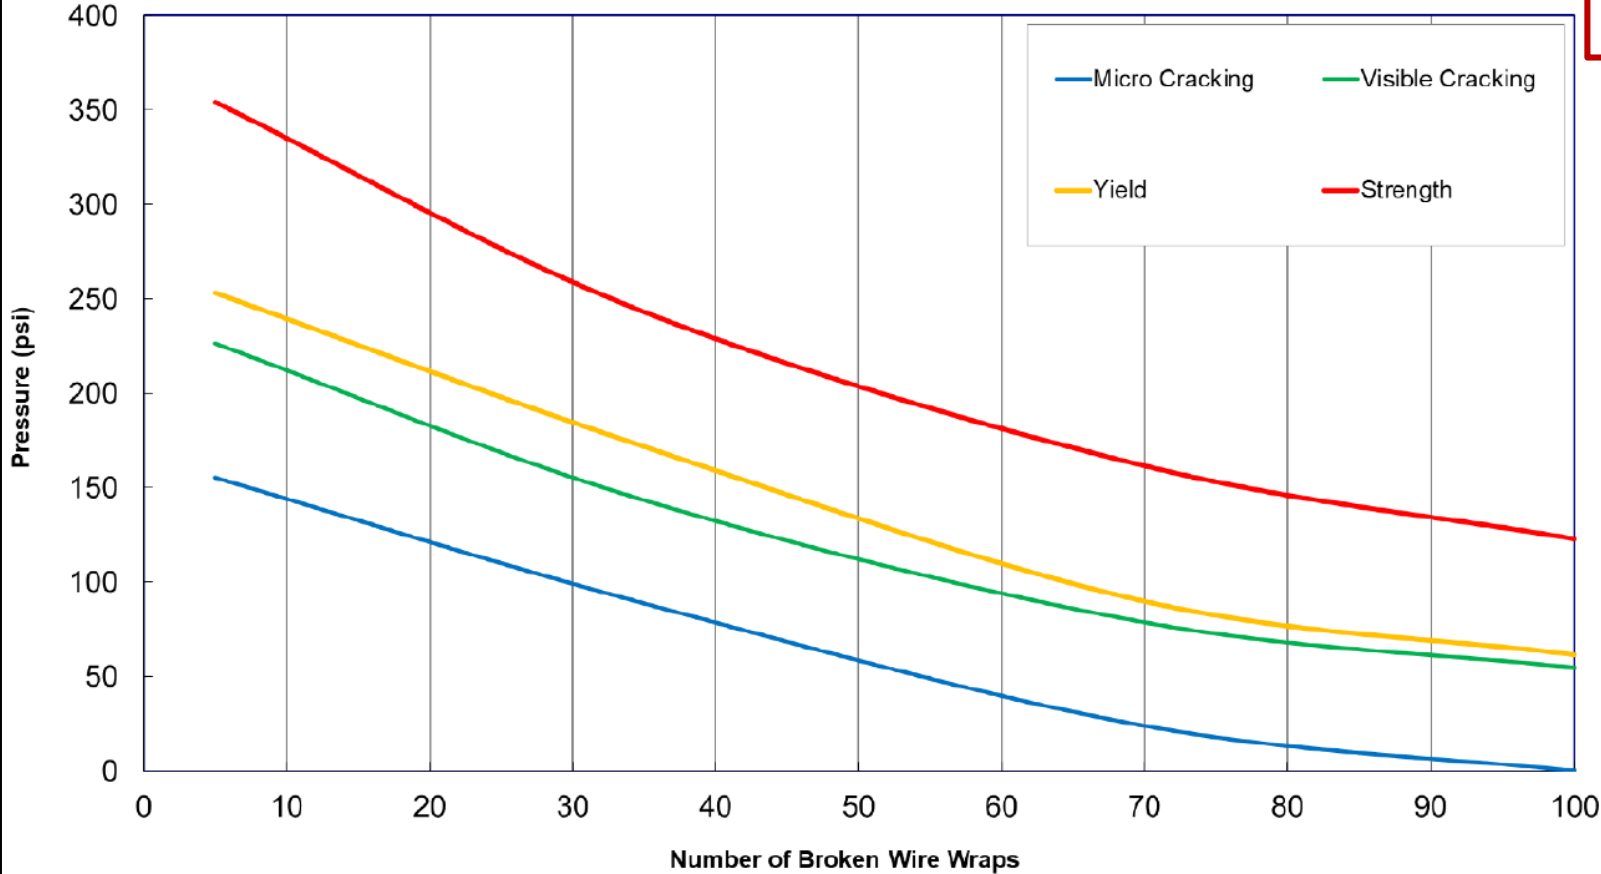
1950-millimetre ECP  
City of Calgary  
2.1 Metres of Earth Cover

The pipe was being operated within structural limits.

Normal working pressure are well within the yield strength and ultimate strength of the pipe.

Pipes could possibly experience microcracking due to mild transient events.

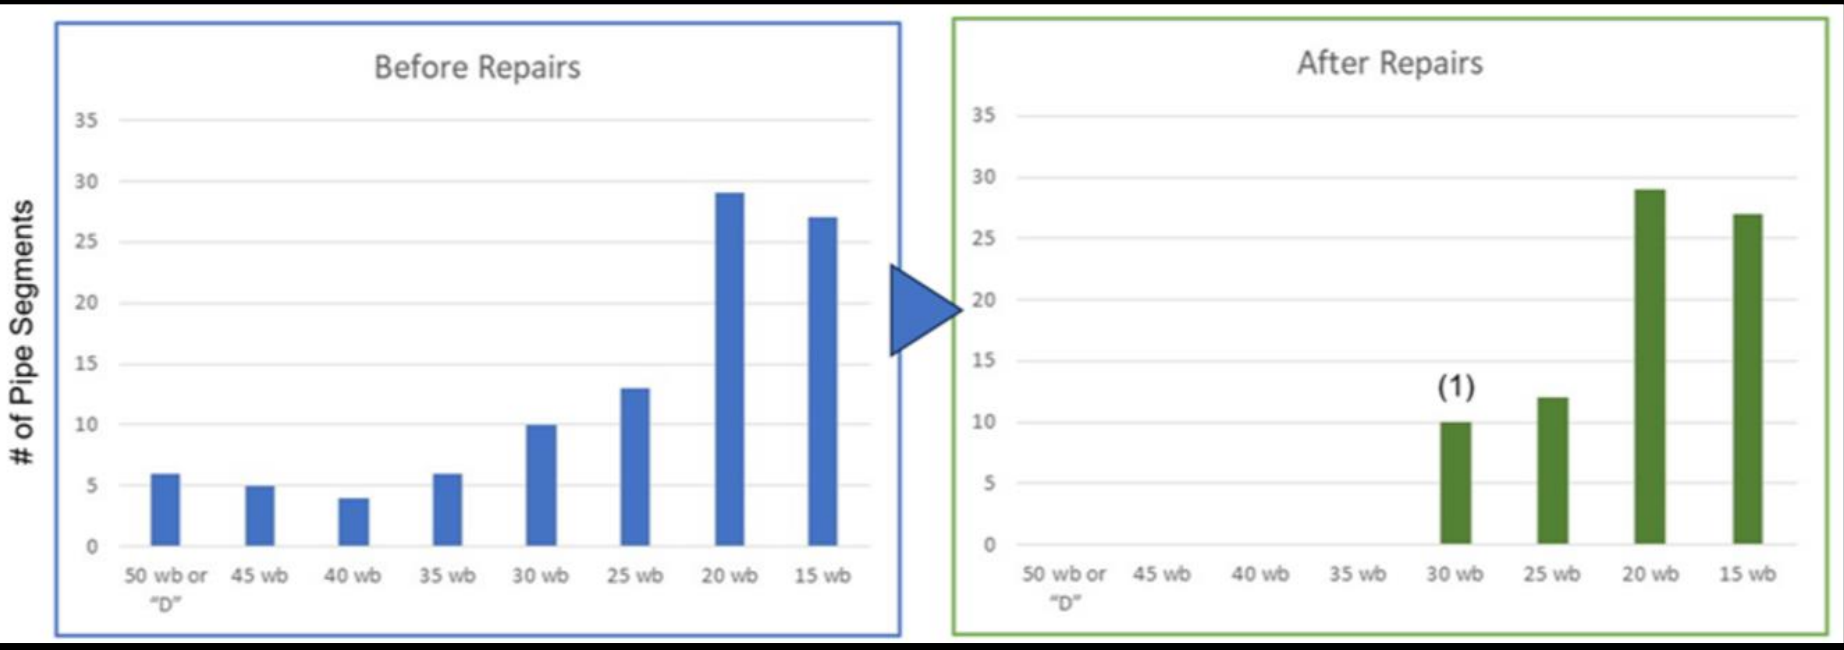
Number of Reinforcing Wire Breaks per Pipe	Recommended Action
0-5	Reinspect at a later date
6-25	Monitor with acoustic monitoring
26-50	Monitor and repair as soon as practical
50+	Emergency Shutdown and Replacement

The feeder main is in good to fair condition, it has stabilized and is being monitored continuously.
