Bearspaw South Feeder Main Pipe Investigation Findings

IP2024-1237

December 11, 2024

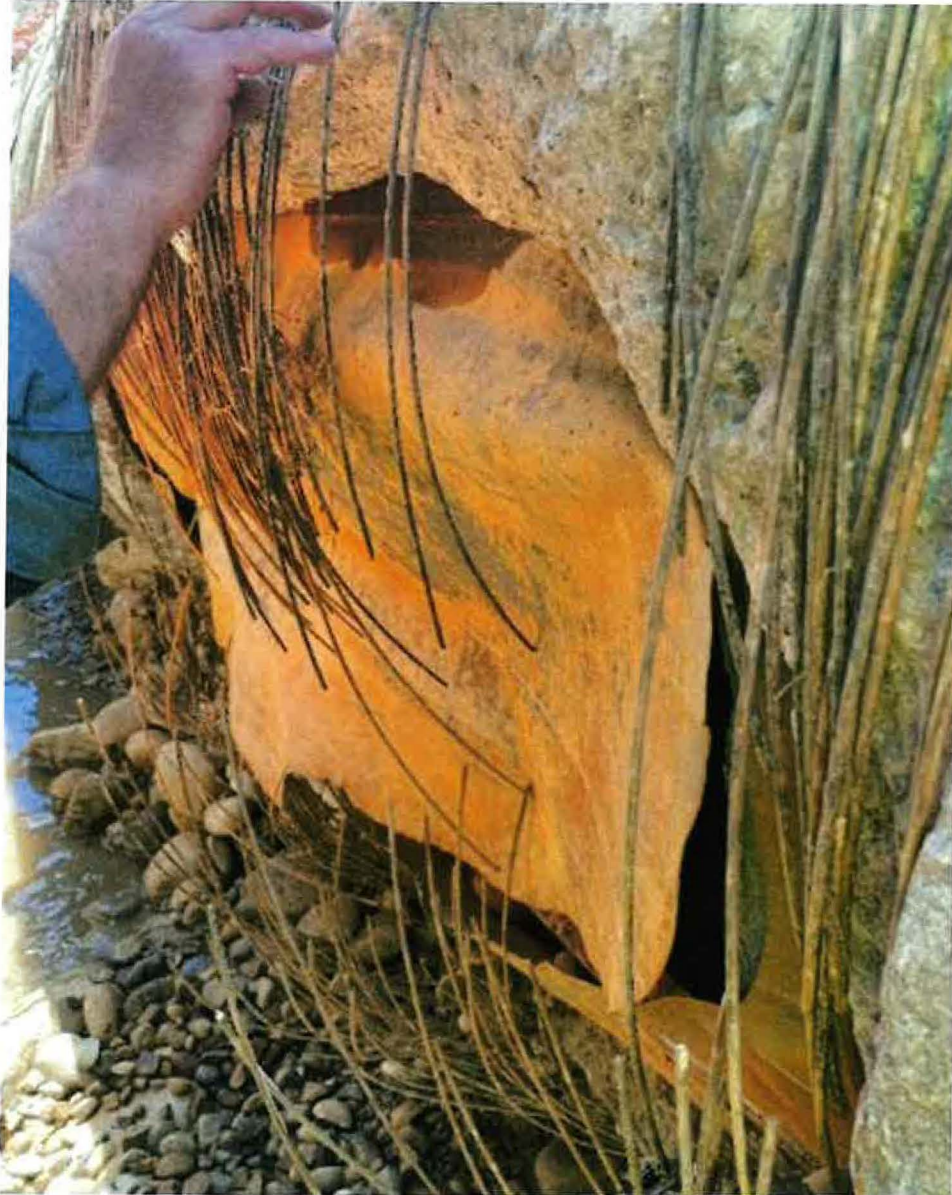
"The cause of the June 5 failure was the **breakage of a sufficient number of prestress wires** in a pipe segment causing loss of pressure resisting capability in the pipe."

"...the ruptured pipe experienced **microcracking or previous mortar damage** allowing soil interaction with the prestress wires. The compromised mortar allowed **Stress Corrosion Cracking and/or Hydrogen Embrittlement** of the prestress wires resulting in brittle wire failures/fractures."

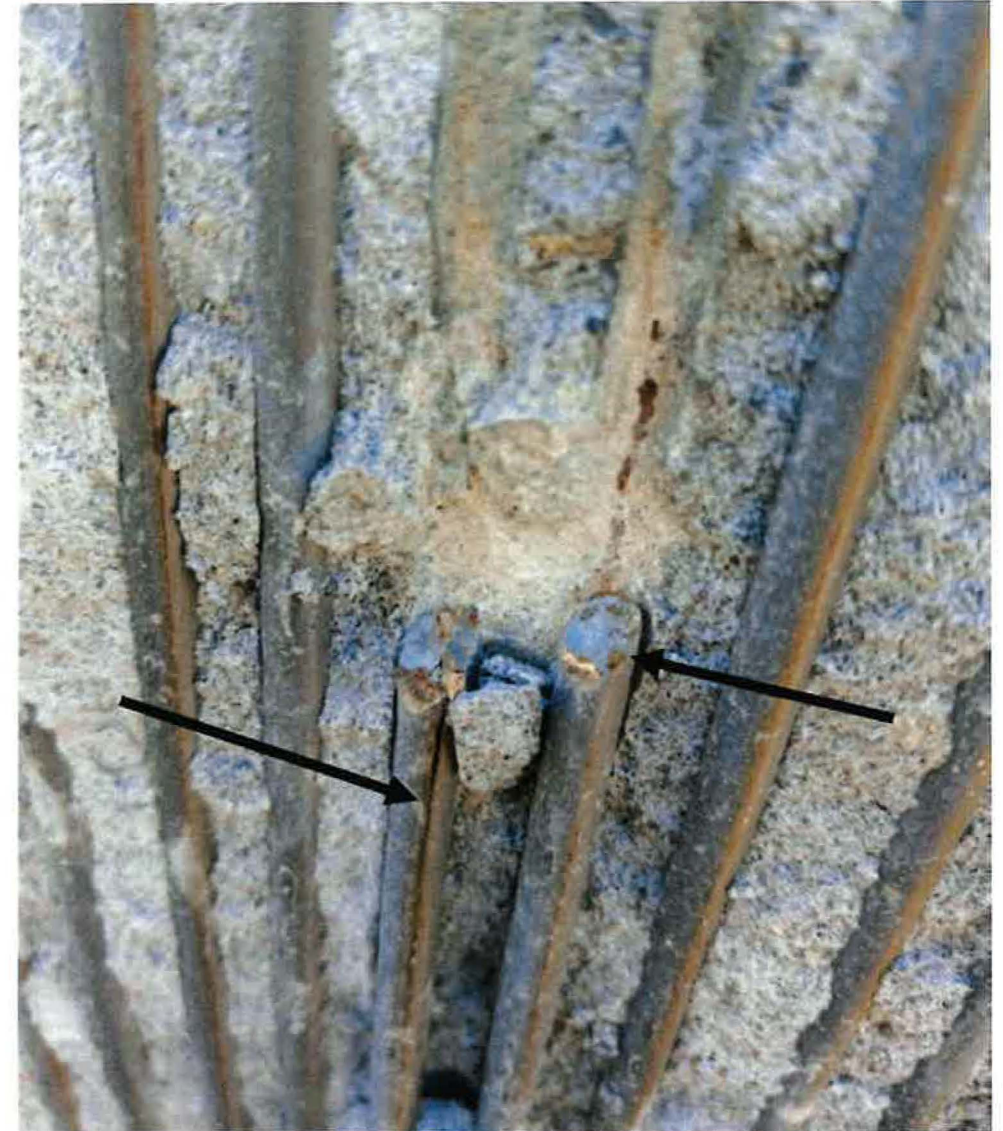
Figure 3-22 Pipe 20202 - Evidence of Brittle Failures

The investigation report yielded the following observations relative to the ruptured and distressed portions of pipe:

- Some pipes showed visible **mortar cracking**, while other pipe had intact mortar.
- Some distressed pipes did have **chlorides penetrate** the mortar, while others showed none.
- Soil testing showed **high chloride soils** in certain areas.
- Severe **pitting and corrosion of the prestress wires** was present, as well as significant quantities of **brittle wire failure**.
- Evidence of **Hydrogen Embrittlement and Stress Corrosion Cracking** due to chloride penetration of the mortar and/or microcracking.

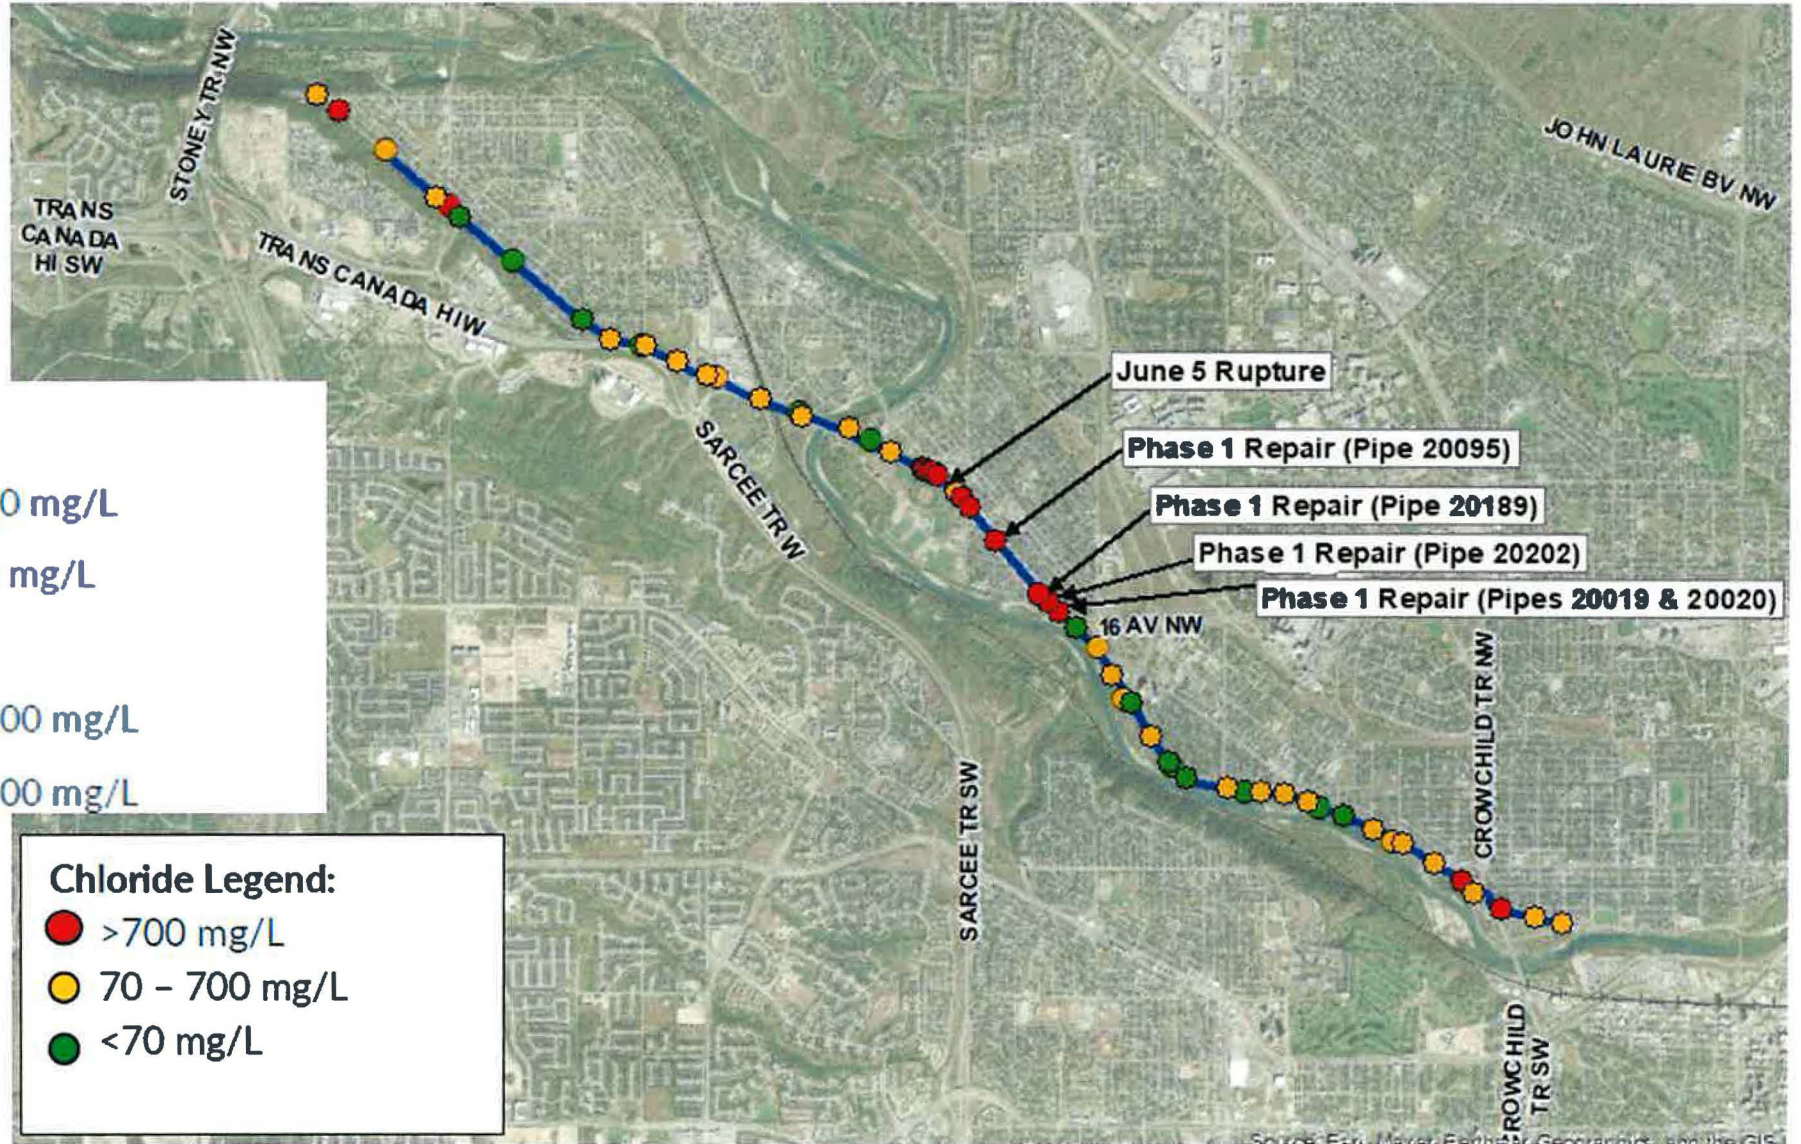
Figure 8-1 Chloride Levels- mg/L

Strong correlation between distress and chlorides.

Strong correlation between distress and chlorides, and likelihood of de-icers contributing to elevated chlorides.

1. Increase our **soil sampling** along critical feeder mains with a specific focus on Chlorides.

3. Continue to investigate the factors that lead to the intermittent presence of **chlorides in soil**.

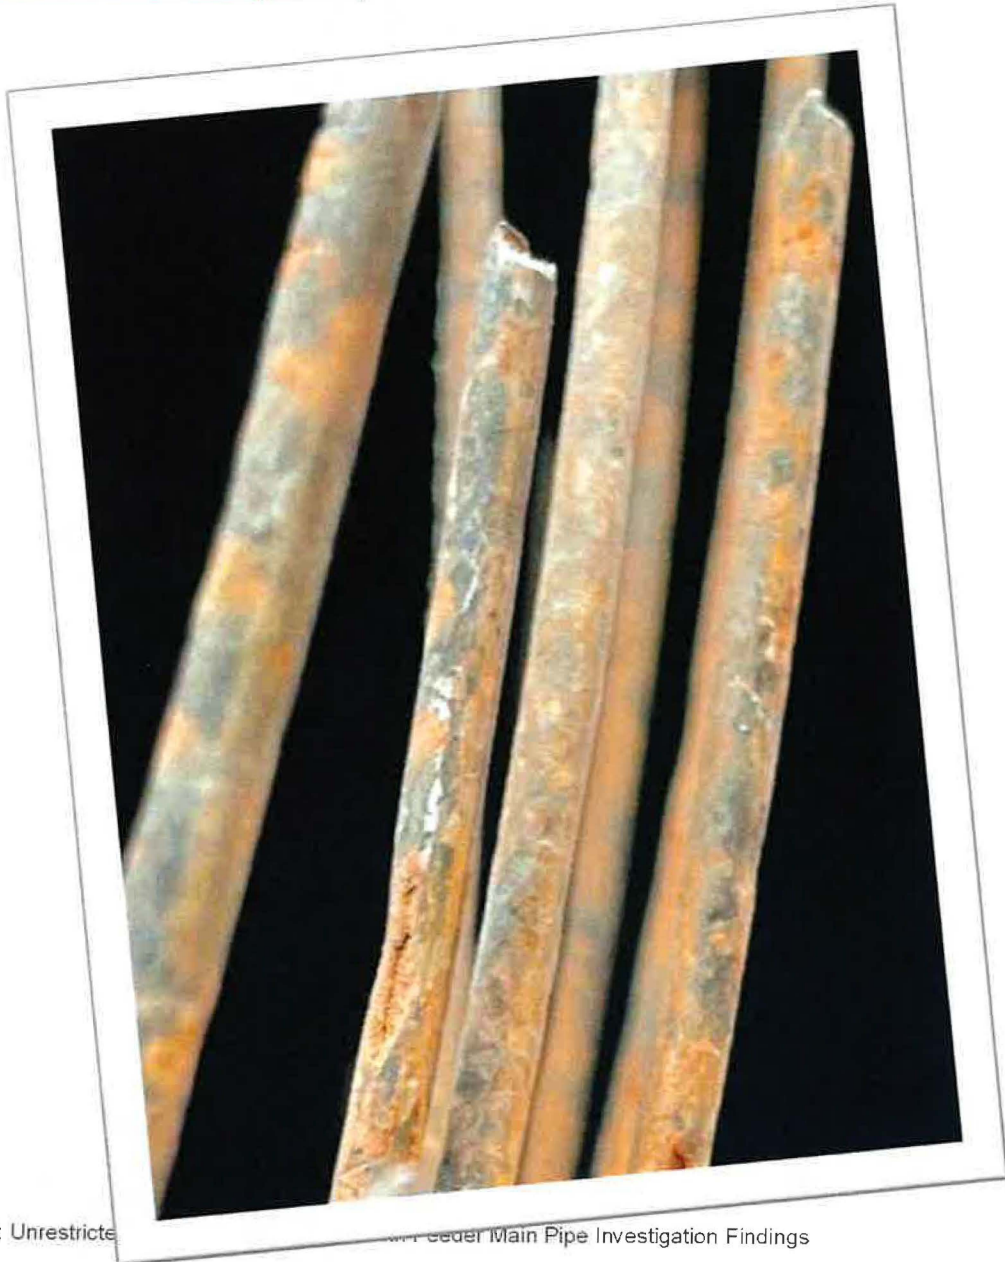
- The **steel cylinder and wires met standards** at the time of manufacturing.
- The **prestress wires had poor torsional ductility** - not a requirement at the time.
- Some had **longitudinal splits**.
- The wire used in the pipe that failed had **hydrogen embrittlement sensitivity**.
- The wire used in the **5 hot spot pipe had some sensitivity to hydrogen embrittlement**.

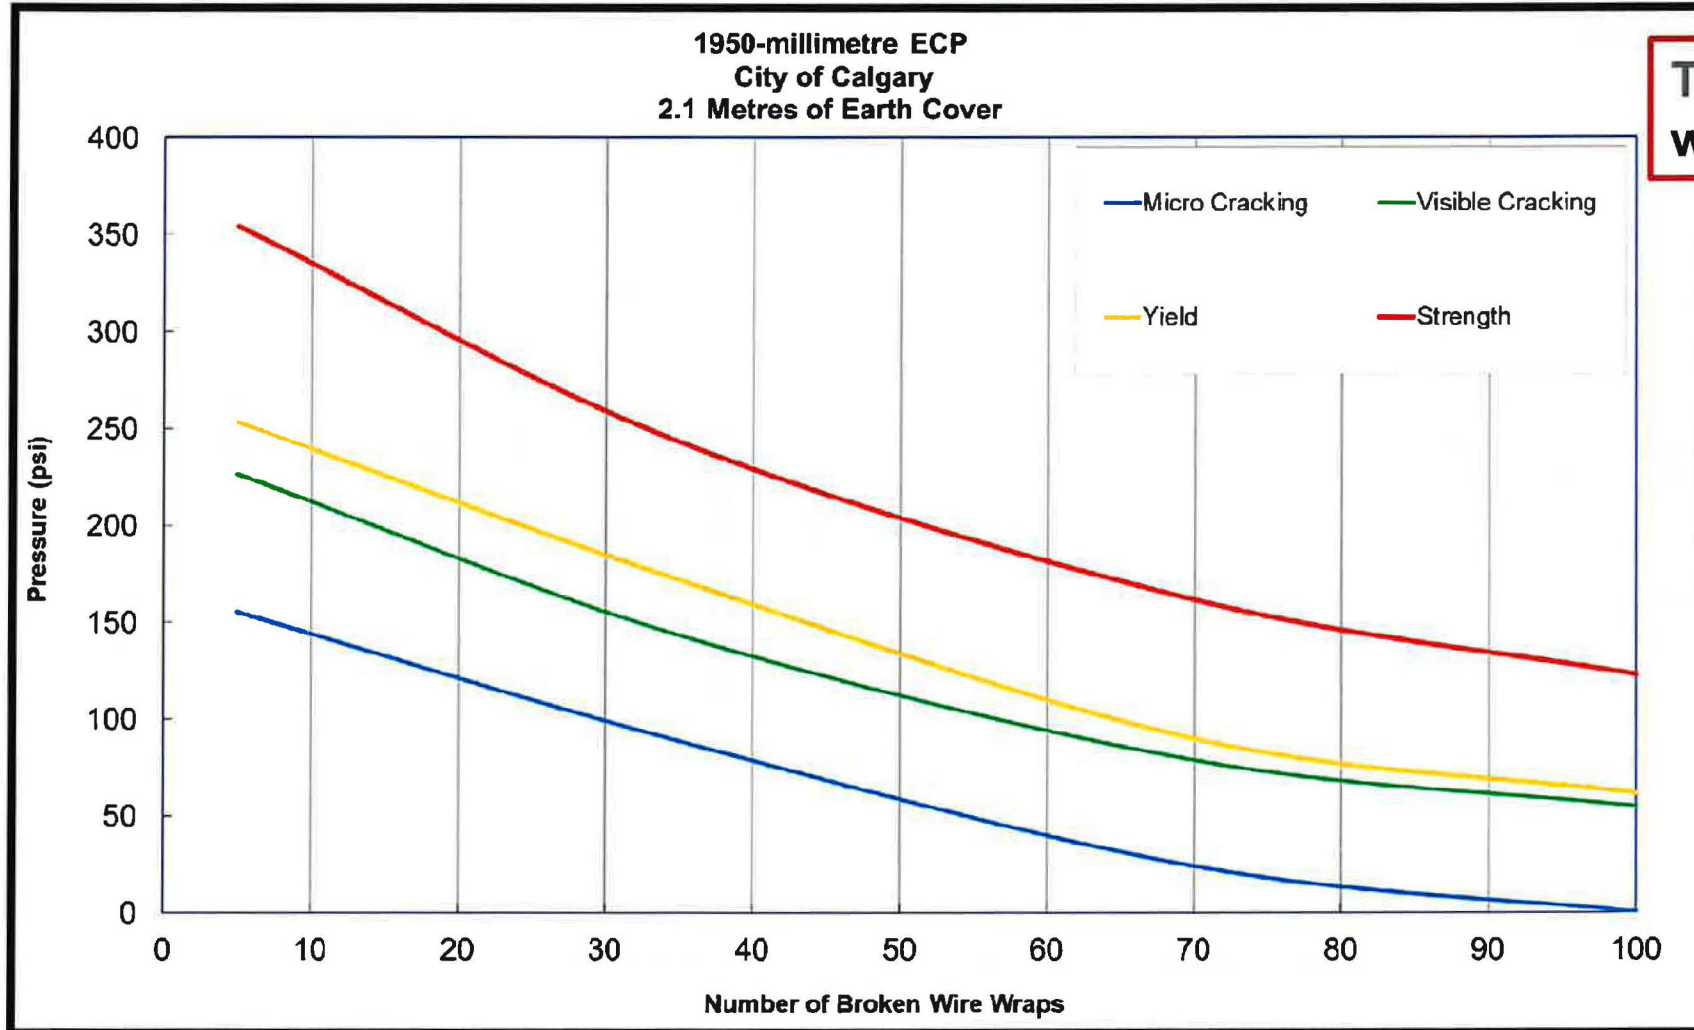
Finite element analysis

The pipe was being operated within structural limits.

Normal working pressure are well within the yield strength and ultimate strength of the pipe.

Pipes could possibly experience microcracking due to mild transient events.

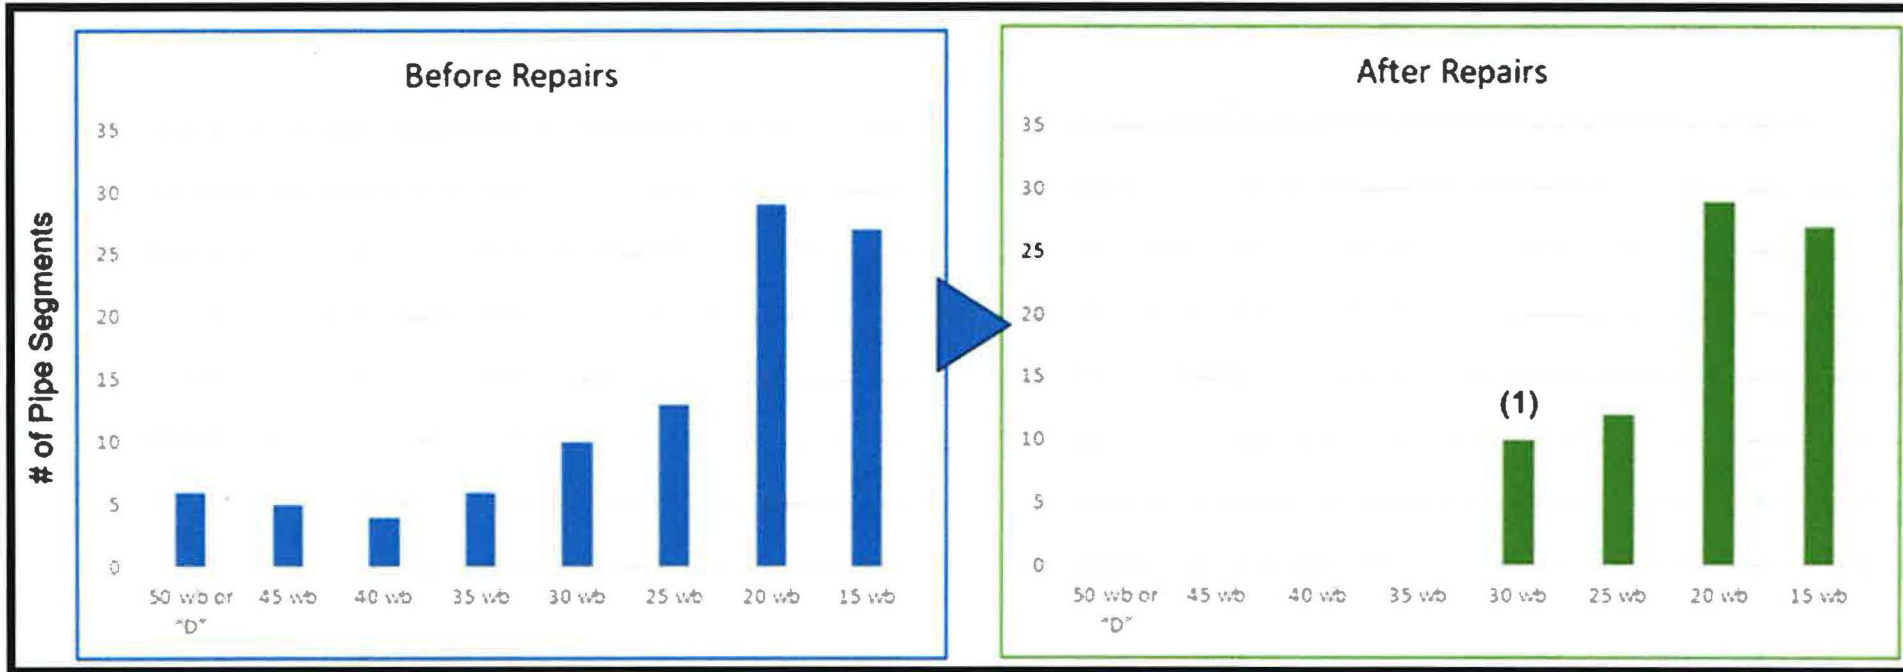
Results of electromagnetic inspection: overall pipe condition

The feeder main is in good to fair condition, it has stabilized and is being monitored continuously.

Number of Reinforcing Wire Breaks per Pipe	Recommended Action
0-5	Reinspect at a later date
6-25	Monitor with acoustic monitoring
26-50	Monitor and repair as soon as practical
50+	Emergency Shutdown and Replacement
