PFC2020-0510 ATTACHMENT 2

FEASIBILITY STUDY

Bow River Regional Pathway Douglasdale/McKenzie Lake Calgary, Alberta

Report Number: 11-1321-0003.2200 Distribution:

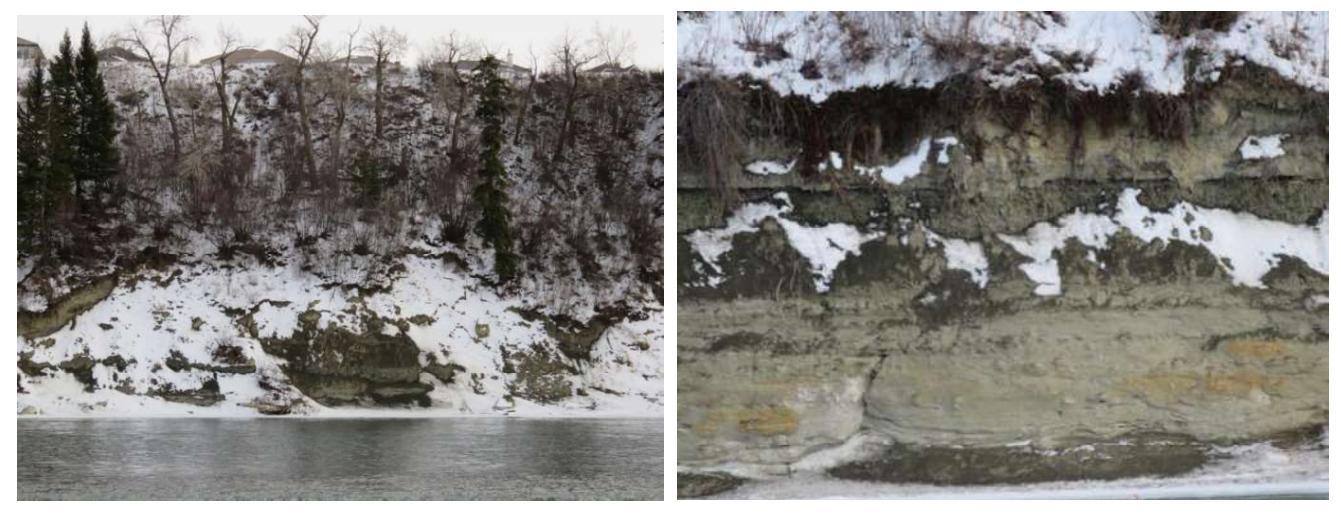
Additional bedrock observations were recorded near the slope toe at approximate elevations ranging between 1,006 to 1,012 masl (or up to 7 m above the toe of the slope) at the southern portion of the Site. Example photographs of the exposed bedrock are shown in Figure 9.

Figure 9: Exposed bedrock observations at slope toe (approximately located at Station 2+550).

The bedrock observed consists of brown, weathered sandy siltstone and mudstone with thin, fine-grained sandstone bedding.

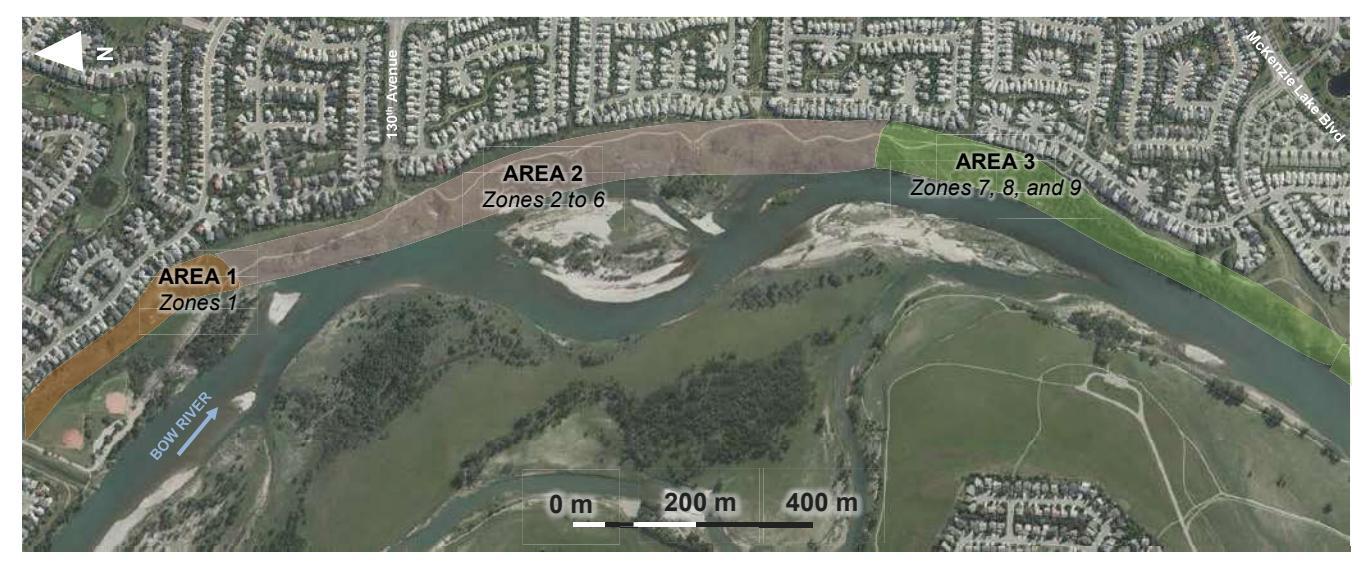
The study area is broken into three distinct areas along the river bank for the purposes of the hydrological study. Upstream Area 1 has low lying banks and is largely vegetated with large mature trees. The river bank along Area 2 is largely vegetated with some bedrock outcrops, and the downstream river bank in Area 3 is steep with exposed bedrock (see Figures 10 and 11).

Figure 10: Area Delineation for River Morphology Assessment (Stn. 0+000 to 3+525)

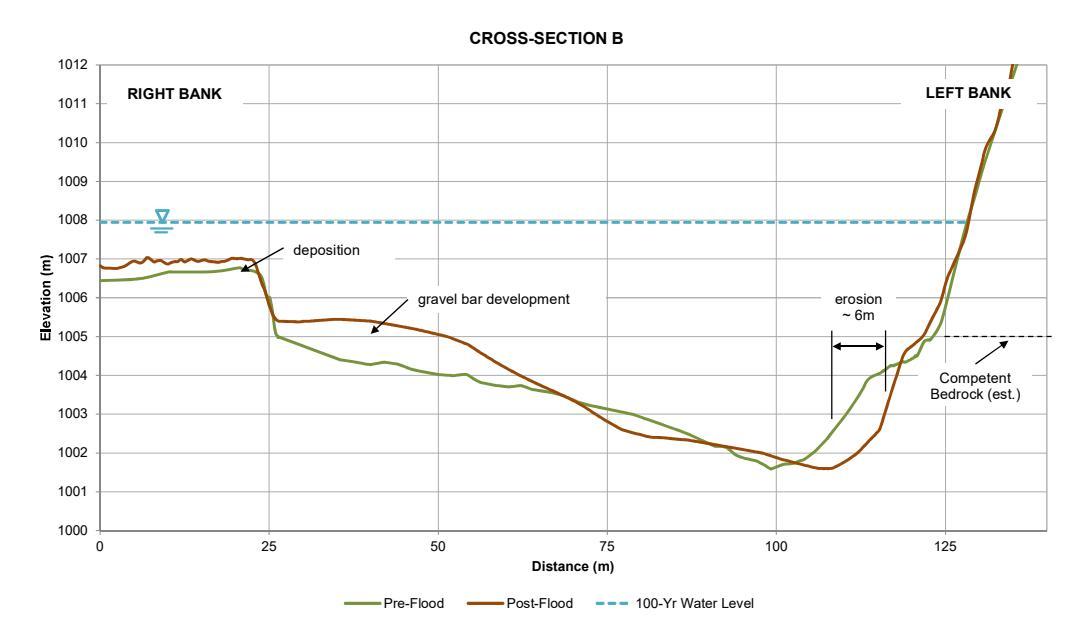
Figure 14: Cross Section Showing Pre and Post-Flood Conditions in Area 1(~ Stn. 0+950)

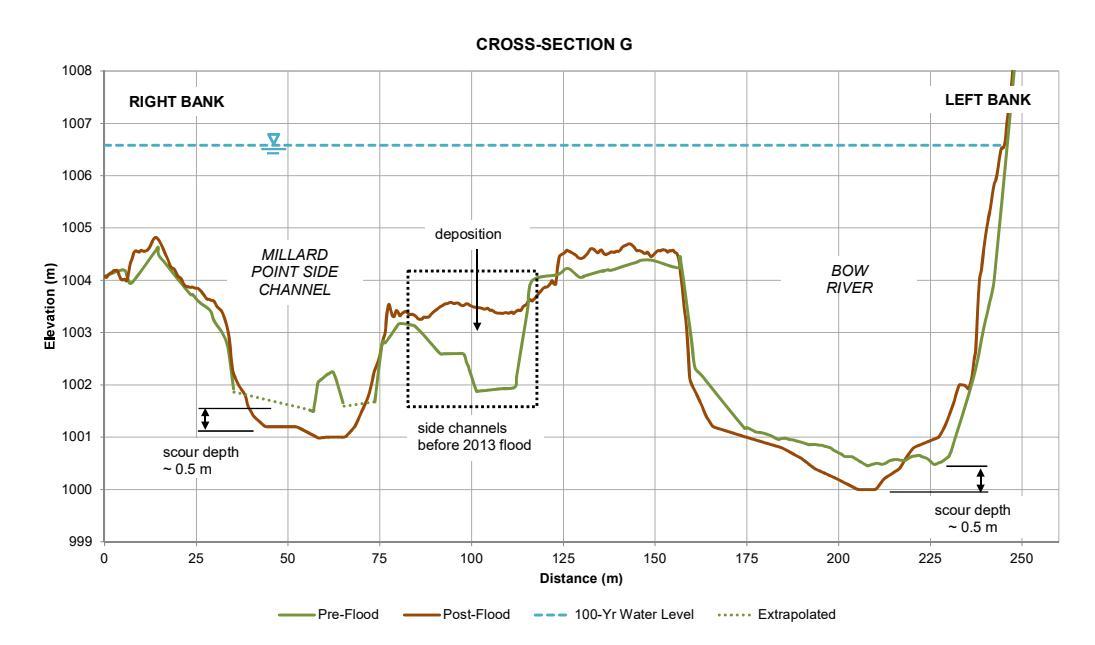
Figure 15: Cross-section Showing Pre and Post-Flood Conditions in Area 2 (~ Stn. 2+200)

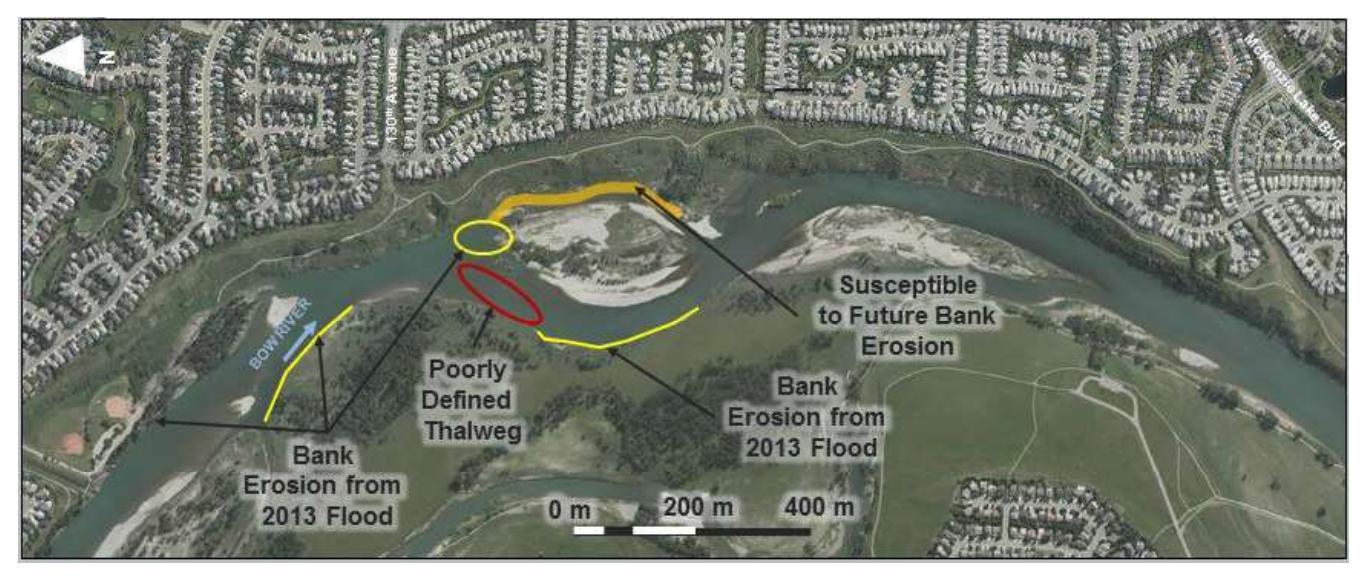
If the thalweg continues to be poorly defined and erosion of the mouth of the side channel continues, the side channel may eventually become the new main channel. As the new main river channel, the existing side channel would likely result in significant initial erosion along the bank. The potential amount of bank erosion along the side channel is uncertain, but is likely to be in excess of 5 m.

Figure 16: Identified Areas for Future Bank Erosion (~Stn. 1+150 to 1+550)
