ITEM #6.2.1 PUD2018-0052 ATTACHMENT 1

BYLAW NUMBER 9M2018

BEING A BYLAW OF THE CITY OF CALGARY TO DESIGNATE THE WEST END TELEPHONE EXCHANGE BUILDING AS A MUNICIPAL HISTORIC RESOURCE

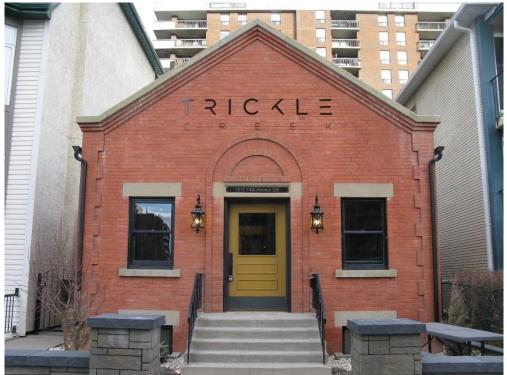
(Image 1.1: South Façade)

- a) The exterior masonry walls of red brick laid common bond pattern with red-pigmented mortar; gabled parapets with sandstone coping (Images 1.1, 1.2, 1.3);
- b) The fenestration with single, wooden-sash single hung windows and wooden-sash multi pane basement windows; sandstone lintels and sills (Image 1.1);
- c) The brick detailing comprising corbelled cornice along gable edge, projecting quoins (at building corners) (Images 1.1, 1.2, 1.3); and
- d) The central front entrance with sandstone lintel and surmounted by brick relief in arch design (Images 1.1).

- a) The long, symmetrical, one-storey rectangular form with medium pitched, front-gable roof; tall red-brick chimney on east elevation (Images 1.1, 2.1, 2.2, 3.1, 4.1); and
- b) The double wall construction with concrete and terra cotta brick interior walls with void of approximately 46cm (18") to 61cm (24") within the two walls.

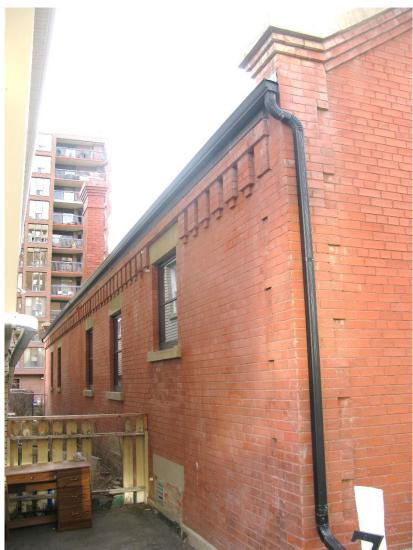
(Image 2.1: oblique view of East Façade looking south)

- a) The exterior masonry walls of red brick laid common bond pattern with red-pigmented mortar (Images 2.1, 2.2, 2.3);
- b) The fenestration with single, wooden-sash single hung windows; sandstone lintels and sills (Images 2.1, 2.2); and
- c) The brick detailing comprising corbelled cornice and corbelled modillions at roof line, projecting quoins (at building corners) (Images 2.1, 2.2, 2.3).

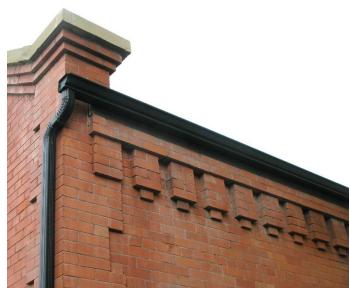
(Image 2.3: example or the brick corbelled cornice with corbelled modillions at roof line, and the projecting quoins at building corners)

- a) The exterior masonry walls of red brick laid common bond pattern with red-pigmented mortar (Image 4.1);
- b) The fenestration with single, wooden-sash single hung windows; sandstone lintels and sills (Image 4.1); and
- c) The brick detailing comprising corbelled cornice and corbelled modillions at roof line, projecting quoins (at building corners) (Images 4.1, 2.3).

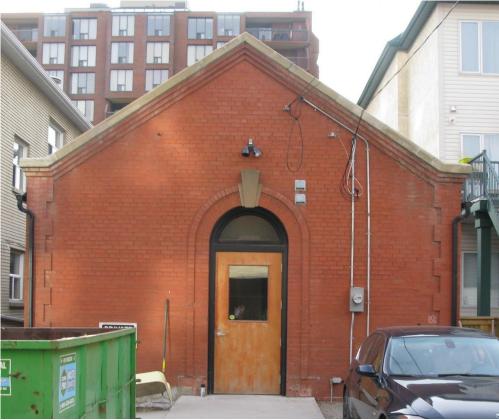
(Image 3.1 North Façade)

- a) The exterior masonry walls of red brick laid common bond pattern with red-pigmented mortar; gabled parapets with stone coping (Images 3.1, 1.2, 1.3);
- b) The brick detailing comprising corbelled cornice under gable, projecting quoins (at building corners) (Images 3.1, 1.2, 1.3); and
- c) The central arched entrance surrounded by brick relief in an arch design with sandstone keystone (Image 3.1).
