ATTACHMENT 3:

Feasibility Study Boundary, Timeline of Closures
and Slope FailuresTT2015-0816
ATTACHMENT 3

History of slope movements

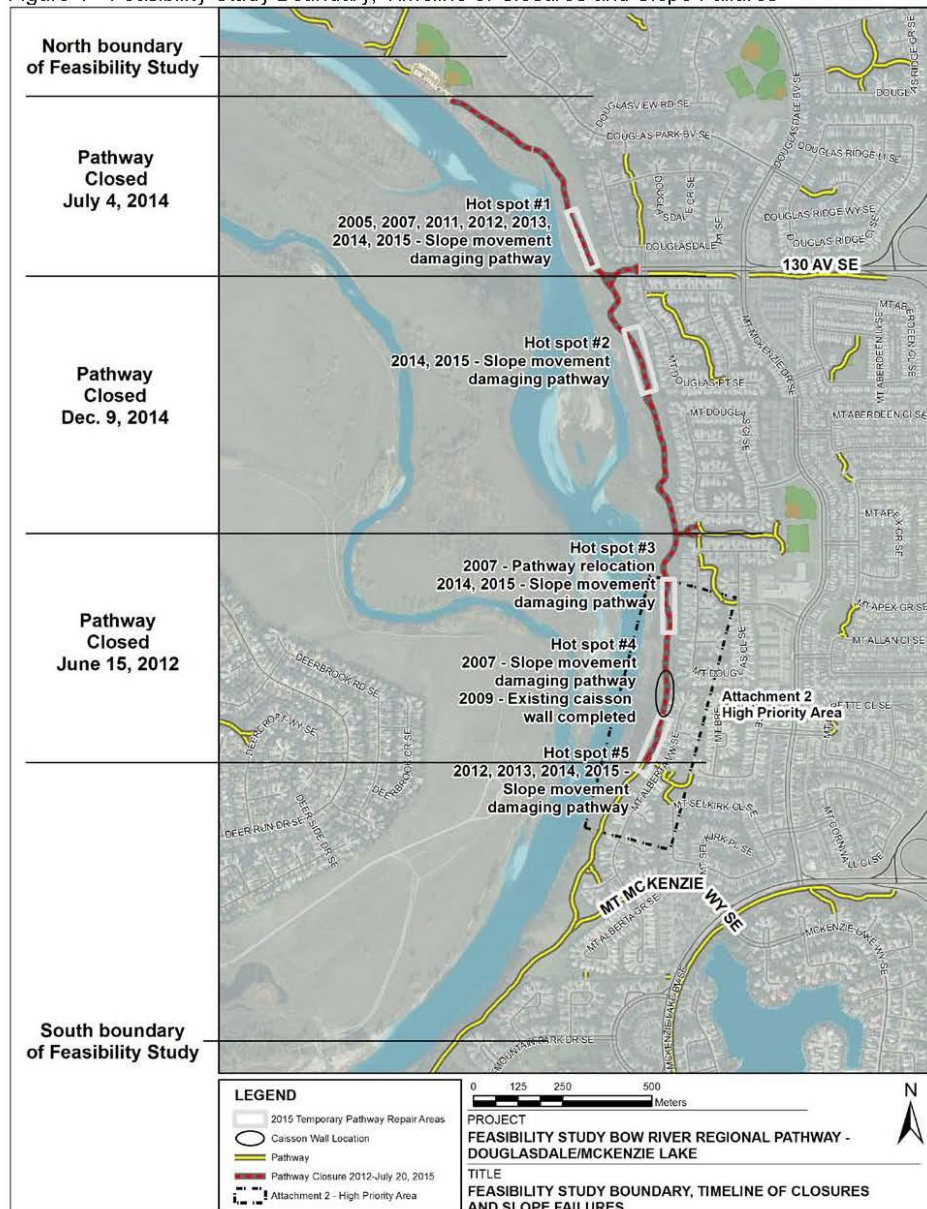
Figure 1 - Feasibility Study Boundary, Timeline of Closures and Slope Failures

Figure 1 below shows the timeline of Pathway closures and slope failures and the boundary of the *Feasibility Study Bow River Regional Pathway Douglasdale/ McKenzie Lake, Calgary AB, Draft* (Feasibility Study) completed by Golder Associates in 2015 included as Attachment 2.

The Pathway has sustained damage from active slope movement following heavy rain and extreme weather events of 2005, 2007, 2011, 2012, 2013, 2014 and 2015. From 2012 to 2015 sections of the Pathway were closed to the public as shown in Figure 1. In 2015 August, the City completed temporary minor repairs to temporarily reopen the Pathway to the public. The repairs are not intended to stabilize the slope. It is unknown when new slope movements will occur and how long the Pathway will be able to remain open to the public. The history of slope movements, damage to the pathway and expenditures is below.
