## **Proposed Wording for a Bylaw to Designate the East Calgary Telephone Exchange Building as a Municipal Historic Resource**

## **SCHEDULE "B"**

## REGULATED PORTIONS

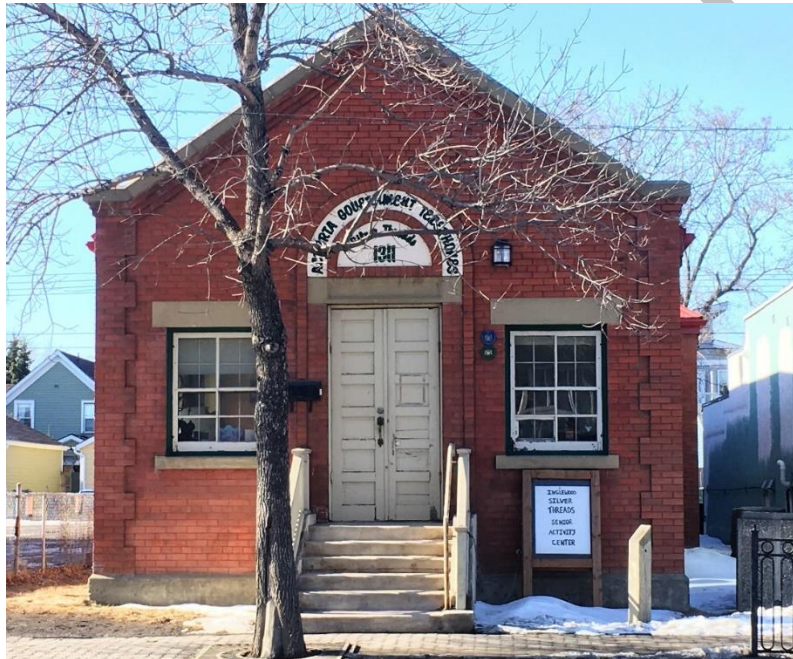
(Image 1.1: North façade)

- a) The exterior masonry walls of red brick laid common bond pattern with red-pigmented mortar and gabled parapets with sandstone coping (Images 1.1 and 1.3);
- b) The fenestration with single, 2-over-4 multi-pane wooden sash storm windows and 1-over-1 wooden sash windows and sandstone lintels and sills (Images 1.1 and 2.2);
- c) The brick detailing comprising corbelled cornice along gable edge and projecting quoins (at building corners) (Images 1.1, 1.3 and 2.2); and
- d) The central front entrance with sandstone lintel and surmounted by brick relief in Roman-arch design and wooden paneled door (Images 1.1, 1.2 and 1.4).

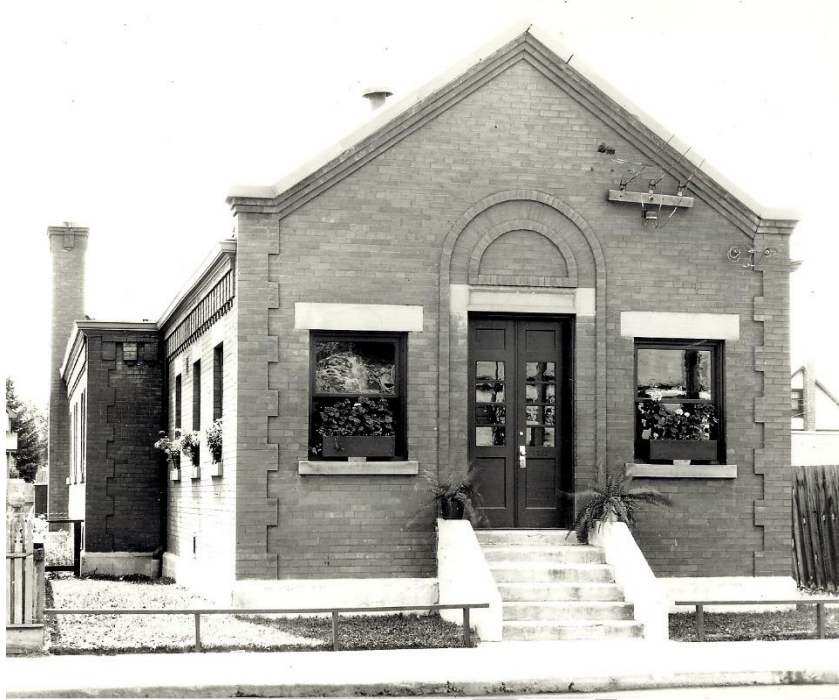
(Image 1.2: Historic image of north façade showing the original 1-over-1 sash windows and Roman arch above the central front entrance, ca. 1910-1920, Copyright AGT Archive)

Note: This does not preclude a return to the original 1-over-1 sash window style or the door style as seen in Image 1.2.

Note: This does not preclude a return to the original 1-over-1 sash window style as seen in Image 1.2.

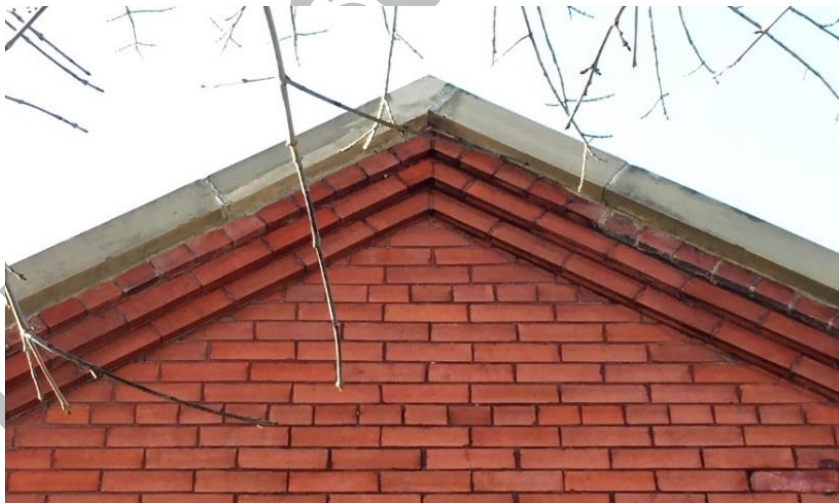
(Image 1.3: Detail of common bond pattern red brick with red-pigmented mortar and corbelled cornice at gable edge with sandstone cap)

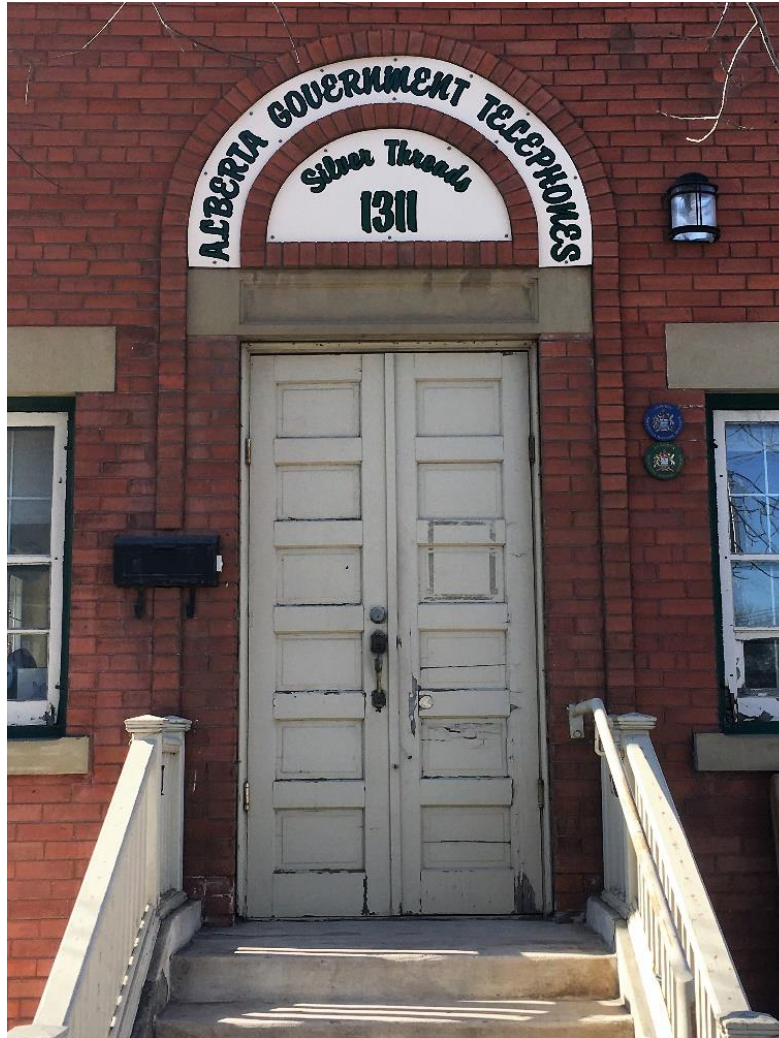
(Image 1.4: Detail of central front entrance with sandstone lintel and surmounted by brick relief in Roman-arch design)

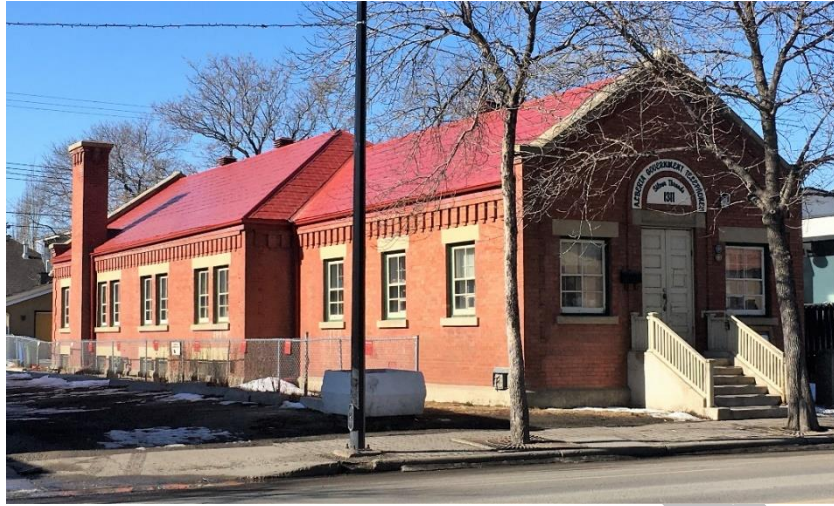
(Image 2.1: Oblique view of east façade with rear addition added 1912-1913)

- a) The exterior masonry walls of red brick laid common bond pattern with red-pigmented mortar (Image 2.1);
- b) The fenestration with 2-over-4 multi-pane wooden sash storm windows and 1-over-1 wooden sash windows and sandstone lintels and sills (Images 2.1 and 2.2);
- c) The brick detailing comprising corbelled cornice and corbelled modillions at roof line and projecting quoins (at building corners) (Images 2.1 and 2.3); and
- d) Tall, exterior red-brick chimney on east elevation of rear addition with corbelled modillions and sandstone cap (Images 2.1 and 2.4).

- a) The long, symmetrical, one-storey rectangular form with medium pitched, front-gable roof; rear addition which mirrors form of original with tall red-brick chimney on east elevation with corbelled modillions and sandstone cap (Image 2.1); and
- b) The double wall construction with concrete and terra cotta brick interior walls with void of approximately 46cm (18") to 61cm (24") within the two walls.

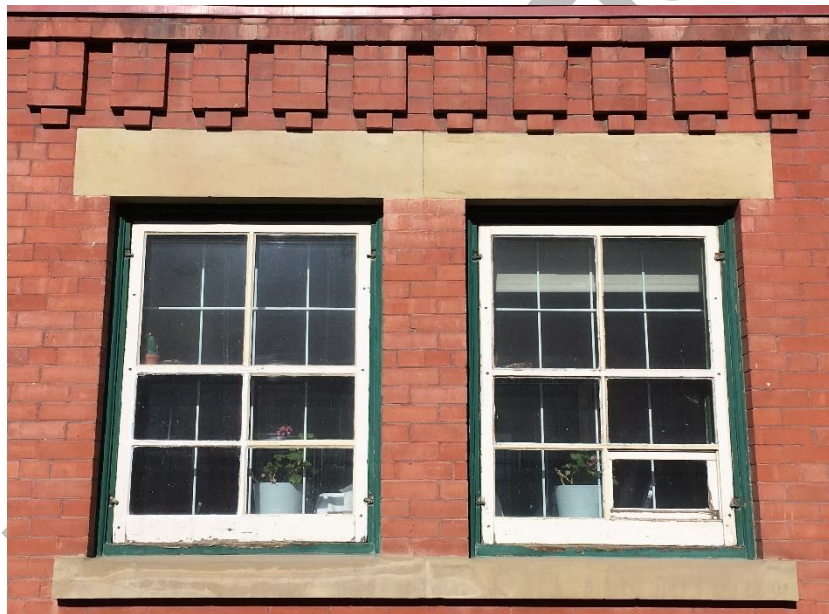
(Image 2.2: Typical fenestration and corbelled modillions on side elevations)

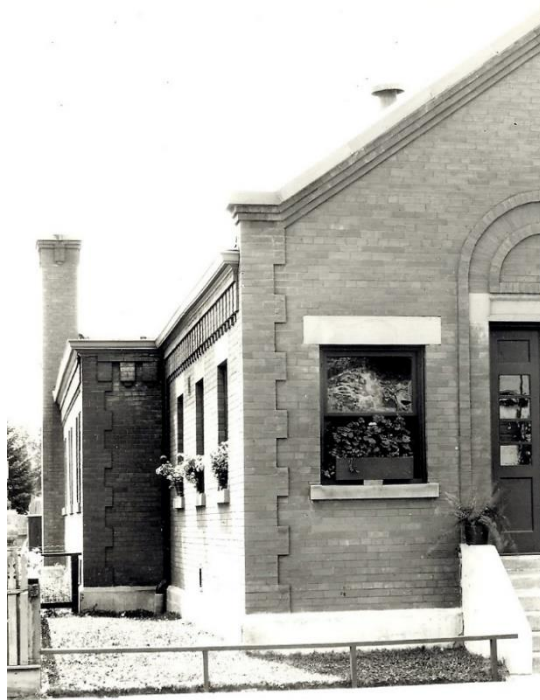
(Image 2.3: Historic image showing detail of quoins at building corner, 1910-1920, Copyright AGT Archive)

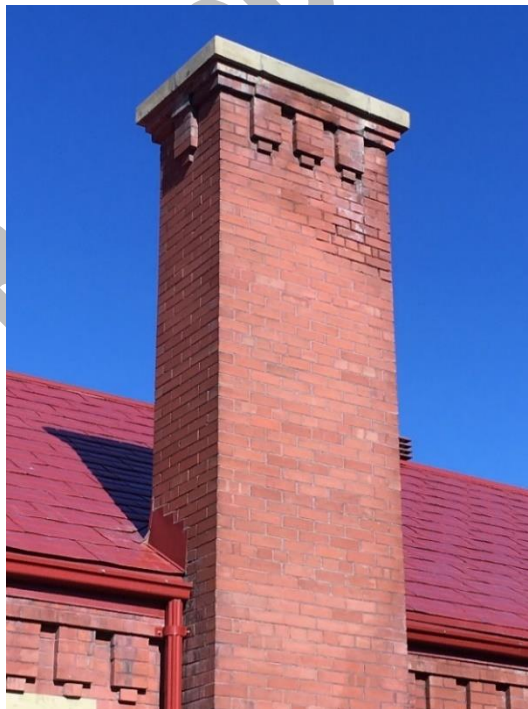
(Image 2.4: Detail of corbelled modillions and sandstone cap of red-brick chimney on east façade of rear addition)

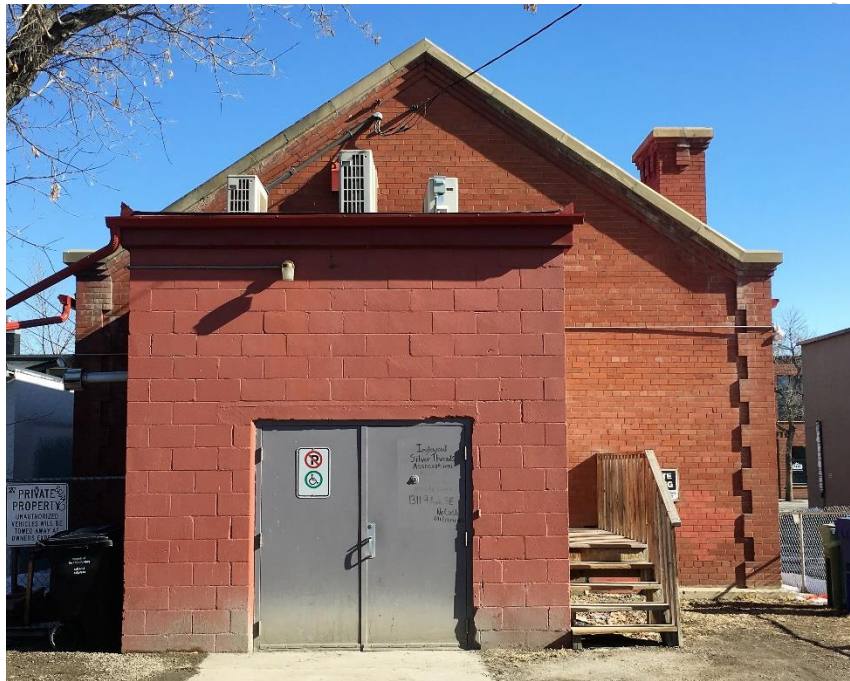
(Image 3.1: South façade with ca. 1955 cinder block rear extension)

- a) The exterior masonry walls of red brick laid common bond pattern with red-pigmented mortar and gabled parapets with stone coping (Image 3.1); and
- b) The brick detailing comprising corbelled cornice under gable and projecting quoins (at building corners) (Image 3.1)

Note: the single-storey extension built ca.1955, is not regulated and a return to original configuration/appearance would not be precluded where documentation of original configuration exists.

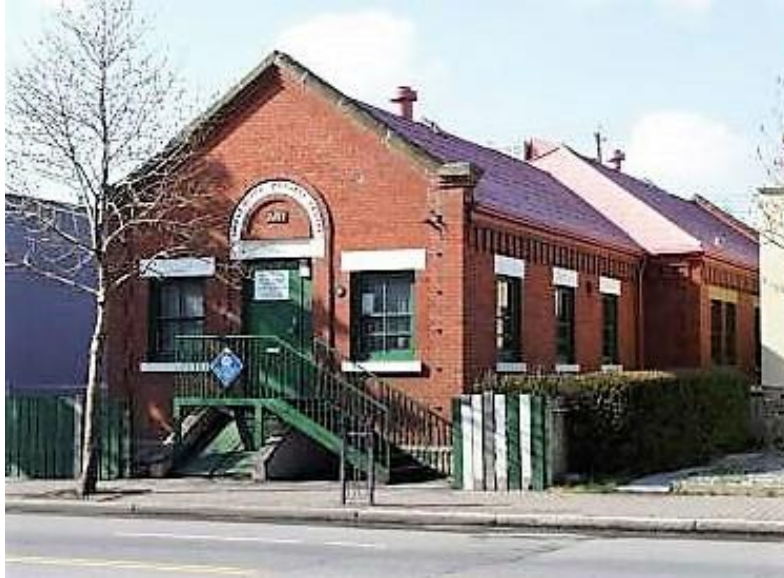
(Image 4.1: Oblique view west façade looking southeast, ca. 1990s)

- a) The exterior masonry walls of red brick laid common bond pattern with red-pigmented mortar (Images 4.1 and 4.2);
- b) The fenestration with 2-over-4 multi-pane wooden sash storm windows and 1-over-1 wooden sash windows and sandstone lintels and sills (Images 4.1 and 4.2); and
- c) The brick detailing comprising corbelled cornice and corbelled modillions at roof line and projecting quoins (at building corners) (Images 4.1 and 4.2).

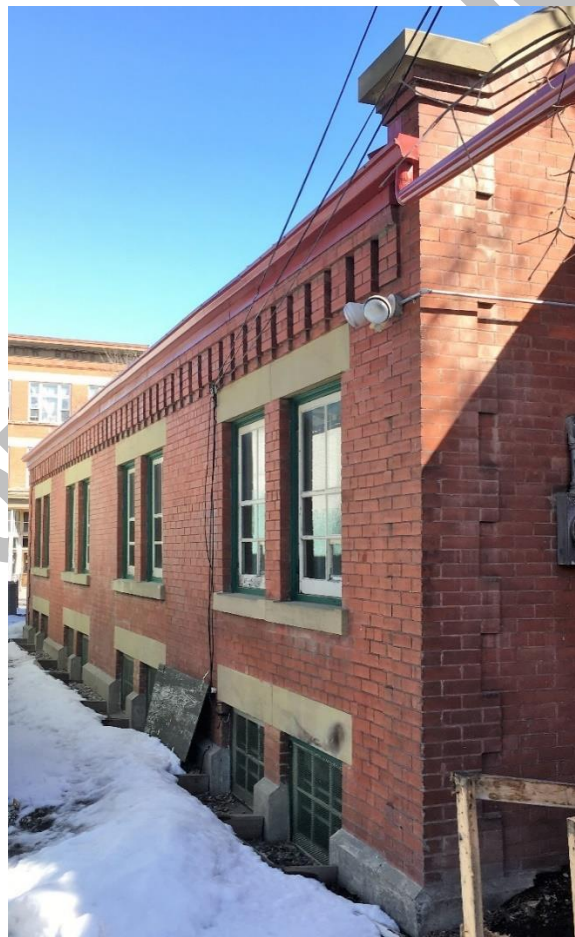
(Image 4.2: Oblique view west façade rear addition looking northeast)
