## **Proposed Wording for a Bylaw to Designate the Grant (Jones) Residence as a Municipal Historic Resource**

## **SCHEDULE “B”**

The Grant (Jones) Residence is a wood-frame one-and-one-half-storey Craftsman style bungalow built in 1913 by W. Hope Grant. It is located on two lots in the area originally known as the Parkdale Addition (now Parkdale). The home was built during the city's boom years (1906-13) just as the land was being annexed to accommodate the need for more housing.

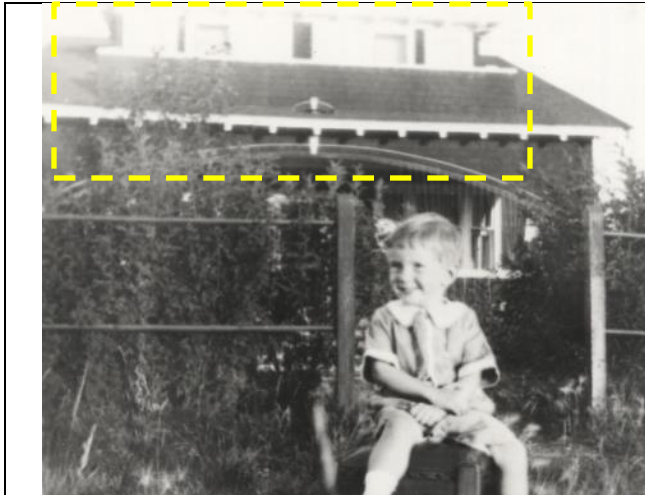
Image 2.3: Historic image c1928 showing upper balcony open and uncovered; solid ballustrade with arched drainage opening with keystone decoration; mirrored fenestraion consisting of four 1-over1 windows and two doors

Note: Main floor façade on southeast façade is not regulated below the gabled roof line eaves (Image 2.7). A return to original configuration/appearance would not be precluded where documentation of original configuration exists (Images 2.1-2.4, 3.9 and 3.10).

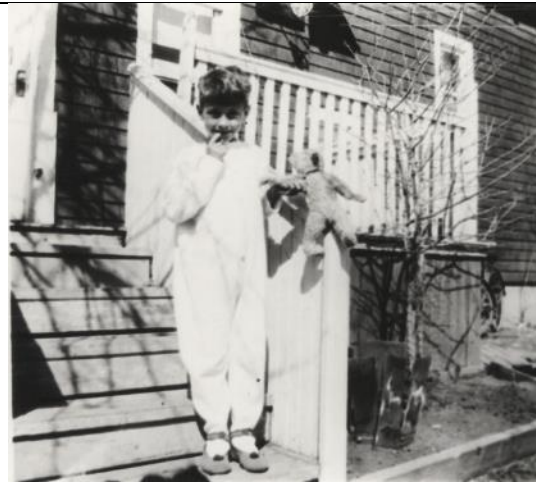
Image 2.4: Historic image showing rear entry.

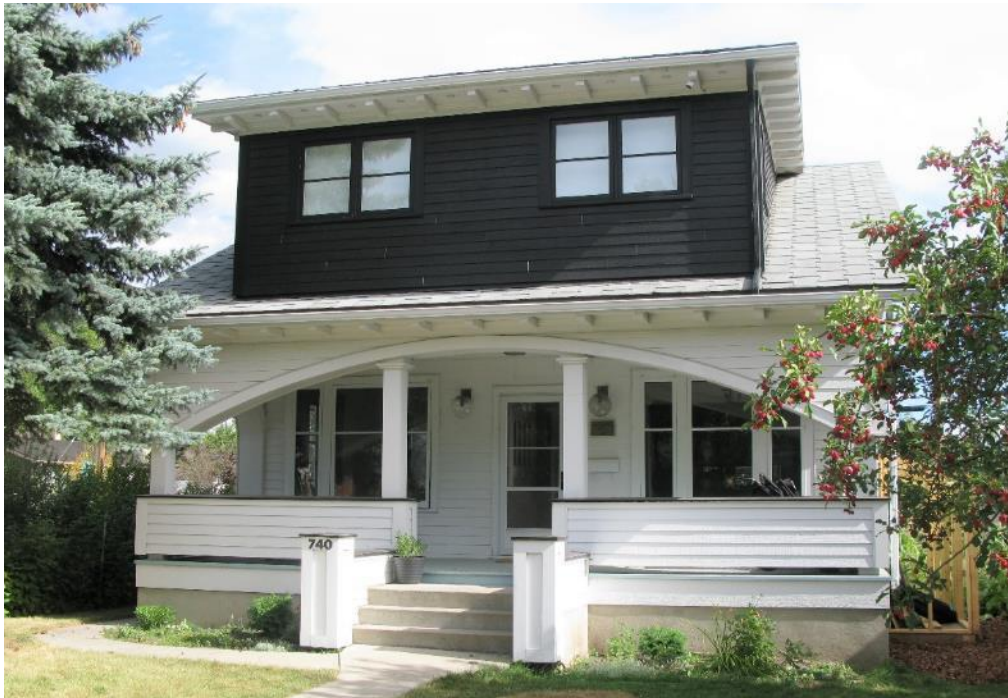
(Image 2.5: Northwest façade showing six original wood windows composed into two triple assemblies on the main floor; sweeping curved opening on porch)

- a) One and one-half story massing; rectangular plan; wood cladding (Images 2.5-2.8);
- b) Side-gabled roof with with shed roof extensions; wood eaves with exposed wood rafter tails with squared ends (shed roof extensions) or beveled ends (gabled roof); plain wood fascia; wood tongue-and-groove soffits (Images 2.3, 2.5-2.9);
- c) Full-width covered porch with curved openings; upper storey balcony (Images 2.1-2.3, 2.5, 2.6, 2.8, 2.10); and
- d) Original extant fenestration with wood single hung windows including: 1-over-1 single, double, and triple assembly windows (Images 2.1-2.8, 2.11-2.13).

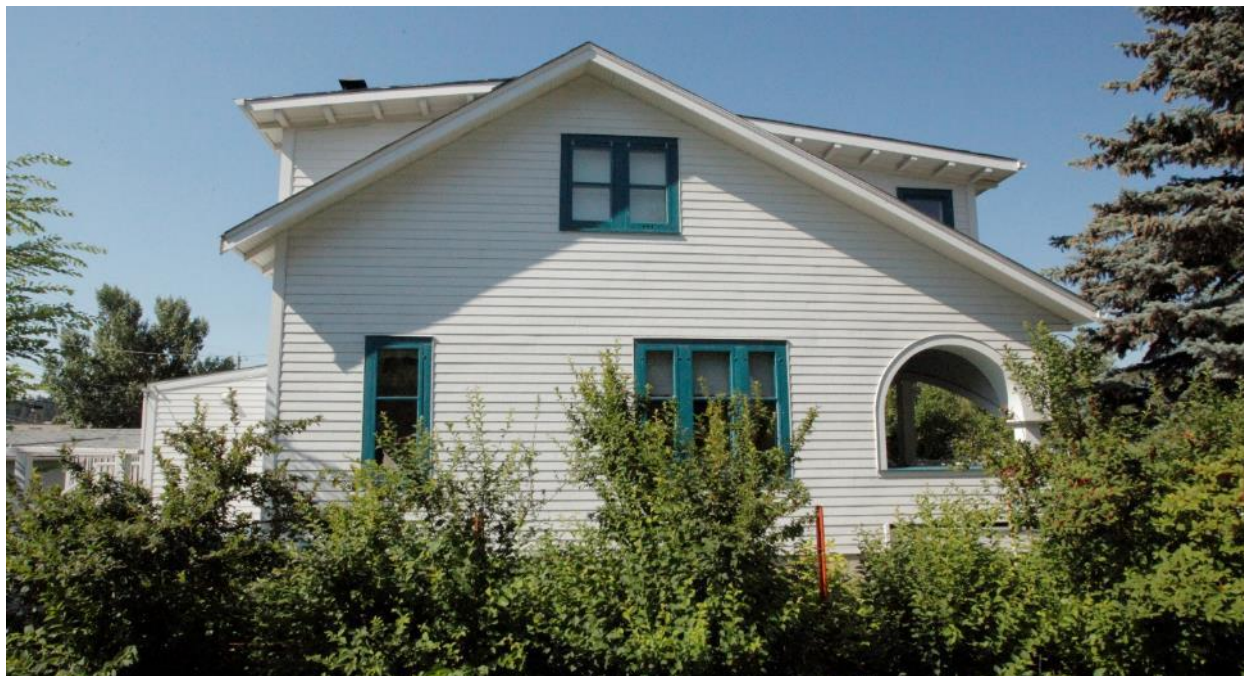
(Image 2.6: Northeast façade showing six 1-over-1 wood windows, three of which are in a triple assembly and two in a double assembly; curved opening on side of porch)

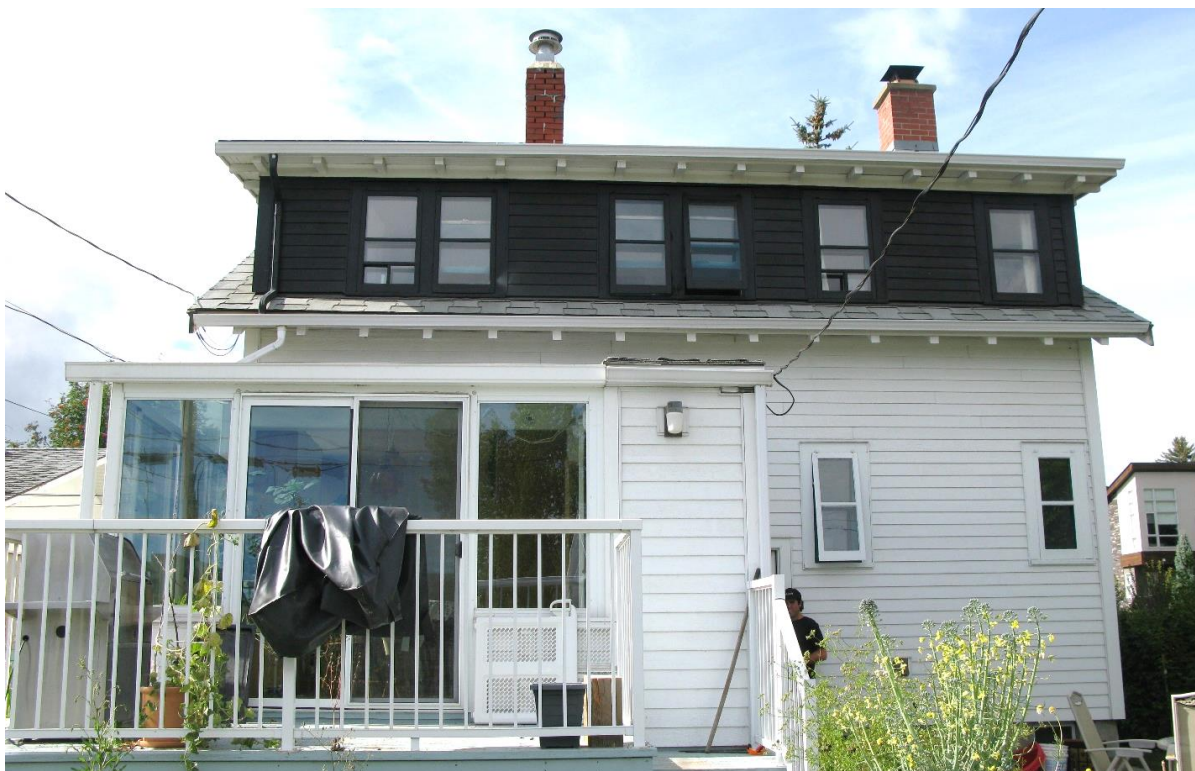
(Image 2.7: Southeast façade showing shed roof extension with six original 1-over-1 wood windows, four of which are in double assemblies. Note: Main floor façade on southeast façade is not regulated below the gabled roof line eaves)

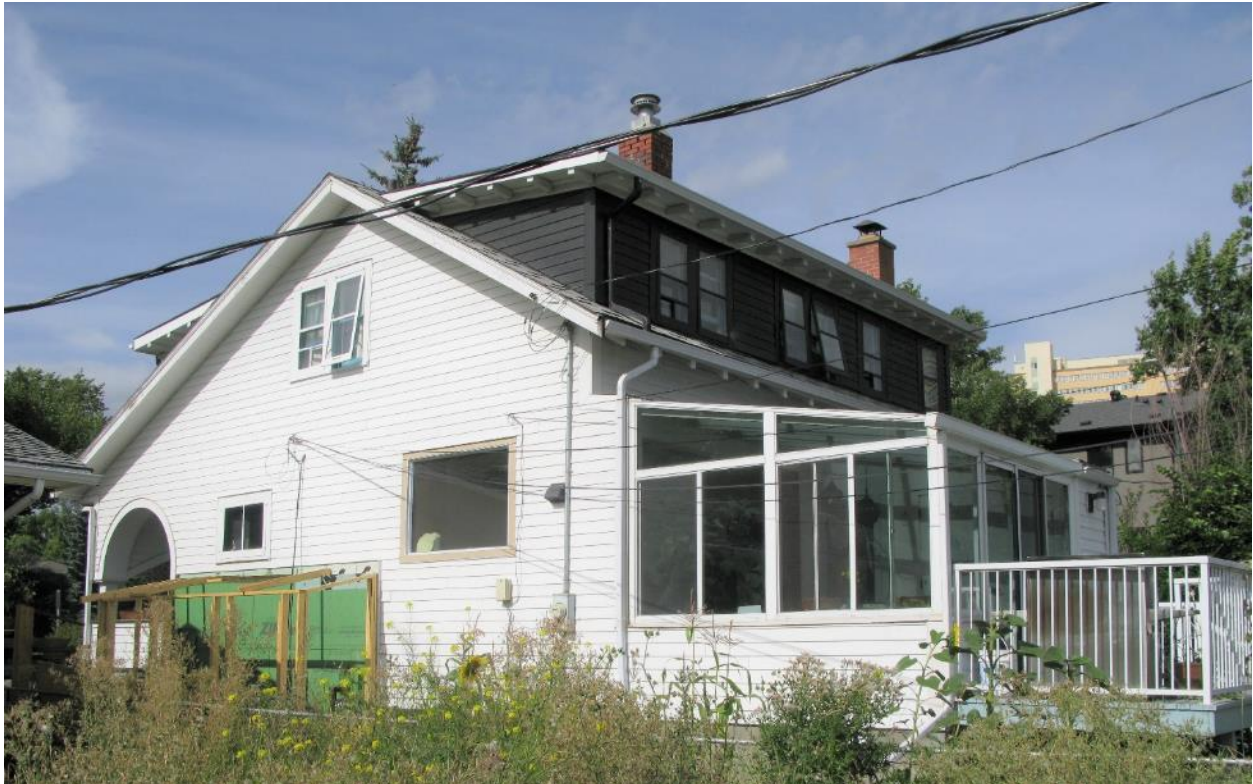
(Image 2.8: Southwest façade showing a double assembly of 1-over-1 wood windows; single fixed window; curved opening on side of porch)

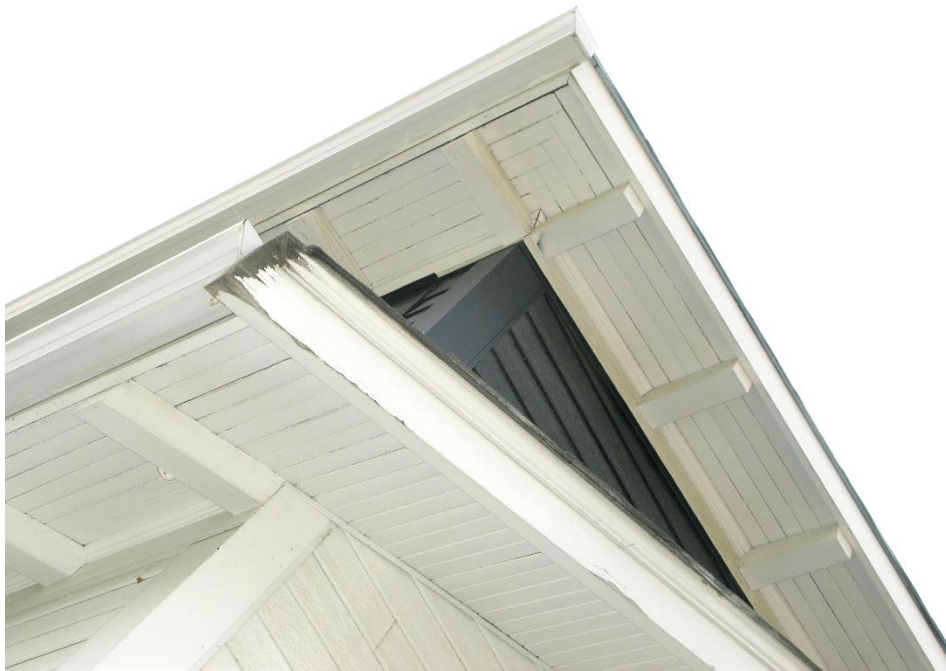
(Image 2.9: detail of typical wood eaves with exposed wood rafter tails with squared (shed roof extensions) or beveled ends (gabled roof); plain wood fascia; wood tongue-and-groove soffits)

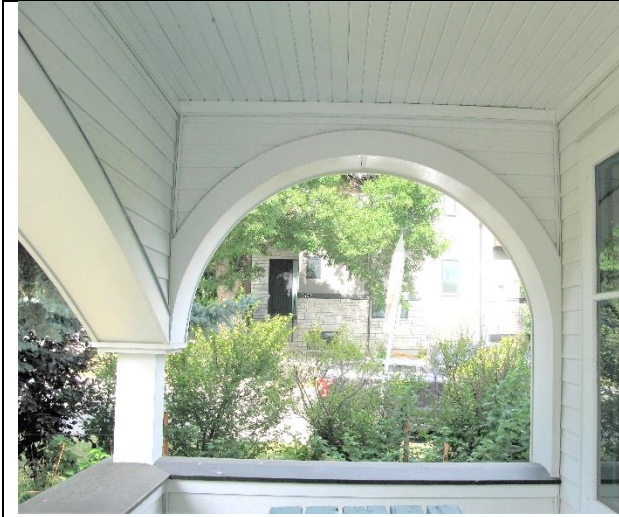
Image 2.10: Example showing curved opening on sides of front porch

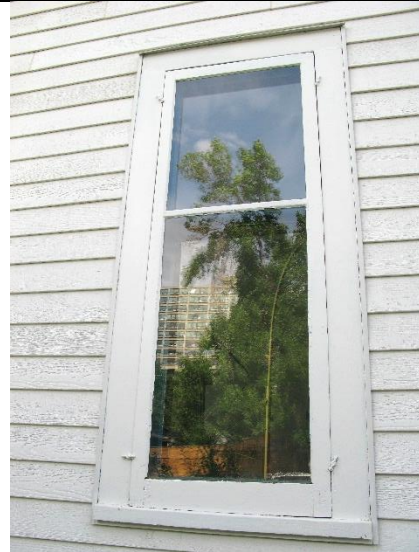
Image 2.11: Example of a single 1-over-1 wood single hung window

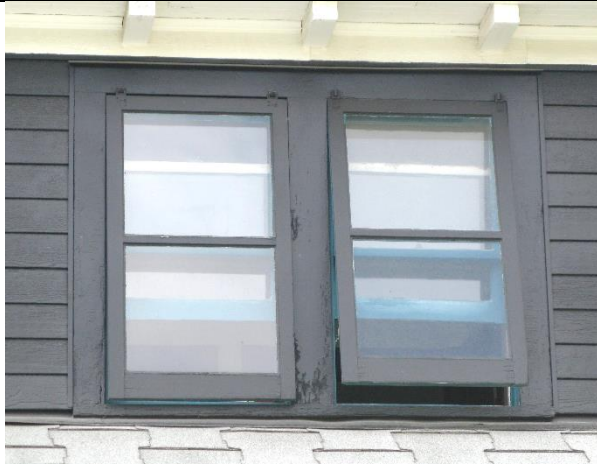
Image 2.12: Example of a 1-over-1 wood single hung windows in double assembly

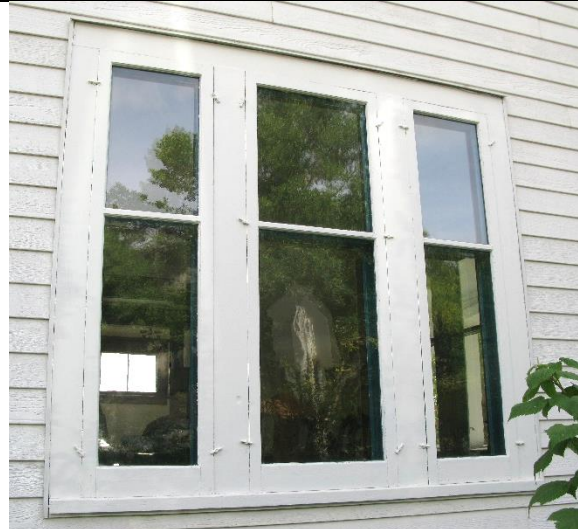
Image 2.13: Example of a 1-over-1 wood single hung windows in triple assembly

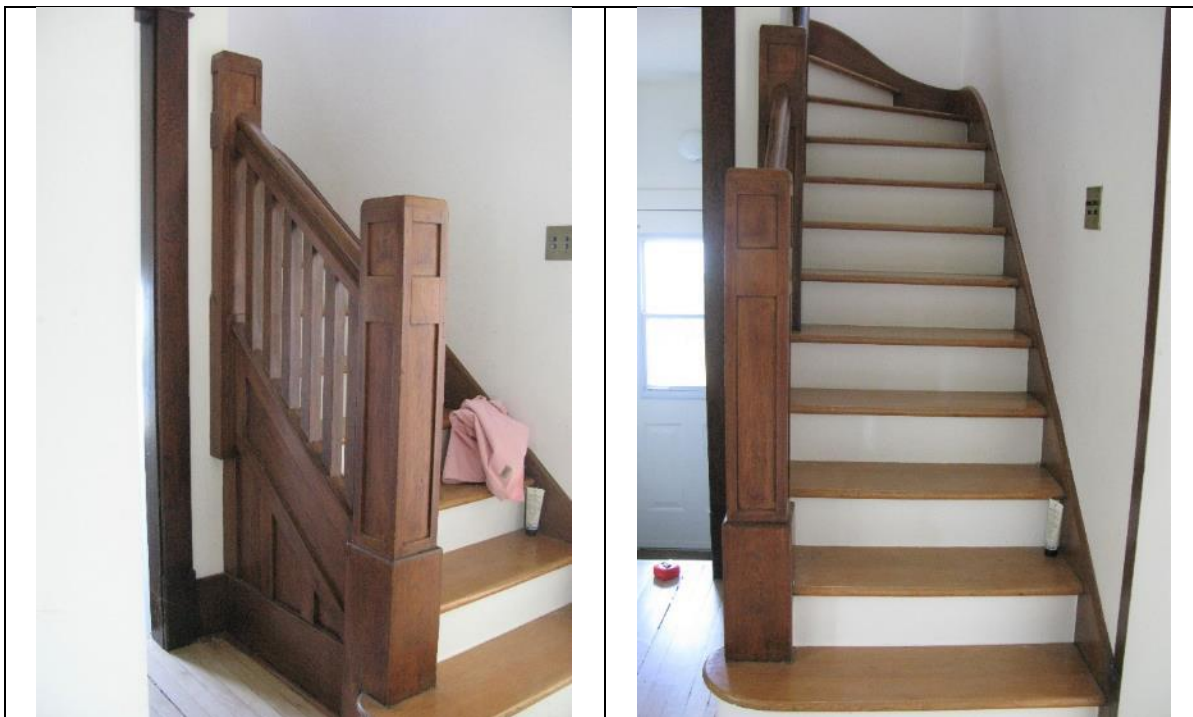
(Images 3.1 and 3.2: staircase with wood balustrade; paneled square newel posts and wall)

- a) Those extant portions of the original floor-plan / configuration including main floor entry, hallway and staircase (Images 3.1-3.3);
- b) Extant original woodwork including staircase balustrade; paneled square newel posts and wall; windows and doors trim; baseboards; interior paneled doors (Images 3.1-3.6);
- c) Extant original wood flooring throughout (Images 3.1-3.3., 3.7 and 3.8); and
- d) Extant in-situ cast iron radiators (Images 3.3, 3.4 and 3.8).

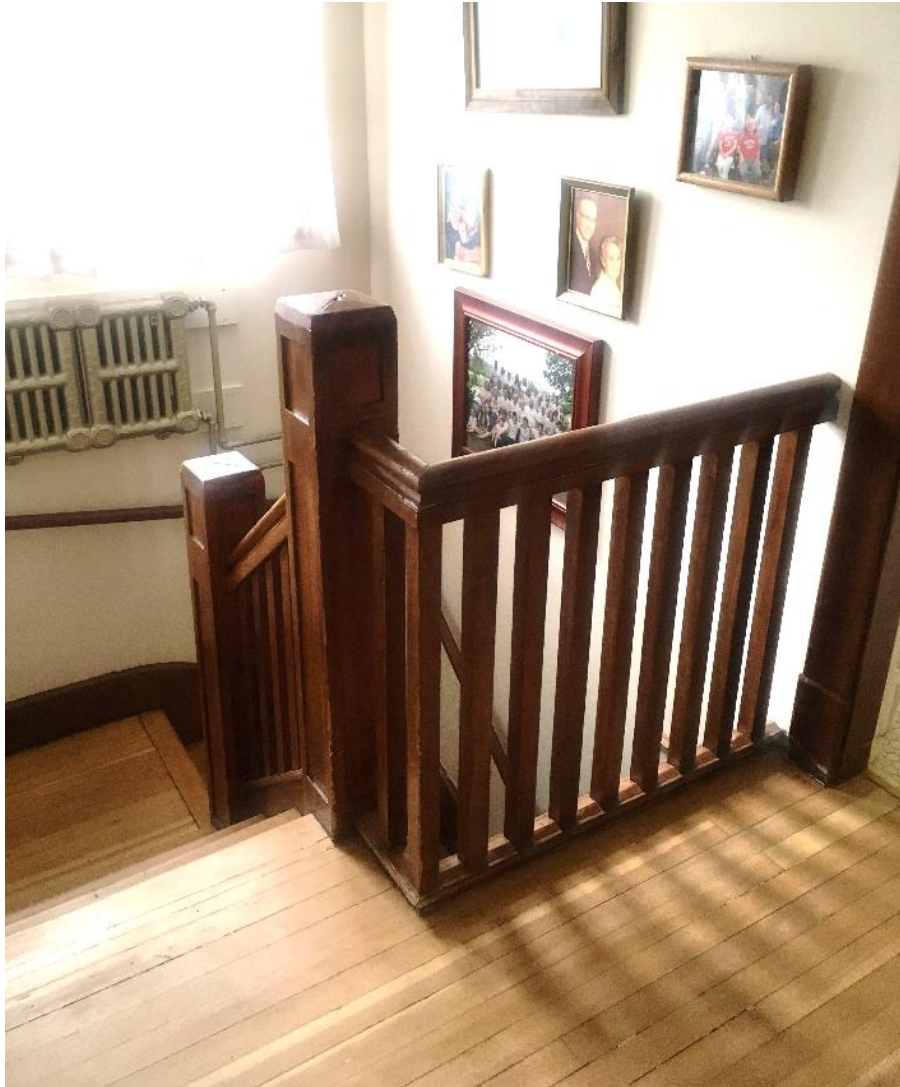
(Image 3.3: upper level staircase with wood balustrade; paneled square newel posts)

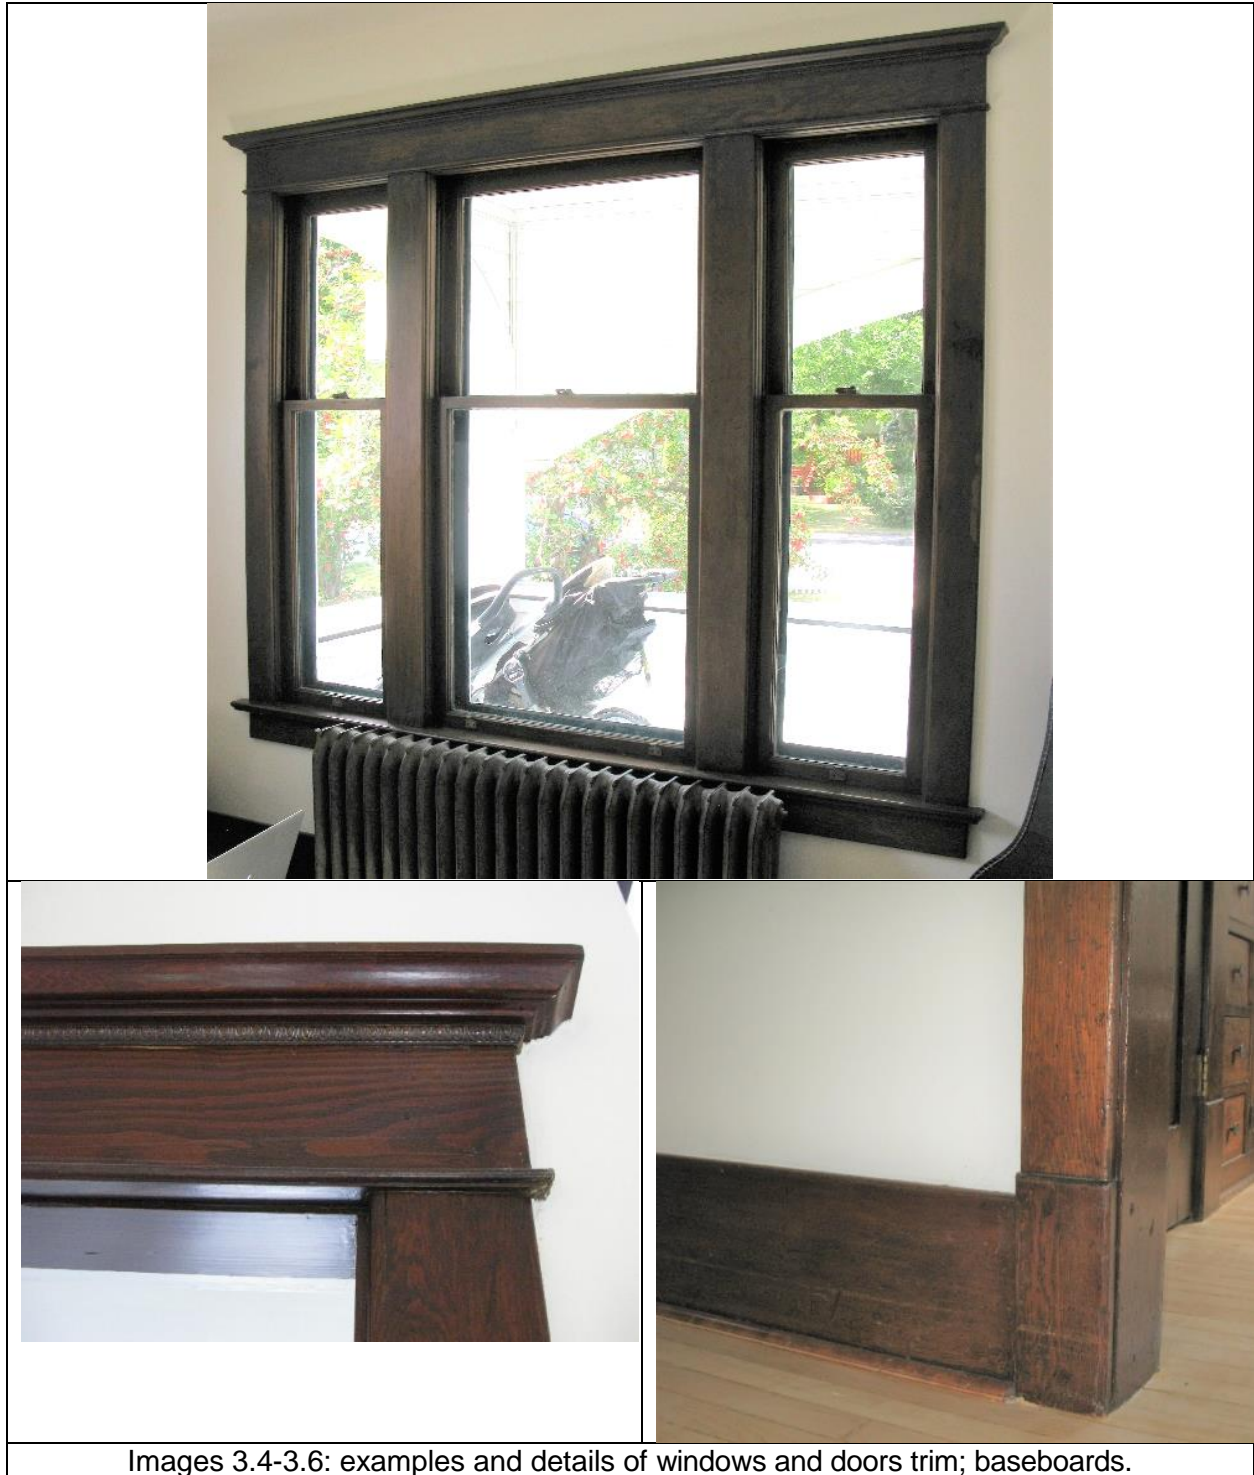
Images 3.4-3.6: examples and details of windows and doors trim; baseboards.

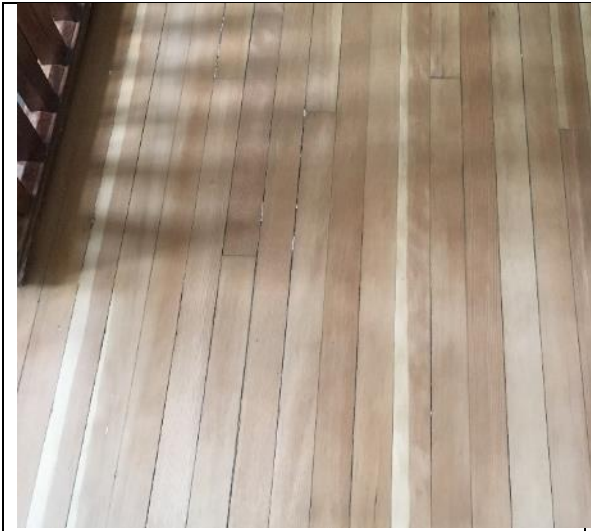
(Image 3.7: Example of original wood flooring throughout )

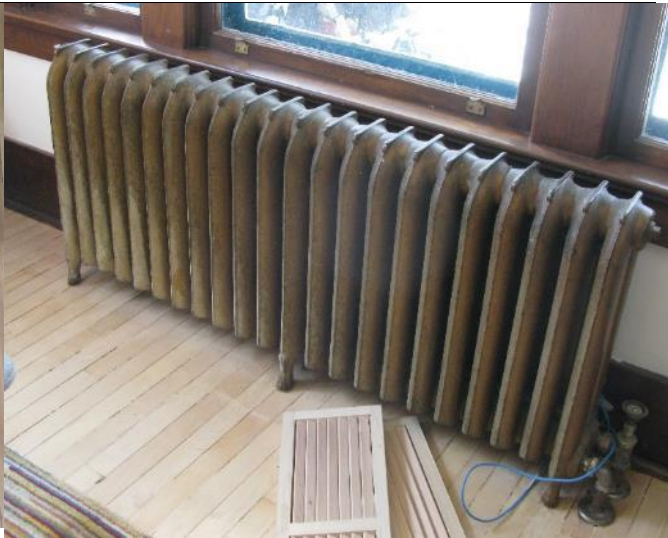
(Image 3.8: Example of cast iron radiator)

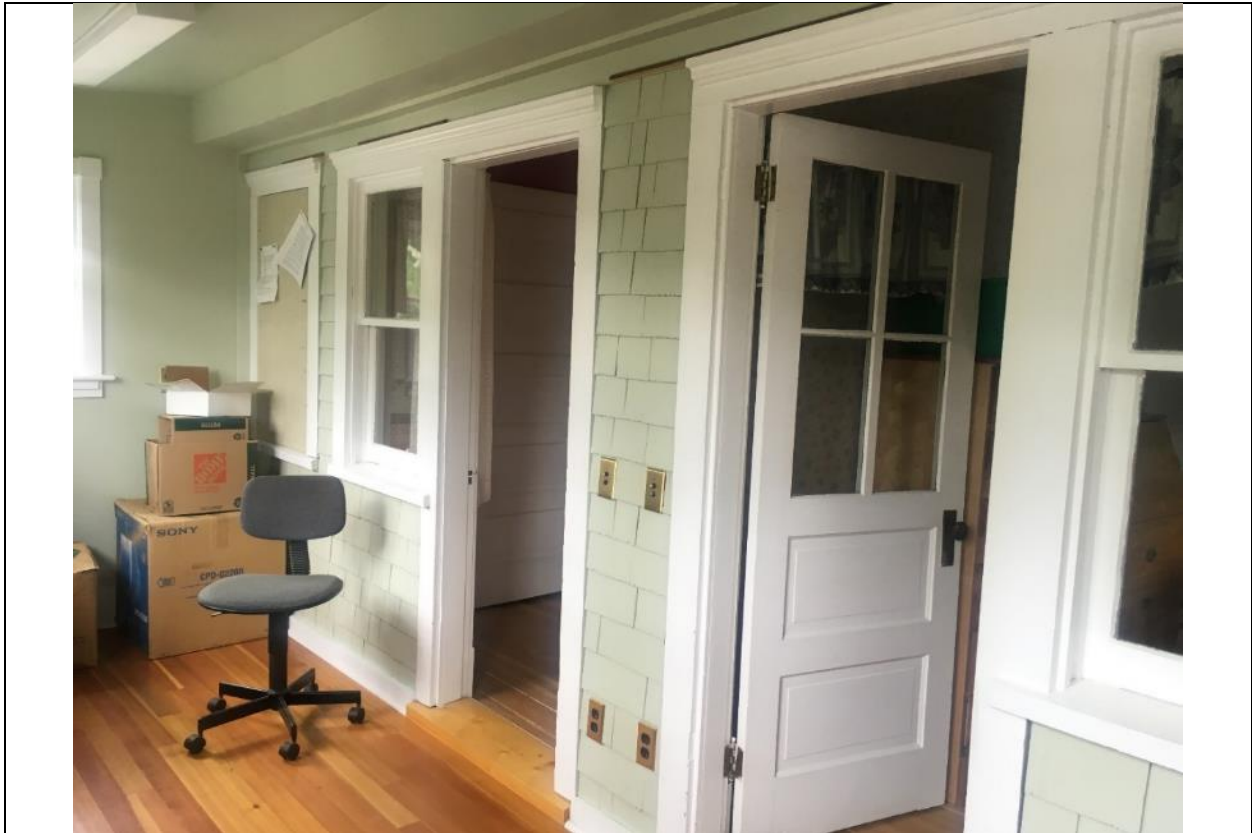
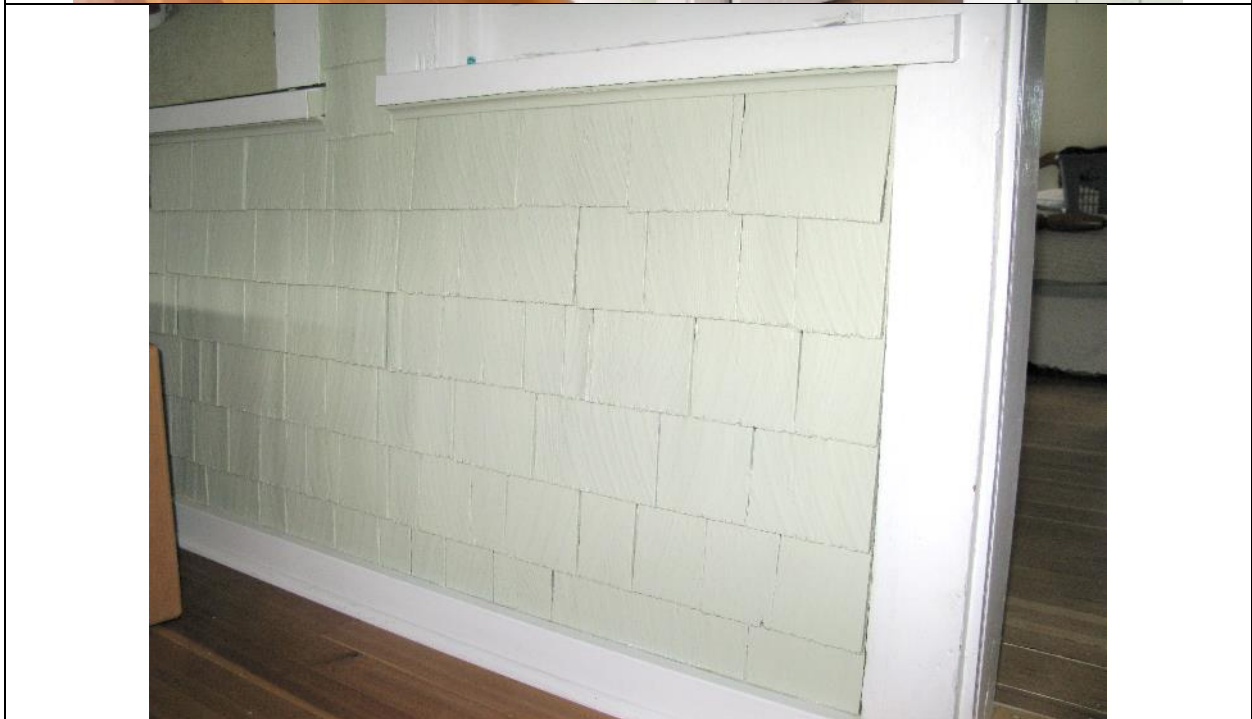
Images 3.9 and 3.10: Original balcony area consisted of mirrored fenestraion with four wood 1-over-1 single hung windows and two panelled doors with 2-over-2 lights; detail of original wood shingle cladding
