Proposed Wording for a Bylaw to Designate the Madden Residence as a Municipal Historic Resource

The Madden Residence is a one and one-half story wood frame house built in 1911 in the community of Rosedale. An example of the Bungalow Style of architecture with Craftsman influences, the structure has shed dormers on all four sides of an irregular high hipped roof, and an enclosed wrap-around verandah. It is situated on four city lots, with mature trees and a generous setback from the boulevard.

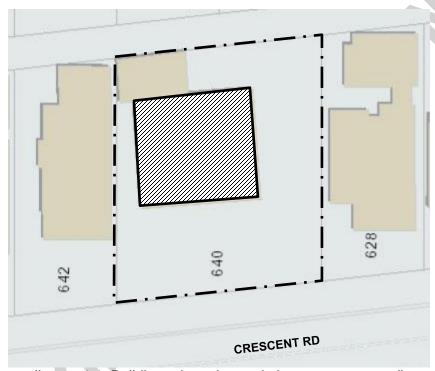
(Image 1.1: Building orientation and placement on parcel)

- a) The building's existing location and placement on the property (attached Schedule "A" and Image 1.1); and
- b) The 1113.3 square-meters of land which comprises the entire parcel, its soft-landscaping character, and
- c) The low ornamental roughcast finish concrete wall along the front, south, property line (Images 1.2-1.5).

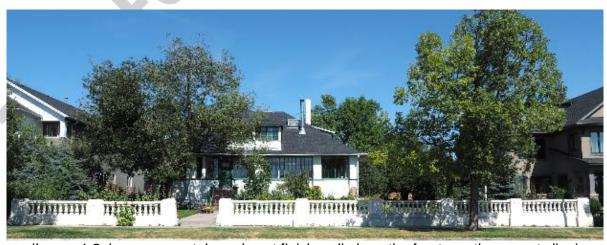
(Image 1.2: low ornamental roughcast finish wall along the front, south, property line)

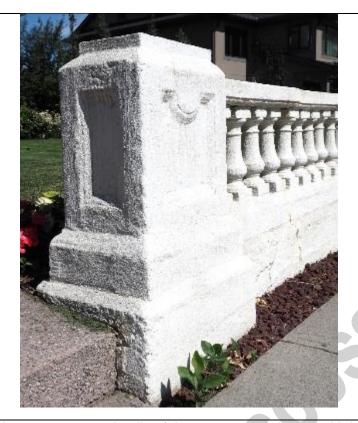
Images 1.3-1.5: details of the ornamental design with balustrade consisting of evenly spaced cast balusters with nine rectangular baluster posts

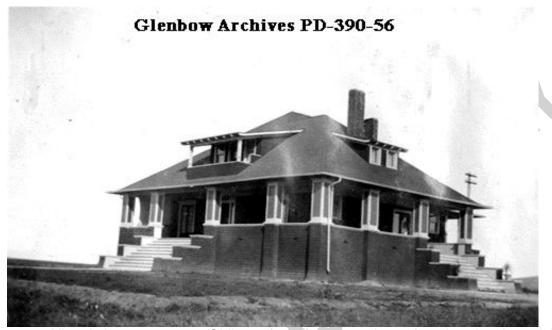
(Image 2.1: Historic image ca.1915. Oblique view of south and east facades showing original design consisted of open wrap around porch which jogged at rear northeast corner; open balcony off of south shed dormer an; panelled porch columns; wide entry stairs on both south and east facades; wood shingle cladding)

Note: Rear northeast corner single storey extension built ca.1996, while sympathetically designed is not regulated and a return to original configuration/appearance would not be precluded where documentation of original configuration exists (Image 2.1).

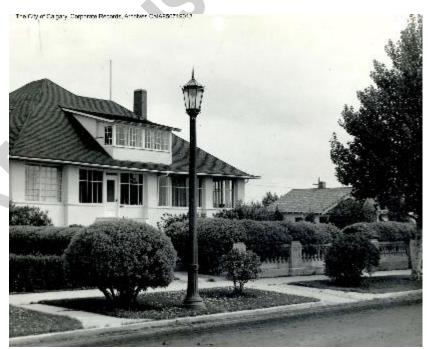
(Image 2.2: Historic image ca.1929. View of south façade showing porch and shed dormer balcony enclosed, and roughcast stucco cladding applied)

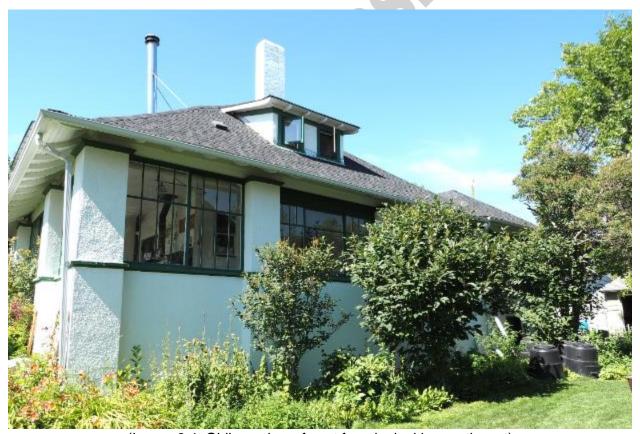
(Image 2.4: Oblique view of east façade, looking northwest)

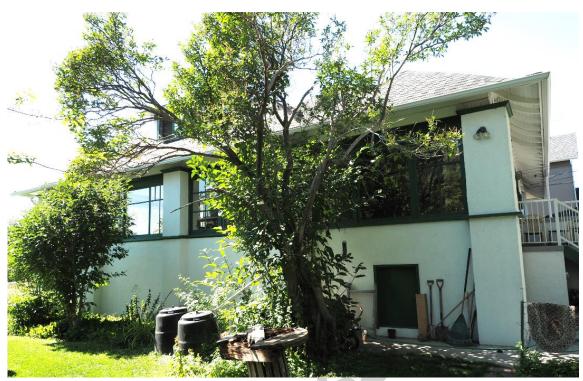
(Image 2.5: Oblique view of east façade, looking southwest)

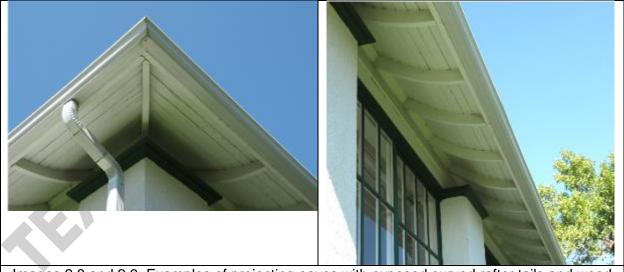
Images 2.8 and 2.9: Examples of projecting eaves with exposed curved rafter tails and wood tongue-and-groove soffits; plain wood fascia

- a) One and one-half story massing; rectangular plan; rough-cast stucco cladding (Images 2.1-2.7):
- b) High-pitched hipped roof with overhanging flared eaves with exposed curved wood rafter tails, plain wood fascia and moulded wood frieze (Images 2.1-2.9);

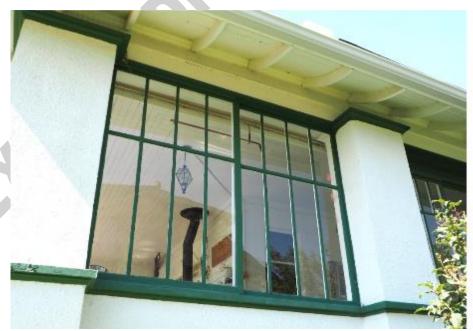
Image 2.14: Example of squared support columns from ground level terminating under the eaves with molded wood trim at caps; continuous molded wood band at balustrade level

- d) Wrap around (south and east) enclosed porch with squared support columns from ground level terminating under the eaves with moulded wood trim at caps; solid balustrade; continuous moulded wood band at balustrade level (Images 2.1-2.5 and 2.14);

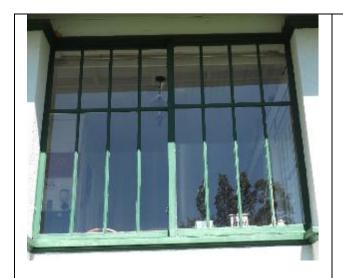
Image 2.15: Example of a 4-over-4 light wood slider windows of enclosed porch

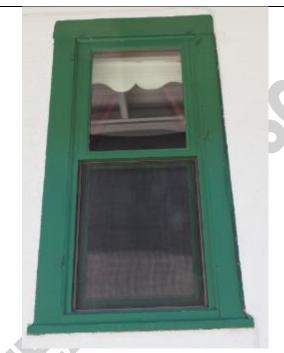
Image 2.17: Example of a 1-over-1 single assembly windows (west and north facades)

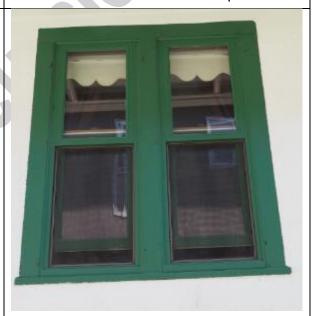
Image 2.18: 1-over-1 double assembly window (west façade only)

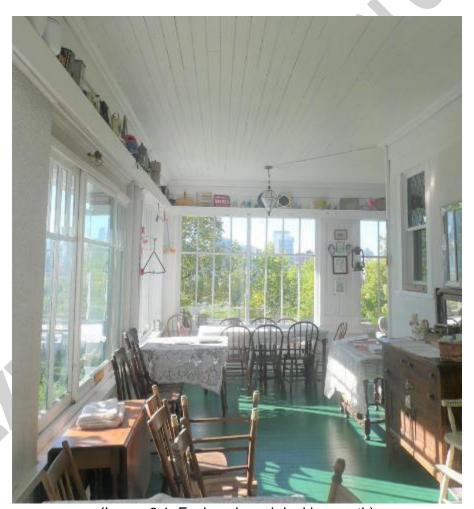
(Image 3.1: Enclosed porch looking south)

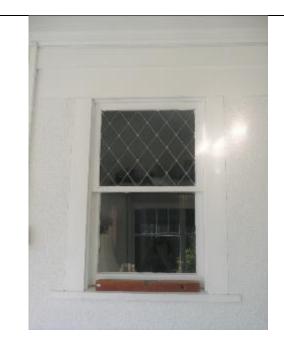
Image 3.2: Example of a 1-over-1 wood window with diamond shaped divided light upper sash

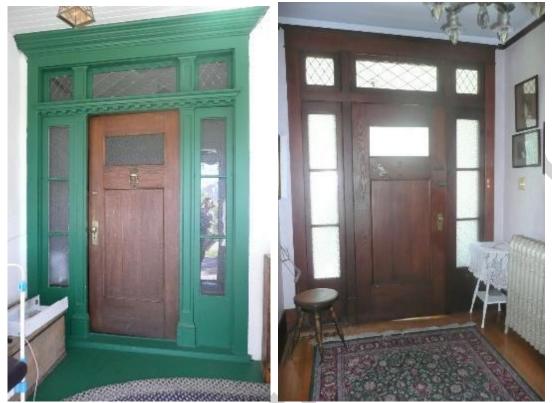
(Images 3.6 and 3.7: Main floor door assembly with decorative trim consisting of 3-pane sidelights and diamond shaped divided light transom)

- c) Original wood door assemblies including main door assembly with decorative trim, 3-pane sidelights and diamond shaped divided light transom; two double assembly doors from porch (Images 3.6-3.9);

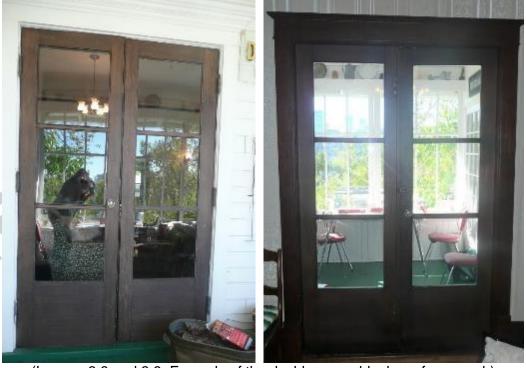
(Images 3.8 and 3.9: Example of the double assembly doors from porch)

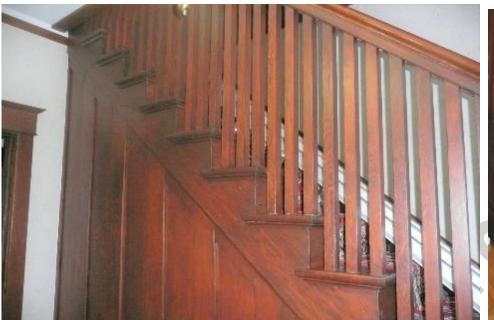
(Images 3.10 and 3.11: Wood paneled stair wall and balustrade with square newel post on rounded riser)

- d) Extant original woodwork including staircase with paneled wall and balustrade with square newel post on rounded riser; windows and doors trim; baseboards; extant interior 5-panel doors (Images 3.10-3.13);

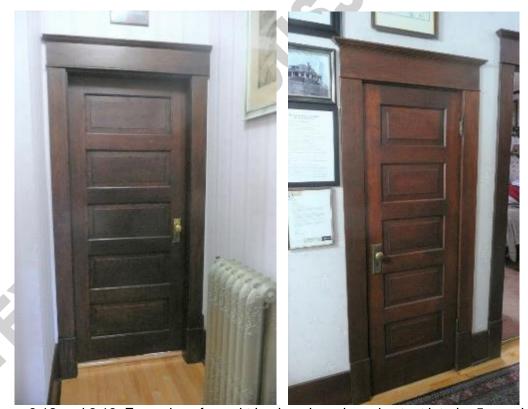
(Images 3.12 and 3.13: Examples of wood trim, baseboards and extant interior 5-panel door)
