BYLAW NUMBER 16M2021

BEING A BYLAW OF THE CITY OF CALGARY TO DESIGNATE THE WALTER HARGRAVE RESIDENCE AS A MUNICIPAL HISTORIC RESOURCE

Description

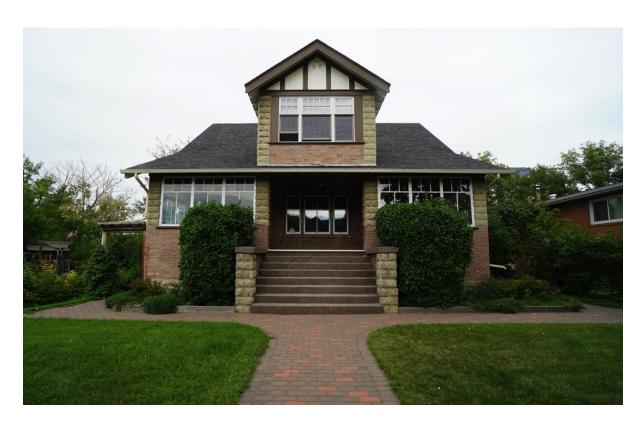
(Image 1.1: South façade)

- a) Stretcher bond concrete brick cladding; continuous hollow rock-faced concrete block band (three rows) (Images 1.1 1.3);
- b) Wraparound verandah with hollow rock-faced concrete block support pillars terminating under painted wooden frieze board; wooden tongue-and-groove ceiling; arched drainage openings with keystone decoration (Images 1.4 1.5);

- a) One and one-half storey massing with double-pitched side-gable roof; front-facing lower cross gable with rear extended shed dormer; linear profile, rectangular plan (Images 1.1, 1.2, 2.1, 2.2, 2.3, 3.1, 4.1, and 4.2);
- b) Open eaves with exposed rafters, projecting painted plain-wood bargeboard, painted wood-plank soffits, painted plain wooden frieze (Images 5.1 and 5.2).

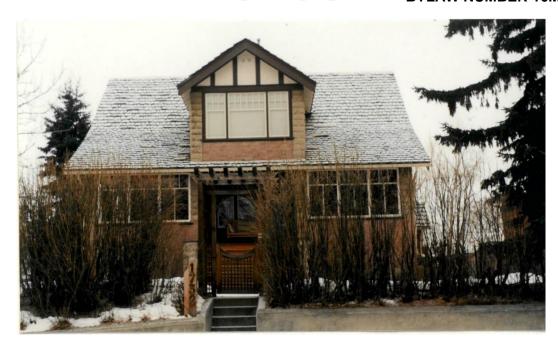
(Image 1.2: ca. 1996 photo showing south façade with original window assembly on second storey)

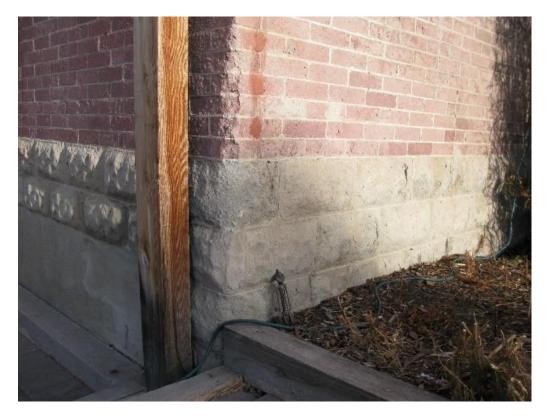
(Image 1.3 Stretcher bond concrete brick cladding; continuous hollow rock-faced concrete block band (three rows in south-facing façade, transitioning to two rows)

- a) Stretcher bond concrete brick cladding; stucco and wood mock half-timbering; continuous hollow rock-faced concrete block band (two rows); continuous wood band with decorative trim (Images 1.3 and 2.1 2.3); and
- b) Original fenestration (window patterns and openings); two 15-pane wood windows with concrete sills (main storey); three 6-over-1 wood hung windows with flat window heads and painted wood trim (Images 2.2 2.5).

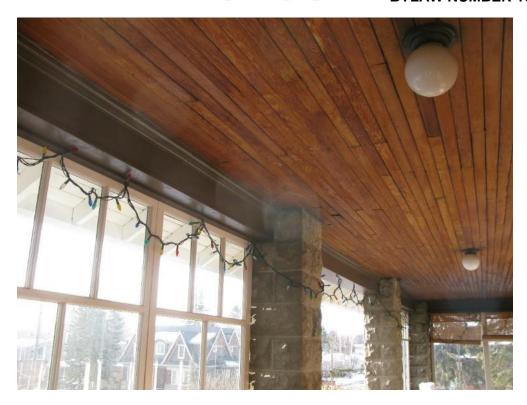
(Image 1.4 Enclosed portion of verandah: tongue-and-groove ceiling, hollow rock-faced concrete block clad support pillars, wood header)

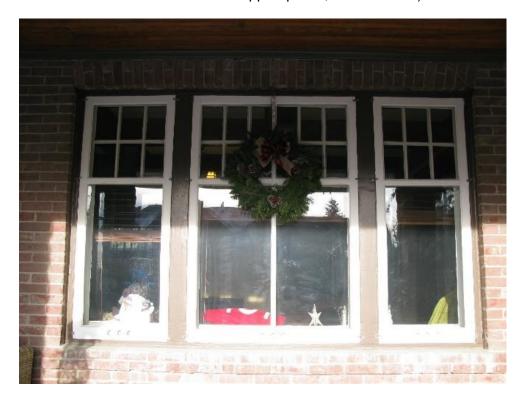
(Image 1.5: triple assembly consisting of a 12-over-1 flanked by 6-over-1 wood windows with sill and flat gauge lintel in concrete brick)

- d) Original fenestration (window patterns and openings);a triple assembly consisting of a 12-over-1 flanked by 6-over-1 wood windows with sill and flat gauge lintel in concrete brick; doorway with flat gauge lintel in concrete brick (Images 1.5 and 1.7); and

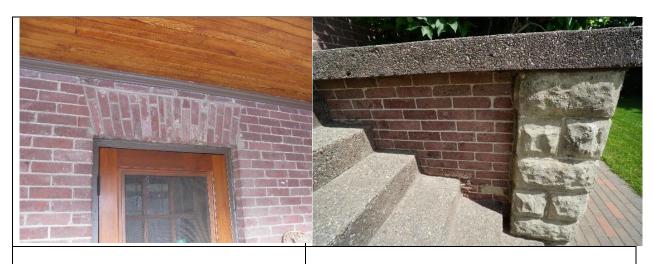
(Image 1.7: doorway with flat gauge lintel in concrete brick)

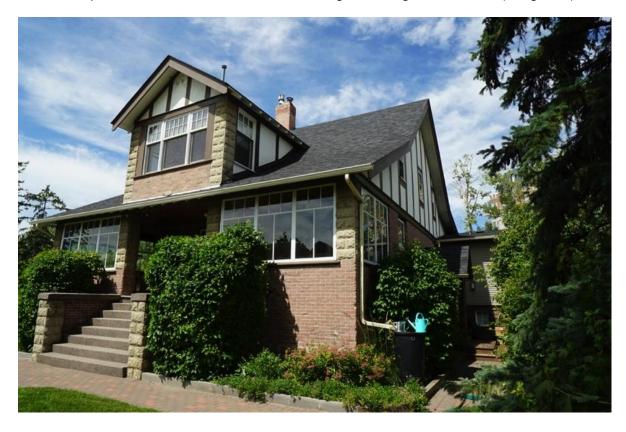
(Image 2.1: View of house from southeast)

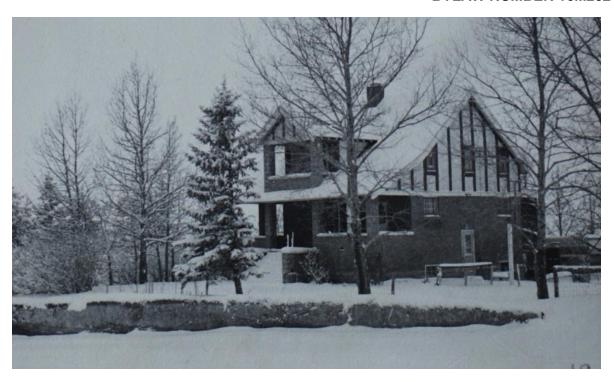
(Image 2.2: Historic photo ca.1959, view of house from southeast)

Note: The east side single-storey projecting vestibule built between 1959 and 1986, while sympathetically designed, is not regulated and a return to original configuration/appearance would not be precluded where documentation of original configuration exists (Image 2.2).

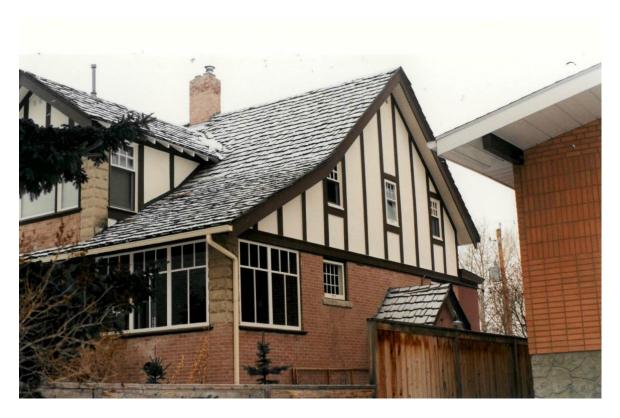
(Image 2.3: photo ca.1996, view of house from southeast)

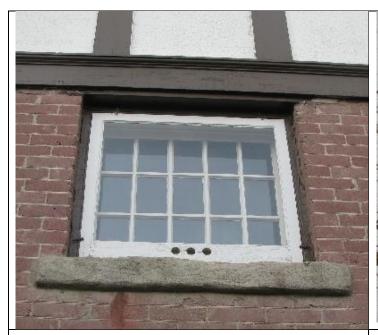
(Image 2.4: example of one of two 15-pane wood windows with concrete sills; continuous wood band with decorative trim)

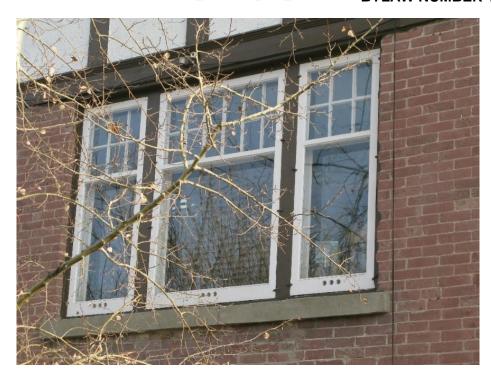
(Image 3.2: triple assembly consisting of a 12-over-1 flanked by 6-over-1 wood windows, with concrete sill; continuous wood band with decorative trim)

- a) Stretcher bond concrete brick cladding; stucco and wood mock half-timbering; continuous hollow rock-faced concrete block band (two rows); continuous wood band with decorative trim (Images 1.3 and 3.1);
- b) Wraparound front verandah with hollow rock-faced concrete block support pillars terminating under painted wooden frieze board; wooden tongue-and-groove ceiling (Images 1.4 and 3.1); and
- c) Original fenestration (window patterns and openings); a triple assembly consisting of a 12-over-1 flanked by 6-over-1 wood windows, with concrete sill; a 12-over-1 wood window with sill and flat gauge lintel in concrete brick; two double assemblies of 6-over-1 wood windows with flat heads and painted wood trim (Images 3.2 3.4).

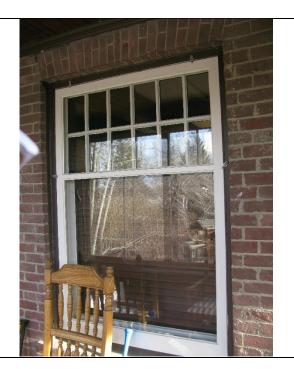
(Image 3.3: a 12-over-1 wood window with sill and flat gauge lintel in concrete brick, located within wraparound verandah)

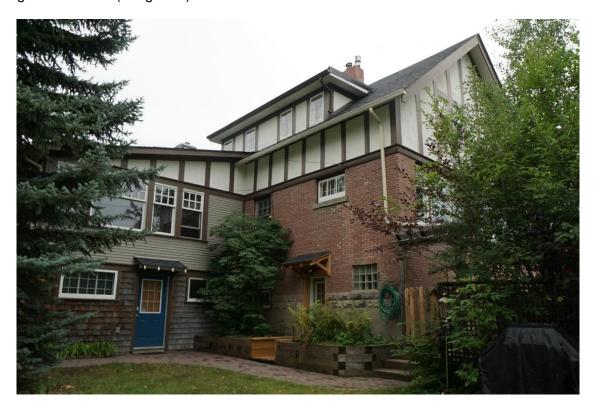
(Image 4.1: North façade)

- a) Stretcher bond concrete brick cladding; stucco and wood mock half-timbering; continuous hollow rock-faced concrete block band (two rows); continuous wood band with decorative trim (Images 1.3 and 4.1 4.2);and
- b) Original fenestration (window patterns and openings); a 6-over-1 wood window and a 12-pane wood window, both with concrete sills; four multi-pane wood windows (shed dormer) (Images 4.1 4.4).

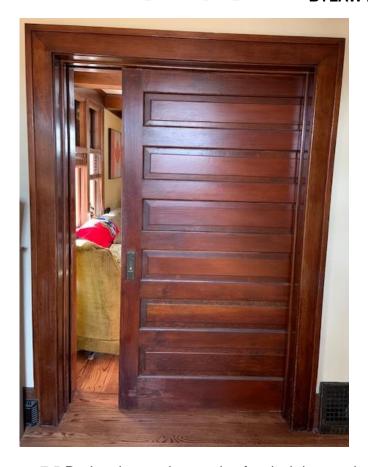
(Image 7.5 Pocket door and example of typical door casing)

- a) Original Douglas fir main door assembly with panels topped by 15 glass panes and plain wooden trim (Image 7.1);
- b) Original Douglas fir second storey porch exterior wood door with panels topped by 12 glass panes and plain wooden trim (Image 7.2);
- c) Extant original main floor Douglas Fir woodwork including baseboards, window and door casings, pocket door, crown moulding and ceiling beams (living and dining rooms) (Images 7.3 7.7):
- d) Quarter-turn closed staircase to second storey with Douglas fir stair rail, newel, and ballustrade (Image 7.7)

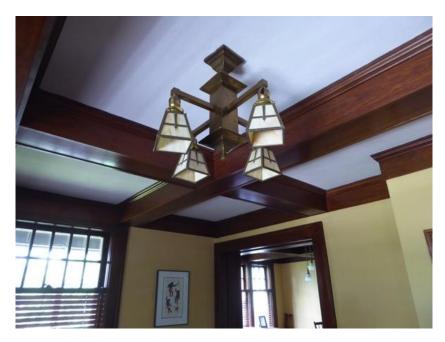
(Image 7.6 Example of extant original Douglas Fir crown moulding and ceiling beams in living and dining rooms)

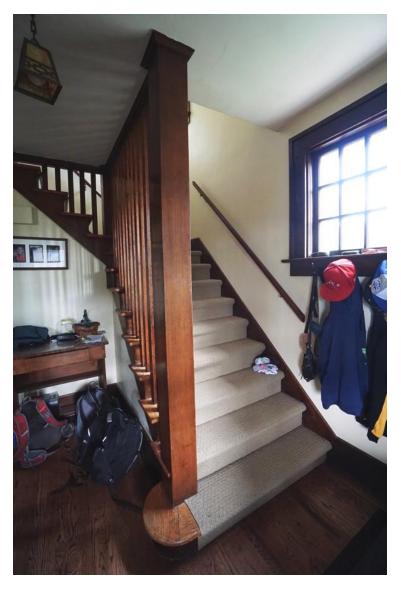
(Image 7.7: Quarter-turn closed staircase to second storey with Douglas fir stair rail, newel, and balustrade; example of a window casing)
