# **Calgary Municipal Land Corporation**

## **West Village**

# **Environmental Analysis**

# **Background Report**

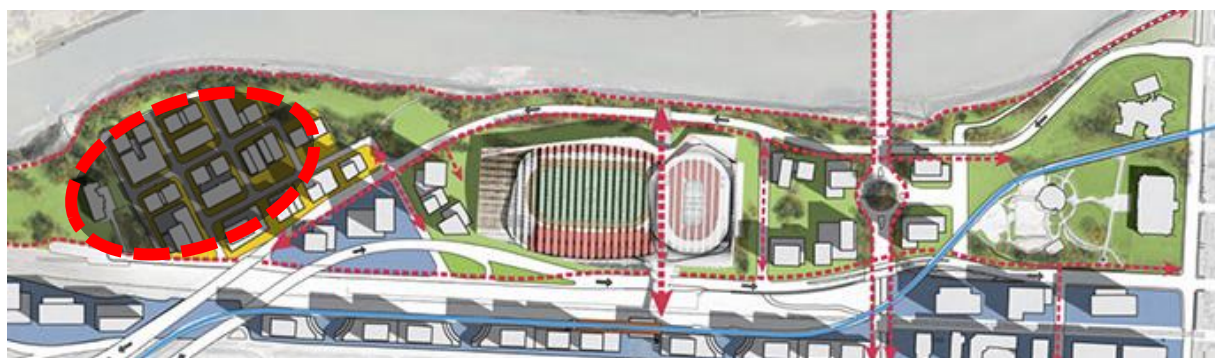
Figure 1-2 West Village, CalgaryNEXT West

● Footprint of CalgaryNEXT, located at the western edge of West Village

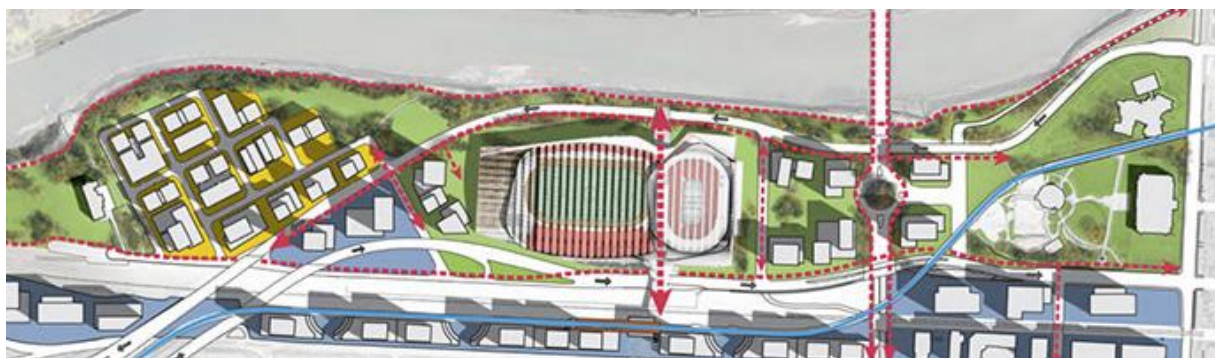
Figure 1-3: CalgaryNEXT as Proposed by CSEC

In the final scenario sports complex is located adjacent to the the Sunalta LRT transit stop. This scenario replicates CSEC's proposal, as CMLC understands it.

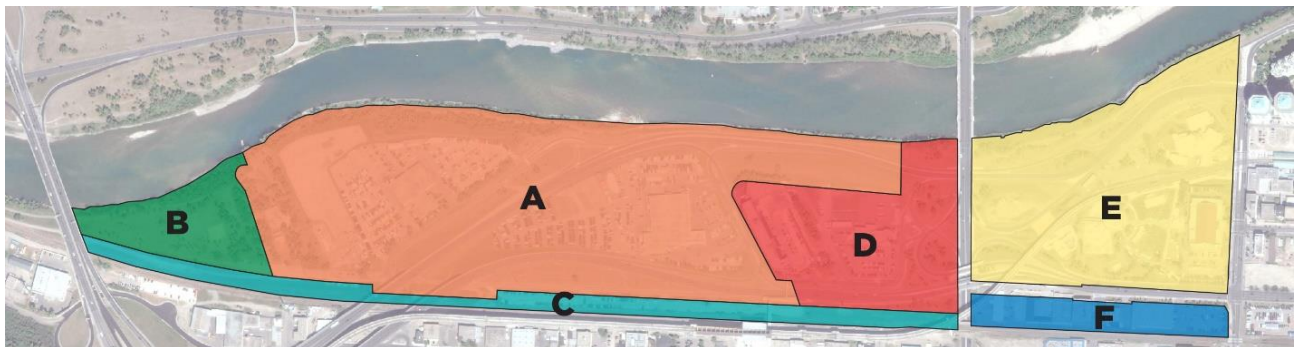
Figure 2-1 West Village Environmental Management Areas

One objective of this report was to evaluate available environmental information for the study area, identify data gaps, and develop a framework to direct future investigations in the context of future redevelopment scenarios. The framework developed involves six management areas, identified as Areas A through F.

Management Area A—the former Canada Creosote Site (CCS)—has a complex set of contaminants to deal with. Management Areas B through F have contamination that is consistent with what is expected for historical industrial land use. These areas have hosted a variety of industrial and commercial operations since the early 1900s including incinerators, gas/service stations, bus terminal, military armoury, former auto body repair operations, car dealerships, railway right-of-way/spur lines/loading docks, asphalt operations, metal machining and transportation corridors. The majority of these previous uses lead to an identification of areas of potential environmental concern (APECs) within these management areas.

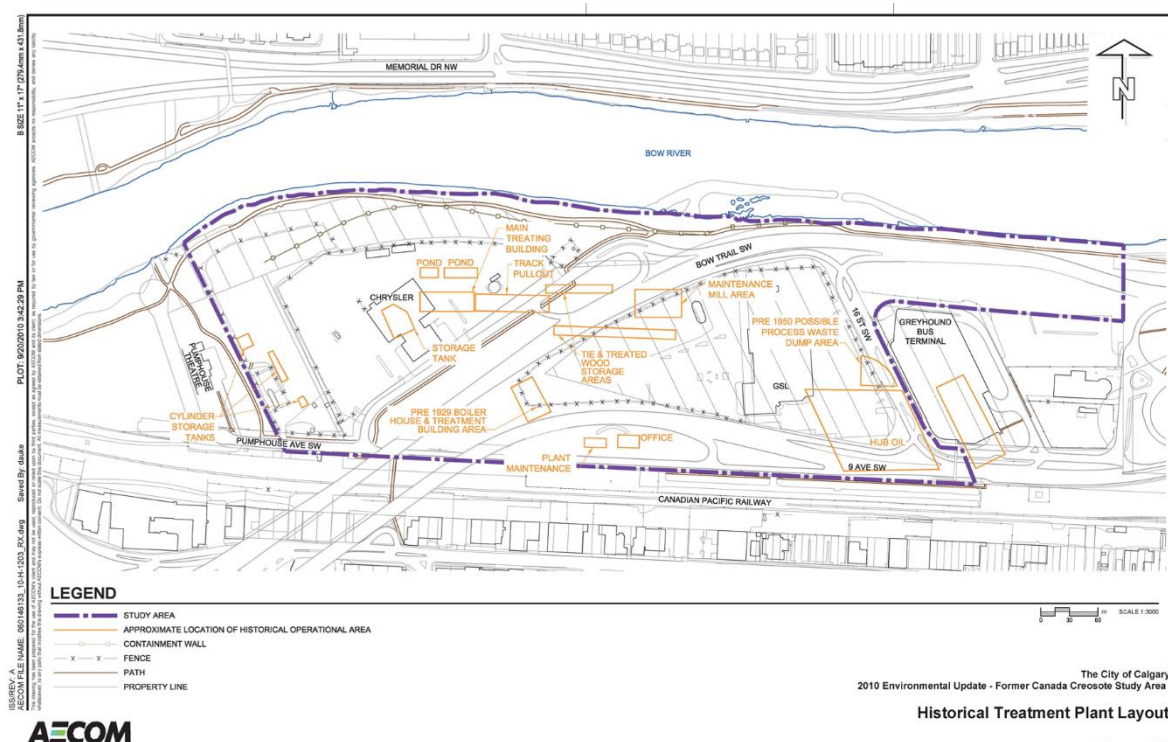
Figure 3-1 Historical Uses

Former operations at the Canada Creosote Site (CCS) primarily consisted of treating wood to preserve it from decay. The operations lead to releases of wood treating chemicals from specific operational areas of the CCS (referred to as “source areas”), which include:

- product storage tanks;
- treatment buildings;
- process water storage ponds; and
- treated wood drying and storage areas.

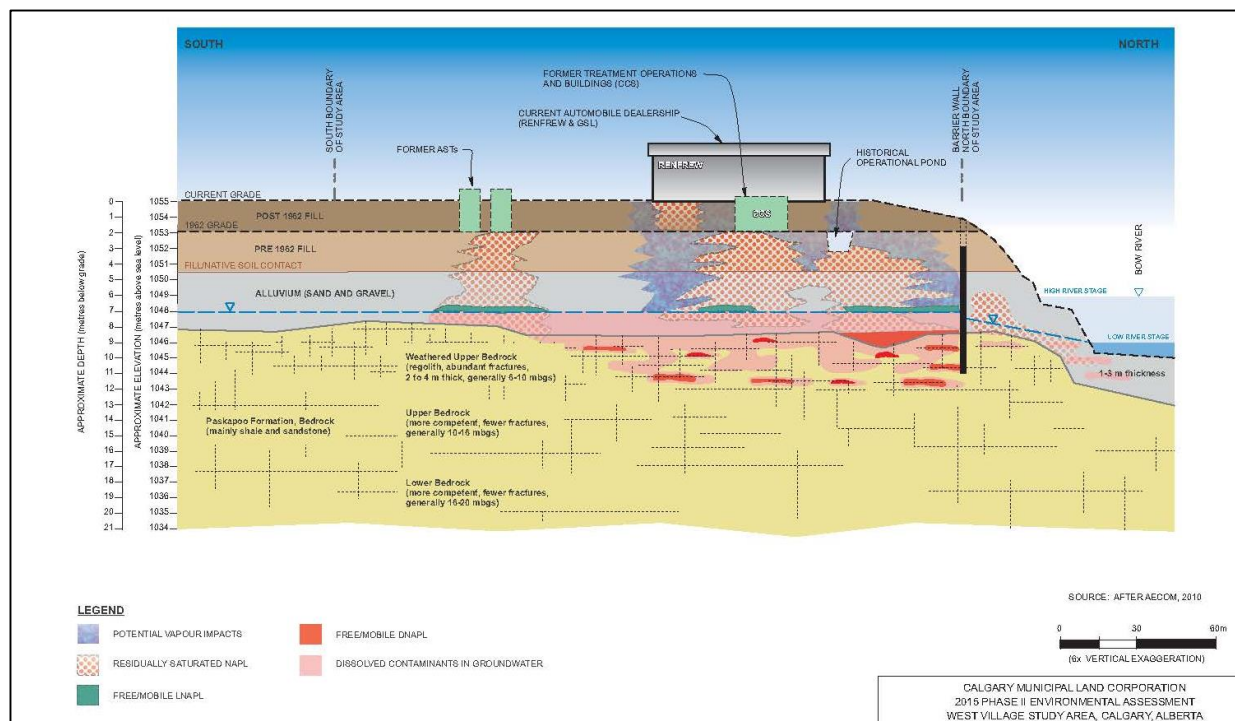
Figure 3-2 Conceptual Site Model

In addition to chemicals of potential concern (COPCs) and their source areas, the site's conceptual site model involves several different layers of soil and bedrock: two types of fill (pre- and post-1962), alluvium (mostly wet or "saturated", but some is dry or "unsaturated"), and bedrock (a highly weathered surface or "regolith" and more competent bedrock underneath). The two types of fill are due to the phases of placing fill during the operation of Canada Creosote (pre-1962 fill) and after the plant was demolished (post-1962 fill). The fill at the site is typically above groundwater; however, when the river is high (e.g., spring), groundwater can extend into the base of the fill, particularly nearer to the river. Alluvium is the underlying native soil that was deposited by the historic reach of the river on top of the bedrock. This is where groundwater beneath the site is first encountered. The top of the bedrock is highly weathered, having been broken down into looser rock and soil called regolith. Beneath this regolith is more competent, or much less weathered and harder bedrock, which is still fractured in many places. The bedrock also carries groundwater.

The main wood preservatives that were used are denser than water and immiscible. They are known as dense non-aqueous phase liquids or DNAPLs. If enough DNAPL is released, gravity will cause it to sink through the saturated soil to bedrock, where it will flow along the bedrock surface, and into the bedrock as well. The diesel-like oil is lighter than water and may separate and accumulate as a light non-aqueous liquid (LNAPL). LNAPL will float on and move with the top of groundwater, so as the groundwater level moves up and down seasonally, a contaminated smear zone fringe is created. These NAPLs are long-term sources of contamination due to the concentrated presence of COPCs within them.

The high concentrations of COPCs in NAPL, and its ability to migrate in the alluvium along the bedrock surface to beneath the river is what led to the installation of the containment wall. The wall not only contains the NAPL that is south of the river, but in combination with clean and dirty pumping wells, contains much of the contaminated groundwater.

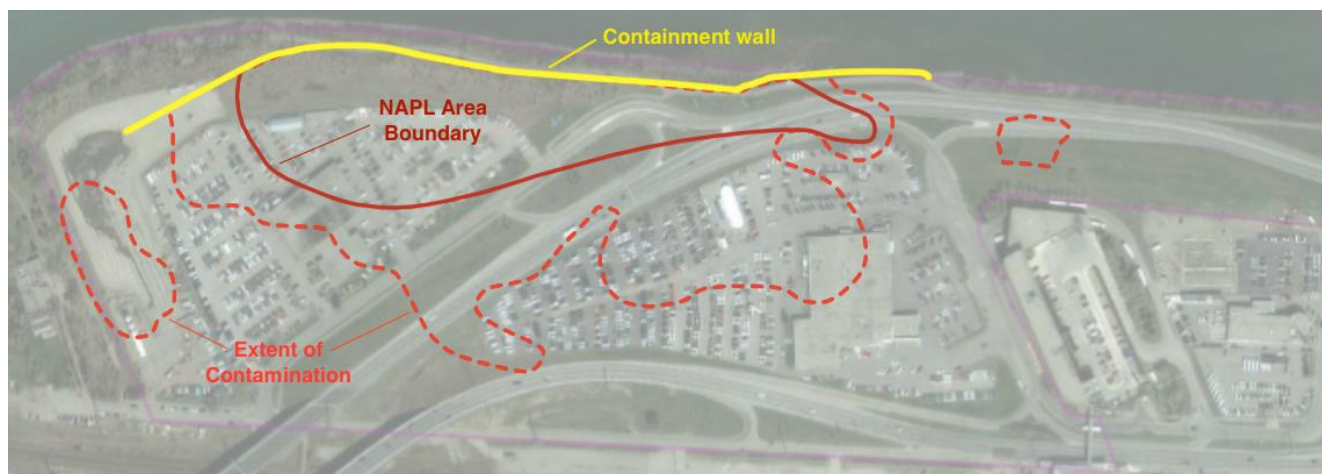
Figure 3-3 Estimated Extent of Contamination

The following figure shows the estimated extent of a plume of NAPL, and the footprint of contamination in soil and bedrock, projected over an aerial photograph of the current development.

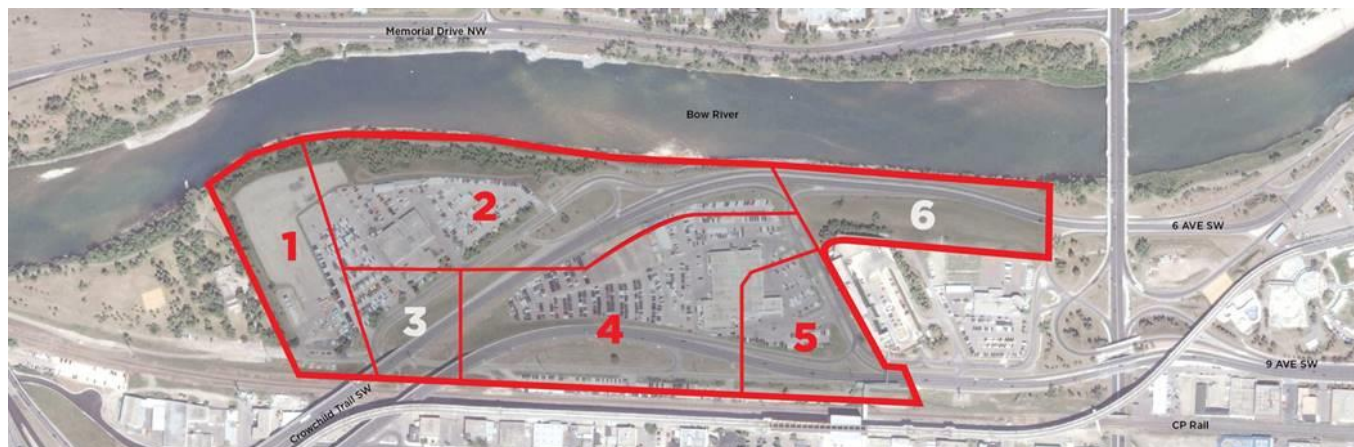
Figure 4-1 Areas of Potential Environmental Concern for the Human Health Risk Assessment

In order to provide a framework for evaluating COPCs and potential health risks, Management Area A, or the Canada Creosote Site, was further divided into six areas or Areas of Potential Environmental Concern (APECs) based on historical land use, available monitoring data and a grouping of COPC types. Six major COPC groups were identified: polycyclic aromatic hydrocarbon (PAHs), petroleum hydrocarbons (PHCs), pentachlorophenol (PCP) and other phenols, halogenated aliphatics, other organic compounds, and metals.

*Area 1, 2, 4, and 5 have the highest chemicals of potential concern that exceed human health guidelines*

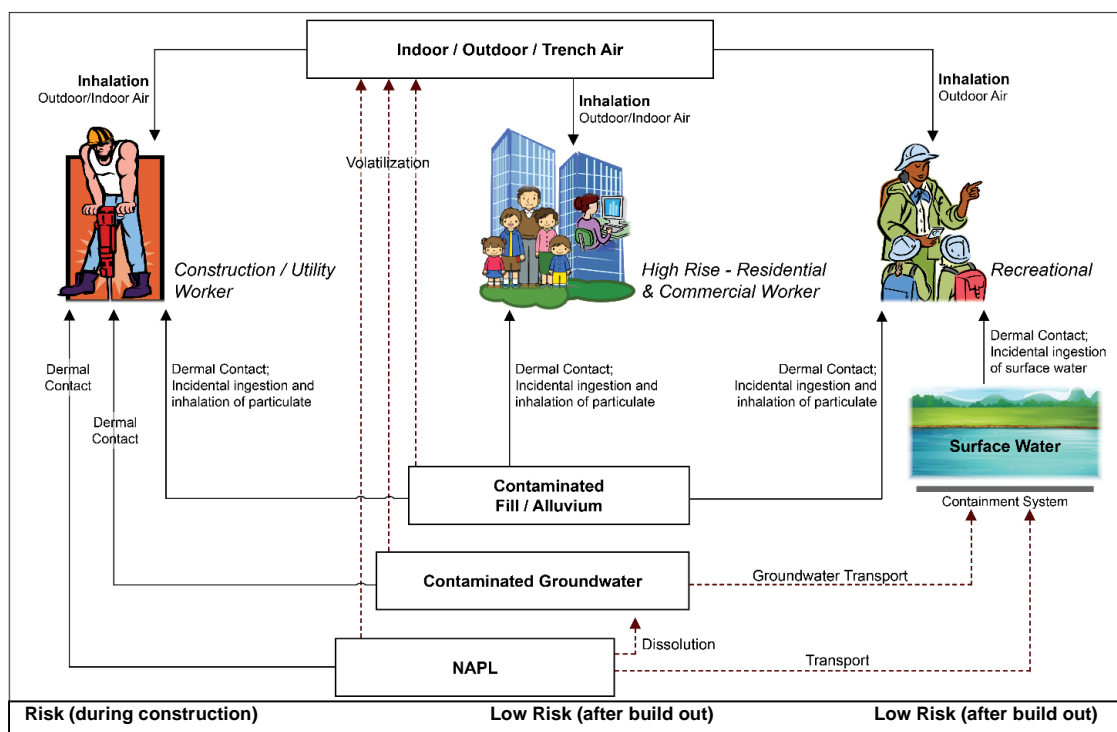
Figure 4-2 Human Health Risk Assessment, During & Post Remediation and Construction, CSM

The CSM for the assessment can be summarised by the following figure:
