## Proposed Wording for a Bylaw to Designate the Guide-Scout Service Centre as a Municipal Historic Resource

1. This Bylaw may be cited as “City of Calgary Bylaw to Designate the Guide-Scout Service Centre as a Municipal Historic Resource”.

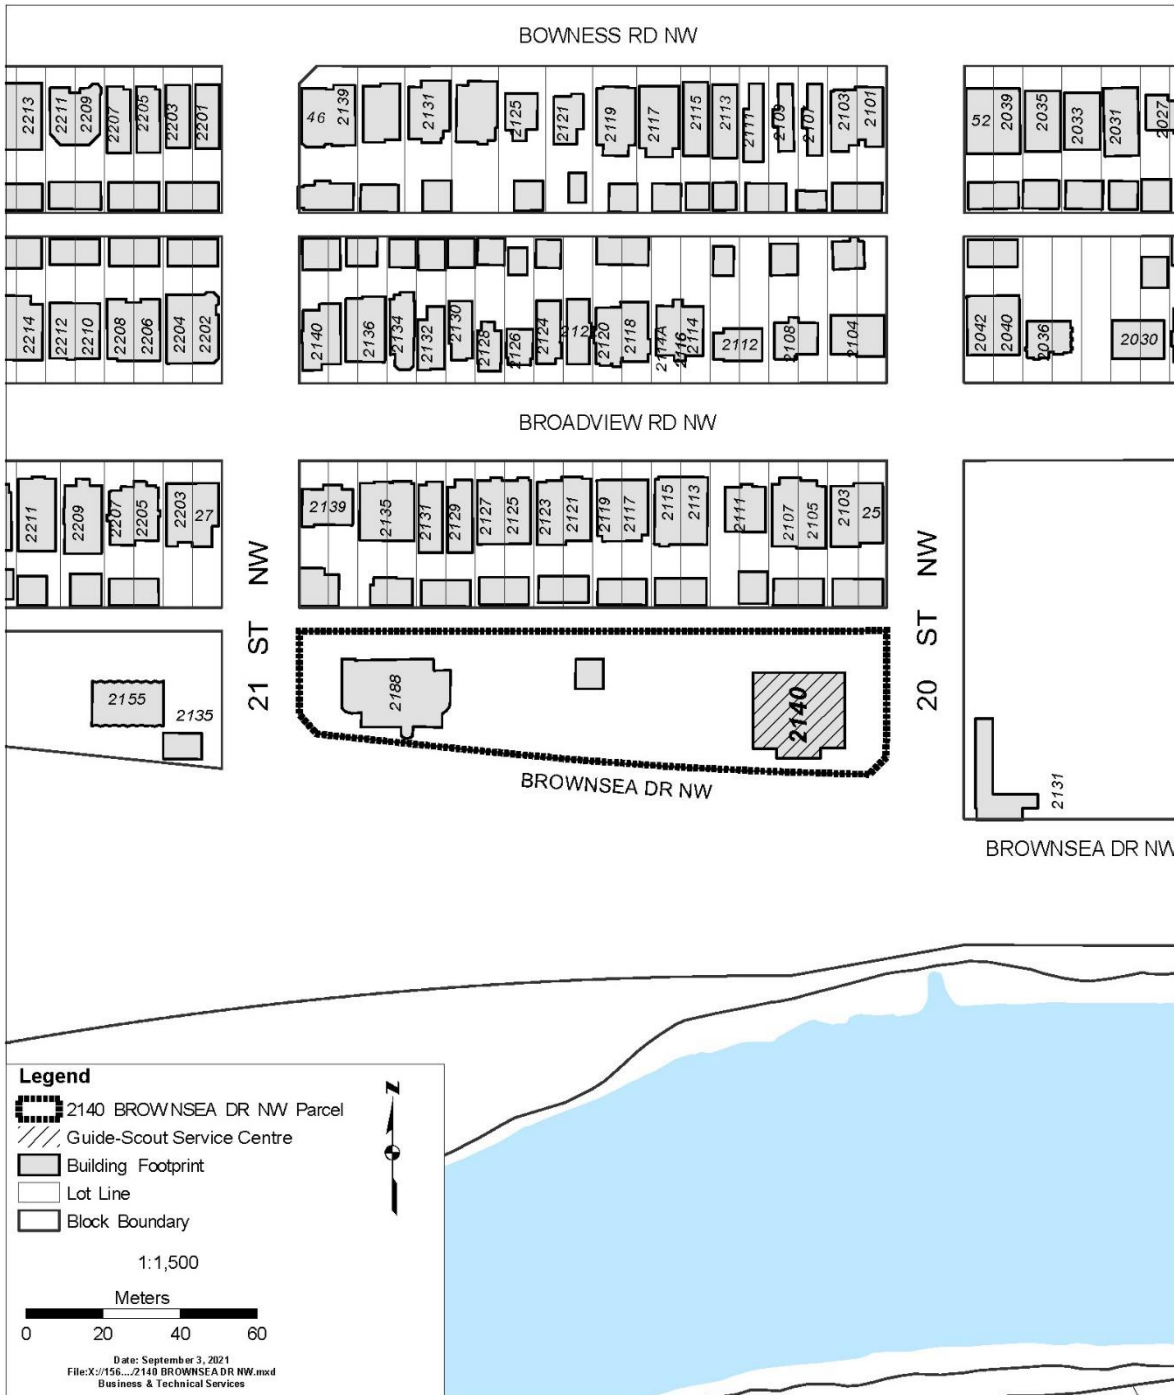
SCHEDULE "A"

2. The building known as the Guide-Scout Service Centre, located at 2140 Brownsea Drive NW, and the land on which the building is located being legally described as,  
PLAN 4118JK  
BLOCK 5  
CONTAINING .777 HECTARES ( 1.92 ACRES) MORE OR LESS  
EXCEPTING THEREOUT:

2140 BROWNSEA DR NW

- a) The building's existing location and placement on the property (attached Schedule "A")

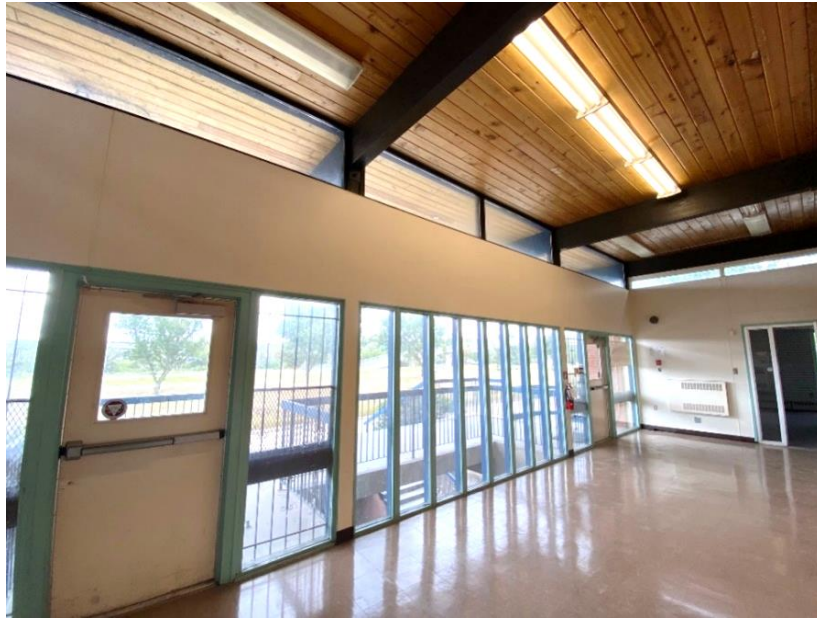
(Image 3.1: Open foyer at upper storey with clerestory windows, glulam beams and wood-paneled ceiling)

- a) open foyer at upper storey with wood-paneled walls and clerestory above (Images 3.1 and 3.2); and
- b) exposed curved glulam beams with wood-paneled ceiling in hall space and hallways at upper storey; clear-span open space to roof peak in main hall at upper storey (Images 3.1 - 3.3).

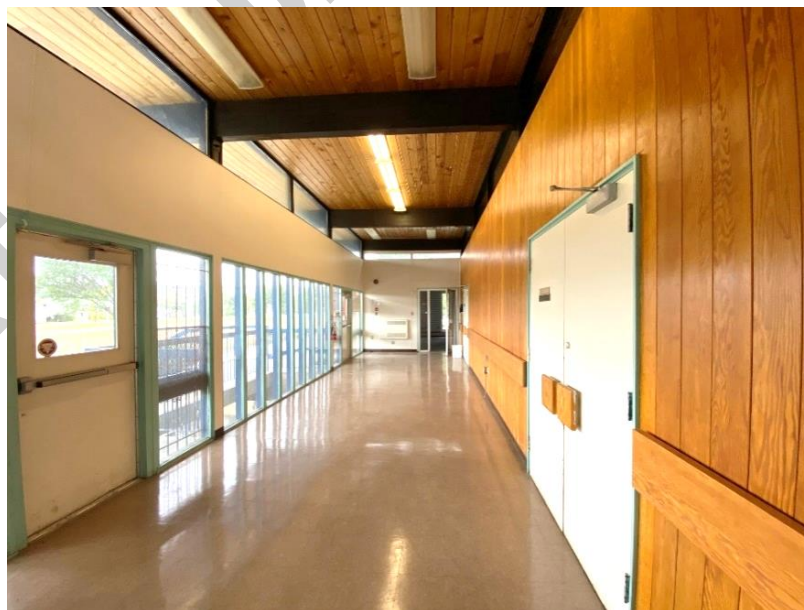
(Image 3.2 Open foyer at upper storey with clerestory windows, glulam beams, wood-paneled ceiling and wood-paneled walls)
