**BYLAW NUMBER 8M2016**

**BEING A BYLAW OF THE CITY OF CALGARY  
TO  
DESIGNATE THE ANDERSON RESIDENCE AS  
A MUNICIPAL HISTORIC RESOURCE**

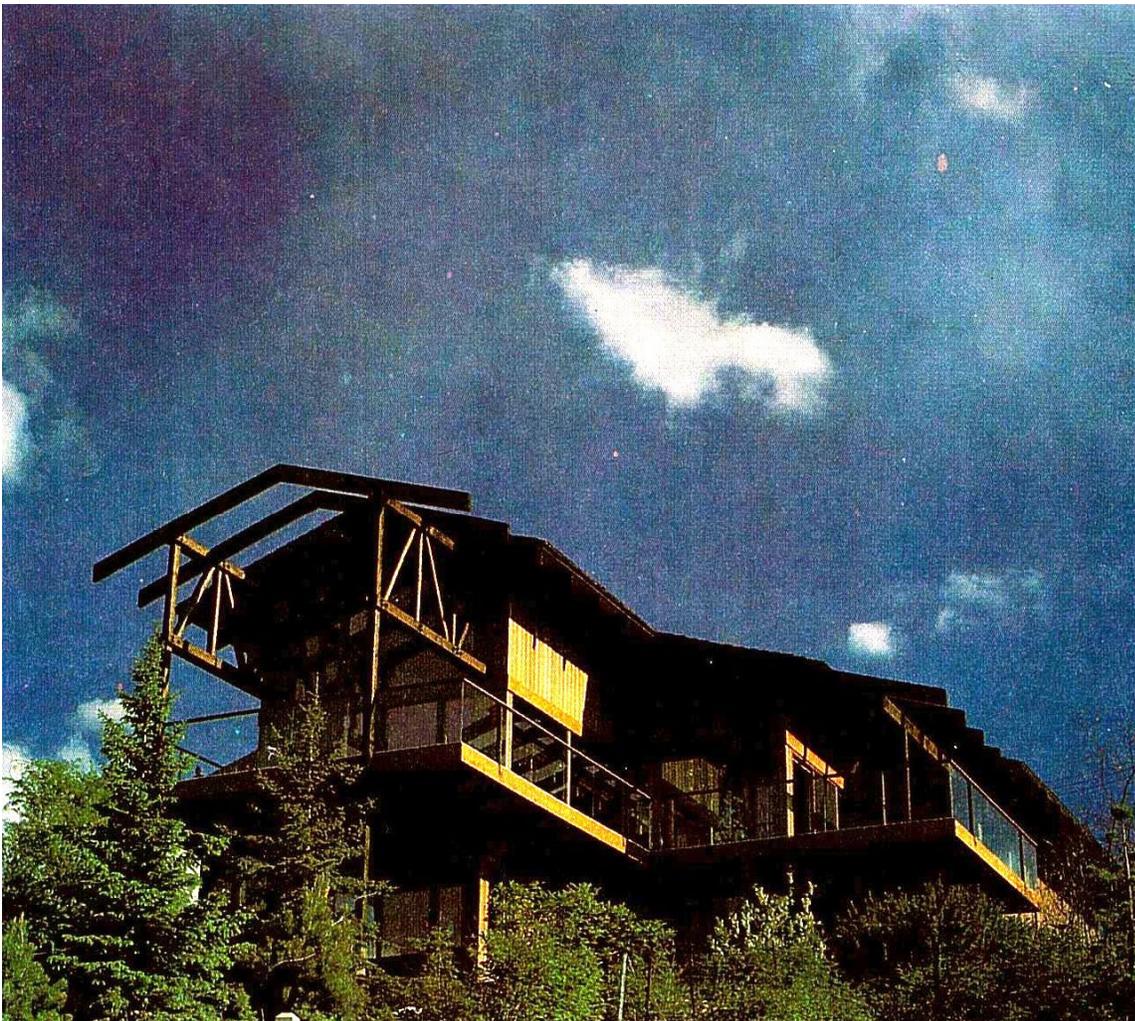
(Photo 1.1: historic view of the North and West Façades – view from the north west - *Western Living* magazine, October 1977 – courtesy Liz Bryan)

- a) vertical, board, cedar siding stained a light brown/olive colour and two horizontal cedar bands stained a light brown colour (Photos 1.1, 1.2, 1.3);
- b) fenestration, comprising plate-glass, thermal-pane windows in a variety of assemblies (Photos 1.1, 1.2, 1.3);
- c) wraparound, upper level deck with steel-rimmed glass balustrade and 2x4 wood decking (Photos 1.1, 1.2, 1.3);
- d) extended, decorative exposed rafters and truss (Photos 1.1, 1.2, 1.3);
- e) two separate basement-level entrances, each with solid wood doors; an upper-level glass and wood deck door (Photos 1.2, 1.3).

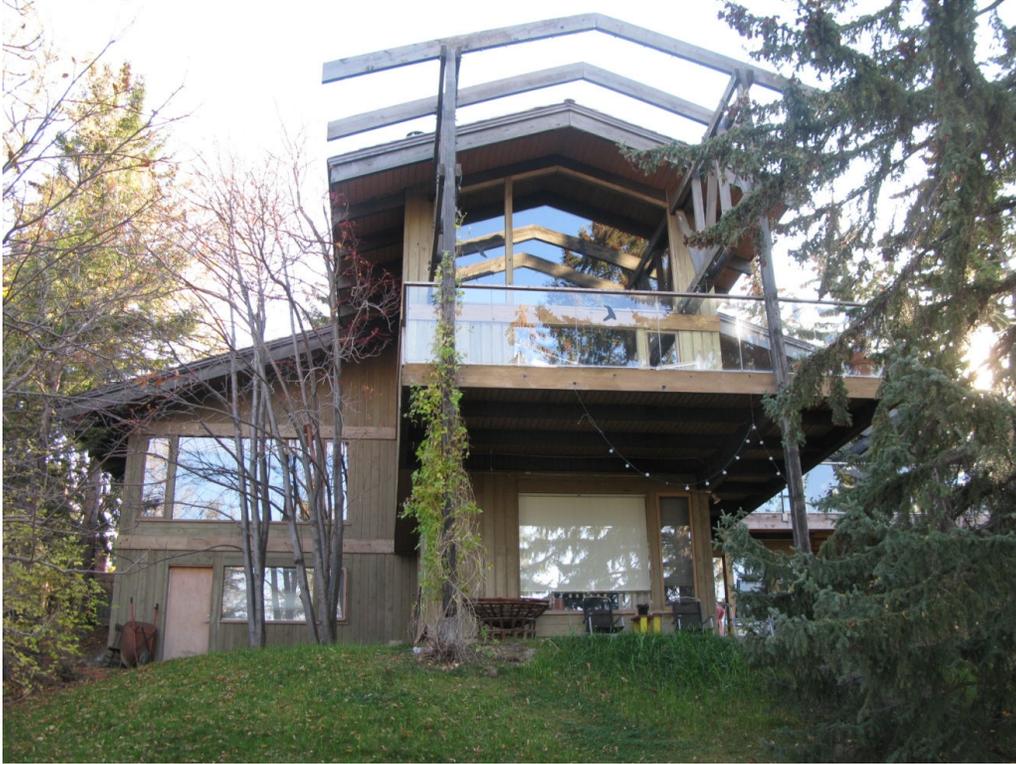
(Photo 1.2: view of the North Façade)

- a) one-storey form, plus an exposed/partially basement (fully exposed at north end of building) (Photos 1.2, 1.3);
- b) front gable roof; exposed rafters and wooden tongue-and-groove soffits (Photo 5.1); operable, vented glass skylight (greenhouse roof) spanning the central courtyard (Photos 5.2, 5.3); operable, vented glass skylight (greenhouse roof) over the potting room (south-east corner) (Photos 5.3, 5.4).

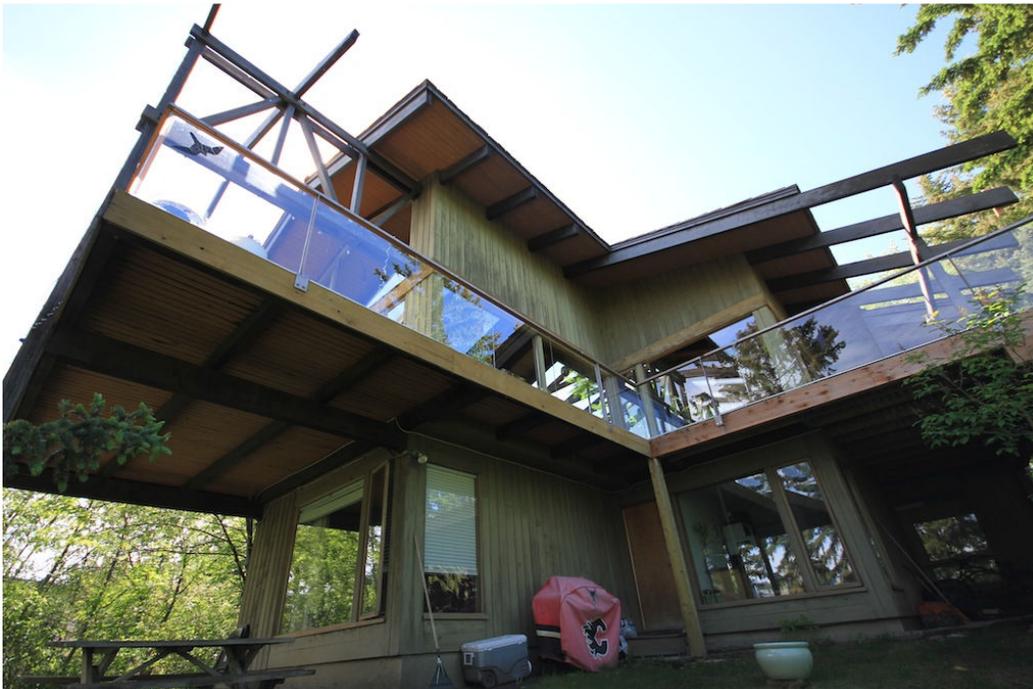
(Photo 1.3: oblique view of the North and West Facades – view from the north west)

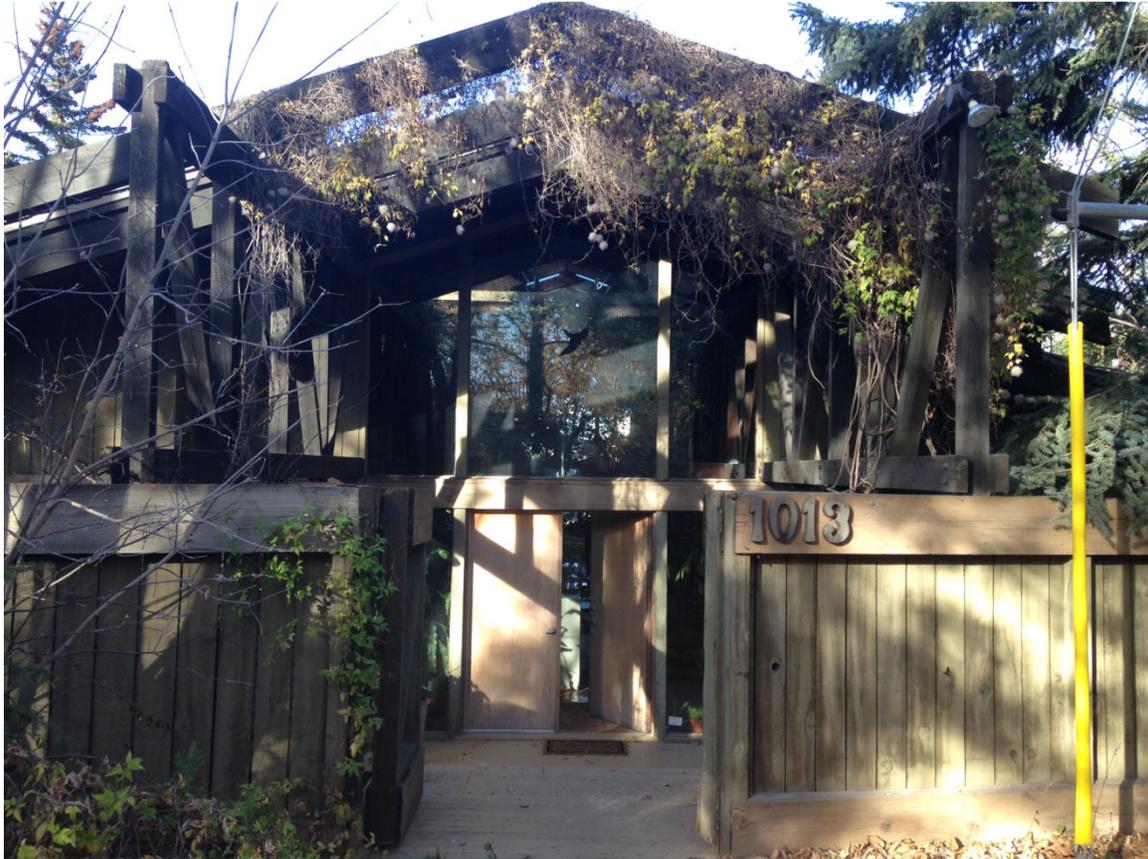
(Photo 2.1: South Façade – the main entrance)

a) vertical, board, cedar siding stained a light brown/olive colour and two horizontal cedar bands stained a light brown colour (Photos 2.1, 2.2, 2.3, 2.4);

- b) fenestration, comprising plate-glass, thermal-pane windows in a variety of assemblies including entrance sidelights and transom light (Photos 2.1, 2.2, 2.3, 2.4);
- c) central entrance with solid wood double doors; asymmetrical garage entrance with unglazed vertical, board, cedar siding (Photos 2.1, 2.2);
- d) extended, decorative exposed rafters and truss (Photo 2.1).

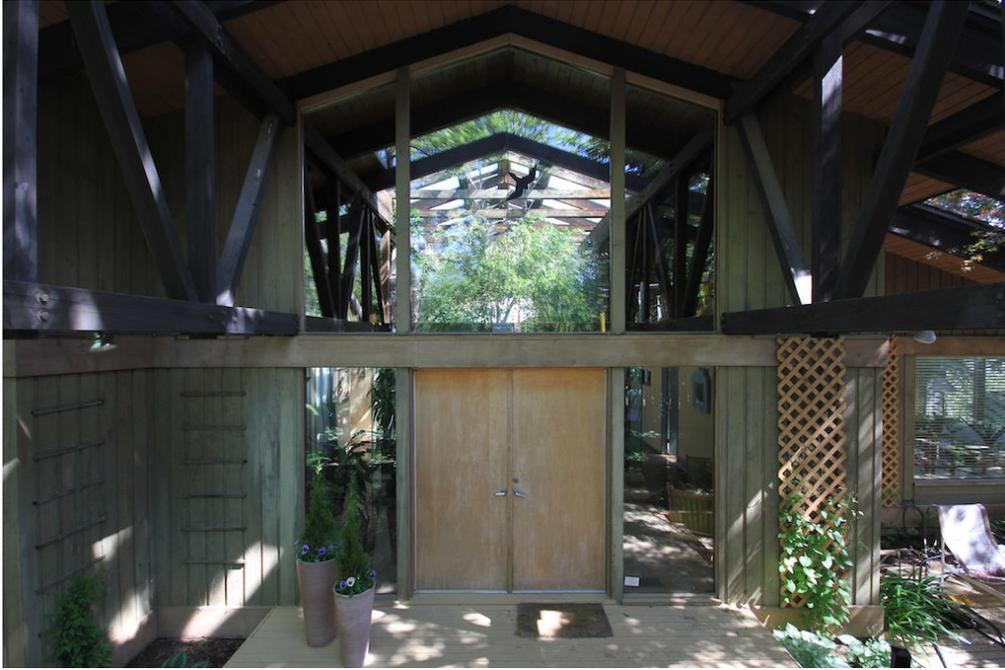
(Photo 2.2: South Façade – the main entrance)

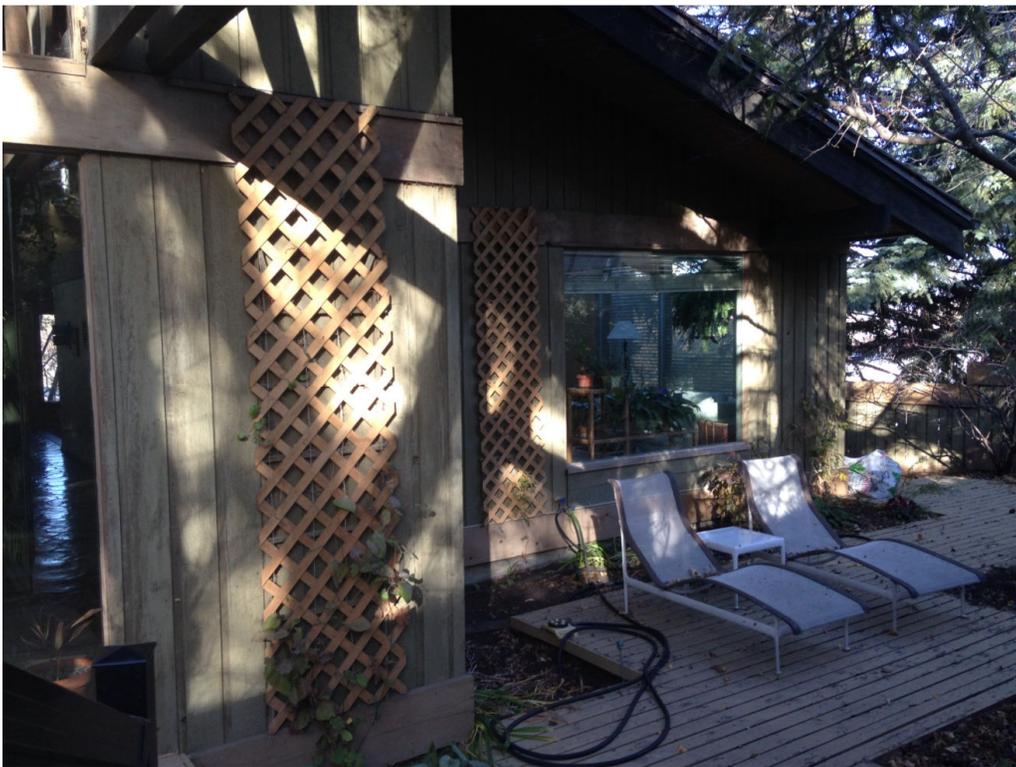
(Photo 2.3: easterly portion of the South Façade)

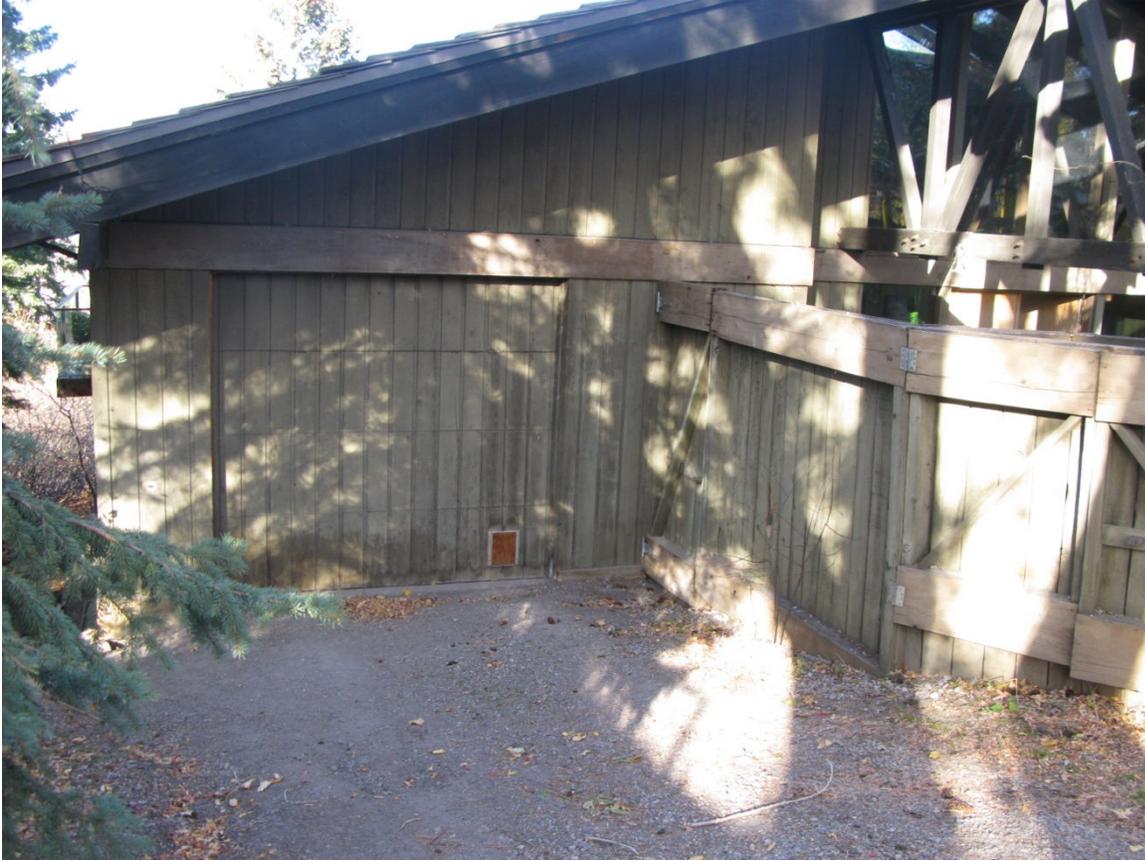
(Photo

2.4: westerly portion of the South Façade, showing garage entrance)

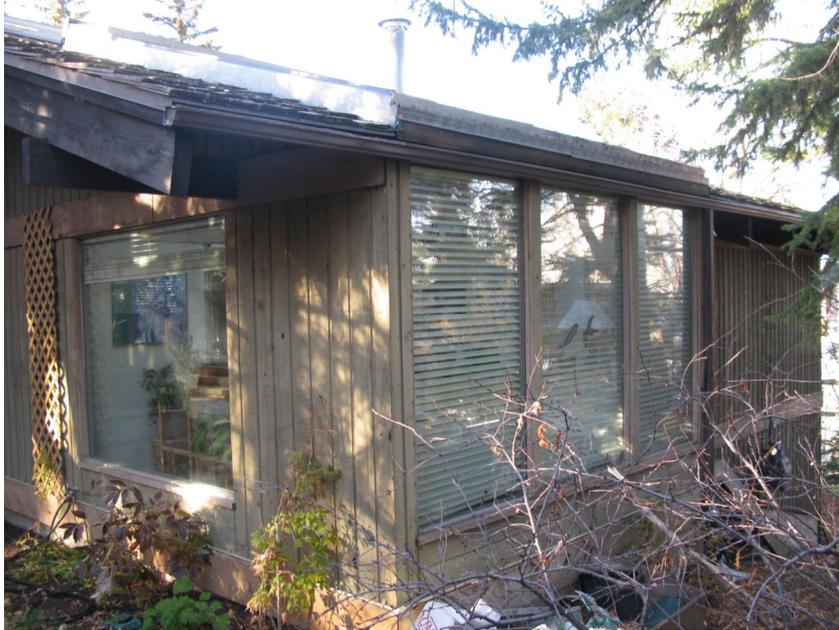
(Photo 3.1: oblique view of the southerly portion of the East Façade – view from the south east)

- a) vertical, board, cedar siding stained a light brown/olive colour and two horizontal cedar bands stained a light brown colour (Photos 3.1, 3.2);
- b) fenestration, comprising plate-glass, thermal-pane windows in a variety of assemblies (Photos 3.1, 3.2).

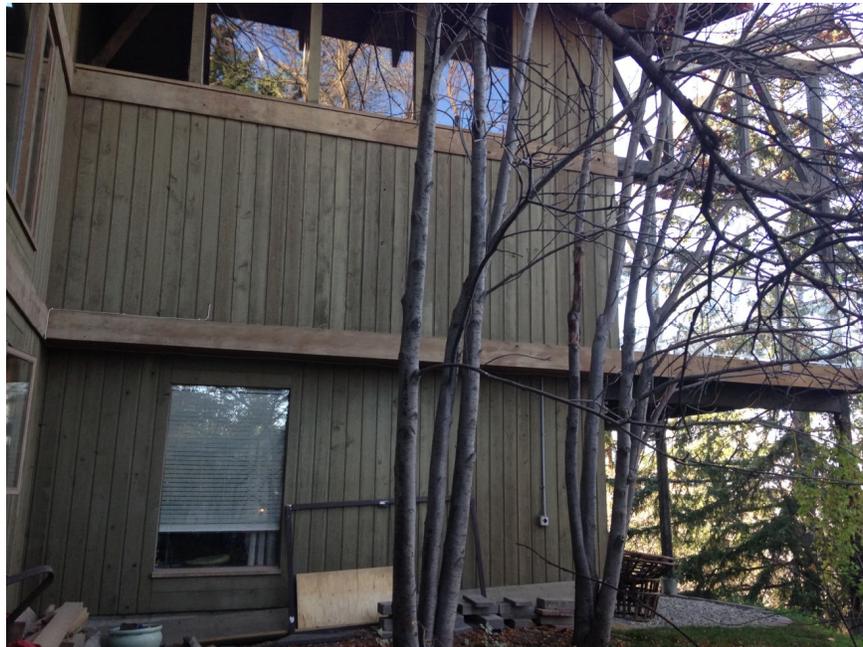
(Photo 3.2: view of the northerly portion of the East Façade)

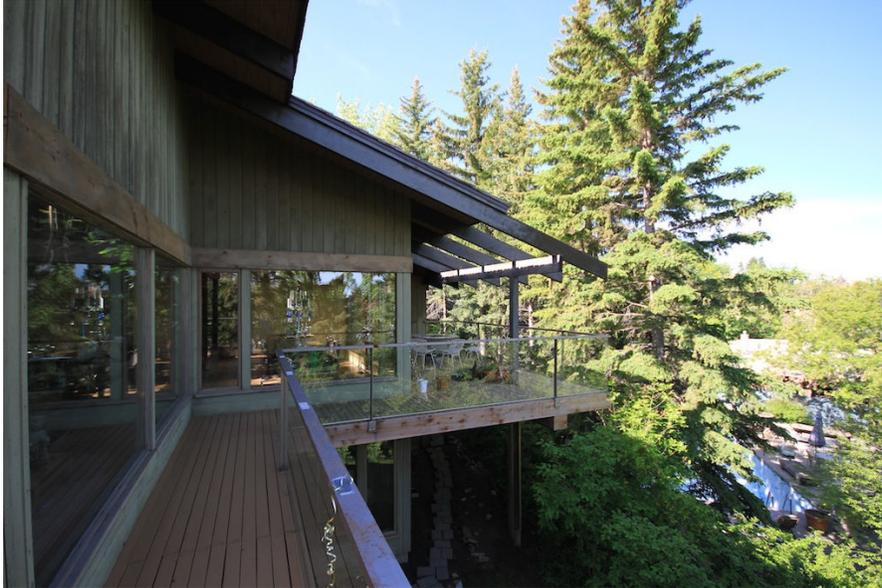
(Photo 4.1: view of the northerly portion of the West Façade – view to the south)

- a) vertical, board, cedar siding stained a light brown/olive colour and two horizontal cedar bands stained a light brown colour (Photos 4.1, 4.2, 4.3, 4.4);
- b) fenestration, comprising plate-glass, thermal-pane windows in a variety of assemblies (Photos 4.1, 4.2, 4.3);
- c) wraparound, upper-level deck with steel-rimmed glass balustrade and 2x4 wood decking (Photos 4.1, 4.2, 4.3, 4.5).

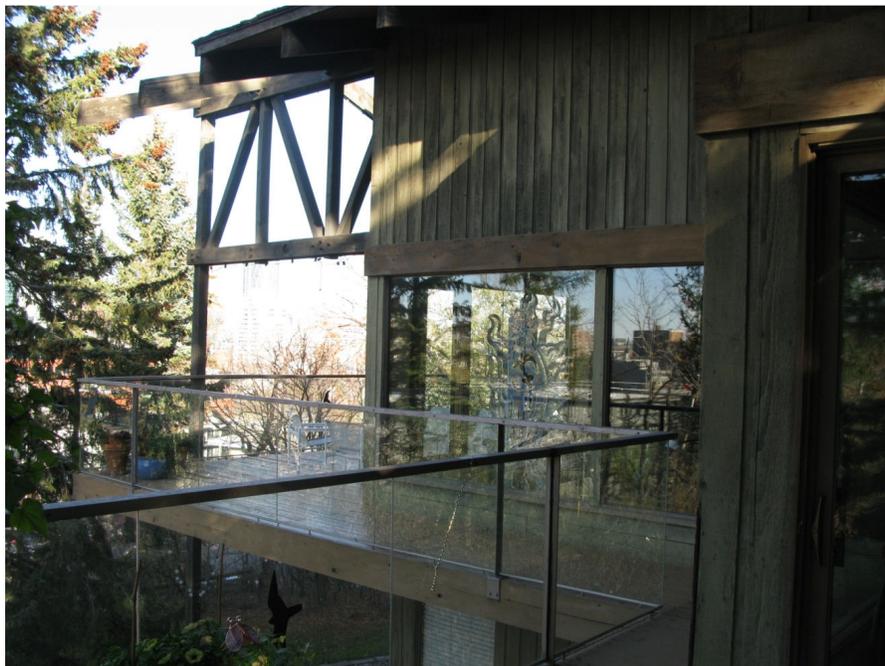
(Photo 4.2: view of the northerly portion of the West Façade – view to the north)

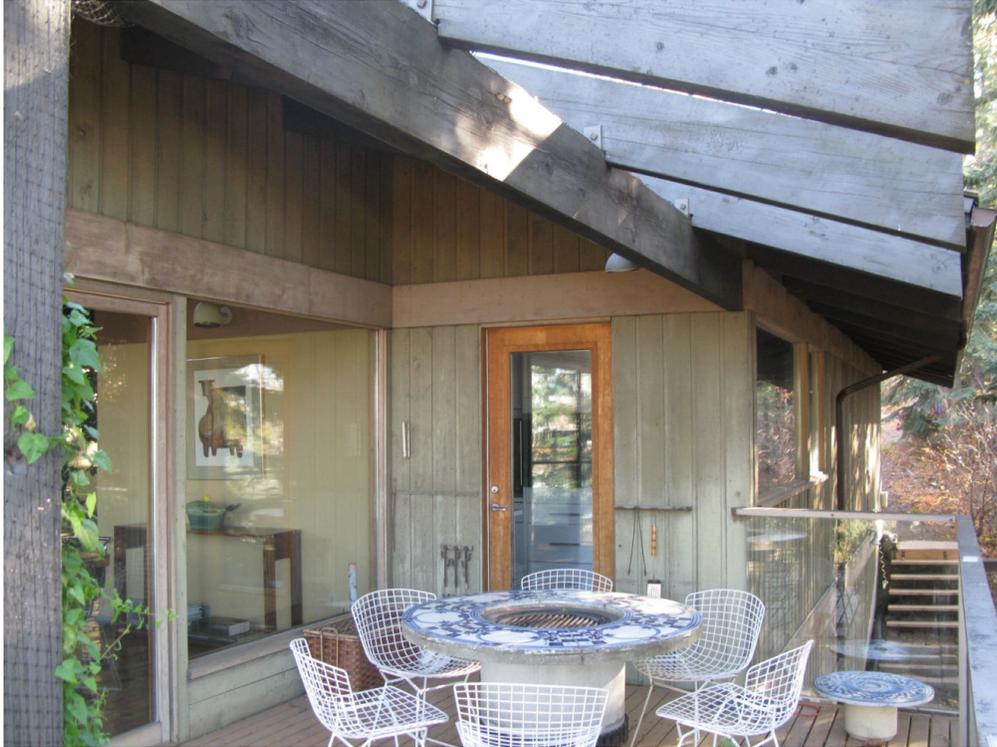
(Photo 4.3: view of the northerly portion of the West Façade- view to the south)

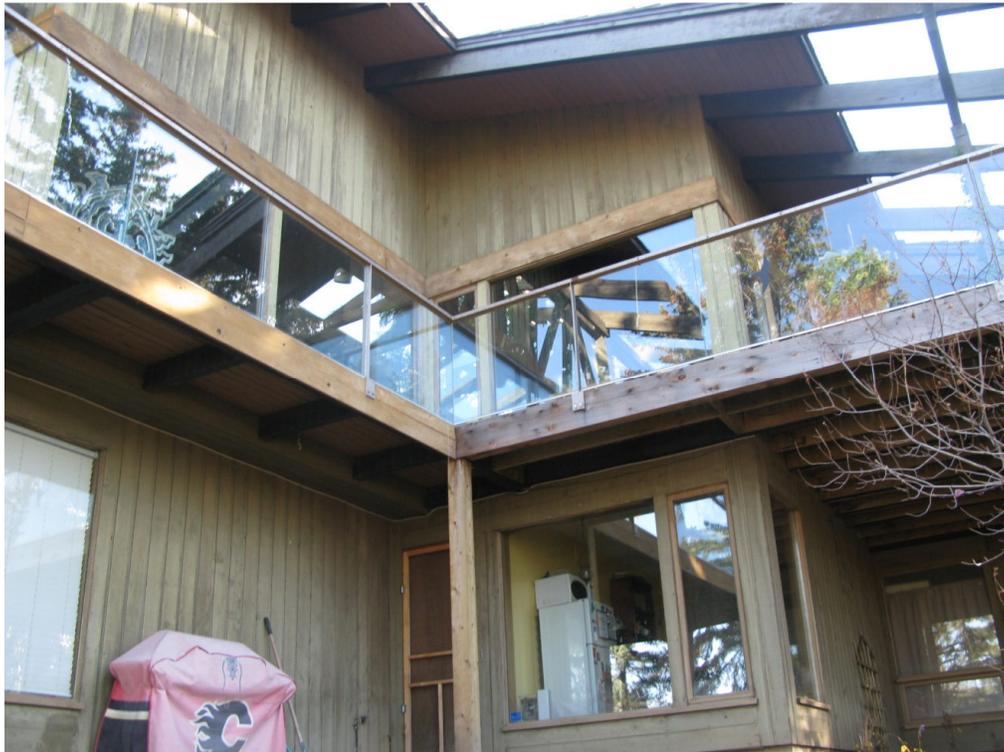
(Photo 4.4: view of northerly portion of West Façade showing exposed basement)

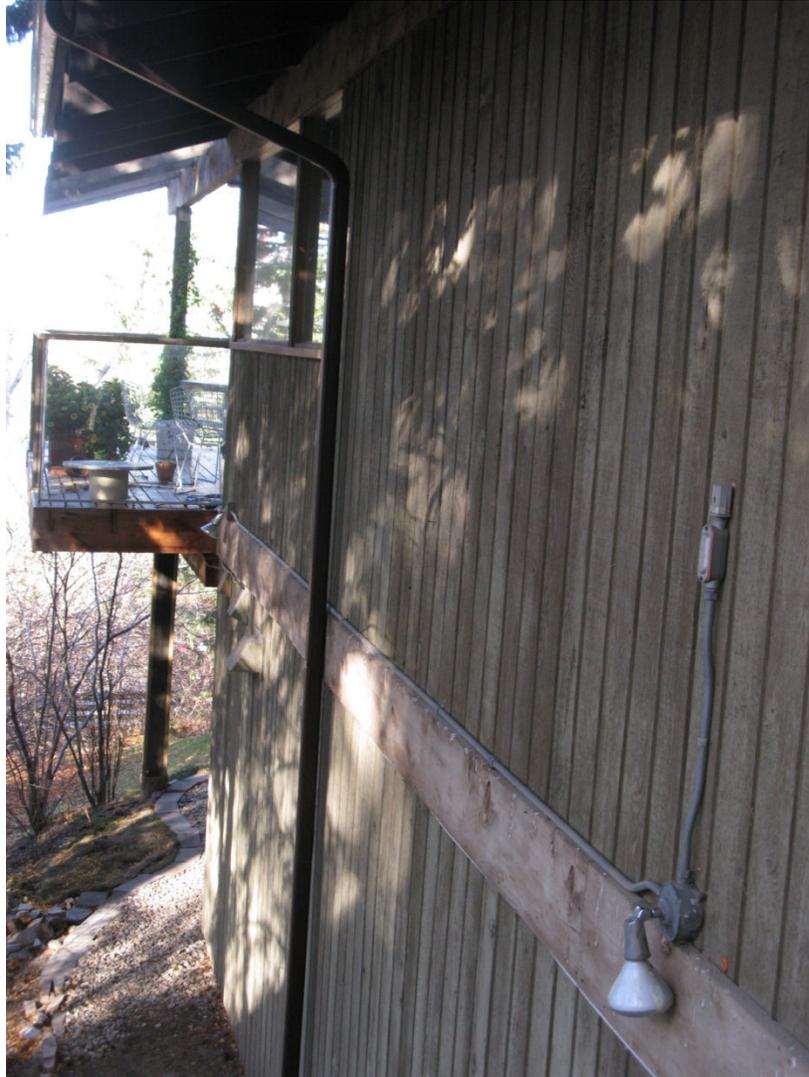
(Photo 4.5: view of southerly portion of West Façade –view to the north)

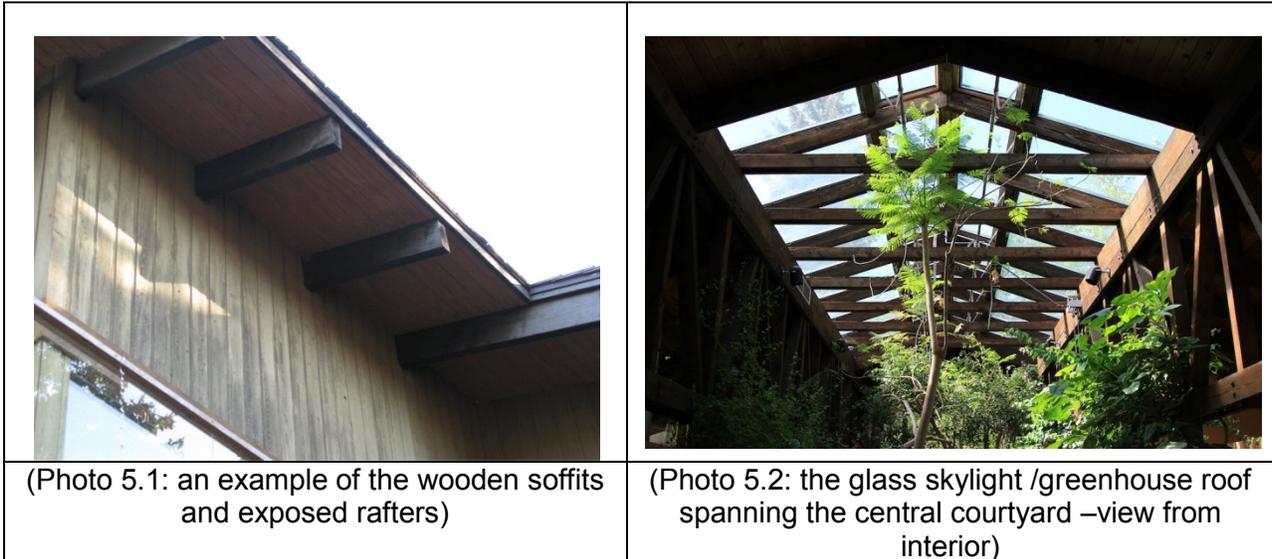
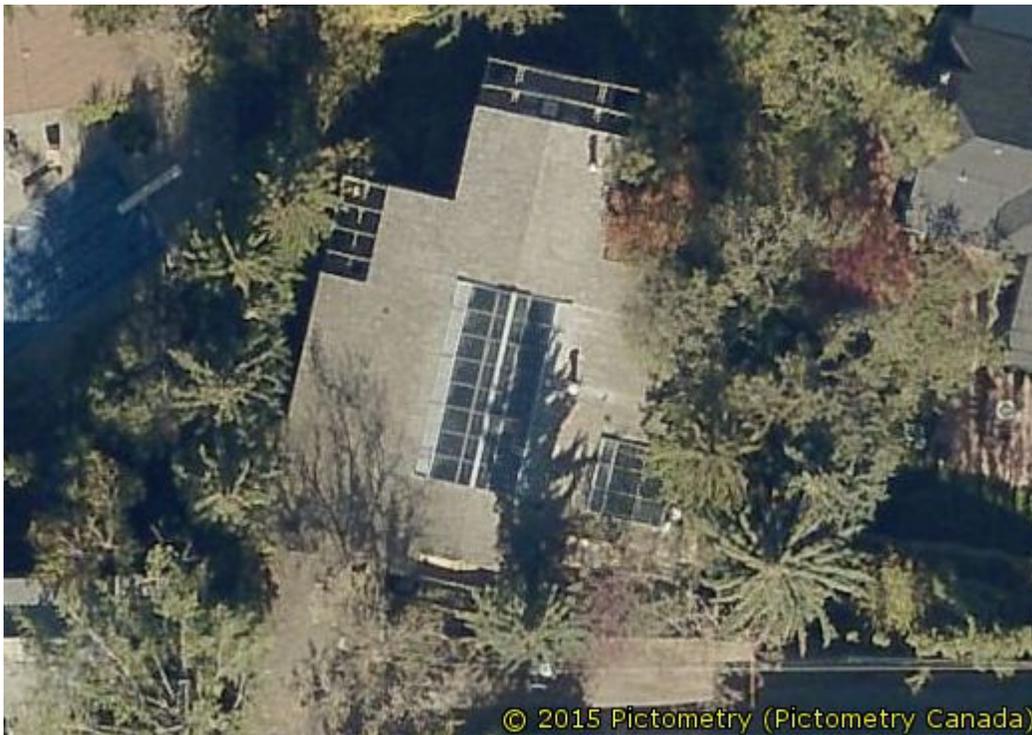
(Photo 5.3: aerial view of the roof and form of the house )

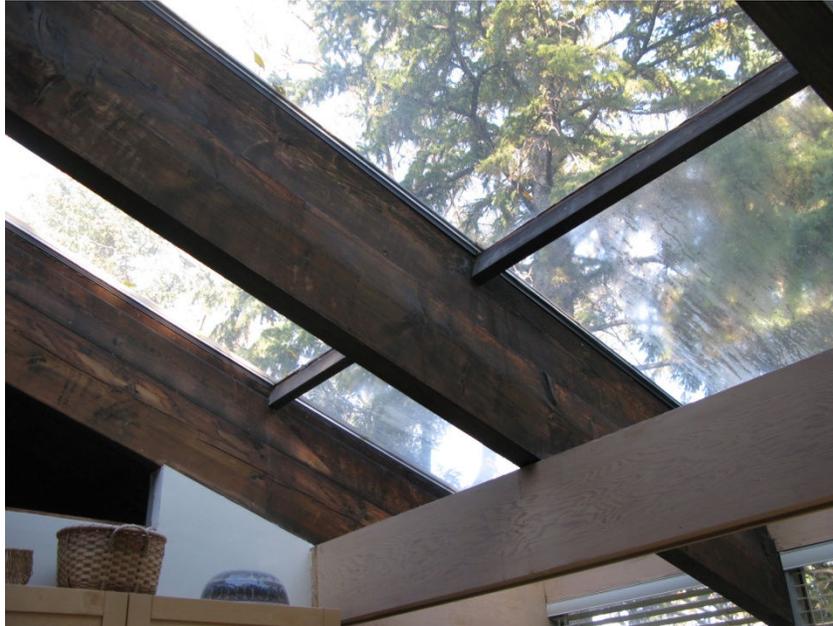
(Photo 5.4: the glass skylight /greenhouse roof over the potting room –view from interior)

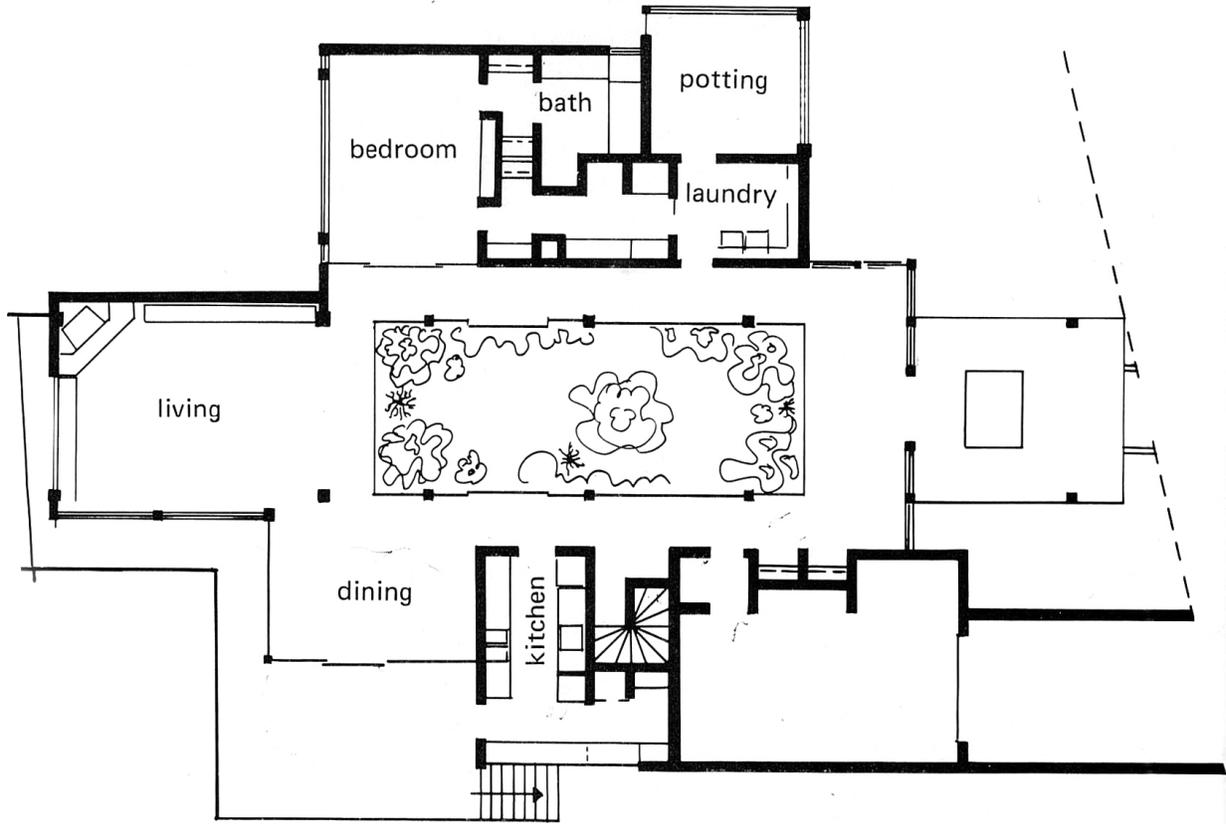
(Image 6.1: the upper-level plan / configuration - *Western Living* magazine, October 1977, courtesy Liz Bryan – note that the drawing does not include the front deck, which was an original feature, and includes stairs from the deck to the ground , which were not constructed)

- a) the upper-level plan/configuration excepting those portions of the plan south of the bedroom wall and east of the courtyard wall (Image 6.1; Photos 6.2 – 6.12)

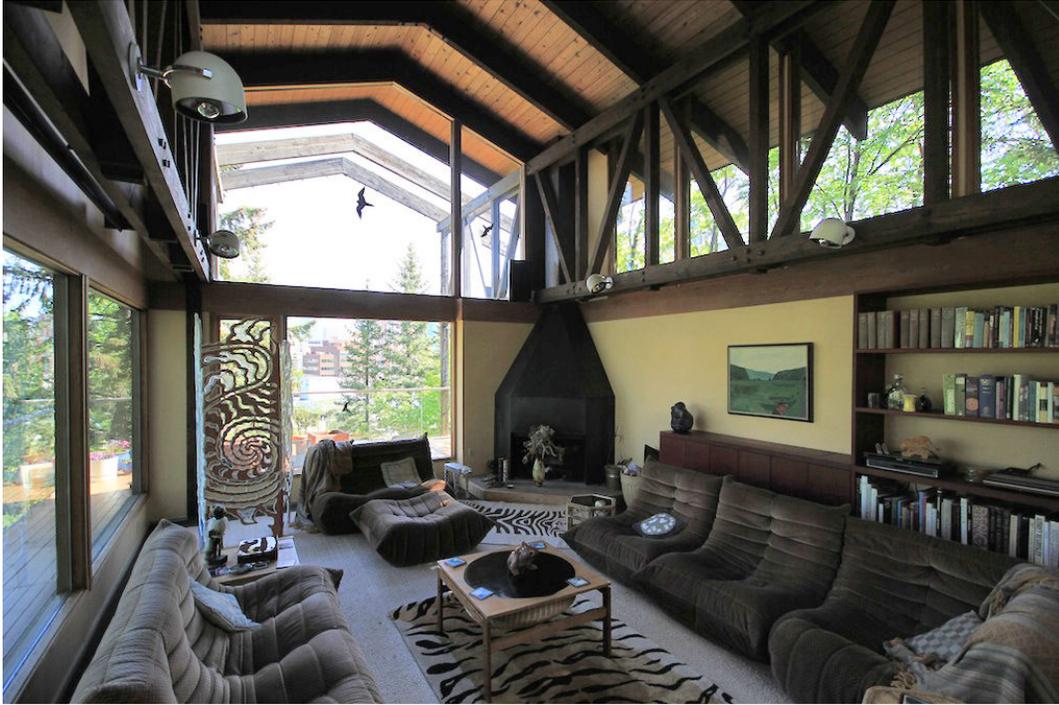
(Photo 6.3: view of the living room)

- b) the exposed wooden roof trusses extending the length of the house from north to south and the associated support posts (Photos 6.3, 6.4, 6.14); and

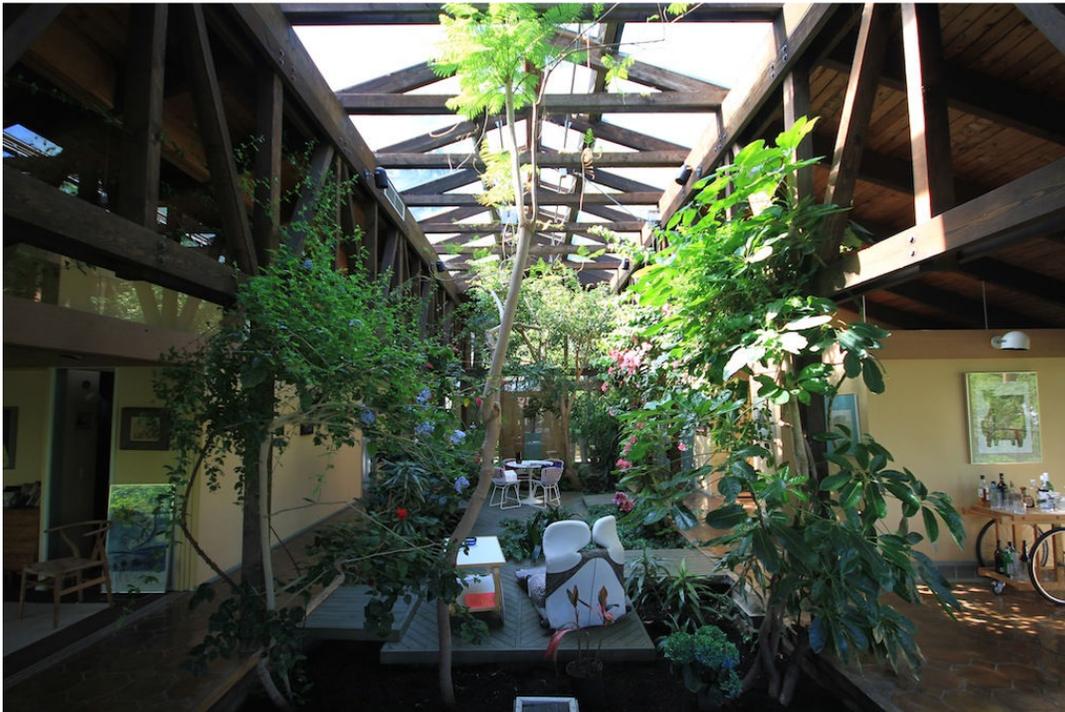
(Photo 6.4: view of the central courtyard)

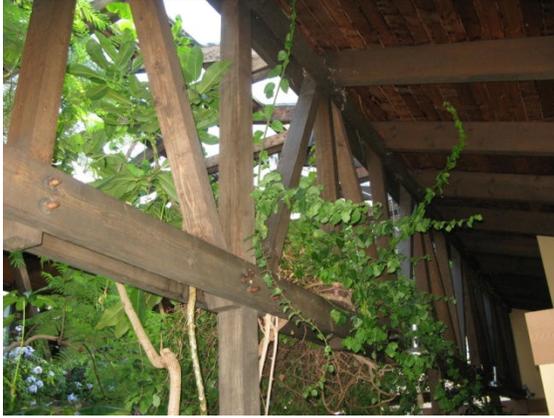
(Photo 6.13: detail view of a portion of the roof truss)

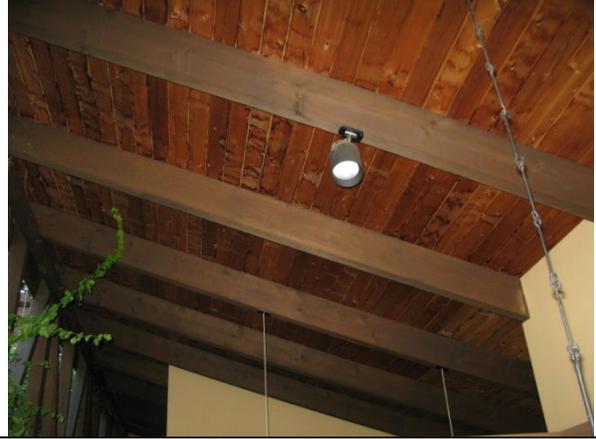
(Photo 6.14: detail view of the wooden tongue-and-groove ceiling and exposed rafters)

- c) the exposed, stained-wood rafters and stained, tongue-and-groove wood ceiling throughout the upper level (Photo 6.14)
- d) the three-quarter height walls comprising the configuration – with glass extensions to the ceiling atop the courtyard walls (Photo 6.15); the plain plaster finish of the walls and the three-quarter-height continuous stained-wood band unifying all of the rooms (Photo 6.16); the glass foyer walls (Photo 6.17);

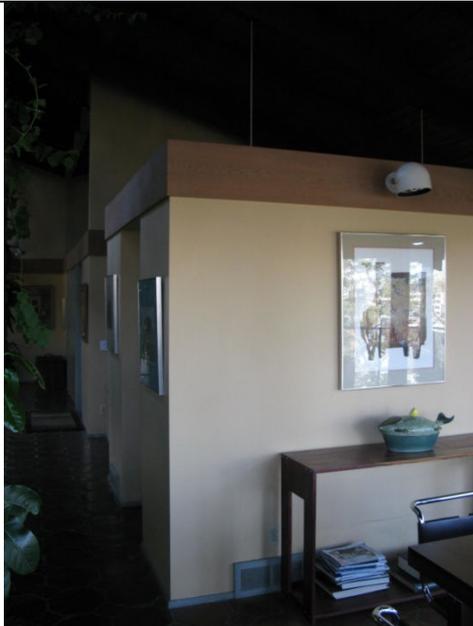
(Photo 6.15: an example of the three-quarter height interior walls around the courtyard)

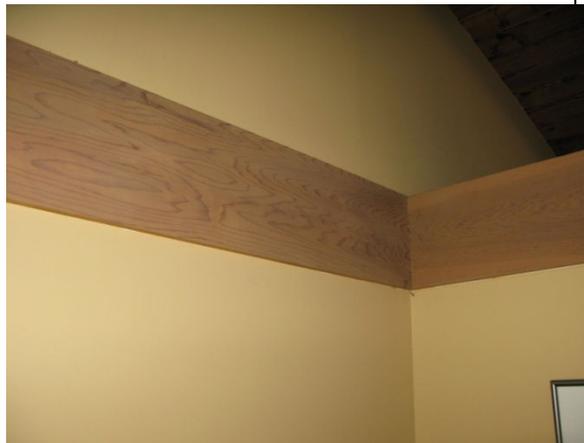
(Photo 6.16: an example of the three-quarter-height continuous, stained-cedar band unifying all of the rooms)

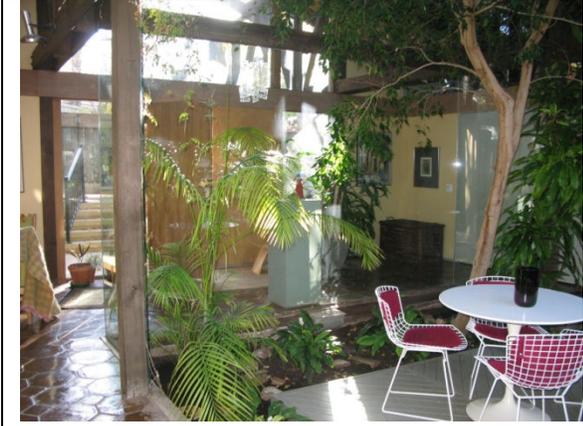
(Photo 6.17: the glass end wall of the foyer, protecting the tropical plantings from cold air from the main entrance)

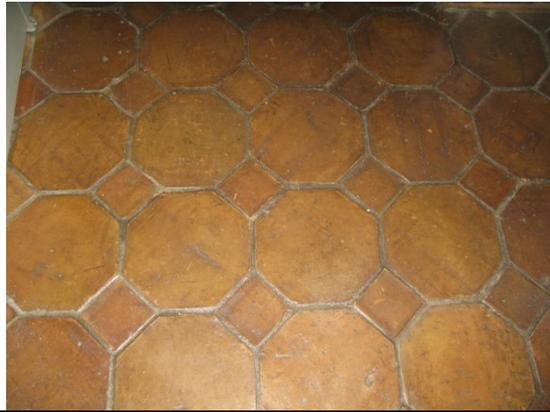
(Photo 6.18: an example of the Mexican clay-tile flooring)

- e) the Mexican clay- tile flooring surrounding the courtyard, in the foyer, dining, kitchen and pantry areas (Photo 6.18);
- f) the staircase finishes including solid, stained-wood railings, plastic balusters/ newels and solid wood stairs (Photos 6.19, 6.20);

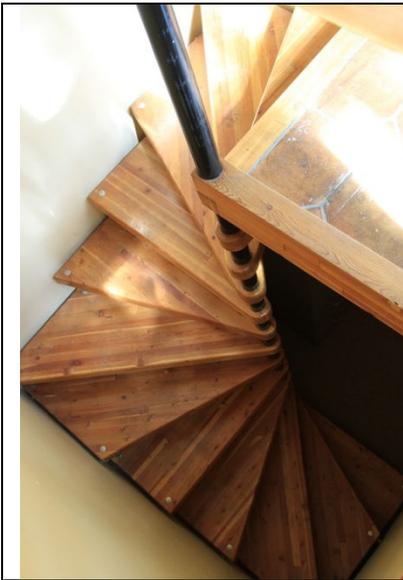
(Photo 6.19: the wooden, spiral staircase)

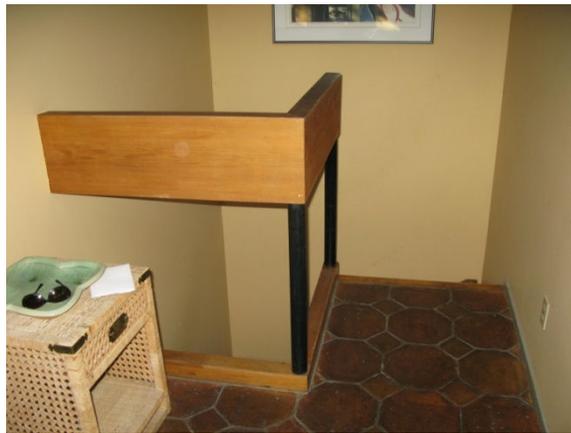
(Photo 6.20: the railings, and plastic newels of the spiral staircase)

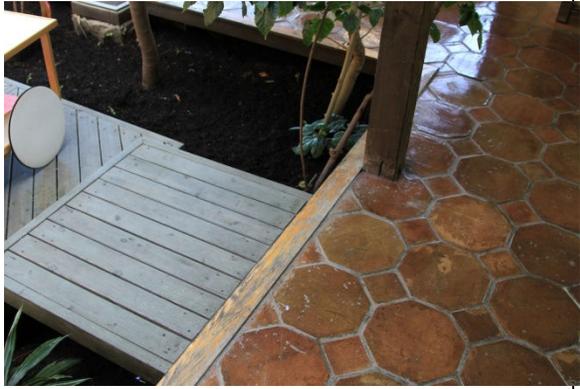
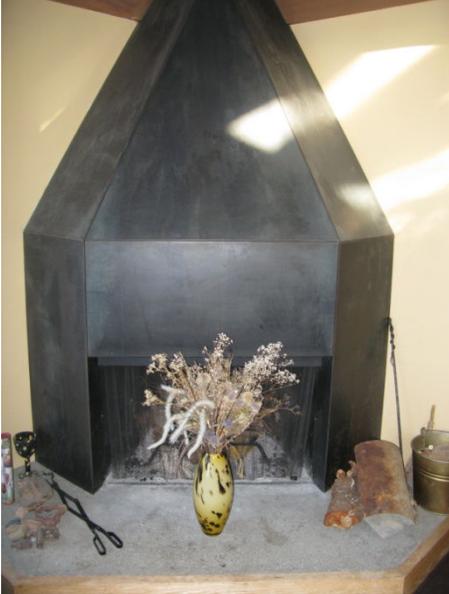
<p>(Photo 6.21: detail view of a portion of the wood decking and planting beds of the courtyard)</p>	<p>(Photo 6.22: the metal living room fireplace)</p>

- g) the elements of the courtyard garden including planting beds and wood decking (2x4 wood decking) (Photo 6.21);
- f) the metal, hooded living room fireplace (Photo 6.22).

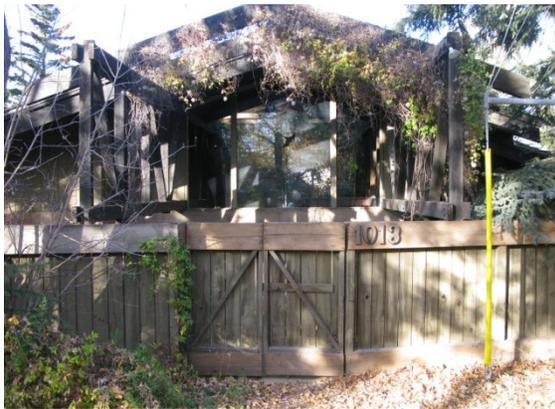
(Photo 7.1: a portion of the fence enclosing the south yard)

- a) the current (original) location of the house on the land (see Schedule “A”);
- b) open and soft-landscaping character of the land in front of the house (to the north), - although specific landscape elements in that area are not regulated;
- c) the fence (wall) of vertical cedar boards - with horizontal wood bands at the top and bottom - that encloses the south yard of the house and extends along the east property line (Photos 7.1, 7.3, 7.4)
- d) the south yard wooden decking fronting and flanking the main entrance (2x4 wood decking) ; the planting beds surrounding the house and the south yard periphery (terraced along the southerly periphery) (Photos 7.2, 7.3, 7.4).

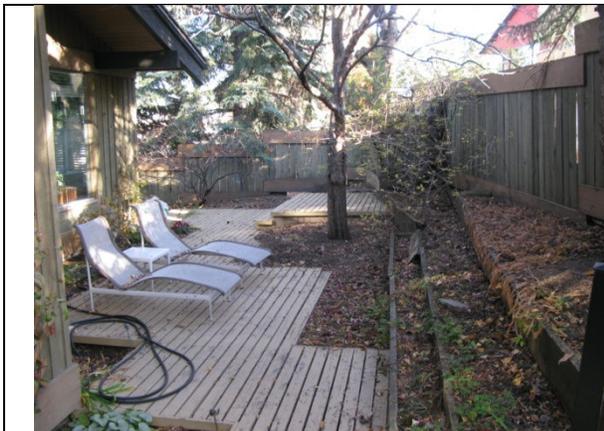
(Photo 7.3: view of the east side of the south yard landscaping showing fencing, decking and planting beds )

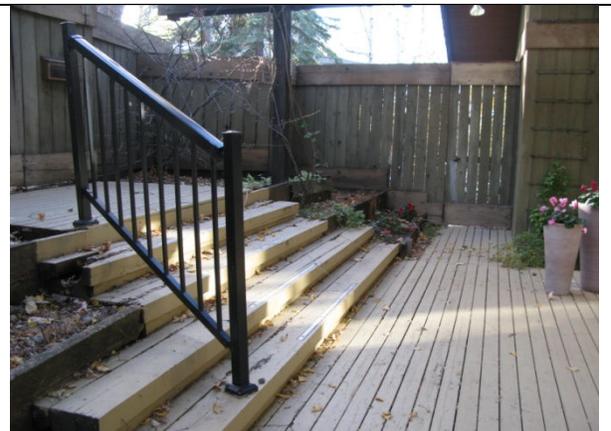
(Photo 7.4: view of the west side of the south yard landscaping showing fencing, decking and planting beds )
