BYLAW NUMBER 49M2021

BEING A BYLAW OF THE CITY OF CALGARY TO DESIGNATE THE DOMINION BANK AS A MUNICIPAL HISTORIC RESOURCE

SCHEDULE "A"

SCHEDULE "B"

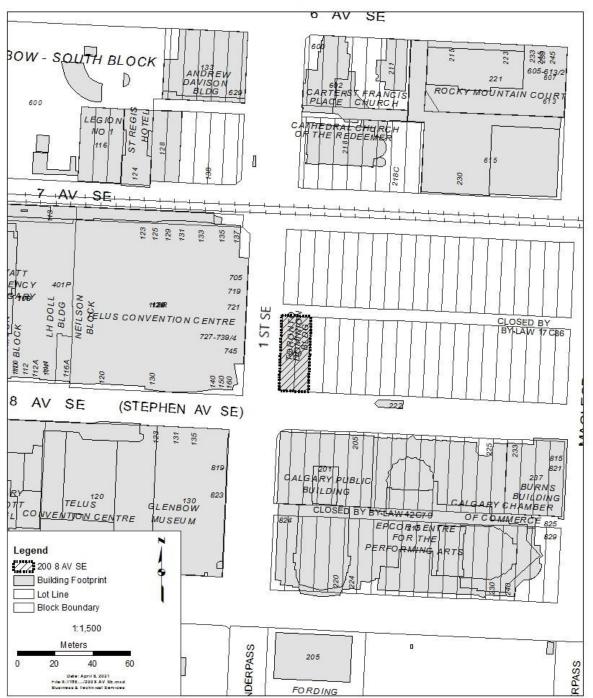
200 8 AV SE

- 2. The building known as the Dominion Bank, located at 200 8 AV S.E., and the land on which the building is located being legally described as PLAN "A" CALGARY; BLOCK FIFTY TWO (52); LOTS THIRTY NINE (39) AND FORTY (40) (the "Historic Resource"), as shown in the attached Schedule "A", are hereby designated as a Municipal Historic Resource.
- 3. The specific elements of the Historic Resource possessing heritage value are hereafter referred to as the Regulated Portions (the "Regulated Portions"). The Regulated Portions are identified in the attached Schedule "B".

a) Any development of any portion of the property (as shown on attached Schedule "A") shall be undertaken in a manner that does not negatively impact the Regulated Portions of the Historic Resource or its landmark character.

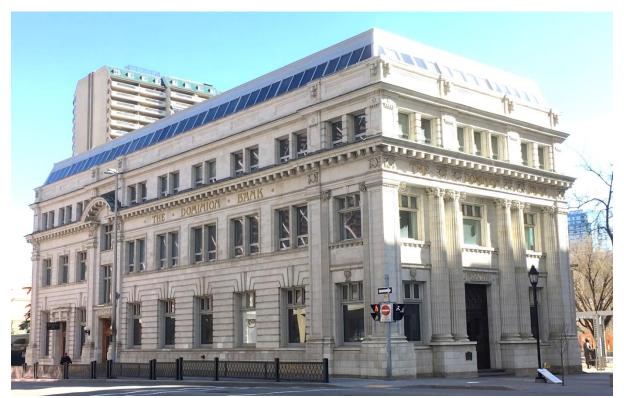
(Image 1.1: South and west façades)

- a) Smooth sandstone blocks with vertical and horizontal rusticated detailing at first storey of west and south facade; terra cotta units to roofline; pilasters decreasing in scale towards roofline; keystone details above window openings; wall surfaces with floral or shield detailing throughout (Images 1.1 1.3);

- b) Cornice at top of second storey with narrowly spaced modillions, dentils and egg-and-dart moulding, with arched hood portion and cornice returns over main west entryway; cornices under second floor windows; entablatures stating 'The Dominion Bank' (Images 1.1 1.4 and 1.8);

- c) South: symmetrical façade; two storey, twinned, fluted round columns with ionic capitals surrounding entryway; pilasters with egg-and-dart moulding and floral relief details on corner; engaged columns at pilasters; southeast corner quoining; decorative door surround; sign band with '19 Bank 11'; double oak doors with single light with diamond wooden sash transom; granite door threshold (Images 1.1 1.3, and 1.6).

- d) West: two storey surround with pilasters with egg-and-dart-moulding and floral relief details; small cornice over main entryway with decorative door surround and entablature stating 'Offices'; main entry double oak doors with single lights, diamond wooden sash transom and granite door threshold; entablature surrounding northernmost entryway with keystone pediment and egg-and-dart detailing; northernmost entry double oak doors with single lights and single light transom; (Images 1.1 1.2 and 1.4, and 1.7 1.9; and

- e) Fenestration comprised of evenly spaced, deeply recessed openings; 3 over 1 with dentil moulding detail, 1 over 1, and 3 over 3 window profiles in single, double and triple assemblies; (Images 1.1 1.5 and 1.7).

a) Form, scale and massing expressed by its rectangular plan; three storey height; massing broken horizontally into three sections stacked in decreasing size; flat roofline (Images 1.1 – 1.3).

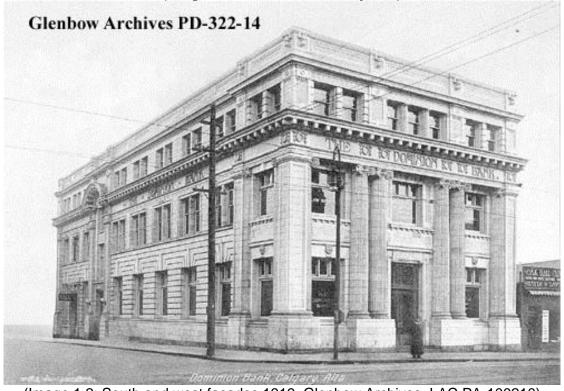
(Image 1.2: South and west façades 1919, Glenbow Archives, LAC PA-100210)

Note: The fourth storey addition, while sympathetic in design, is not regulated and a return to original configuration/appearance would not be precluded where documentation of original configuration exists (Images 1.2 and 2.2)

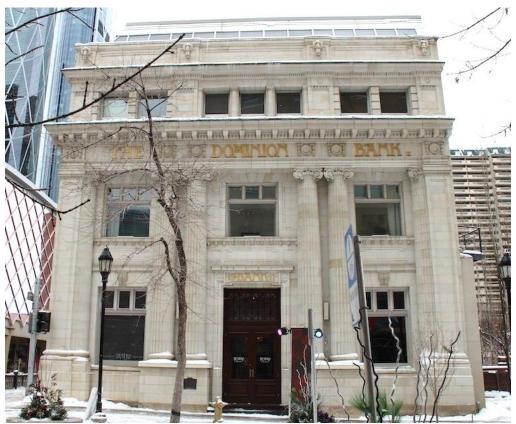
(Image 1.3: South façade)

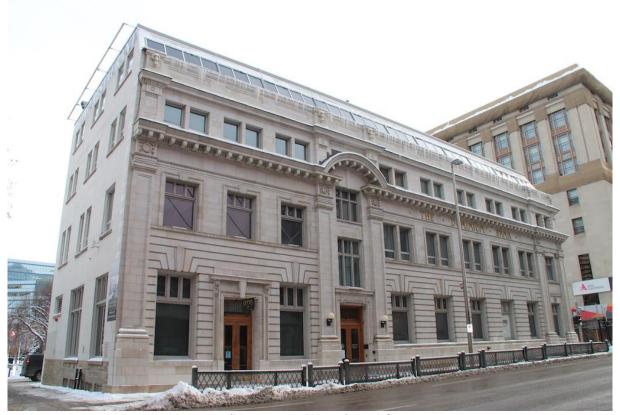
(Image 1.4: West façade)

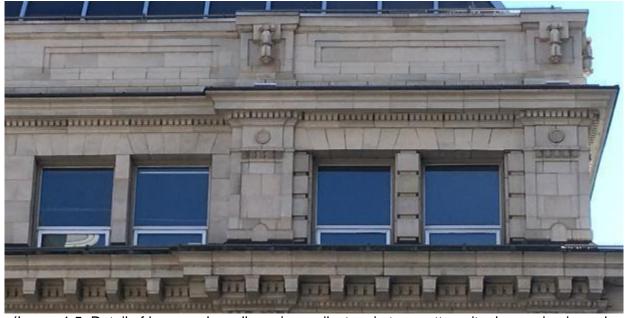
(Image 1.5: Detail of large and small cornices, pilasters in terracotta units decreasing in scale towards roofline, and floral and shield detailing)

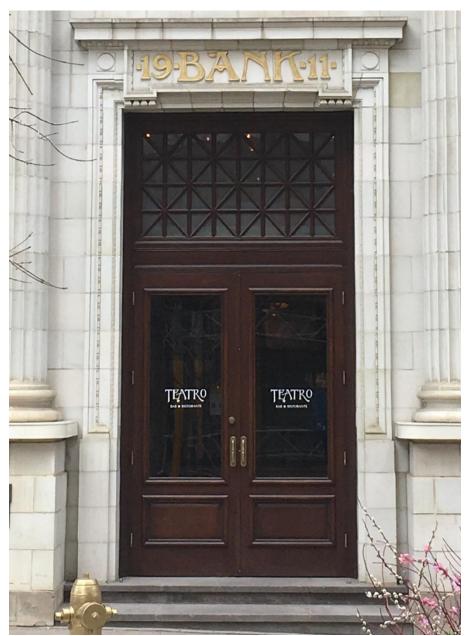
(Image 1.6: South entryway, decorative door surround '19 Bank 11' sign band, double oak doors with single lights with diamond wooden sash transom; granite door threshold)

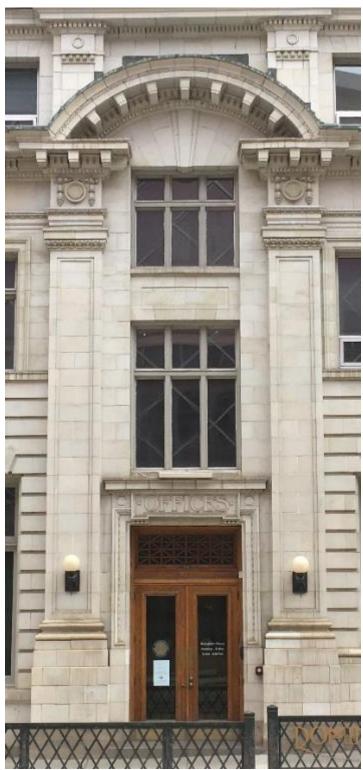
(Image 1.7: West façade, main entryway with two storey surround with pilasters; arched hood at cornice)

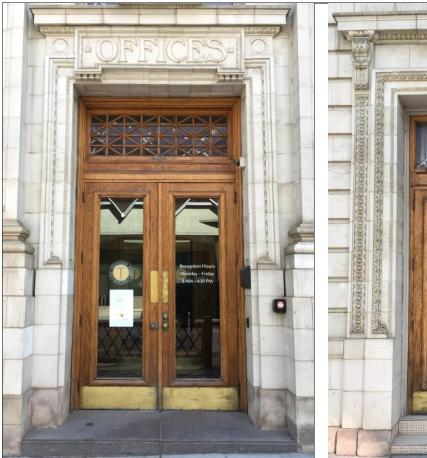
Image 1.8: Main entryway on west façade.

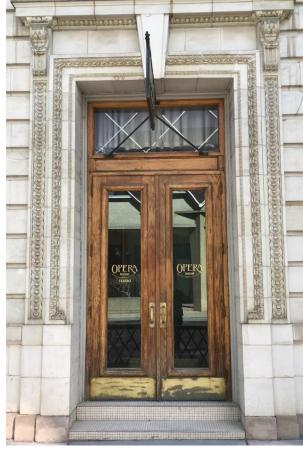
Image 1.9: Northernmost entryway on west façade

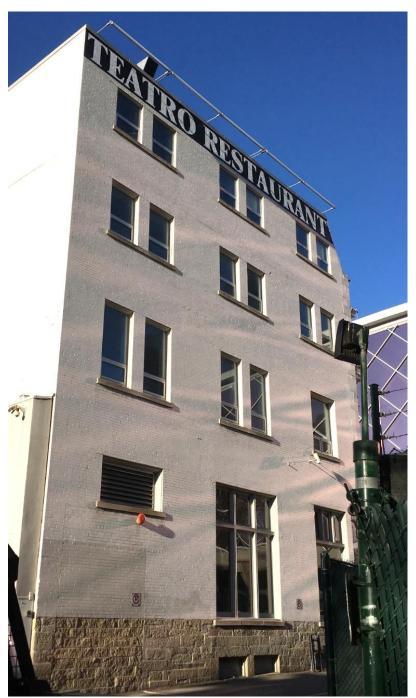
(Image 2.1: North façade with square cut ashlar sandstone and brick wall in common bond)

- a) Square cut ashlar sandstone blocks at grade level; brick wall in common bond (Image 2.1);
- b) Quoining at northwest corner (Image 2.2); and
- c) Fenestration comprised of evenly spaced openings; 1 over 1, 3 over 1 and 3 over 3 window profiles in single double assemblies; sandstone sills (Images 2.1 and 2.2).

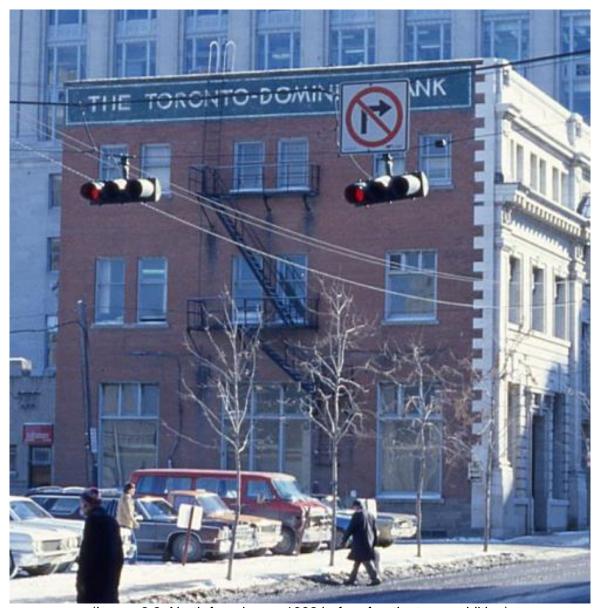
(Image 2.2: North façade, ca. 1982 before fourth storey addition)

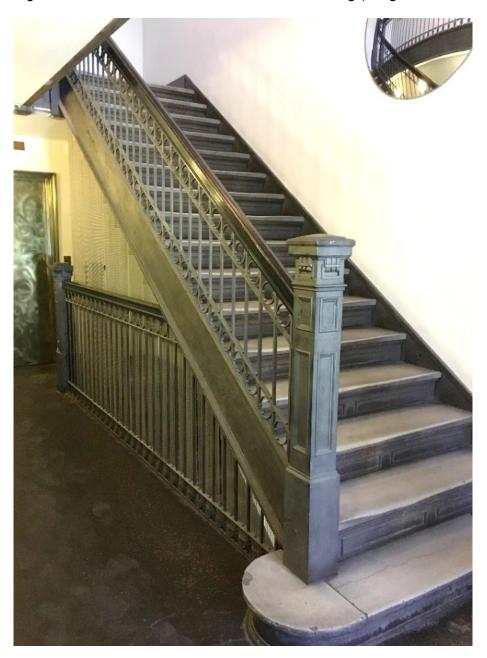
(Image 2.1: Original steel staircase, balustrade and newel post in west inner vestibule)

- a) Steel stairs, balustrade and newel posts in main west vestibule (Images 2.1 and 2.3);
- b) Terrazzo floor in main west vestibule (Image 2.3);
- c) Double oak doors; side lights and single light transom in main west vestibule (Image 2.4); and
- d) Plaster ceilings with coffered insets with dentil and leaf detailing (Images 2.5 and 2.6).

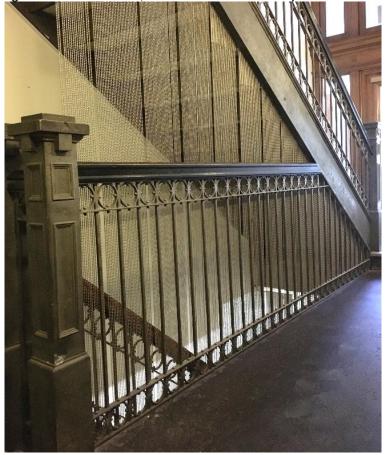
(Image 2.2: Original steel staircase, balustrade and newel post in west inner vestibule)

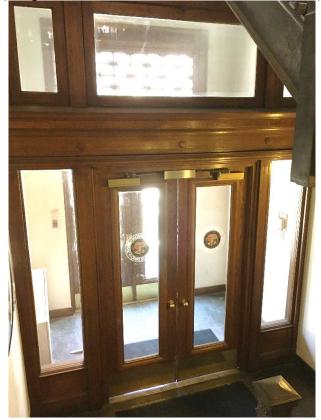
(Image 2.4: Double oak doors with transom and side lights at west entryway, terrazzo floor in outer vestibule)

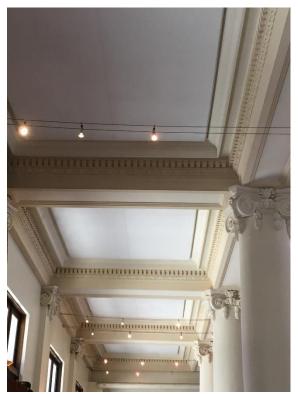
(Image 2.3: Plaster ceilings on west side of main floor dining room)

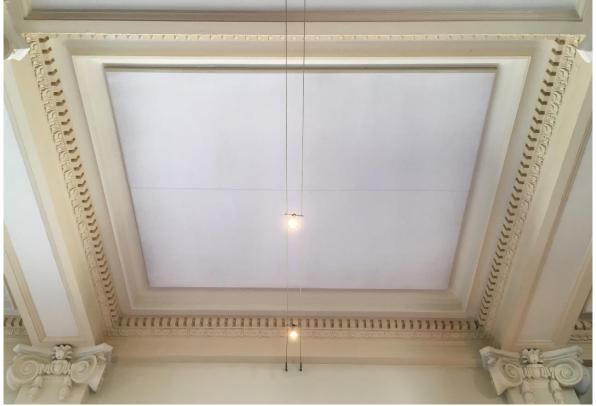
(Image 2.6: Detail of coffered insets with dentil and leaf detailing)
