BYLAW NUMBER 21M2022

BEING A BYLAW OF THE CITY OF CALGARY TO DESIGNATE THE IMPERIAL BANK BUILDING AS A MUNICIPAL HISTORIC RESOURCE

SCHEDULE "B"

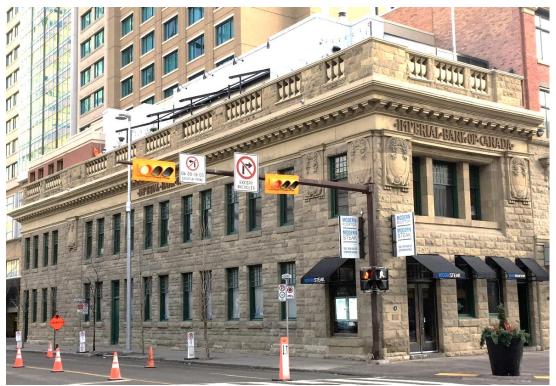
(Image 1.1: South and west façades)

- a) Rough-faced sandstone exterior; carved sandstone cartouches on upper storey (Images 1.1 1.8):
- b) Balustraded parapet; metal urn-shaped balusters; parapet coping; deep, pressed-metal block-modillion cornice with boxed eaves; pressed-metal frieze stating 'Imperial Bank of Canada' (Images 1.1 1.6); and
- c) Original fenestration; original wood sash windows; including multi-pane-over-single pane (29); multi-pane-over-single pane in triple assembly divided by sandstone mullions (1); deeply recessed moulded sandstone window surround; wood frames; sandstone lintels and sills; multi-pane transom (2) (Images 1.1 1.5, 1.8 1.10).

a) Form, scale and massing expressed by its long rectangular plan; two storey height and massing; flat roofline (Images 1.1 - 1.5).

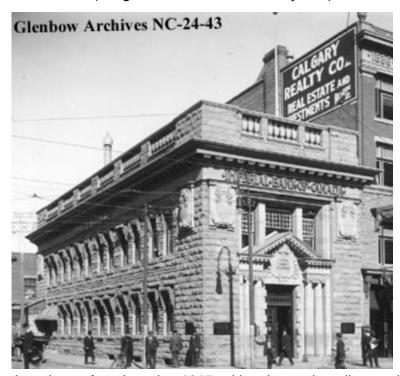
(Image 1.2: South and west façades, circa1915, with columned, pedimented central entry way)

Note: Fenestration changes on lower storey south façade and southwest corner and removal of portico are not regulated and a return to original configuration/appearance would not be precluded where documentation of original configuration exists (Image 1.2).

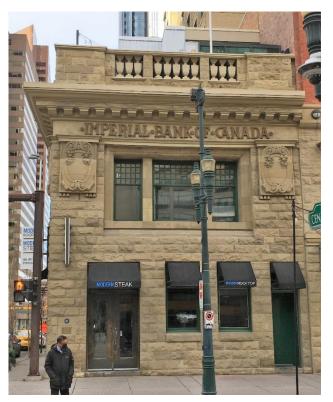
(Image 1.3: South façade)

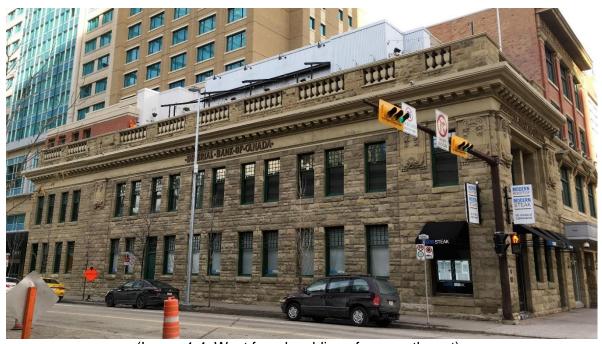
(Image 1.4: West façade, oblique from southwest)

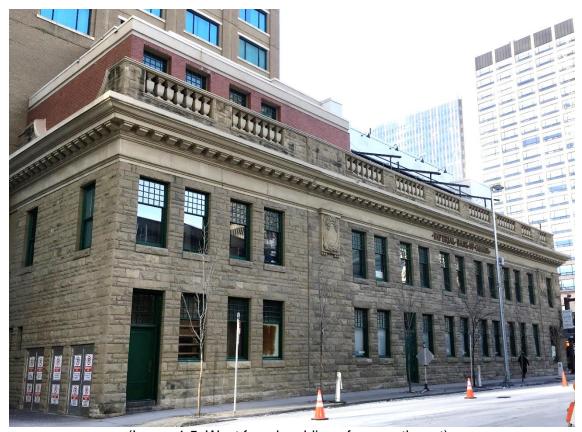
(Image 1.5: West façade, oblique from northwest)

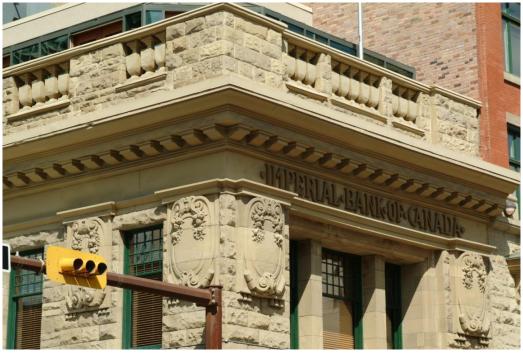
(Image 1.6: Detail of parapet, pressed-metal cornice and frieze)

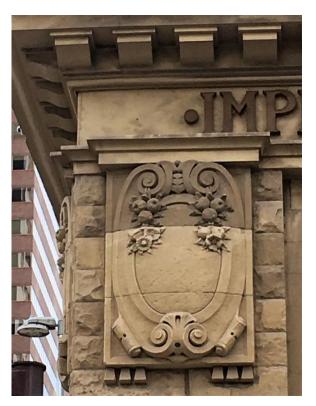
(Image 1.7: Detail of carved sandstone cartouche)

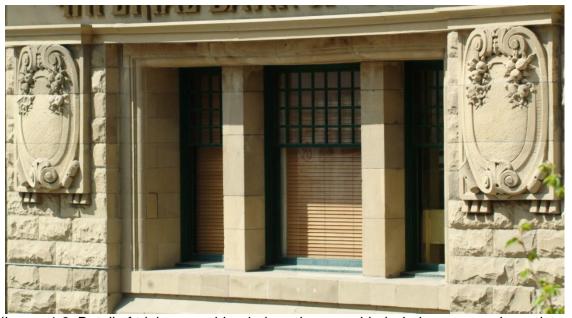
(Image 1.8: Detail of triple assembly window, deep moulded window surround, sandstone mullions)

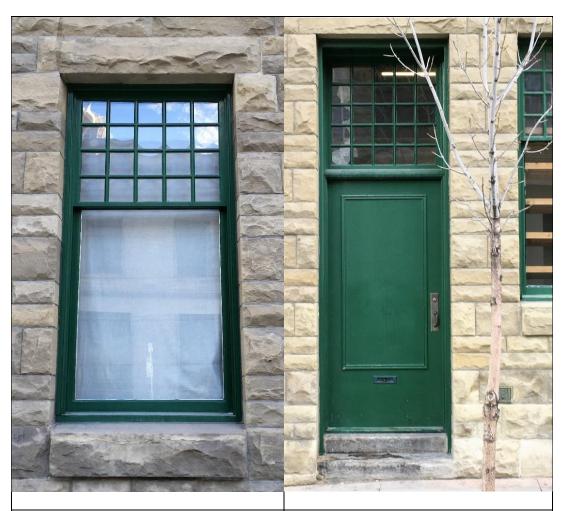
Image 1.9: Typical fenestration, sandstone lintel and sill.

Image 1.10: Example of multi-pane transom (above northern most entry on west façade.

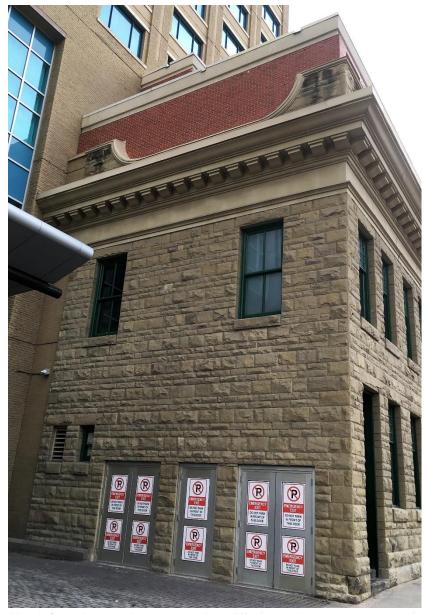
(Image 2.1: North façade, sandstone exterior; 'U'-shaped parapet, pressed-metal block-modillion cornice and frieze)

- a) Rough-faced sandstone exterior (Image 2.1);
- b) 'U-shaped' parapet; parapet coping; deep, pressed-metal block-modillion cornice with boxed eaves, pressed-metal frieze (Image 2.1); and
- c) Original fenestration; original wood sash windows; including two-over-two sash windows (2); one-over-one sash window (1); wood frames; sandstone lintels and sills (Images 2.1 2.3).

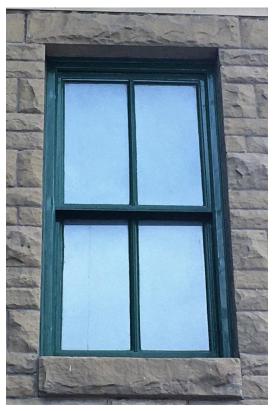
(Image 2.2:Typical upper storey fenestration, sandstone lintel and sill)

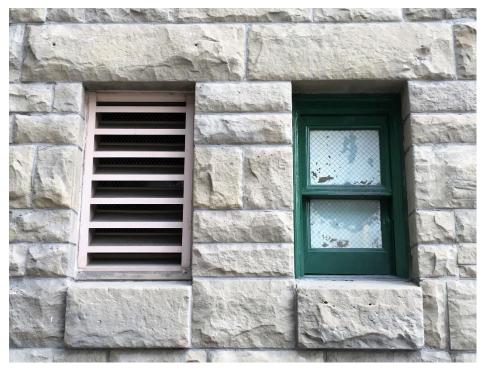
(Image 2.3: Lower storey fenestration, sandstone lintels and sills)
