BYLAW NUMBER 54M2014

**BEING A BYLAW OF THE CITY OF CALGARY
TO DESIGNATE THE SCARBORO AVENUE
UNITED CHURCH AND MANSE AS A
MUNICIPAL HISTORIC RESOURCE**

SCHEDULE "A" TO THE BYLAW TO DESIGNATE THE SCARBORO AVENUE UNITED CHURCH AND MANSE AS A MUNICIPAL HISTORIC RESOURCE

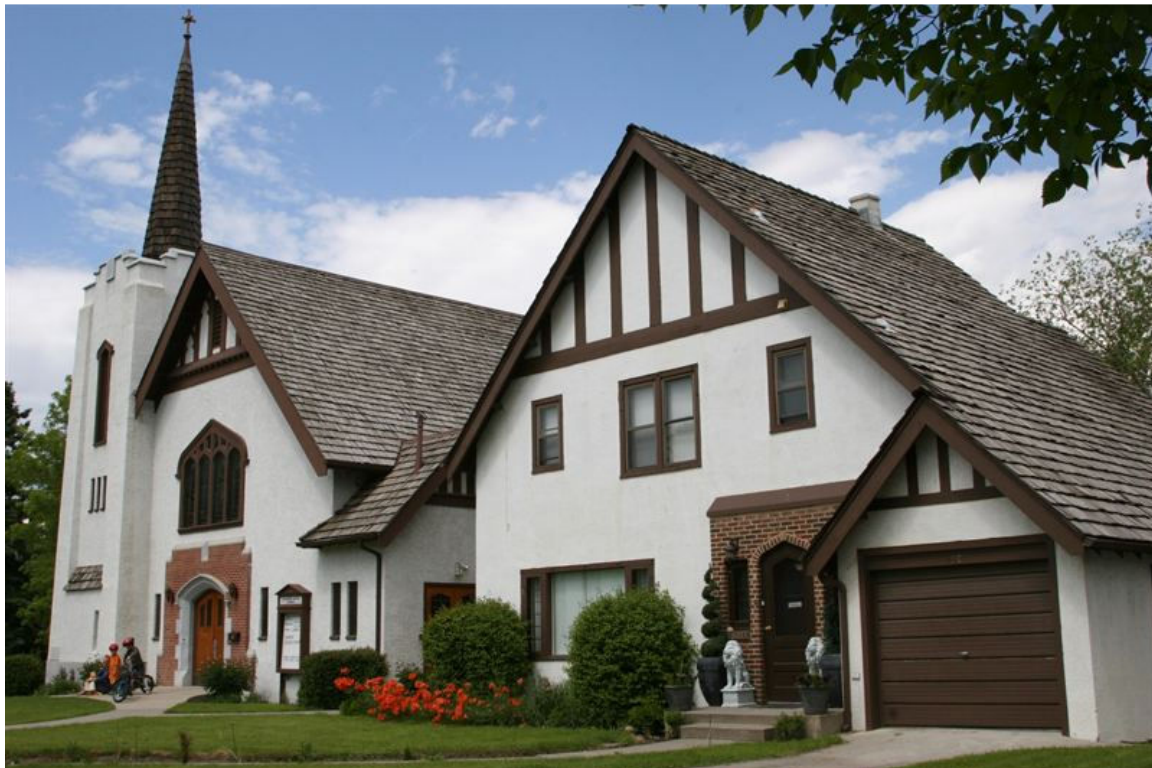
(Image 1.2: view from the southeast showing the side-by-side placement and special relationship of the church and the manse)

- the side by side placement and spatial relationship of the church and the manse; the location of the church and the manse on the property (Images 1.2, 1.3);
- the existing form of each the church and the manse, excepting the hall addition and structure connecting the hall to the church (Images 1.3, 1.4).

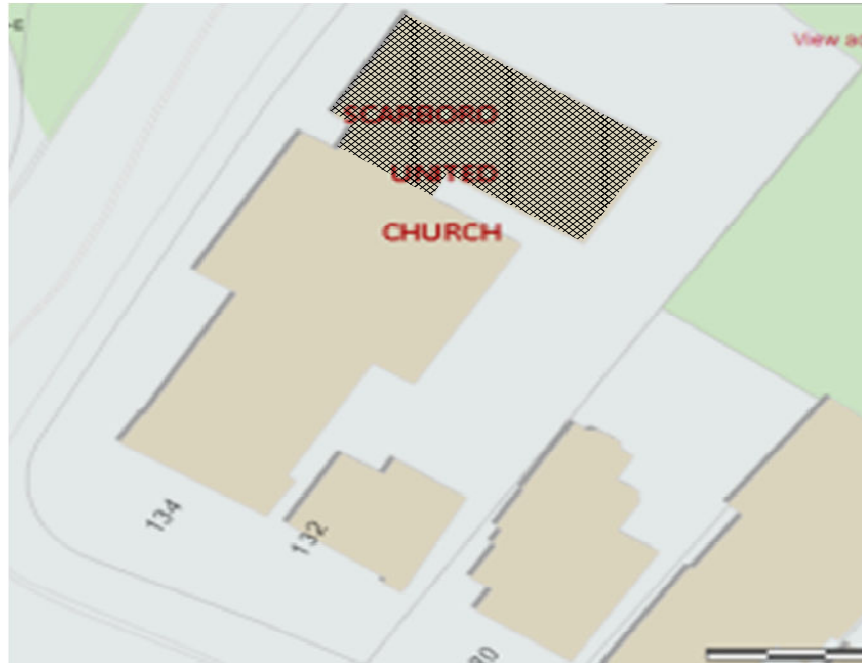
(Image 1.3: view of the form and footprint of the church and the manse – Note, the portion of the property cross hatched, being the hall and connecting structure, is not regulated)

- The land which surrounds the church and manse, south from a point of alignment with the regulated North Façade of the church (Image 1.3).

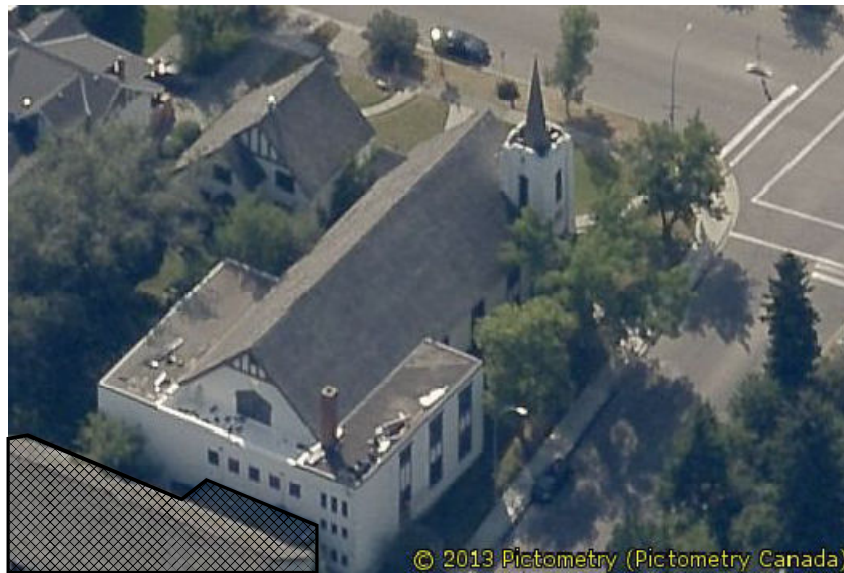
(Image 1.4: aerial view from the northwest showing the spatial relationship and form of the church and manse – Note, the portion of the property cross hatched, being the hall and connecting structure, is not regulated)

- textured cement-stucco cladding (Image 5.2);
- mock half-timbered gable with overhang moulding (Image 1.4);
- fenestration; numerous, rectangular wood-frame windows; large, pointed-arch wood-frame, stained glass window (Images 1.4, 5.2).

- front gable-roof and polygonal tower spire (with finial) with cedar-shingle roofing (Images 1.4, 6.2).

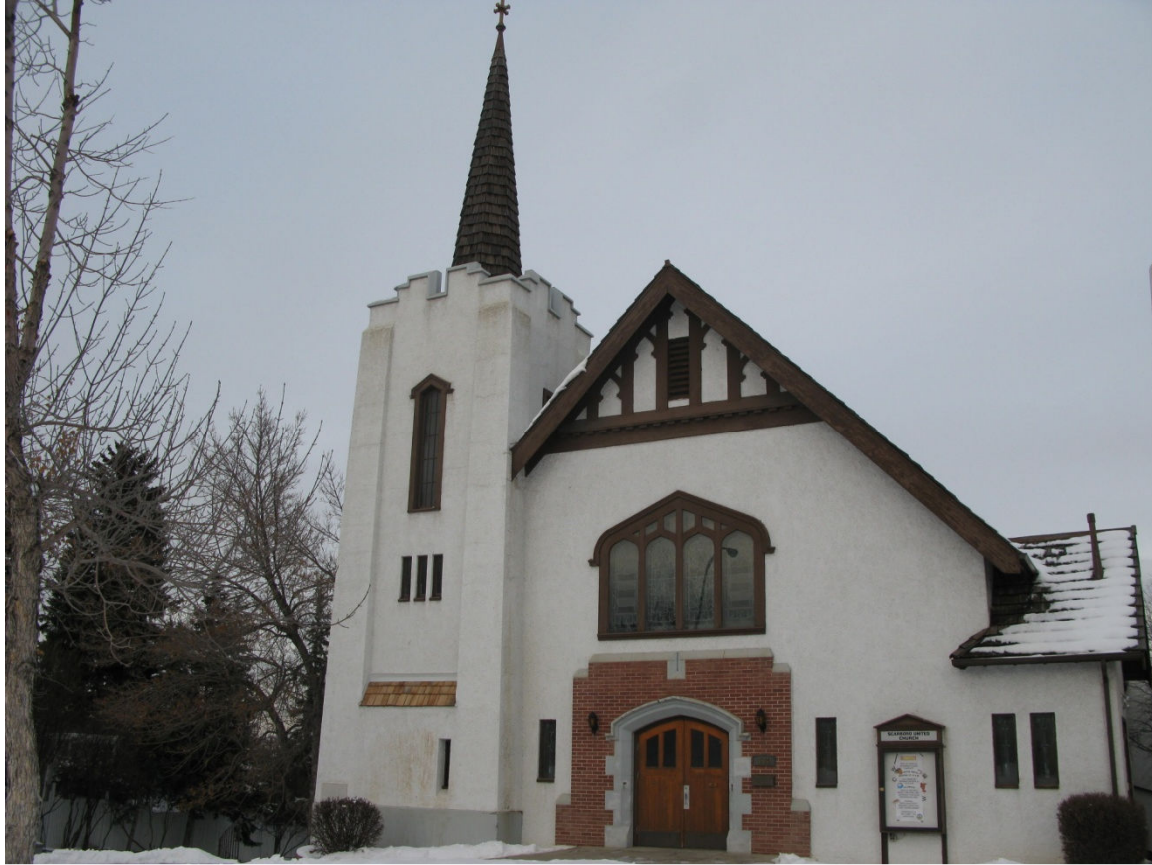
(Image 2.2: South façade of the church)

- textured cement-stucco cladding (Image 2.2);
- crenellated tower; wood-shingled ledge detail (Image 2.2);
- mock half-timbered gable with overhang moulding (Image 2.2);
- red-brick frontispiece with cast concrete mouldings (coping, blocked-surround and label mouldings) (Images 2.2, 2.3);
- pointed-arch doorway with wooden, battened glazed doors (Image 2.3);
- fenestration; leaded, slit windows; large, wood-frame, pointed-arch stained-glass window; label mouldings (Image 2.2).

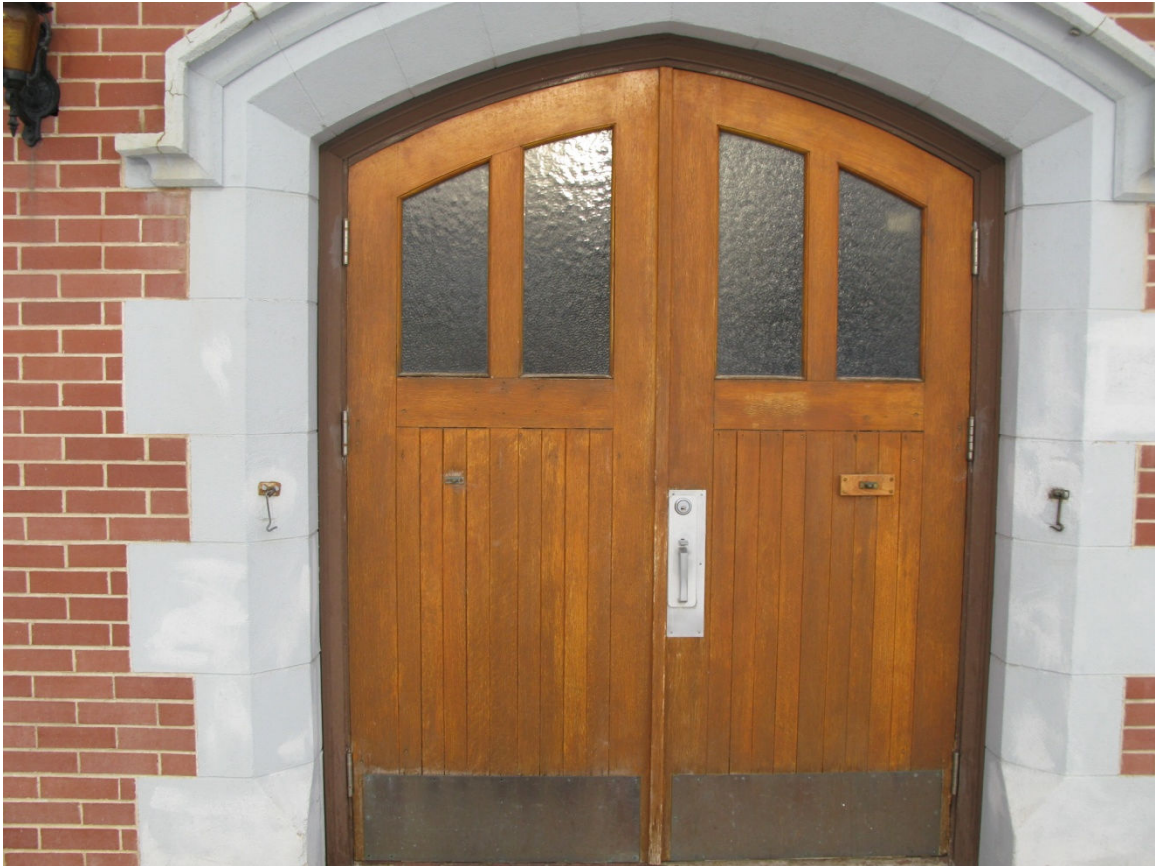
(Image 2.3: South Façade doorway and doors of the church)

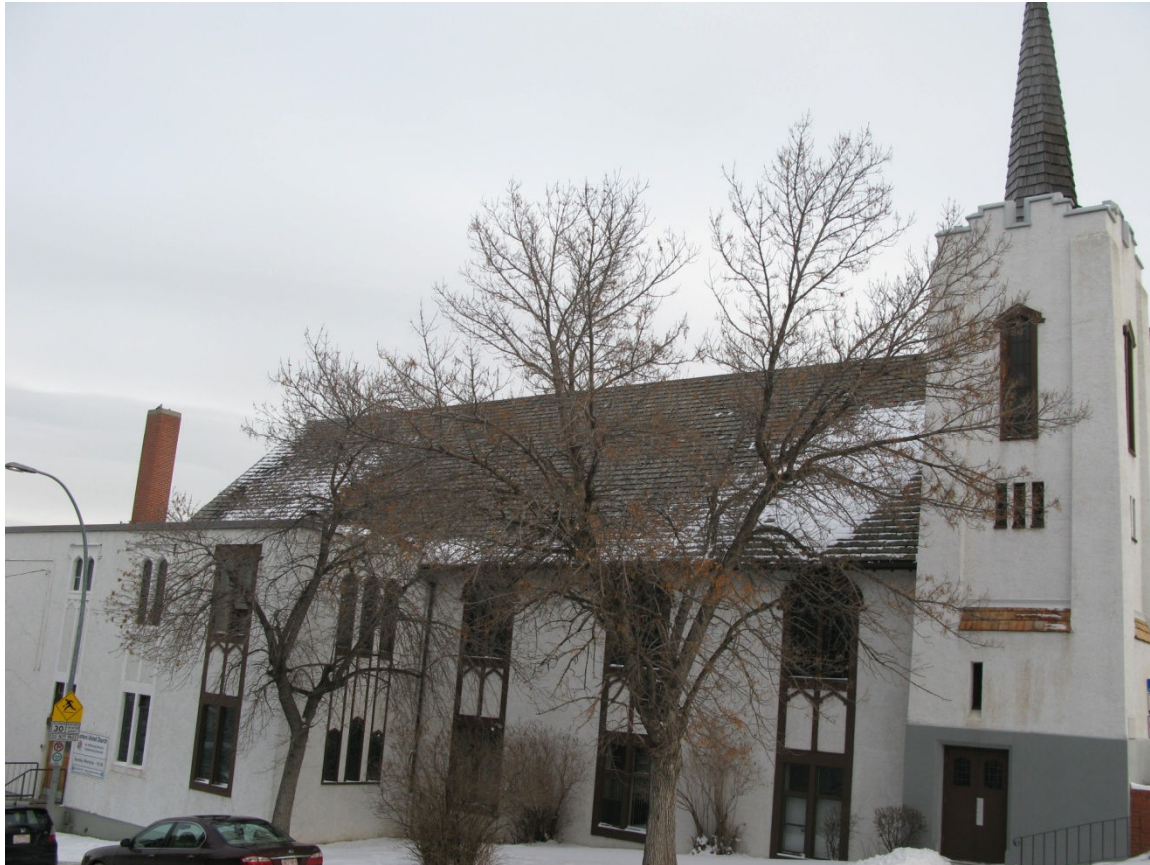
(Image 3.2: West Façade – oblique view from the southwest)

- textured cement-stucco cladding (Images 3.2, 3.4);
- crenellated tower; wood-shingled ledge detail; double doorway in tower base with battened wood doors (Images 3.2, 3.3);
- fenestration; sanctuary / upper-level windows in wood-frames that form pointed arches topped by label mouldings; decorative wood casings with pointed-arch motif that contains (groups) sanctuary / upper-level windows with ground-level windows; leaded slit windows (tower) (Images 3.2, 3.4).

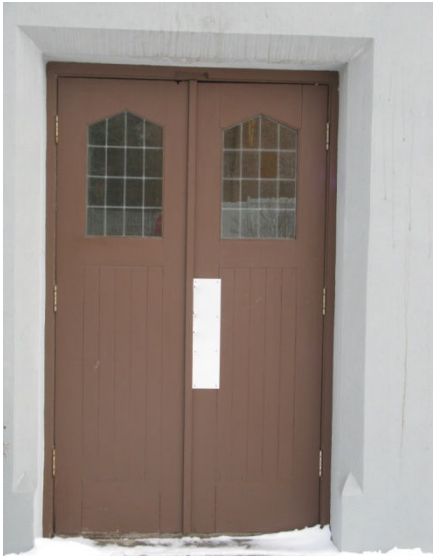
(Image 3.3: battened doors at tower base)

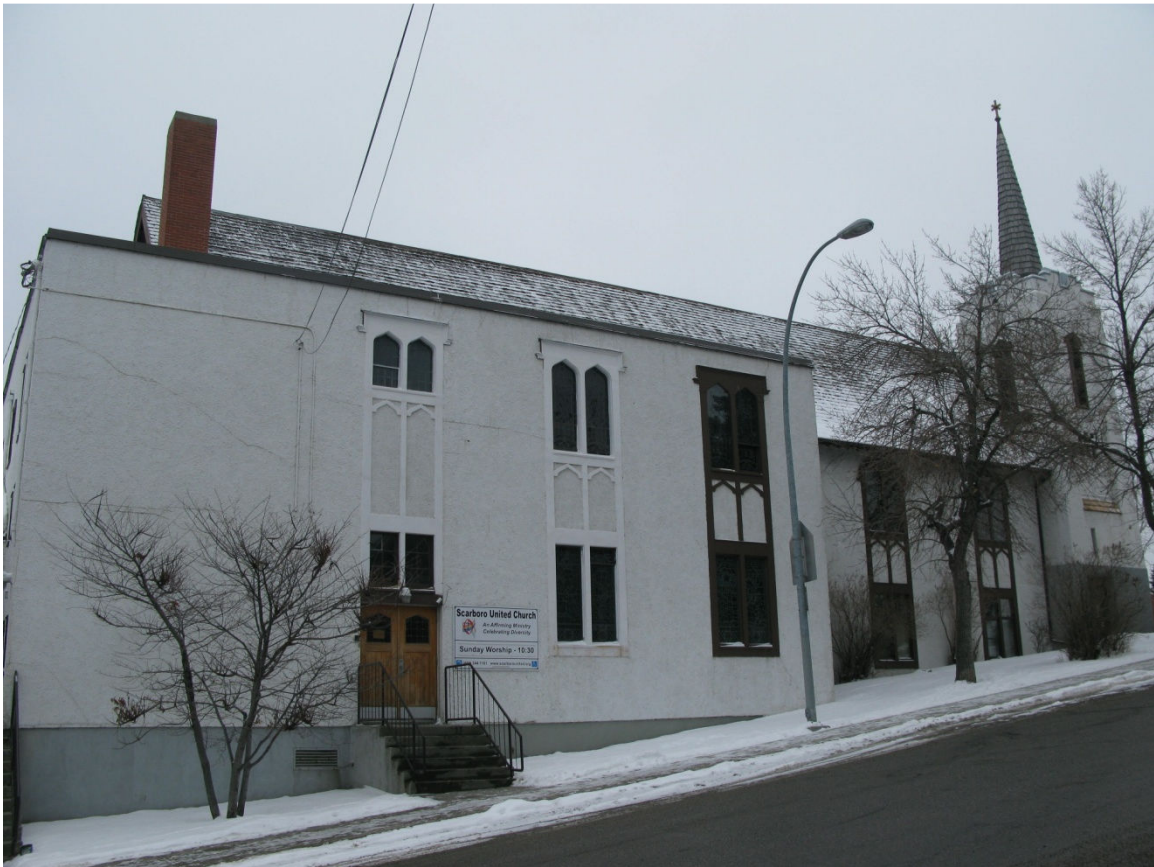
(Image 3.4: West Façade, oblique view from the northwest)

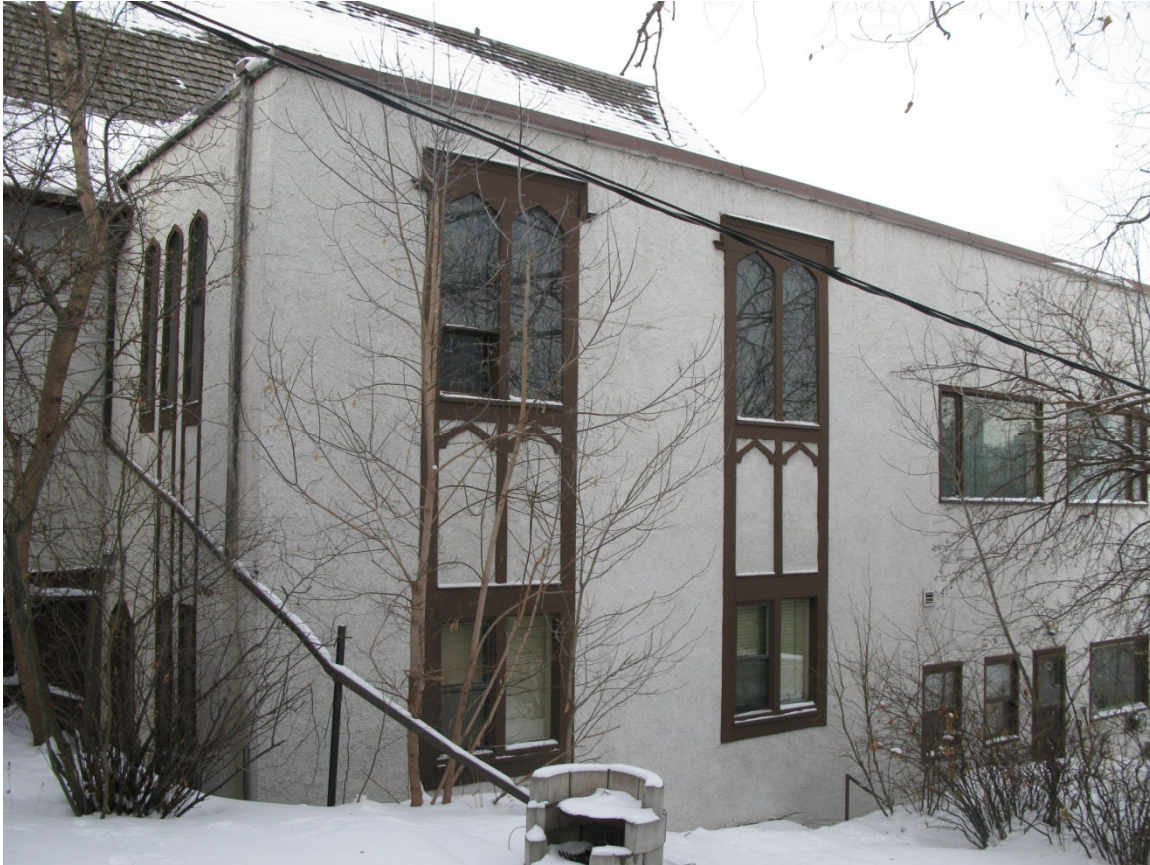
(Image 4.2: Northerly portion of East Façade – oblique view from the southeast)

- textured cement-stucco cladding (Images 4.2, 4.3);
- double doorway (to main foyer) with battened, wood doors;
- fenestration; sanctuary / upper-level windows in wood-frames that form pointed arches topped by label mouldings; decorative wood casings with pointed-arch motif that contains (groups) sanctuary / upper-level windows with ground-level windows (Images 4.2, 4.3).

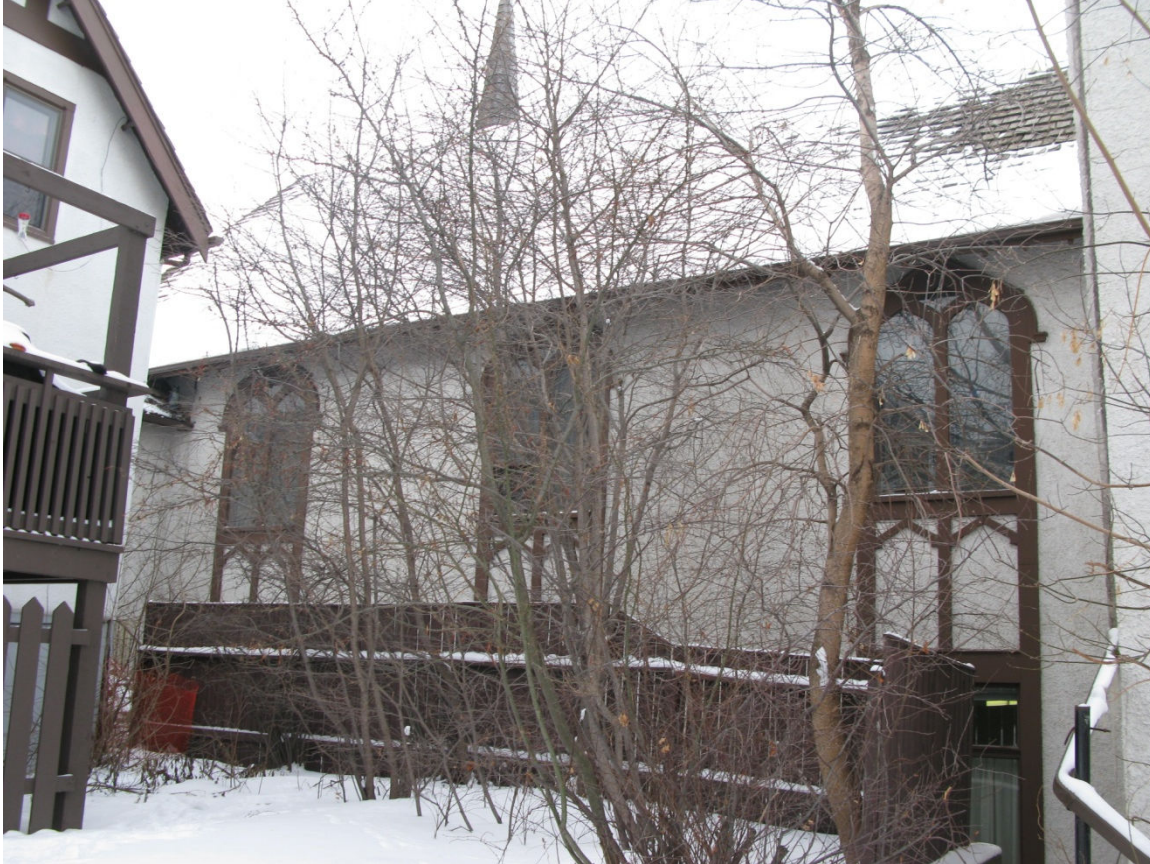
(Image 4.3: Southerly portion of East Façade – oblique view from the northeast)

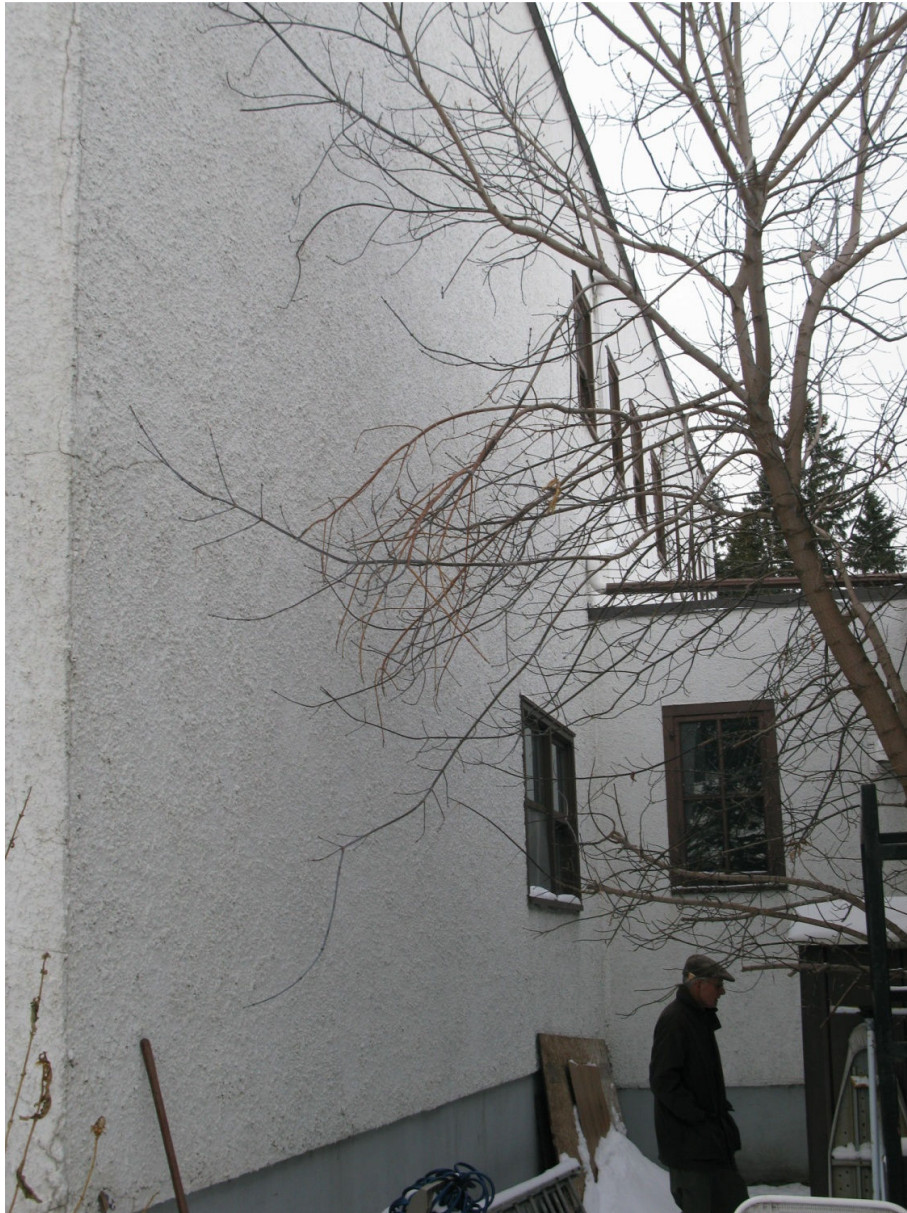
(Image 5.2: Portion of North Façade – oblique view from the northeast. Note – one-storey connecting structure to the Hall is not regulated)

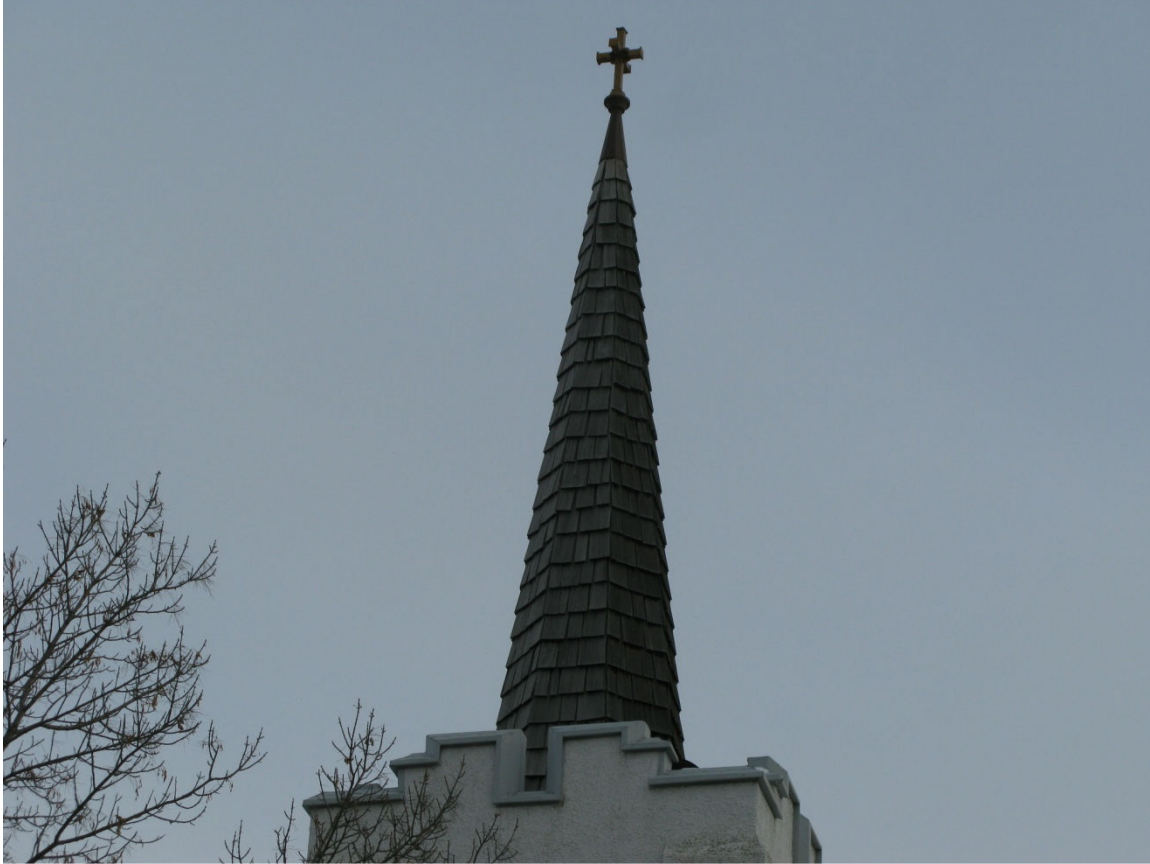
(Image 6.2: the tower spire)

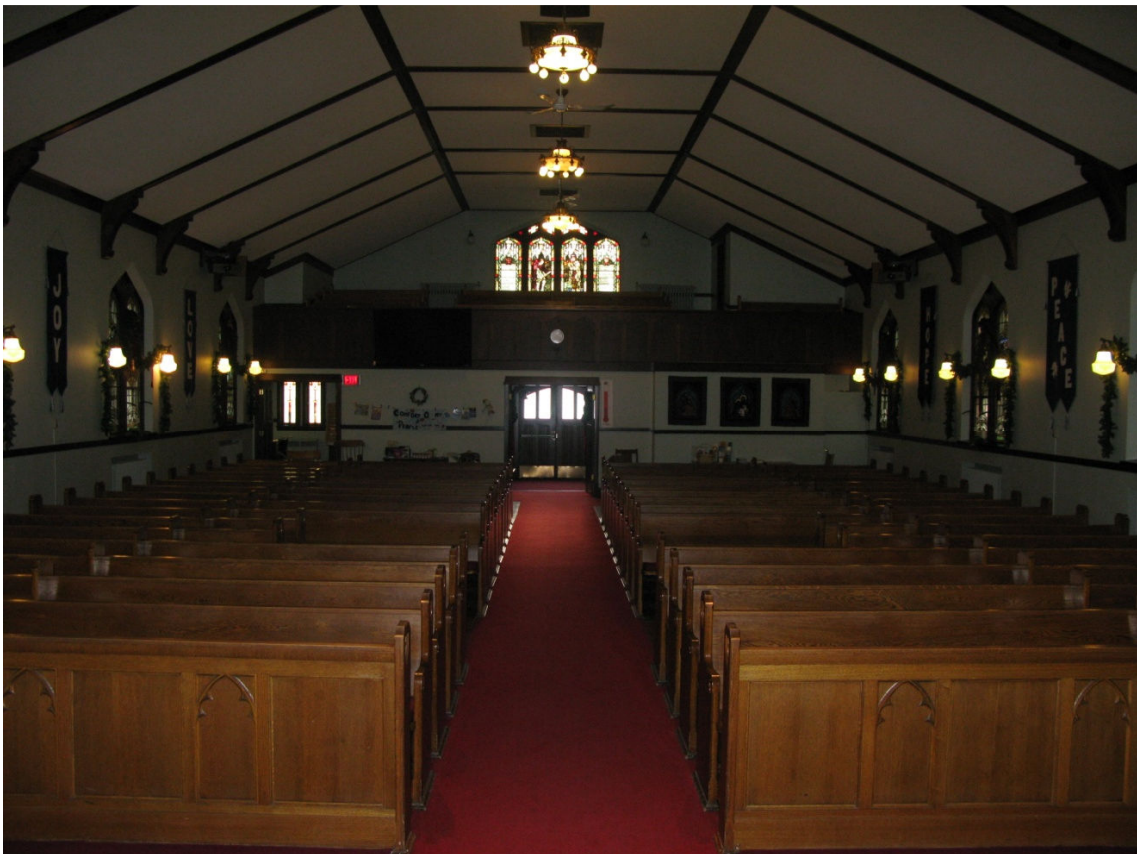
(Image 7.1.2: The sanctuary, looking south toward the balcony and main entrance)

- cruciform sanctuary plan, raised chancel, and open character (Images 7.1.2, 7.1.3, 7.1.4, 7.1.5);
- high, three-plane, wood-beam (fir) ceiling with supporting wooden (fir) brackets (Image 7.1.2);
- simple plaster-finished walls with plain, fir, cornice and rail mouldings; fir-panelled chancel (Images 7.1.3, 7.1.4);
- balcony with solid, fir-paneled balustrade (Image 7.1.2);
- fir flooring (nave); oak flooring (transepts);
- multi-light brass chandeliers with glass globes; matching wall sconces with single glass globes (Images 7.1.6, 7.1.7);
- stained-glass windows with wood-framing (7.1.10, 7.1.11, 7.1.12);

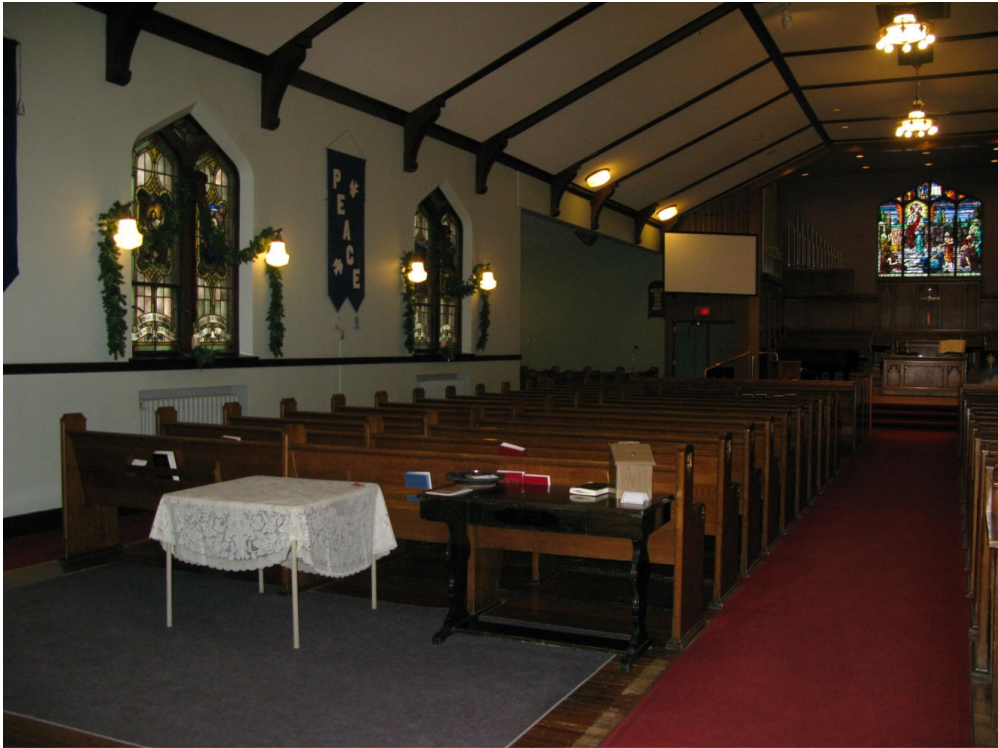
(Image 7.1.3: The sanctuary, looking northwest to the chancel)

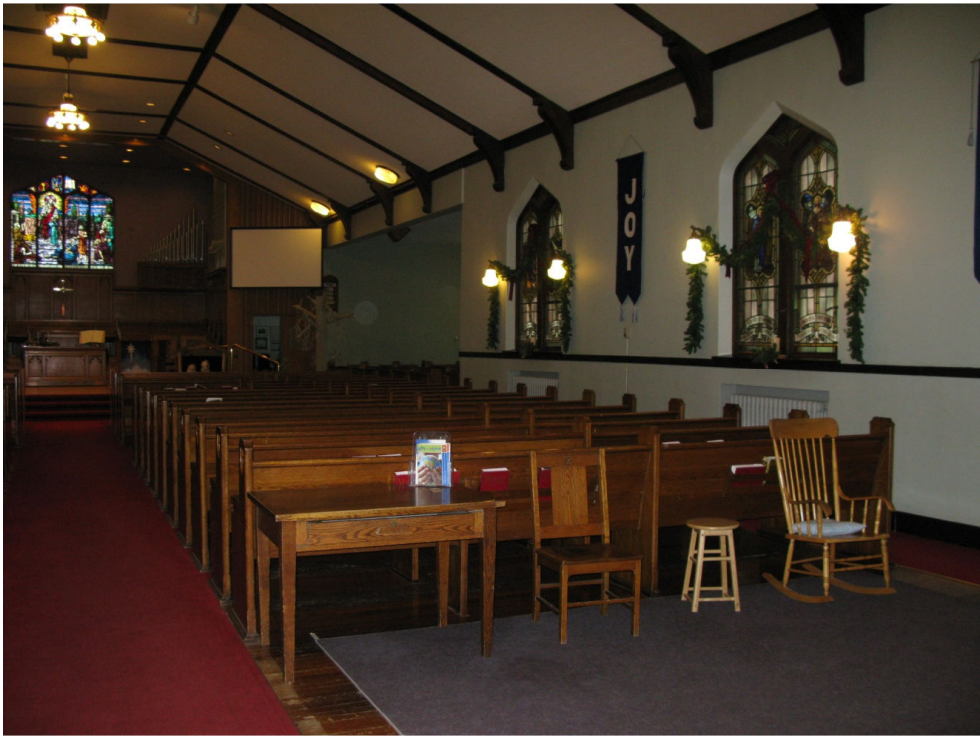
(Image 7.1.4: The sanctuary, looking northeast to the chancel)

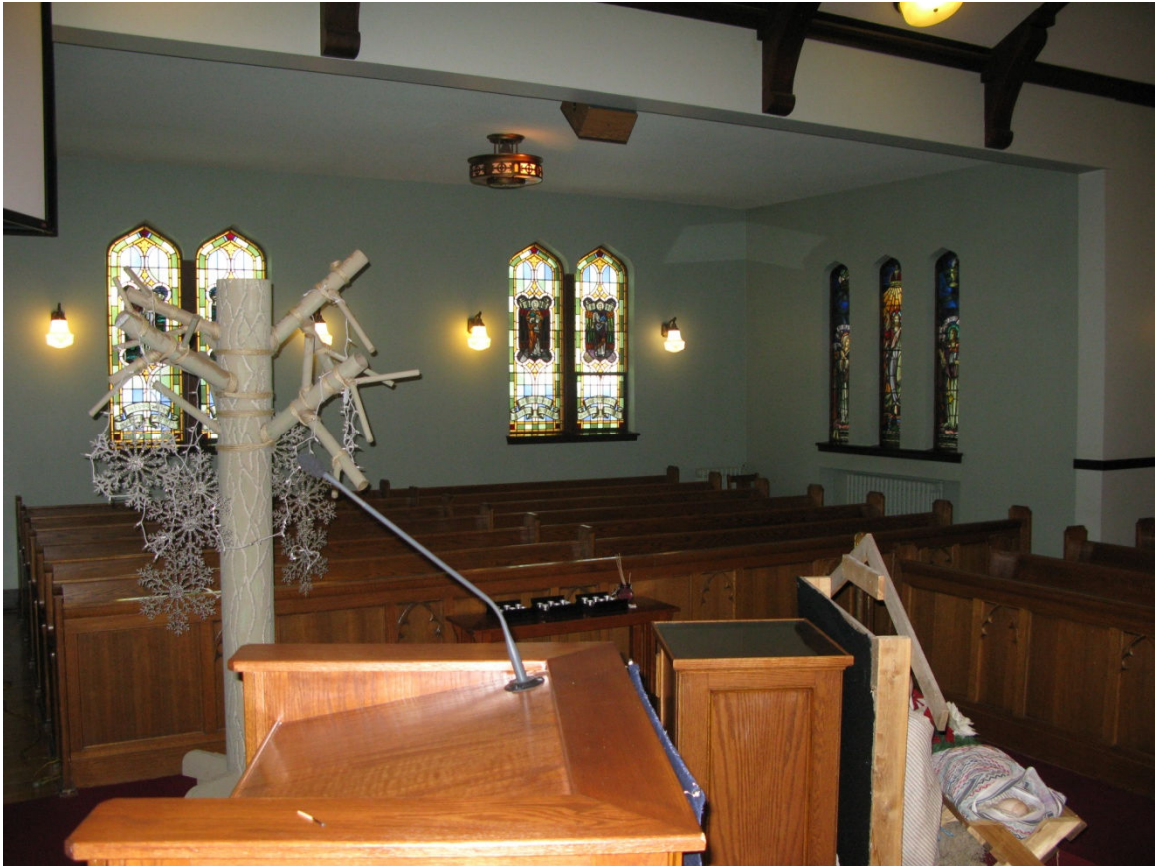
(Image 7.1.5: The east transept, view from the chancel)

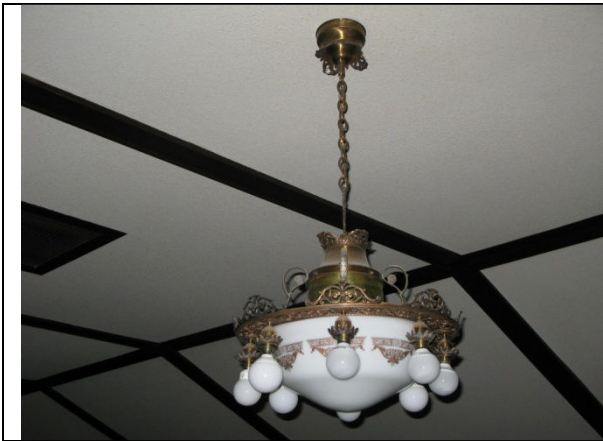
(Image 7.1.6: Sanctuary chandelier)

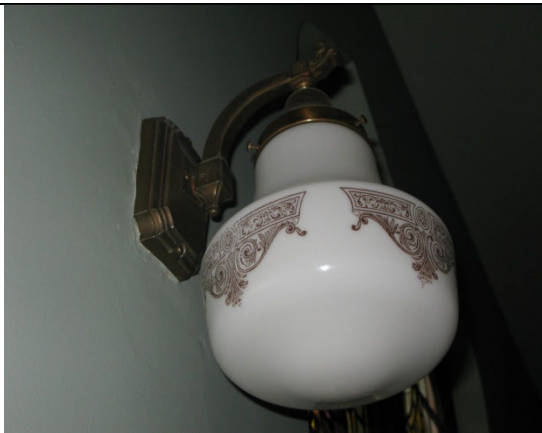
(Image 7.1.7: Sanctuary wall sconce)

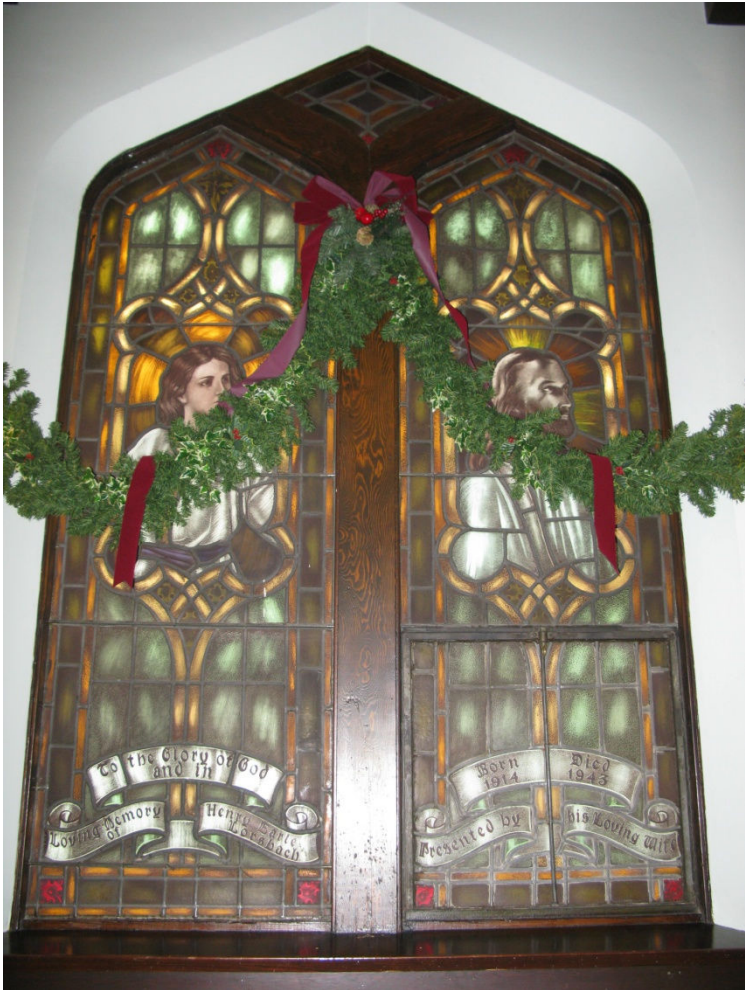
(Image 7.1.8: Example of sanctuary leaded stained-glass windows within the nave)

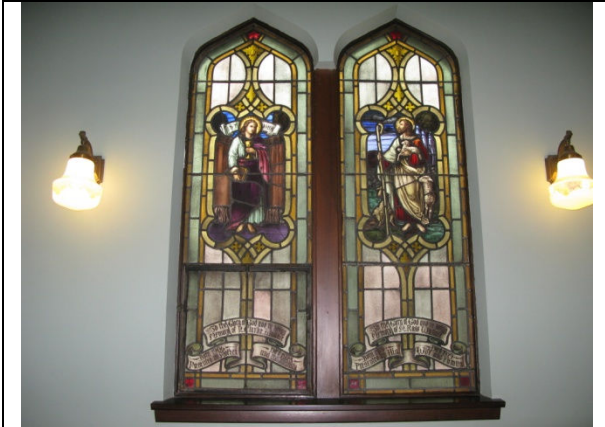
(Image 7.1.9: Example of leaded stained-glass windows within a transept)

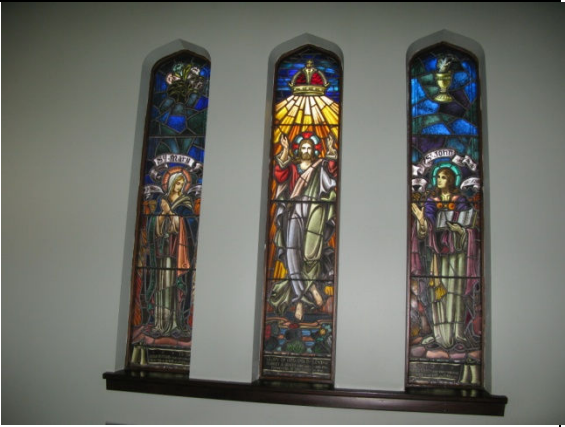
(Image 7.1.10: Example of leaded stained-glass windows within a transept)

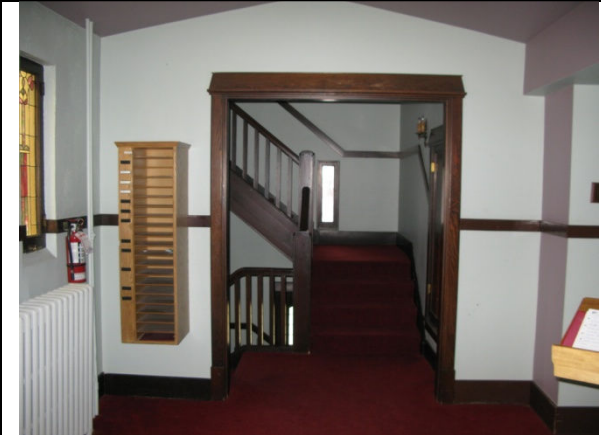
(Image 7.2.2: Main foyer, view to the west toward the stair hall)

- large, open main foyer with separate stair hall; open staircase with plain fir balustrades to balcony (Image 7.2.2, 7.2.3, 7.2.4);
- simple plaster-finished walls with plain, fir, rail mouldings and doorway and window casings (Images 7.2.2, 7.2.3, 7.2.4).
- paneled, fir, double doors with leaded-glass glazing separating sanctuary from foyer, and associated casings (Image 7.2.5).

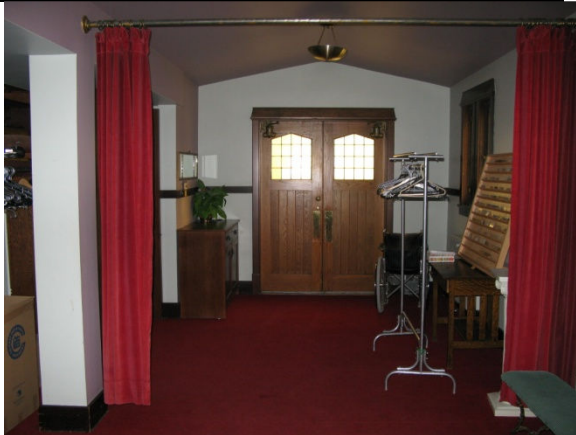
(Image 7.2.3: main foyer view to the east)

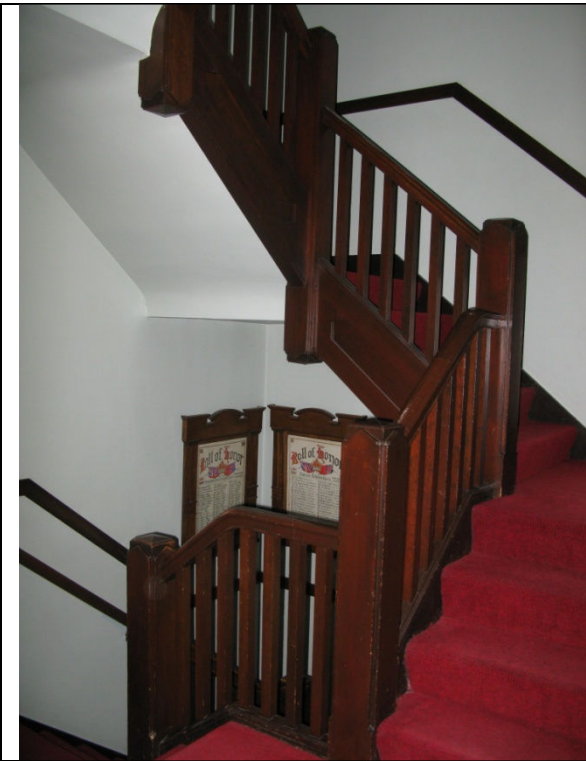
(Image 7.2.4: The staircase to the balcony)

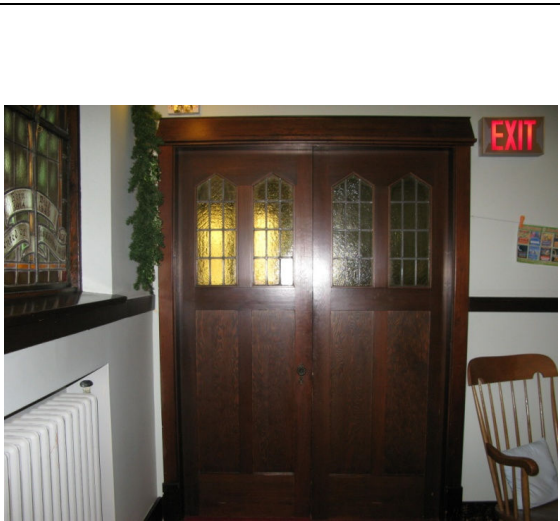
(Image 7.2.5: Example of the doors separating the sanctuary from the main entrance foyer)

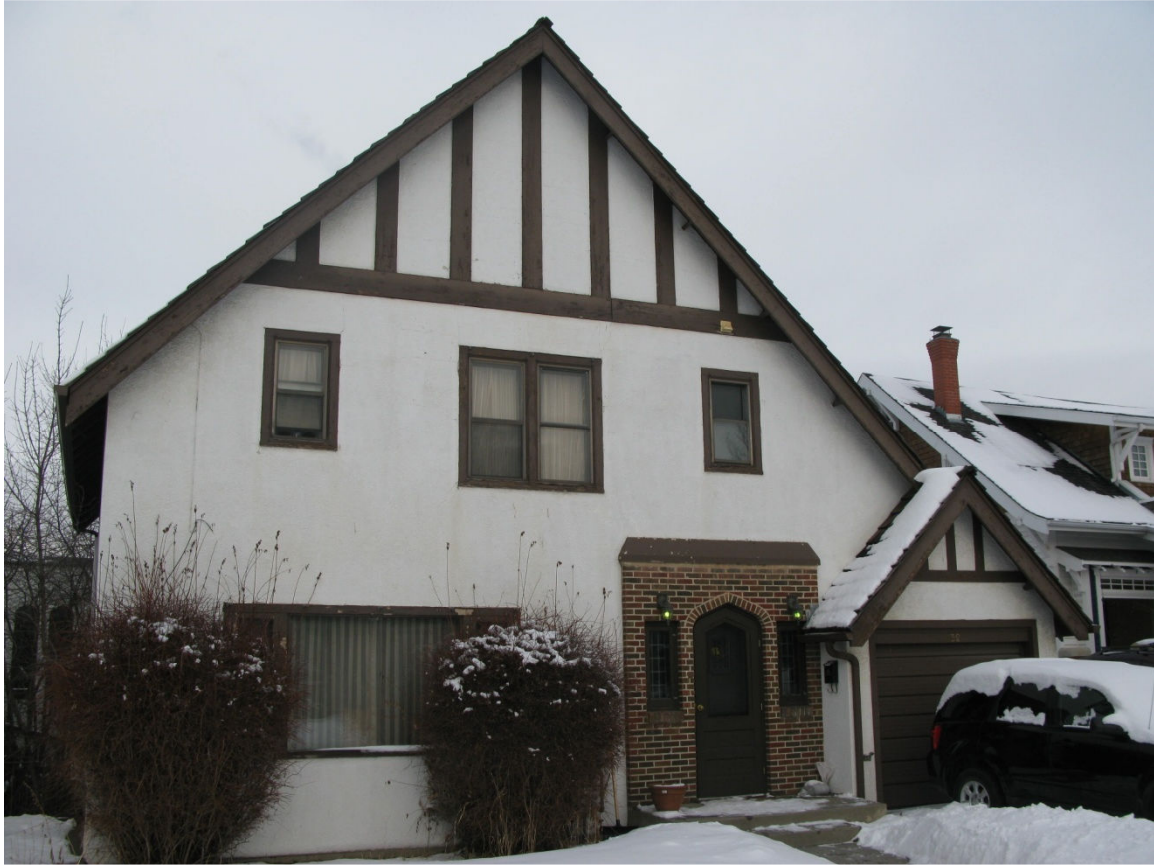
(Image 8.2: South Façade of the Manse)

- cement-stucco cladding; mock half-timbered gables (Image 9.2);

- rugged-brick frontispiece with leaded sidelights, pointed arch doorway with paneled wood (inner) door, and wood-paneled and glazed outer door (Images 9.2, 9.3, 9.4);
- integral garage with large doorway, and gable-roof (Image 9.2);
- fenestration; wood-frame, single and double assembly windows; large three-part main window with leaded outer sashes (Image 9.2).

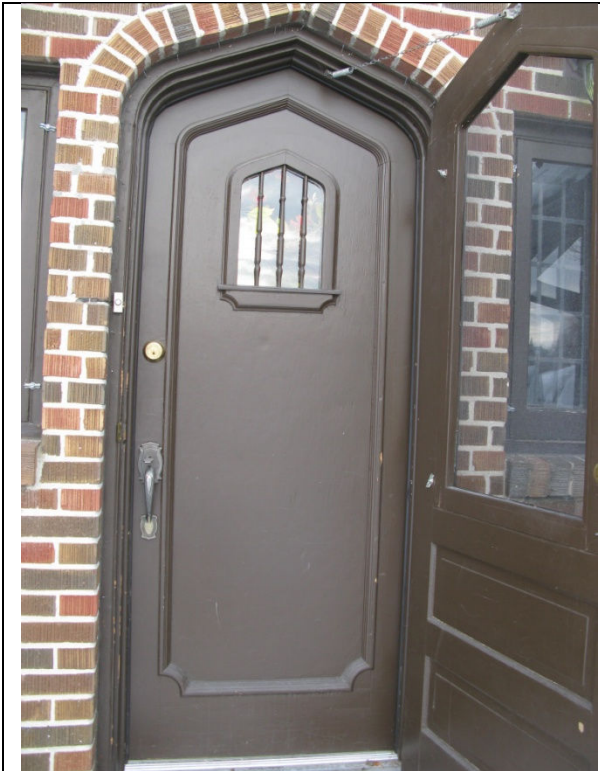
(Image 8.3: pointed arch doorway with paneled wood (inner) door, and wood-paneled and glazed outer door with rugged-brick frontispiece surround)

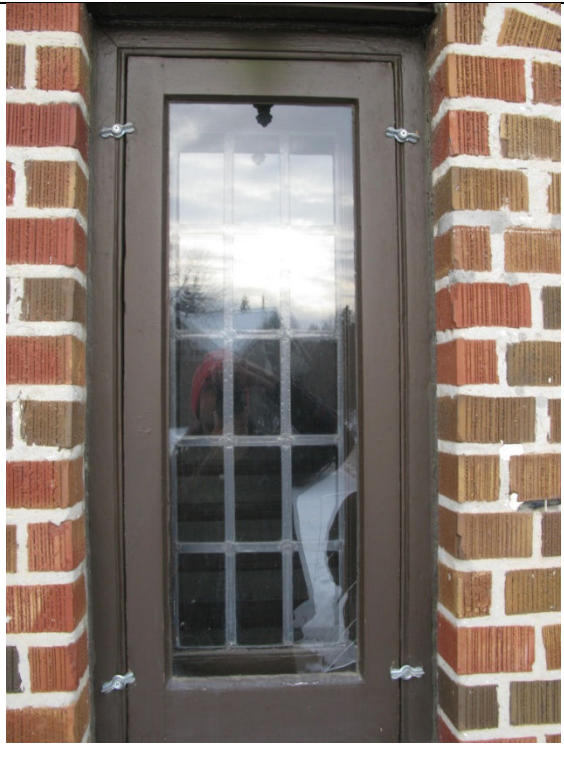
(Image 8.4: leaded sidelights surrounded by rugged brick)

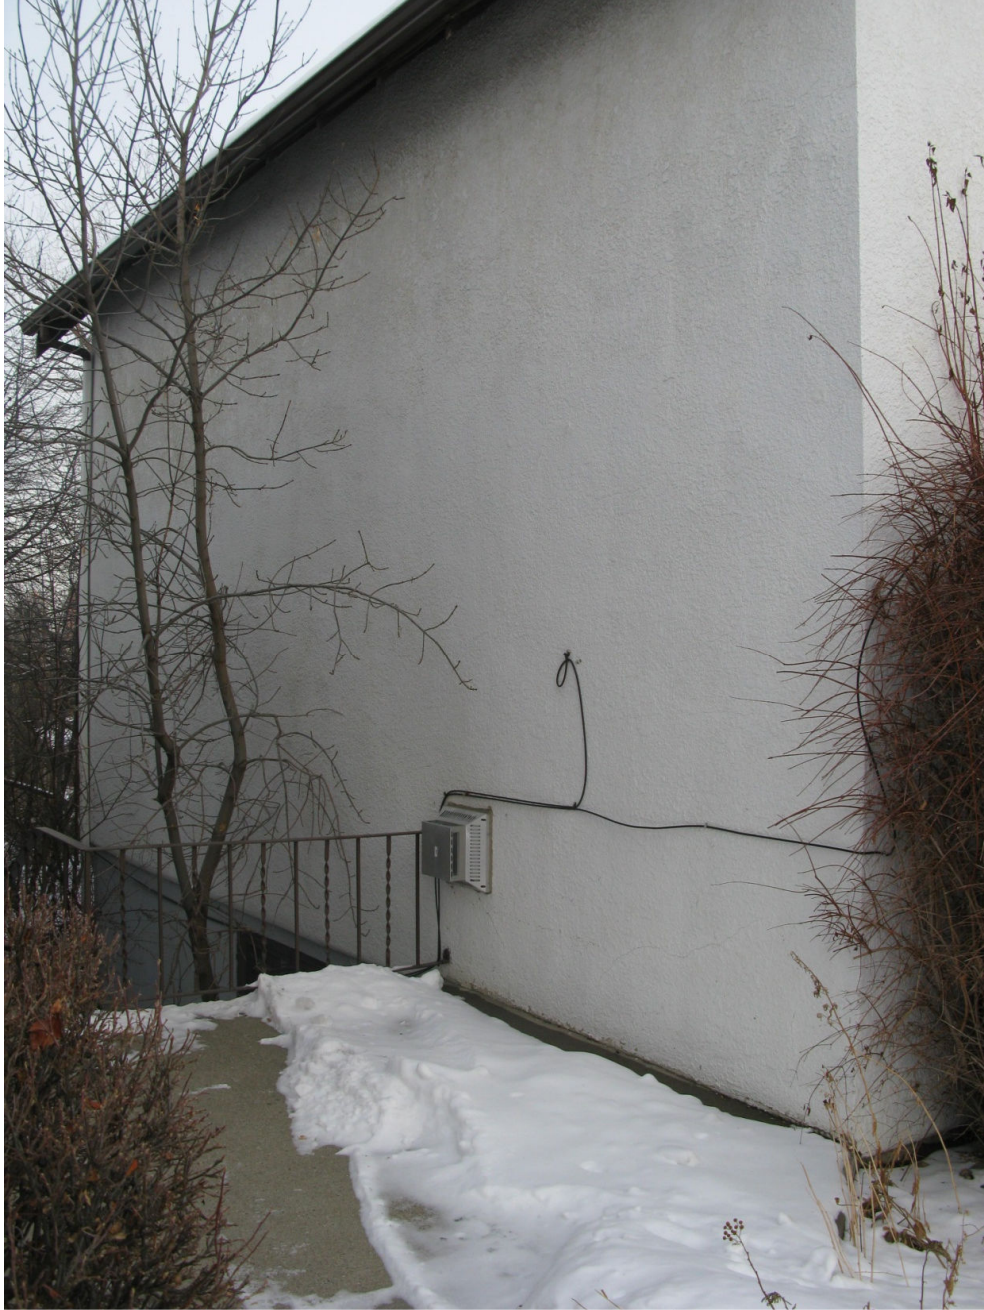
(Image 9.2: West Façade of the Manse)

- cement-stucco wall cladding and foundation (Image 10.2);

- front gable roof forming multiple gables and with extended east slope; cedar-shingle roofing; open soffits with exposed rafter tails; wide wood bargeboards (Images 9.2, 11.2, 12.2).

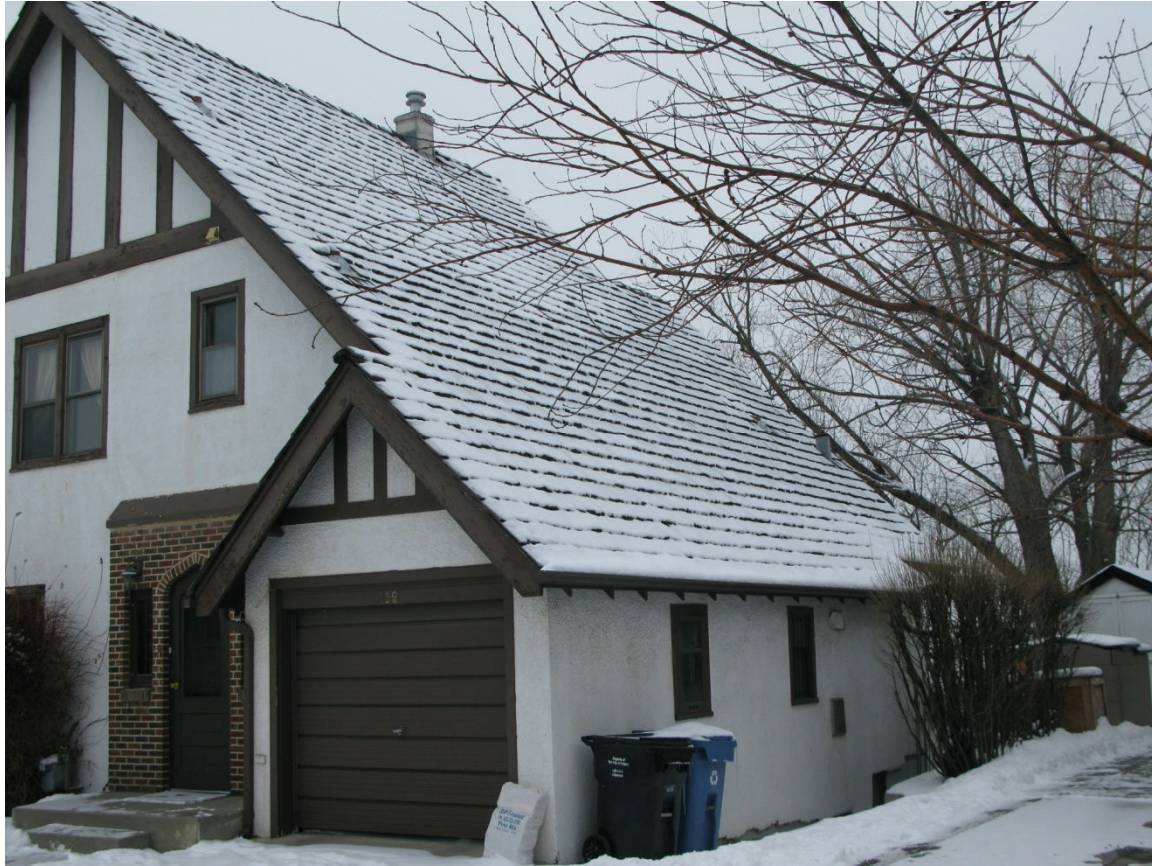
10.2: Oblique view from the southeast of the East Façade of the Manse)

- cement-stucco wall cladding and foundation (Image 11.2);
- fenestration; wood-frame windows (Image 11.2).
