BYLAW NUMBER 54M2014

**BEING A BYLAW OF THE CITY OF CALGARY
TO DESIGNATE THE SCARBORO AVENUE
UNITED CHURCH AND MANSE AS A
MUNICIPAL HISTORIC RESOURCE**

SCHEDULE "A" TO THE BYLAW TO DESIGNATE THE SCARBORO AVENUE UNITED CHURCH AND MANSE AS A MUNICIPAL HISTORIC RESOURCE

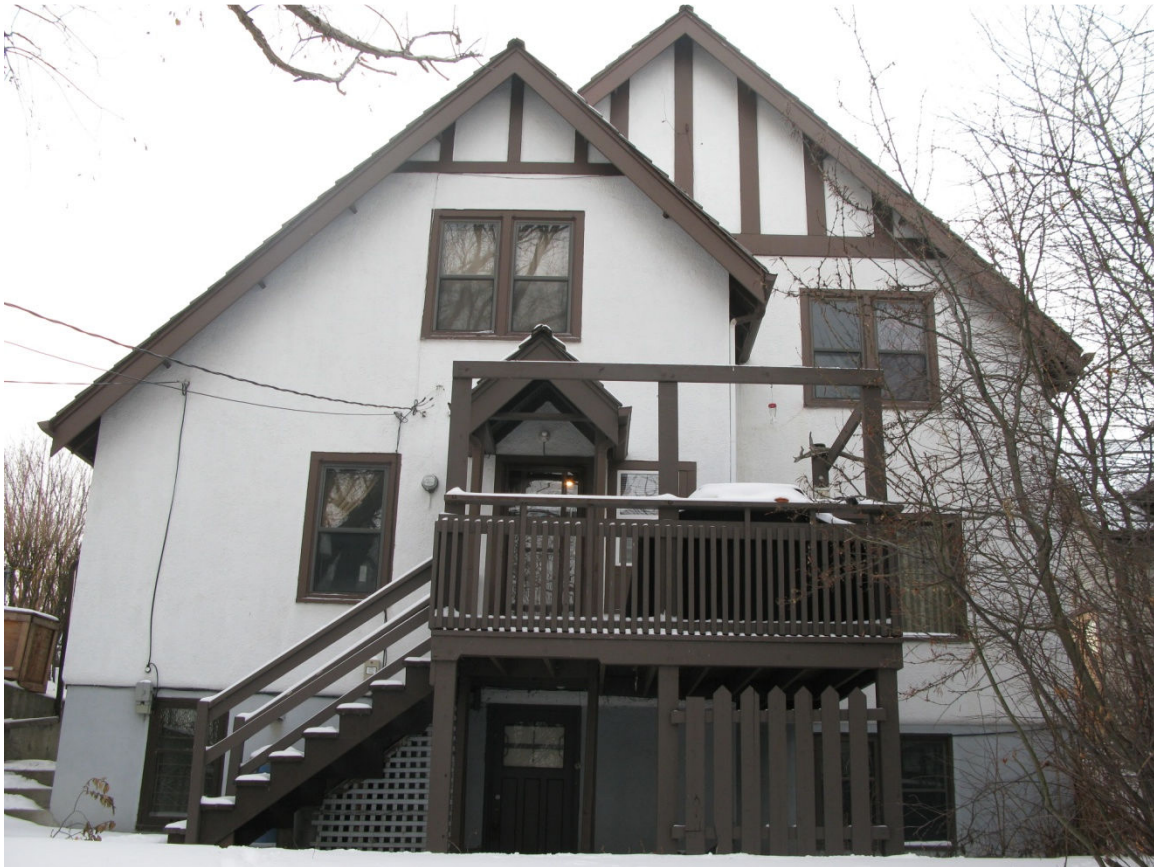
(Image 11.2: North Façade of the Manse)

- cement-stucco wall cladding and foundation; mock half-timbered gables (Image 12.2);
- fenestration; wood-frame, single- and double-assembly windows (Image 12.2);
- first-floor doorway with gable-roof hood with wide bargeboards; glazed, wood-paneled basement door (Image 12.2);

(Note – an addition to the North Façade would not be precluded, but would be subject to the Standards and Guidelines)

- front gable roof forming multiple gables and with extended east slope; cedar-shingle roofing; open soffits with exposed rafter tails; wide wood bargeboards (Images 9.2, 11.2, 12.2).
