BYLAW NUMBER 28M2019

BEING A BYLAW OF THE CITY OF CALGARY TO DESIGNATE THE NORMAN AND JO ANN STEWART RESIDENCE AS A MUNICIPAL HISTORIC RESOURCE

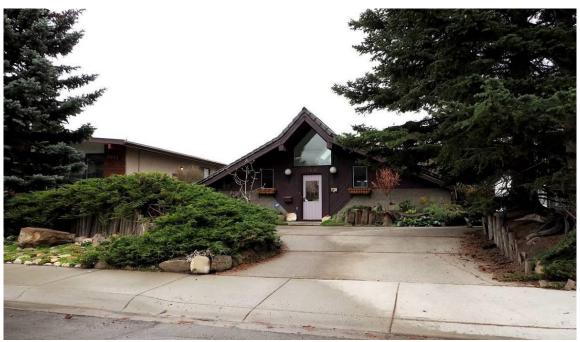
(Image 2.1 – Context and front parking area)

The placement of the building on the parcel of land as indicated in Image 1.0, with front concrete parking area –oriented to reduce visibility of a parked vehicle from the street (Image 2.1).

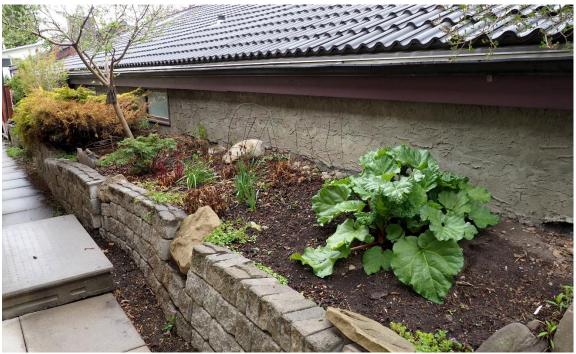
(Image 2.3 – North earth berm with 'Allan Block' retaining wall and inset local stone)

- The 580.8 square-meters of land which comprises the entire parcel, integrated with the building in an 'earth-sheltered' design;
- Hard-landscaped elements: Retaining walls for earth berms mixed local stone (sandstone, limestone, granite) along west (front) façade, concrete 'Allan Block' along north and south façades with inset stones (Images 2.2-2.4); sunken rock garden at rear featuring stream and pond (Images 2.7-2.8); sandstone table with a large single-slab top (Image 2.9), custom-built redwood fence and gate (Images 2.10, 2.12); dry-stacked retaining walls of mixed local stone (Image 2.10; and

- Soft-landscaped elements: Earth-berms surrounding original 1977 portion (Image 1.0 figure 1; Image 2.0; Images 2.2-2.4; Image 2.6); abundant planting along earth berms with local and prairie-hardy flora; flowering deciduous tree in center of rear yard (Image 2.7; Image 2.11); coniferous tree along south fence (Image 2.9; Image 2.12).

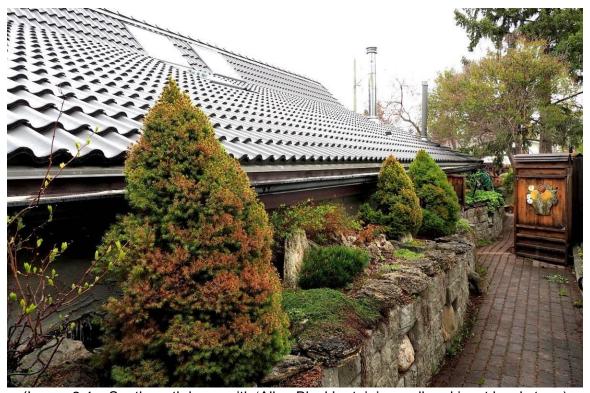
(Image 2.4 – South earth berm with 'Allan Block' retaining wall and inset local stone)

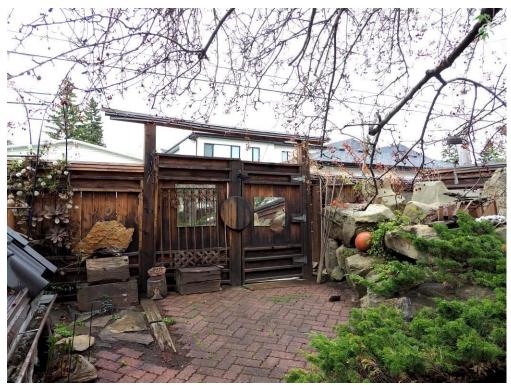
(Image 2.10 -Redwood fence and gate to alleyway; dry stacked retaining wall on right)

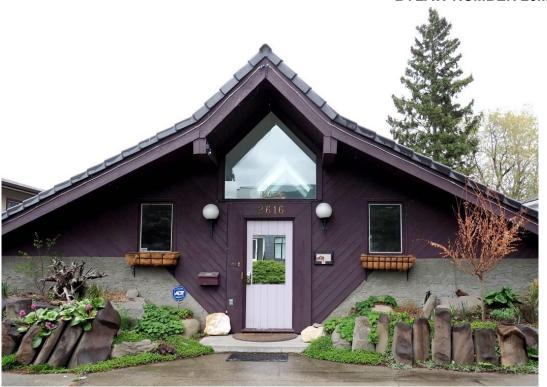
(Image 3.0 – West Façade)

- The concrete construction of below-grade portions of the building, wood-frame construction above-grade;
- The exterior cladding comprising: concrete parging and angled cedar-plank siding on the 1977 portion of the building (Image 3.0), corrugated metal and vertical and angled cedar plank siding on the extension (Images 3.2-3.3); plain cedar door/window surrounds (Images 3.0-3.1);

- The low, double-pitched front gable roof (Image 3.0); pent roof over living/dining portion of extension (Image 1.0, figure 2(a); Image 3.1); gable roof over conservatory/garage (Image 3.3); deep overhanging eaves with cedar wood-plank soffits (Image 3.1);

- The fenestration, including central front doorway flanked by matching windows, large above-door lights at front and rear (Images 3.0-3.1); skylights; rear glass single door flanked by floor-to-ceiling windows (Image 3.1), small windows at ground level on sides of building (Image 2.0; Image 2.3); in living/dining extension, glass double-door and full wall of double-height windows (Image 3.1); on conservatory, full slanted wall of plain, rectangular, single-light windows (Image 3.2); and

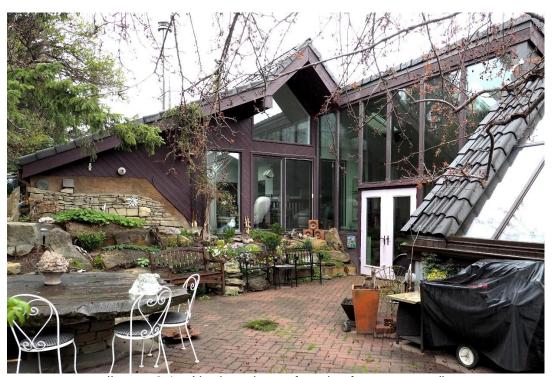
(Image 3.1 – North and west façades from rear yard)

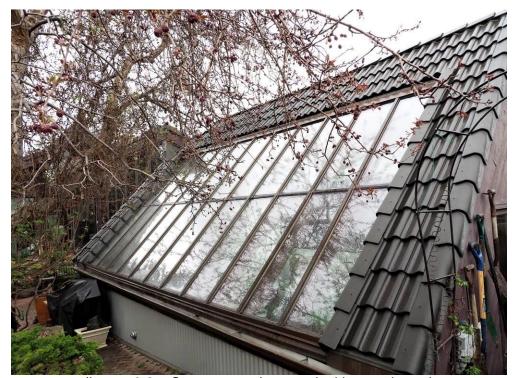
(Image 3.2 – Conservatory/garage, looking northwest)

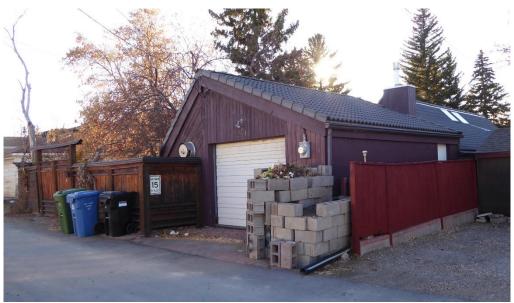
(Image 3.3 – Conservatory/garage, looking southeast)

- The plain, rectangular chimney faced in cedar planks with metal cap (Image 3.3).

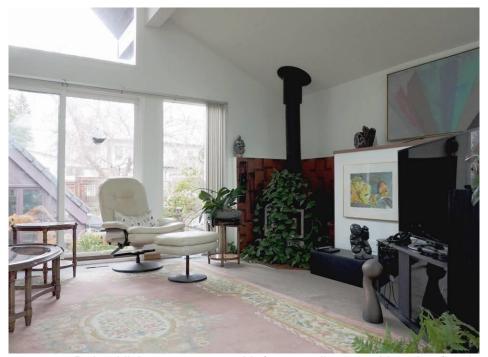
(Image 4.1 – Raised living room area with freestanding wood-burning fireplace)

- The interior configuration: "Air-lock" front lobby (Image 4.2), raised living room with storage drawers beneath (Images 4.0-4.1); built-in furniture and shelving (Image 4.4):
- The interior windows above partial-height partition walls (Images 4.2-4.3); stained glass window on north wall of dining/living extension (Image 4.7);
- Materials and finishes: Quarry tile flooring with some inset river stones (Image 4.5), grated steel flooring in conservatory between main floor and basement (Image 4.8), fir woodwork including window and door surrounds, stair rails, bannisters, ledge, firewood box opening to both living area and garage (Image 4.0; Images 4.2-4.10); and
- The freestanding wood-burning fireplace (Image 4.1) and gas fireplace with plain surround (Image 4.6).

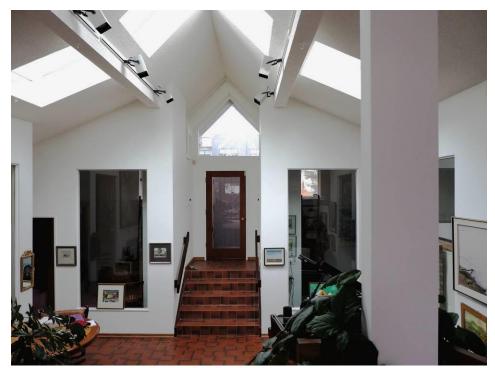
(Image 4.2 – Front entryway [from raised living room], showing 'air-lock' front lobby)

The earth berm construction, which puts most of the living areas partially below ground level for natural insulation, was innovative in Alberta and is still rare. An "air lock" lobby with firmly

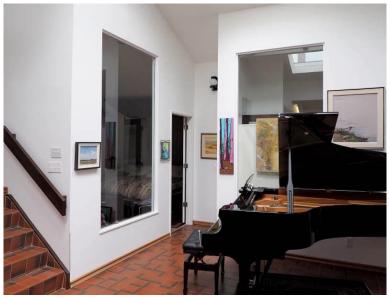
Image 4.3 – Detail of interior windows)

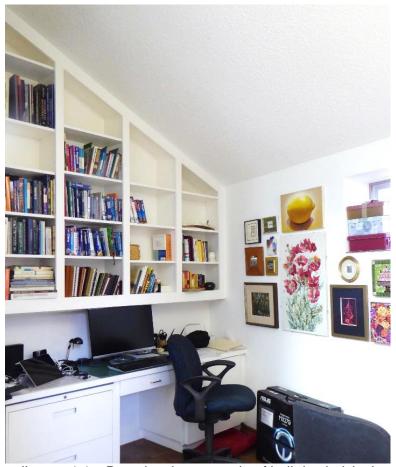
(Image 4.4 – Den showing example of built-in shelving)

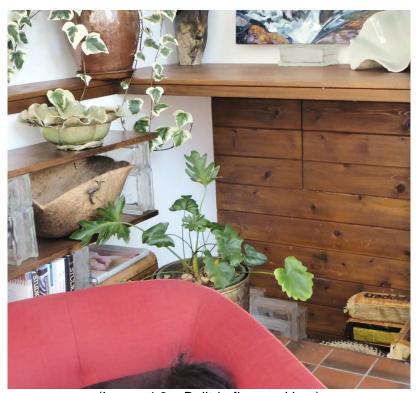
(Image 4.8 – Built-in firewood box)

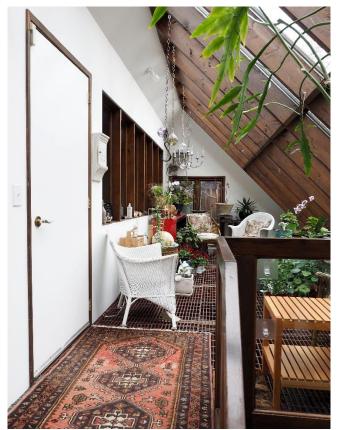
(Image 4.9 – Raised conservatory with grated flooring; door to garage on left)
