**BYLAW NUMBER 47M2014**

**BEING A BYLAW OF THE CITY OF CALGARY  
TO DESIGNATE THE GEORGE C. CUSHING  
RESIDENCE AS A MUNICIPAL HISTORIC  
RESOURCE**

**SCHEDULE “C” TO THE BYLAW TO DESIGNATE THE GEORGE C. CUSHING RESIDENCE  
AS A MUNICIPAL HISTORIC RESOURCE**

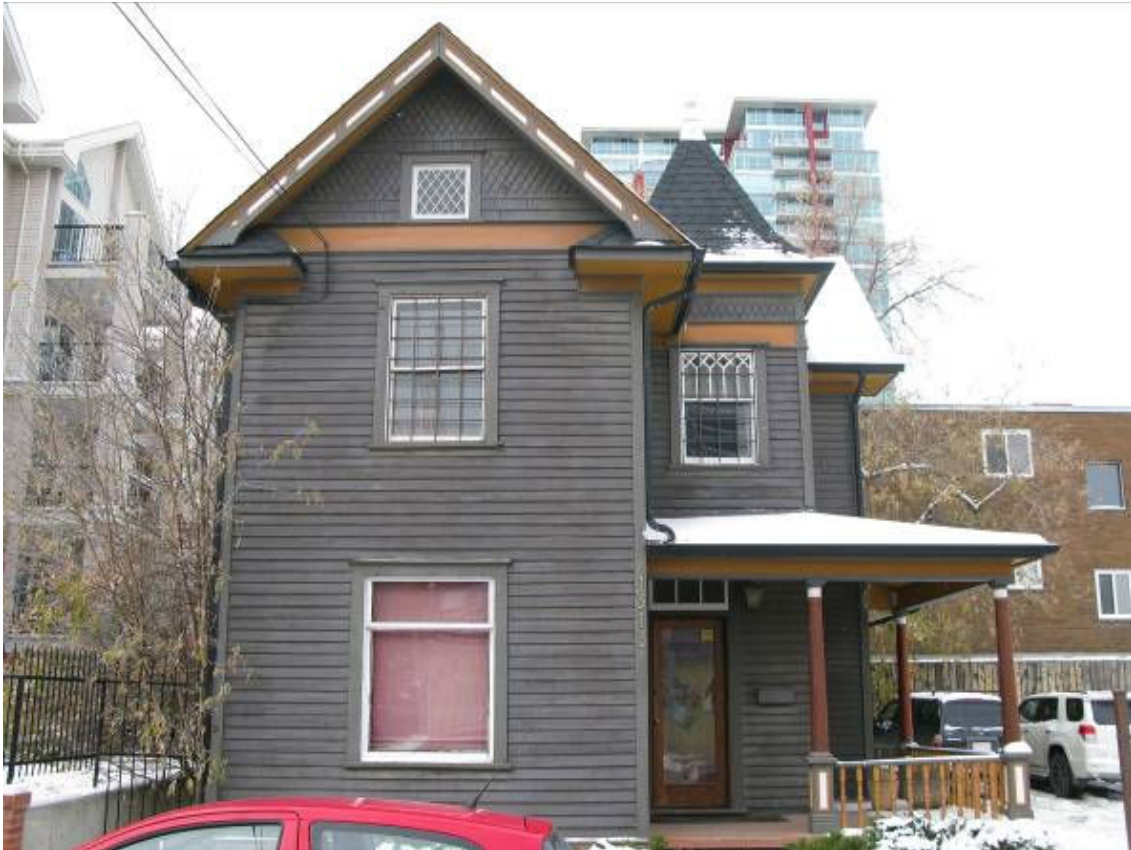
(Photo 1.2: East Façade)

- 1.1** a) Wooden cladding materials and detailing including the drop siding, corner boards, cornice boards, frieze band, and the alternating courses of regular and diamond-shaped shingle cladding (within gable) (Photos 1.2, 1.3);

- c) Single-door, main-entrance assembly with transom light (Photo 1.8);
- d) Open, wraparound veranda with wood finishes comprising classical, Tuscan-style columns on panelled bases, turned balusters, and a tongue-and-groove ceiling (Photo 1.2, 1.9)

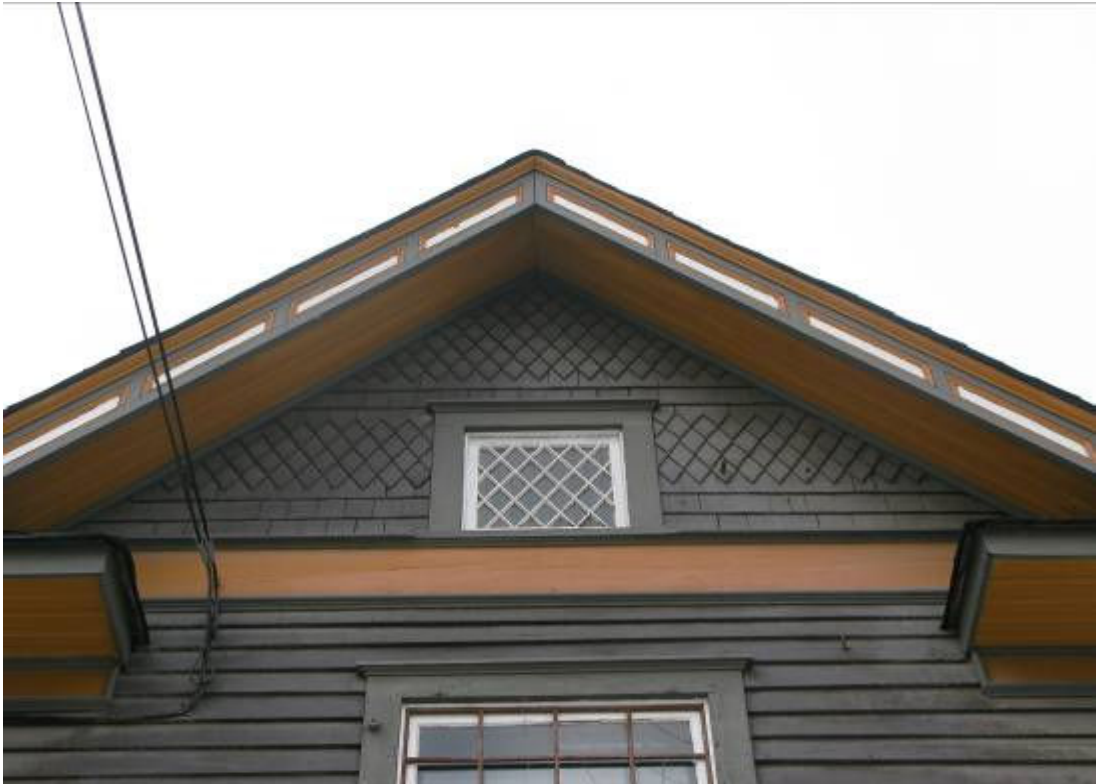
(Photo 1.3: Gable cladding showing alternating courses of regular and diamond-shaped shingles with frieze band below)

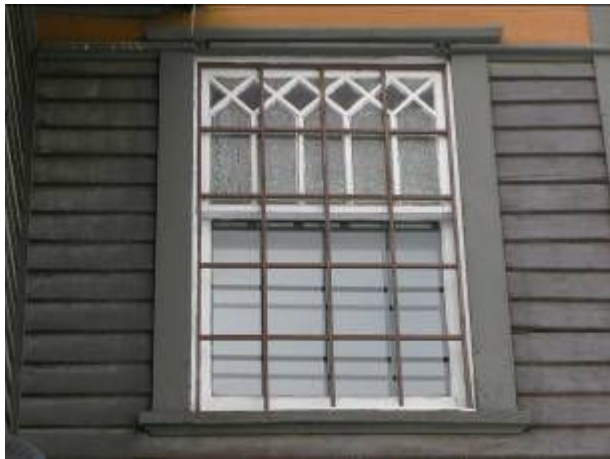
(Photo 1.6: Hung-sash window with a single-pane lower sash and a patterned upper sash with textured and stained glazing (second storey) and corniced casing)

- b) Fenestration with wooden-sash windows and wooden, corniced casings comprising: a single-pane sash with single-pane transom light (first storey) (Photo 1.4); a hung-sash, one-over-one window (second storey) (Photo 1.5); a hung-sash window with a single-pane lower sash and a patterned upper sash with textured and stained glazing (second storey) (Photo 1.6); a fixed-sash window with diamond-patterned glazing (attic) (Photo 1.7);

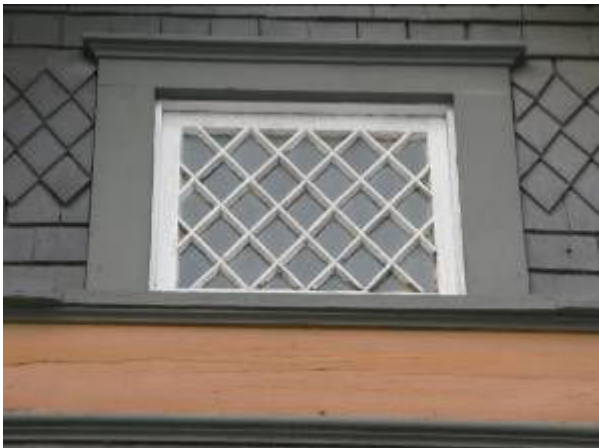
(Photo 1.7: Fixed-sash window with diamond-pattered glazing (attic) and corniced casing)

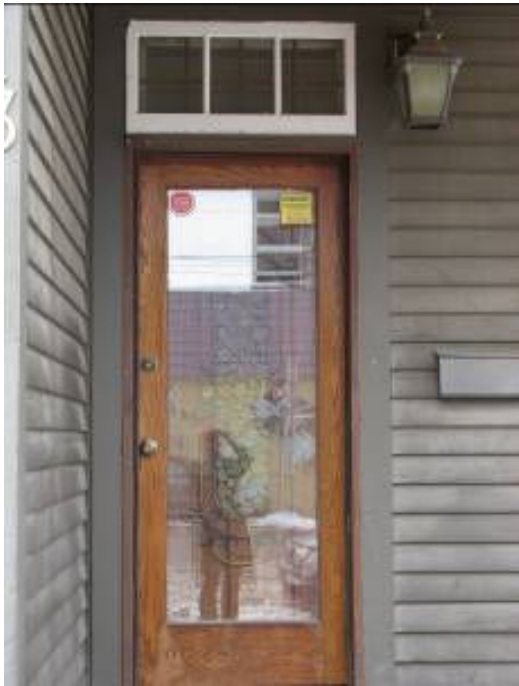
(Photo 1.8: Single-door, main-entrance assembly with transom light)

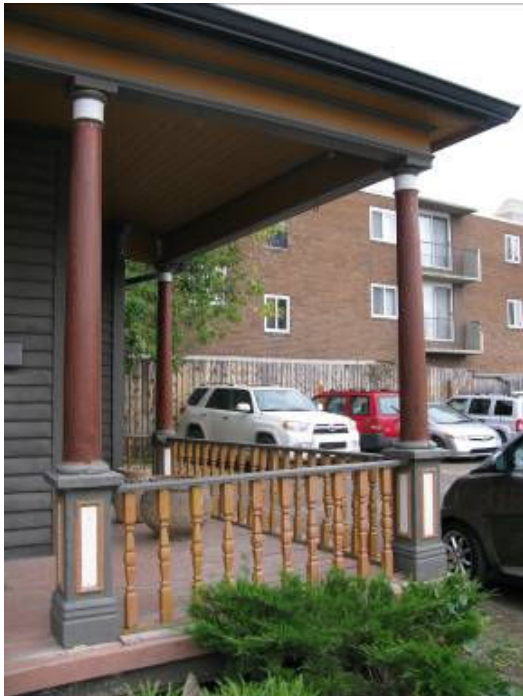
(Photo 1.9: Open, wraparound veranda)

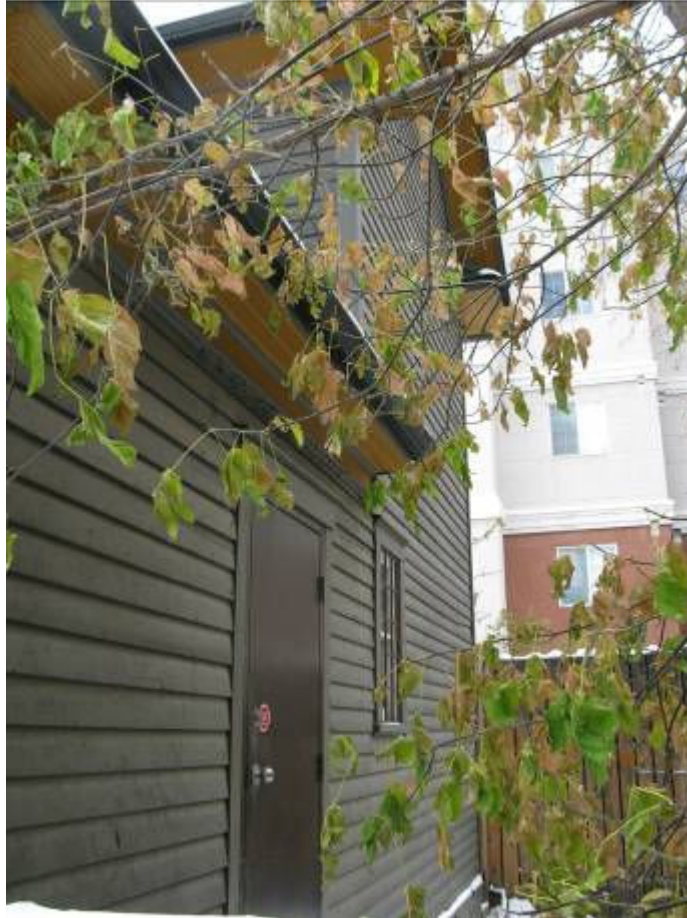
(Photo 2.2: West Façade, oblique view)

- 2.1** a) Wooden cladding materials comprising drop siding, corner boards (Photos 2.2, 2.3)  
b) Fenestration with wooden-sash windows and wooden, corniced casings comprising: hung-sash, one-over-one windows (two) (Photo 2.2);

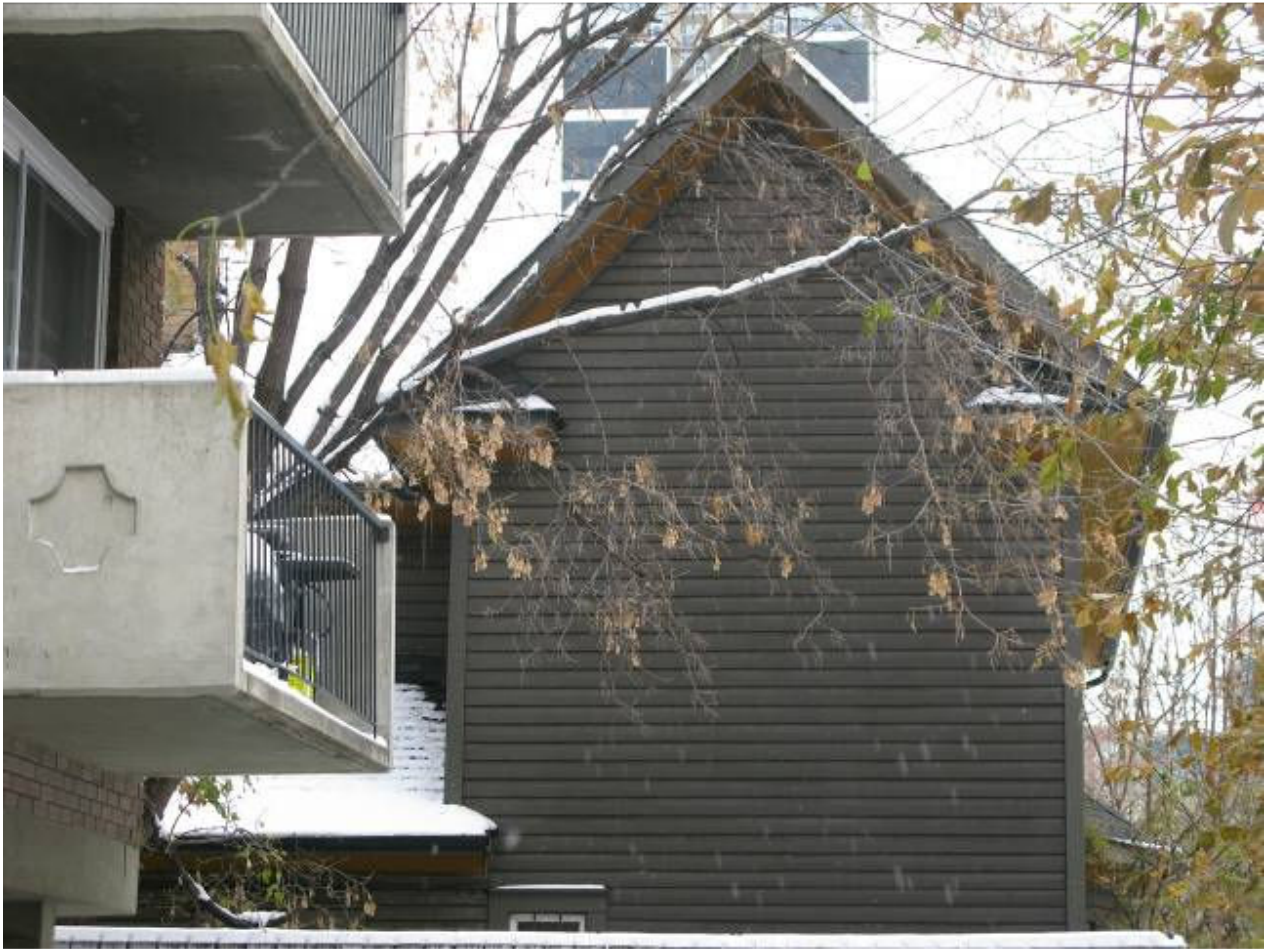
(Photo 2.3: West Façade, upper section)

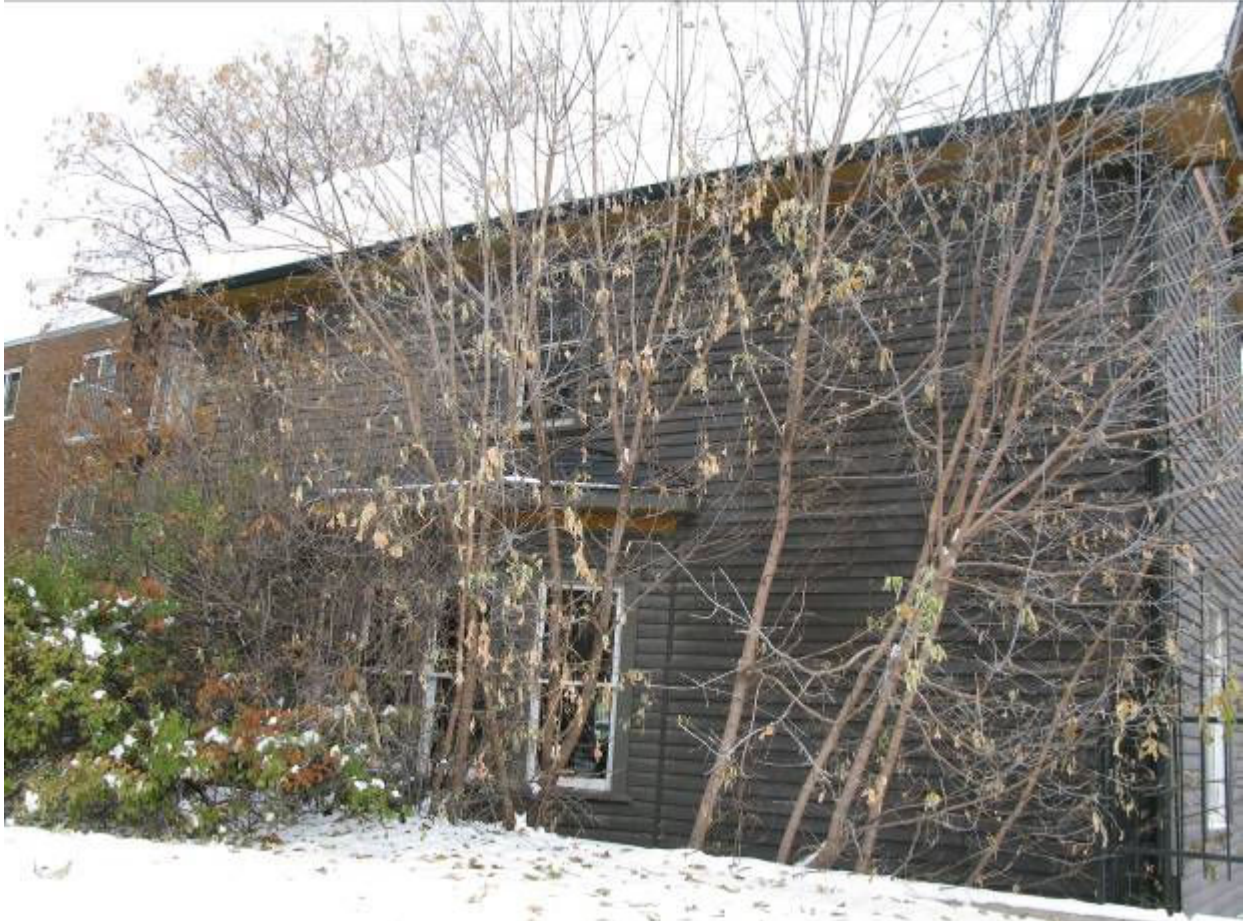
(Photo 3.2: South Façade, oblique view)

- 3.1 a) Wooden cladding materials and detailing including the drop siding and corner boards (Photo 3.2)
- b) Fenestration with wooden-sash windows and wooden, corniced casings comprising: a bay window with four (4) one-over-one, hung sash windows (first storey); two (2) one-over-one, hung-sash windows (second storey) (Photos 3.2, 1.5)

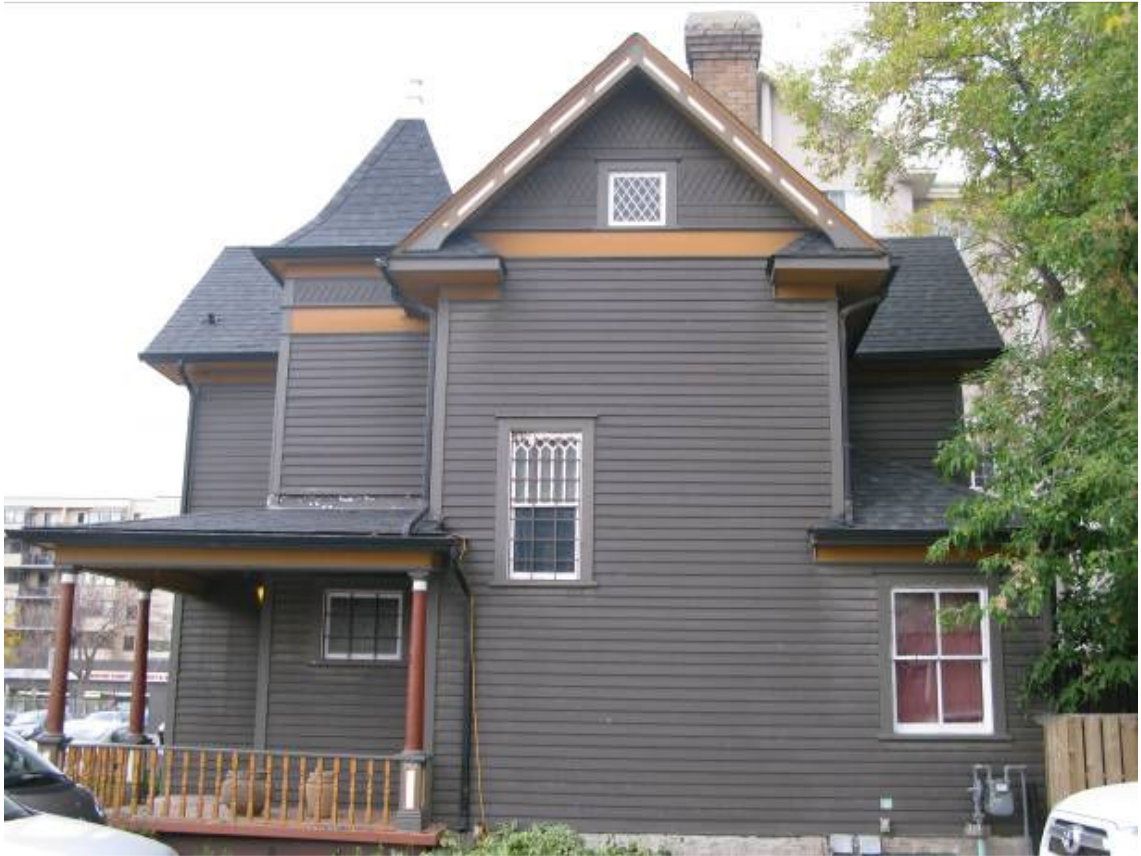
(Photo 4.2: North Façade)

- 4.1 a) Wooden cladding materials and detailing including the drop siding, corner boards, cornice boards, frieze boards, and the alternating courses of regular and diamond-shaped shingle cladding (within gable) (Photo 4.2);
- b) Fenestration with wooden-sash windows and wooden, corniced casings comprising: a fixed leaded, beveled, and 'jewelled' glass stair hall window (first storey) (Photo 4.3); a two-over-two hung-sash window (first storey) (Photo 4.4); a hung-sash window with a single-pane lower sash and a patterned upper sash with textured and stained glazing (second storey) (Photo 4.5); a fixed-sash window with diamond-patterned glazing (attic) (Photo 4.6);

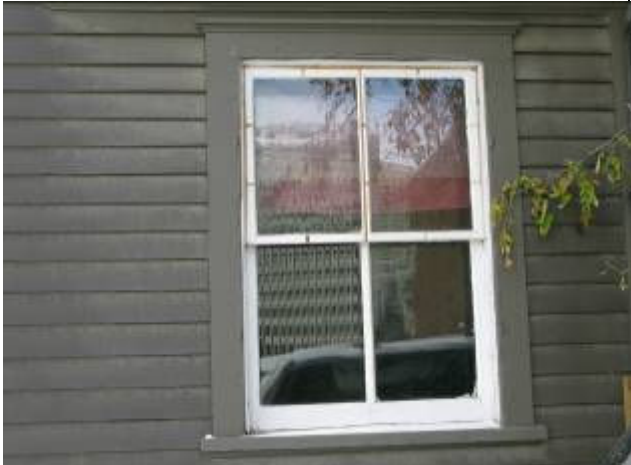
(Photo 4.3: Fixed leaded, beveled, and 'jewelled' glass stair hall window (first storey))	(Photo 4.4: a two-over-two hung-sash window (first storey))

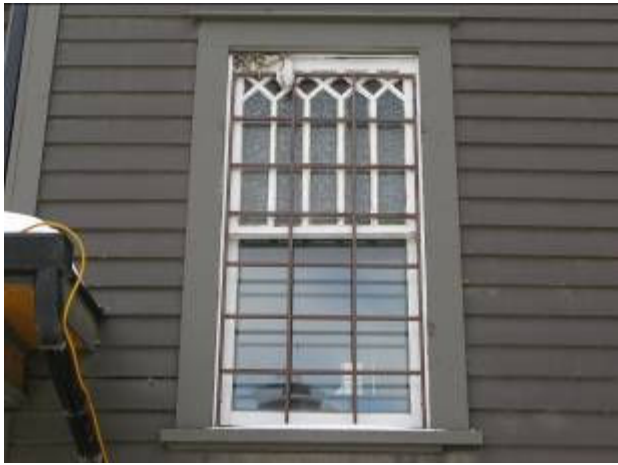
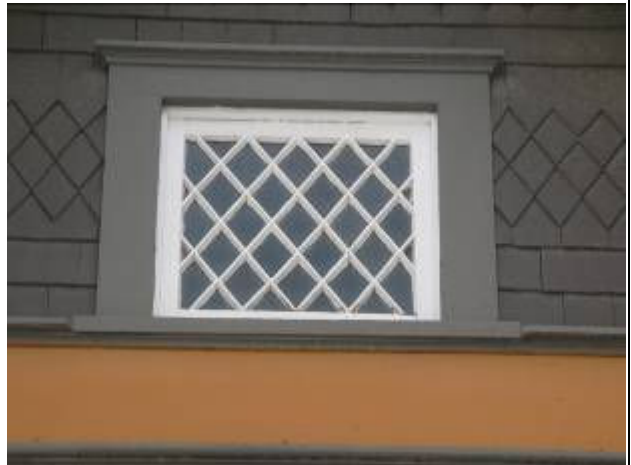
(Photo 4.5: Hung-sash window with a single-pane lower sash and a patterned upper sash with textured and stained glazing (second storey))	(Photo 4.6: fixed-sash window with diamond-patterned glazing (attic);

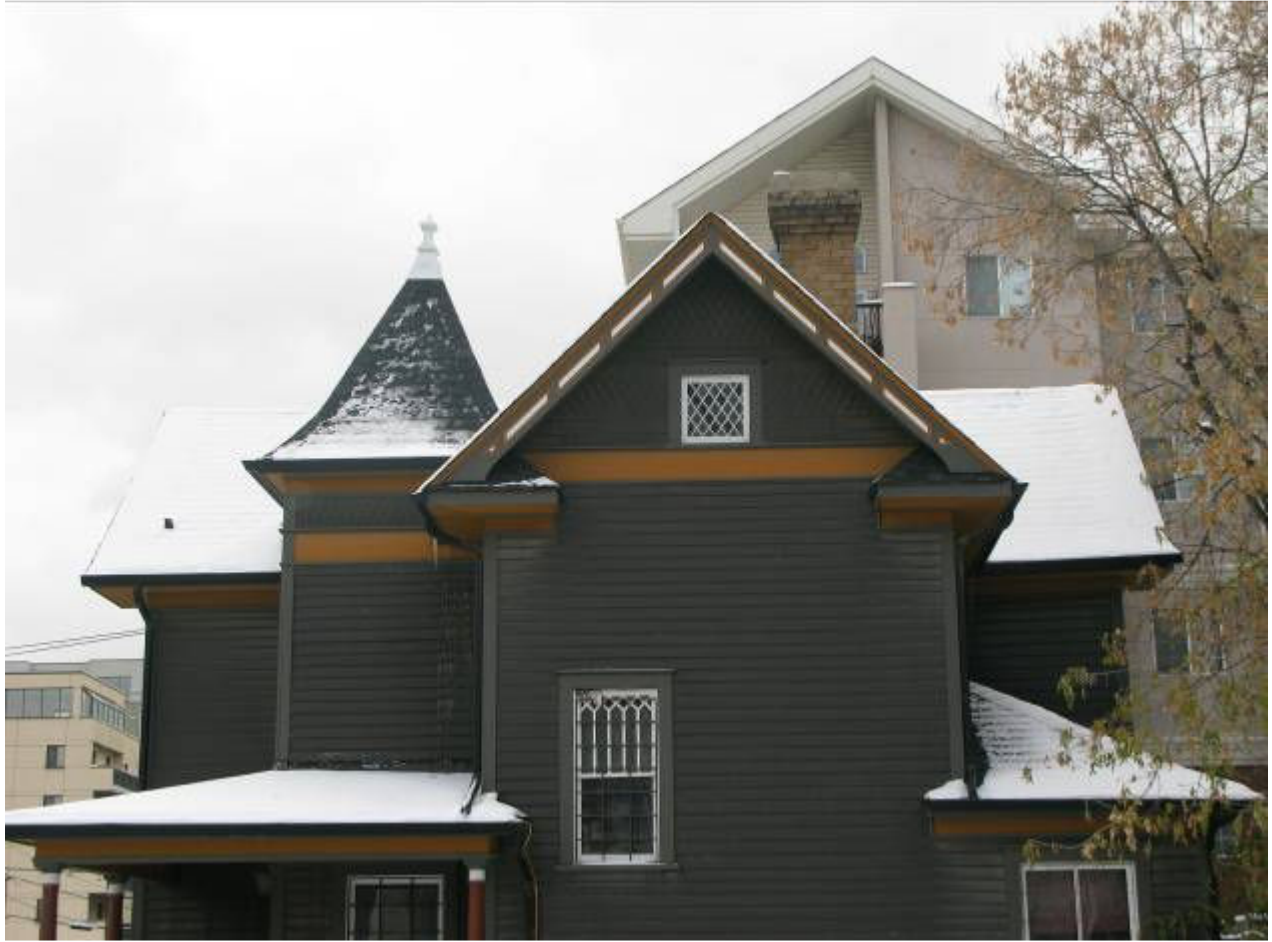
(Photo 5.2: View of the rooflines / profiles)

- 5.1 a)** the cross-gable form of the principle rooflines: hipped roofs on the front verandah and northwest corner; the polygonal tower roof with ornamental metal finial (Photos 5.2, 5.5);
- b) roof-wall junctions comprising closed eaves and wooden soffits with distinctive tooled and textured finish (Photos 5.3, 5.4); framed cornice boards (Photo 5.4); wooden, panelled fascia boards (on gables) (Photo 5.3);
- c) buff-coloured brick chimney with corbelled cap (Photo 5.6).

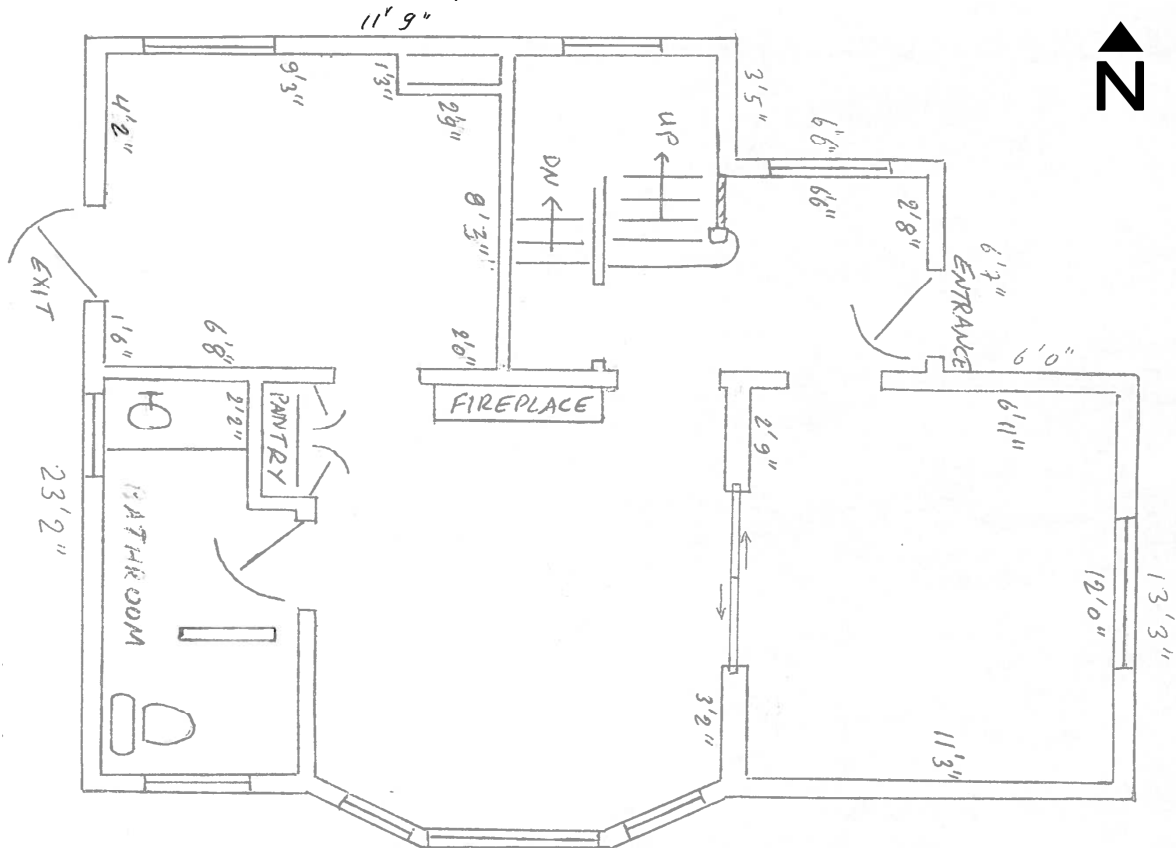
Image 6.02: First-floor plan / configuration

- 6.1 a) Those extant portions of the original floor-plan / configuration which includes all interior demising walls of the ground floor and second floor (not basement) and which on the ground floor comprise a stair hall, large southeast room, large southwest room and small northwest room; and which on the second-floor comprise a stair hall and corridor, and a small northwest room (bathroom). (Images 6.02, 6.03)

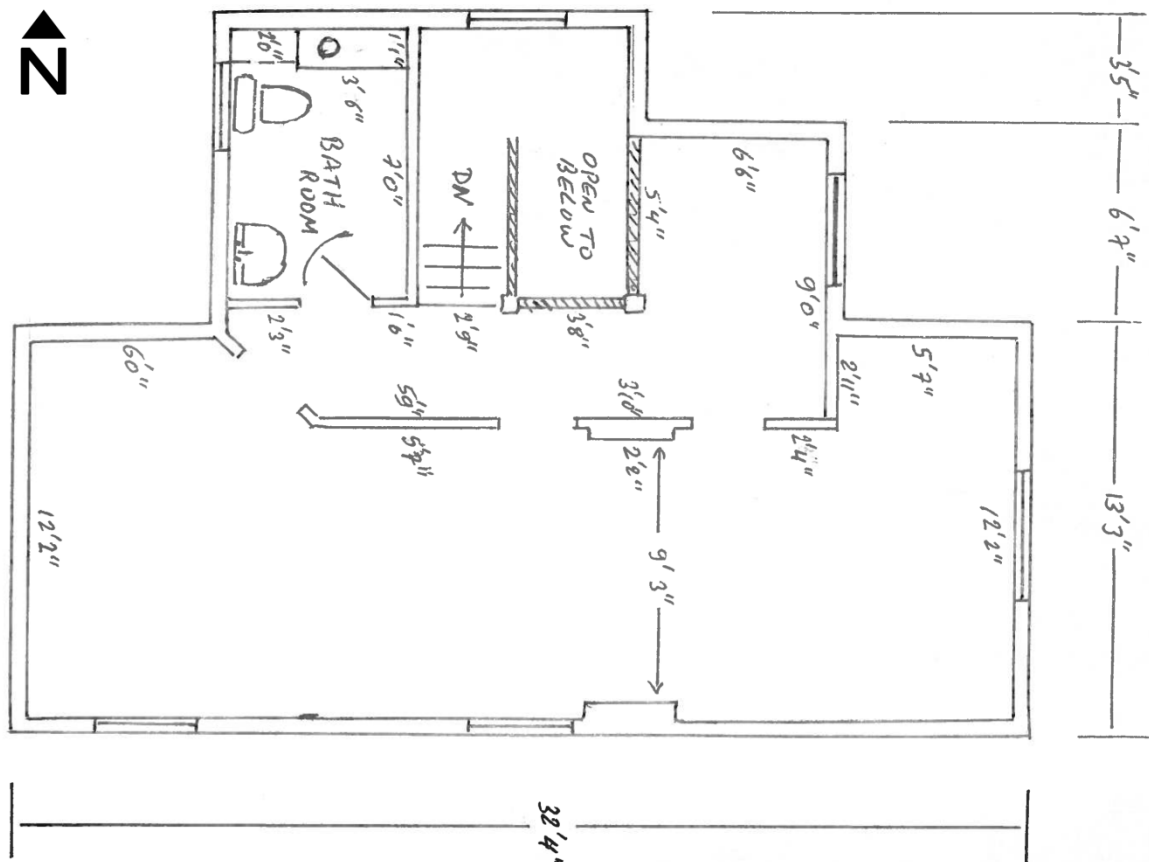
Image 6.03: Second-floor plan / configuration

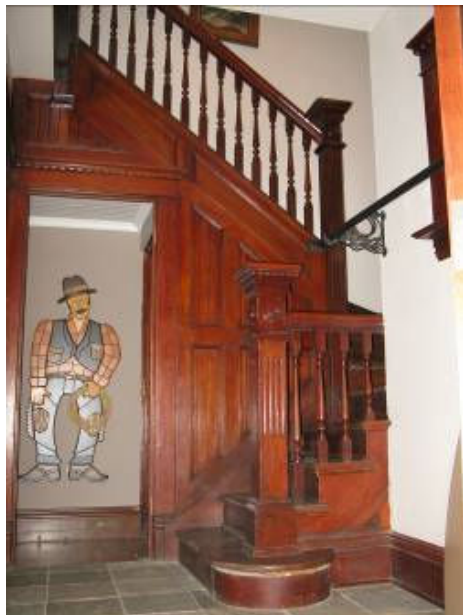
(Photo 6.04: The staircase - first floor)

- b) The staircase, comprising balustrades of turned balusters, squared newel posts, and wooden, tongue-and-groove paneling (Photos 6.04, 6.05)
- c) All historic window and door casings (Photos 6.06, 6.11, 6.12); baseboards (Photos 6.13);

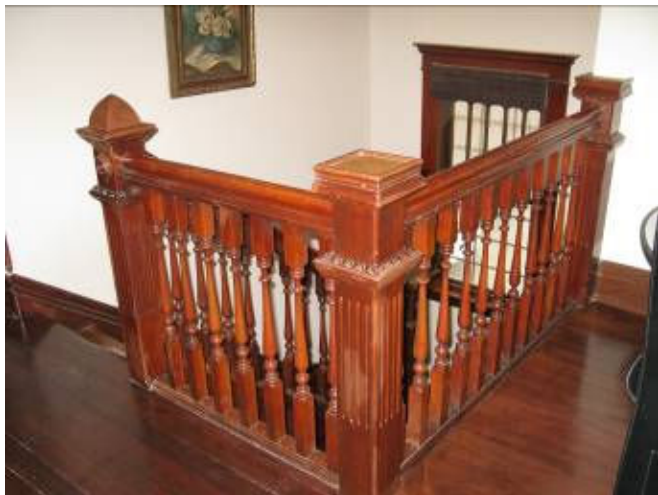
(Photo 6.05: The staircase -second floor)

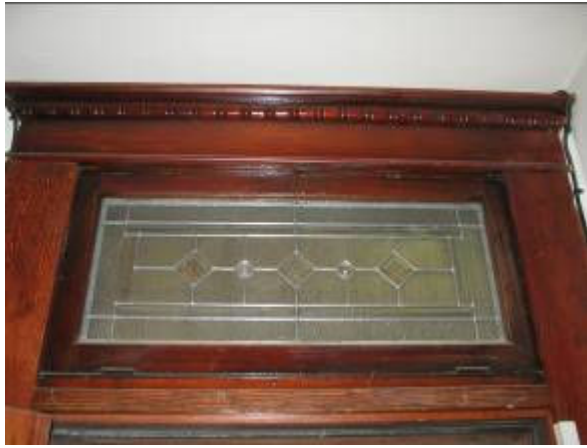
(Photo 6.10: The first-floor leaded and 'jewelled' transom light above the main entrance door)

- e) The leaded and 'jewelled' glass first-floor foyer window (Photo 6.09); and the leaded and 'jewelled' glass transom light above main entrance door (Photo 6.10);

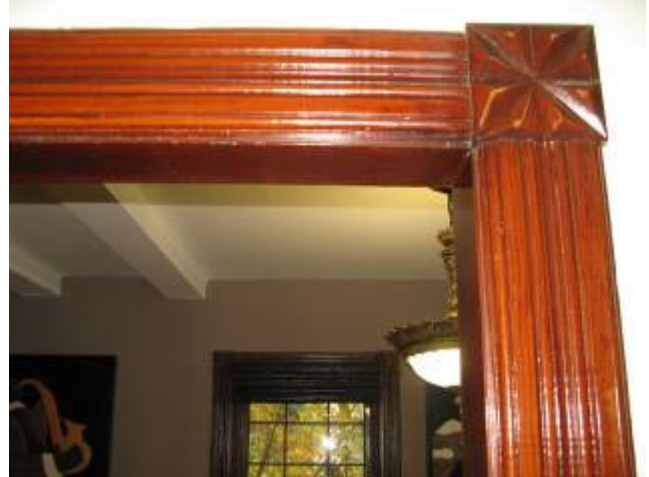
(Photo 6.11: Example of the second-floor window and door casings – note some casings retain a varnish finish while some are painted)

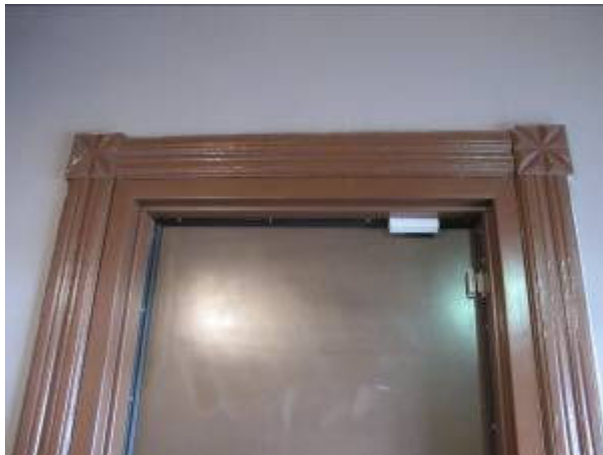
(Photo 6.12: Example of the second-floor window and door casings – note some casings retain a varnish finish while some are painted)

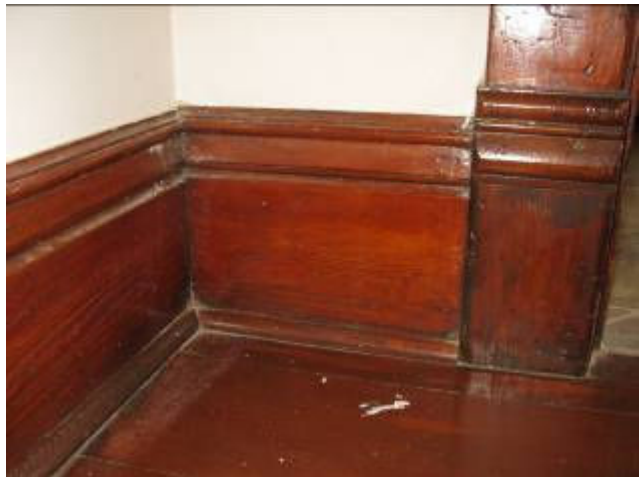
(Photo 6.13: Example of the baseboards – first and second floors)
