# BEING A BYLAW OF THE CITY OF CALGARY TO DESIGNATE THE ROBERT AND MARY TAYLOR RESIDENCE AS A MUNICIPAL HISTORIC RESOURCE

# SCHEDULE "A" TO THE BYLAW TO DESIGNATE THE ROBERT AND MARY TAYLOR RESIDENCE AS A MUNICIPAL HISTORIC RESOURCE

# SCHEDULE "C" TO THE BYLAW TO DESIGNATE THE ROBERT AND MARY TAYLOR RESIDENCE AS A MUNICIPAL HISTORIC RESOURCE

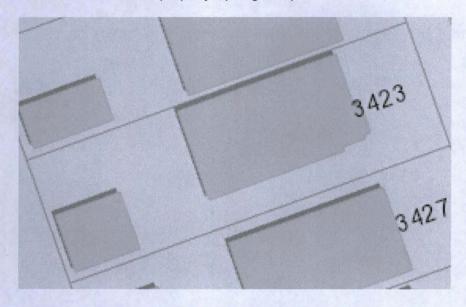
- The two storey form and existing footprint of the residence; and the location of the residence on the property. (Image 1.2);

(Image 1.2: Footprint and location of the residence on the property)

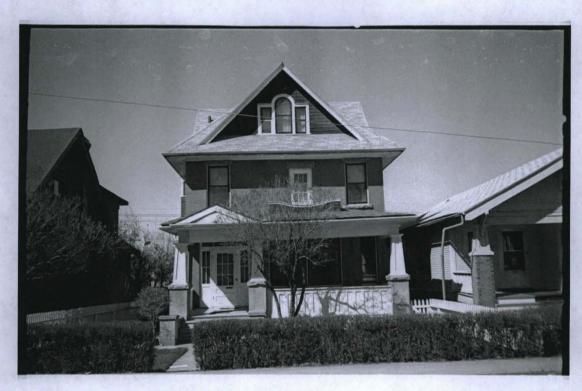
- The pressed red-brick wall cladding laid in stretcher bond; rough-faced sandstone sills and lintels; wood-shingled gable detailing (Photos 2.2 and 2.3);

- Open, full-width front verandah with tapered and panelled columns on brick and stone
  piers, the moulded frieze, wooden tongue-and-groove ceiling and shed roof profile
  incorporating a pediment detail and an open wood-shingle-clad balcony (Photos 2.2, 2.3,

(Photo 2.2: Historic view of the East Façade, 1973)

- Hipped roof with lower cross gables; rear shed-roof dormer with wooden tongue-and-groove soffits and exposed rafter tails; one internal sandstone chimney; closed, wooden, tongue-and-groove soffits around the main roofline (Photos 2.2, 2.3, 5.2 and 5.3);

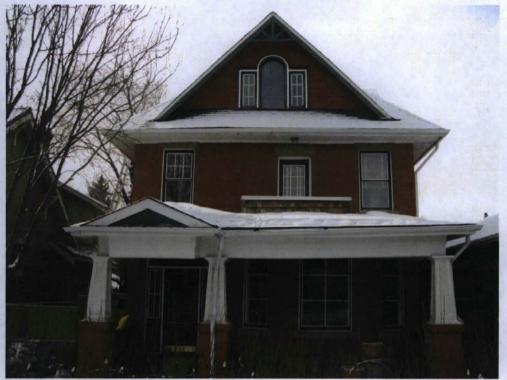
(Photo 2.3: View of the East Façade)

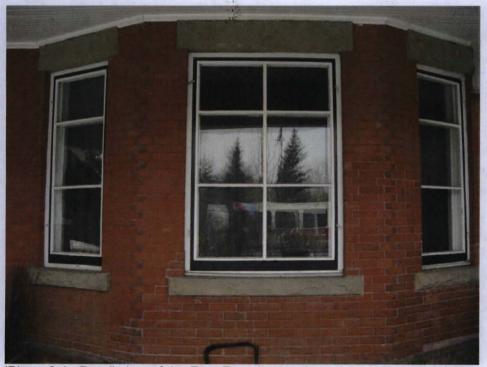
2.5);
- Fenestration (design and arrangement of window openings) with original one-over-one, wooden, hung-sash first-storey windows with multi-light, wooden, storm sashes (Photos 2.2, 2.3, 2.4); and

(Photo 2.4: Detail view of the East Façade showing original windows with storm sashes)

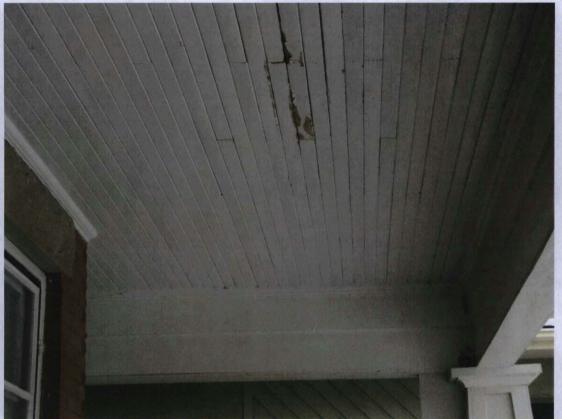
(Photo 2.5: Detail view of the East Façade showing the veranah's frieze and tonge-and-groove ceiling.)

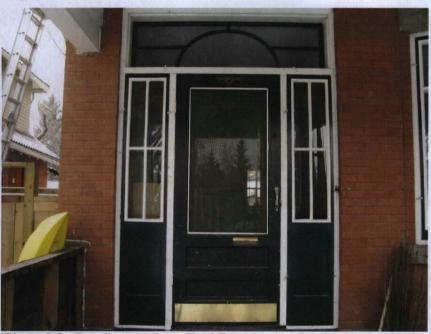
- Side-hall doorway opening and assembly comprising bevelled-glass and wood-panelled door and sidelights, and a transom light with muntins forming a stylized 'fan' pattern; multipane sidelight storm sashes with wood-panelled base and wood-panelled storm door (Photos 2.2, 2.3, 2.6, 2.7).

(Photo 2.6: Detail view of the East Façade showing the doorway opening and assembly.)

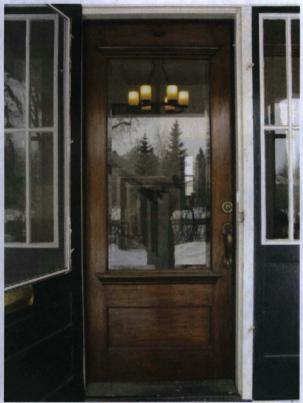
(Photo 2.7: Detail view of the East Façade showing the inner door.)

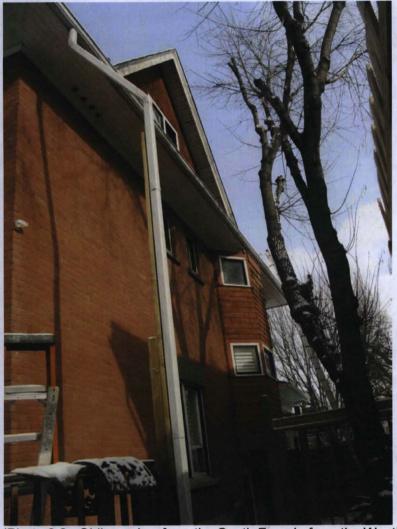
- The pressed red-brick wall cladding laid in stretcher bond; smooth-finished sandstone sills and lintels; rough-faced sandstone water table wood-shingled bay window cladding (Photo 3.2, 3.3); and
- Fenestration (design and arrangement of window openings) (Photo 3.2).

(Photo 3.2: Oblique view from the South Façade from the West)

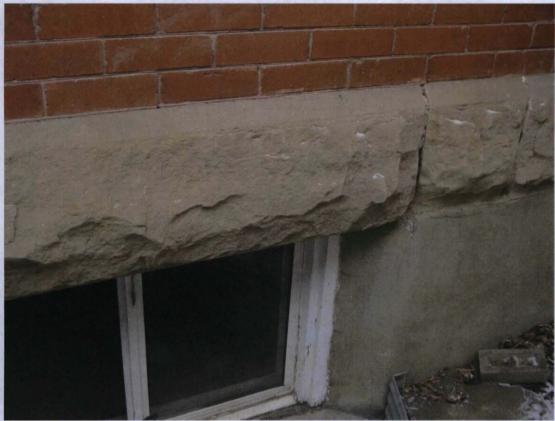
(Photo 3.3: Detail view showing an example of the rough-faced sandstone water table on the South Façade and which also surrounds the West and North Facades.)

- 4.1
- The pressed red-brick wall cladding laid in stretcher bond; rough-faced sandstone sills and lintels; rough-faced sandstone water table wood-shingled bay window cladding (Photos 4.2, 4.3 and 3.3); and
- Fenestration (design and arrangement of window openings) with original one-over-one, wooden, hung-sash first-storey windows with multi-light, wooden, storm sashes (Photos 4.2, 4.3 and 4.4).

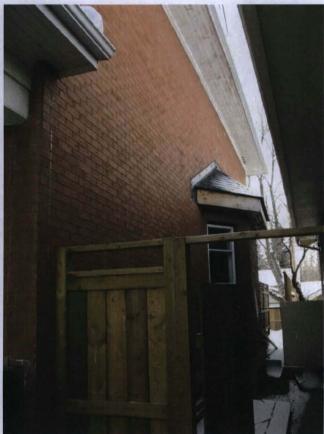
(Photo 4.2: Oblique view from the East of the North Façade.)

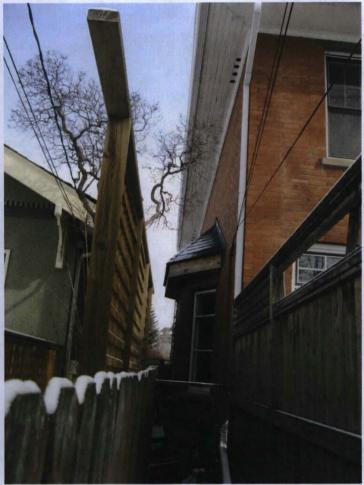
(Photo 4.3: Oblique view from the West of the North Façade.)

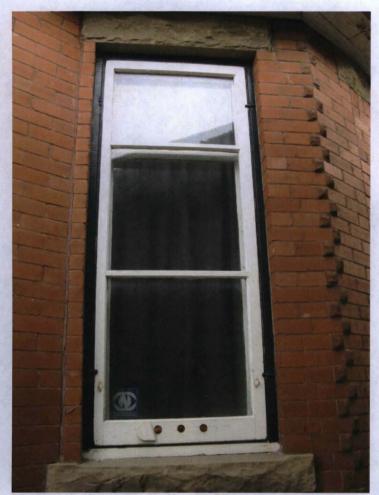
(Photo 4.4: An example of one of the two extant original windows on the North Façade – with storm sash.)

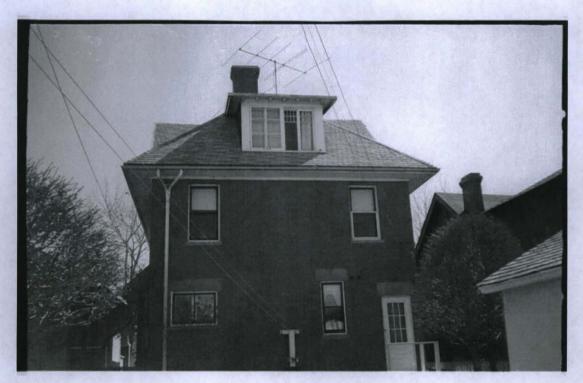
- The pressed red-brick wall cladding laid in stretcher bond; rough-faced sandstone sills and lintels; rough-faced sandstone water table (Photos 5.2 and 5.3); and
- Those elements of the historic fenestration (design and arrangement of window openings); the wooden, attic-level, casement sashes with multi-pane upper portions (Photos 5.2 and 5.3).

(Photo 5.2: Historic view of the West Façade, 1973 - shows original fenestration and detailing.)

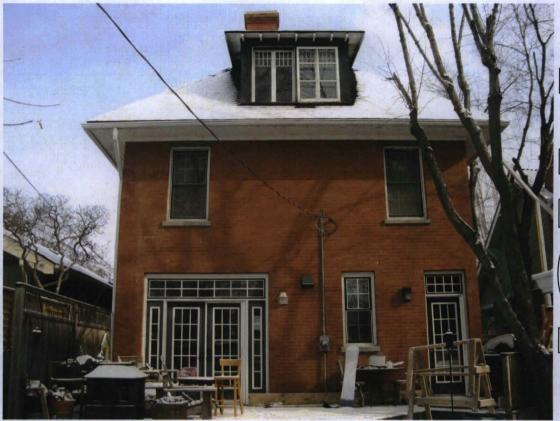
(Photo 5.3: View of West Façade)
