Proposed Wording for a Bylaw to Designate the Nimmons Residence as a Municipal Historic Resource

1. This Bylaw may be cited as “City of Calgary Bylaw to Designate the Nimmons Residence as a Municipal Historic Resource”.

2. The building known as the Nimmons Residence, located at 1420 19 AV SW, and the land on which the building is located being legally described as Plan 1610440; Block 1; Lot 23 as shown in the attached Schedule “A” (the “Historic Resource”), are hereby designated as a Municipal Historic Resource.
3. The specific elements of the Historic Resource possessing heritage value are hereafter referred to as the Regulated Portions (the “Regulated Portions”). The Regulated Portions are identified in the attached Schedule “B”.

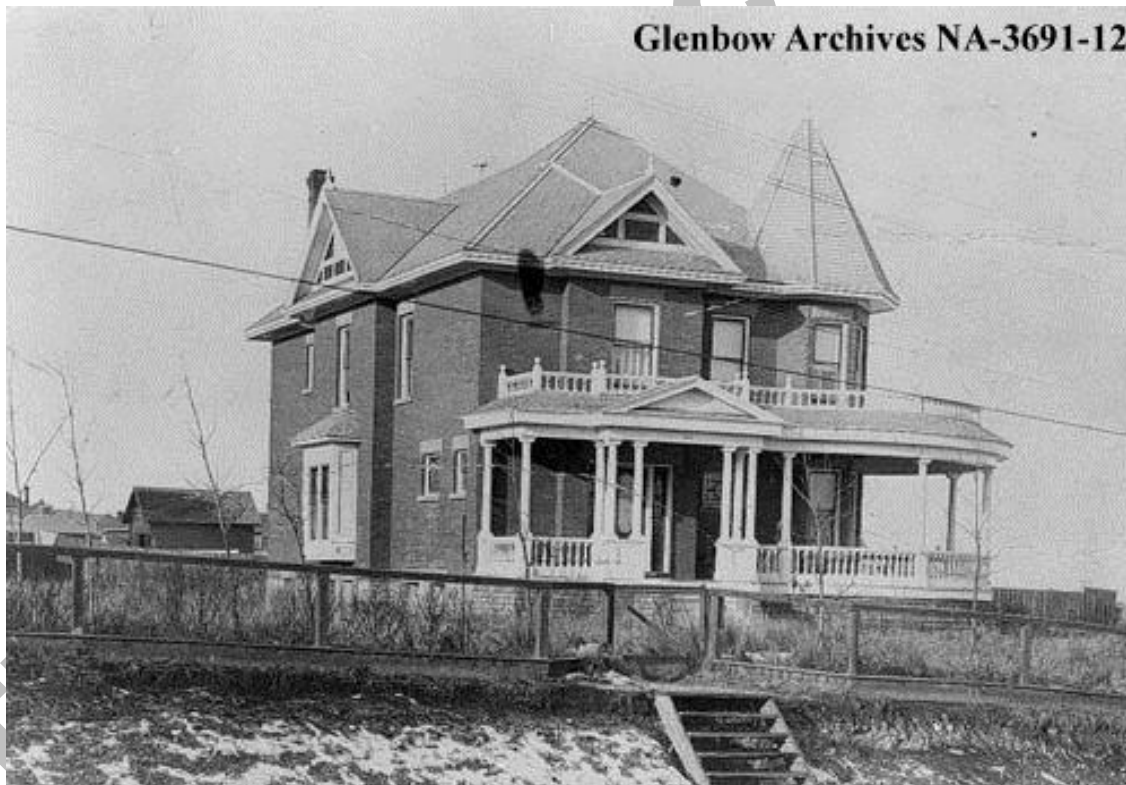
(Image 1.0 – Historic (1912) contextual view of the Nimmons Residence in its original siting, showing east and south facades; image courtesy Glenbow Archives)

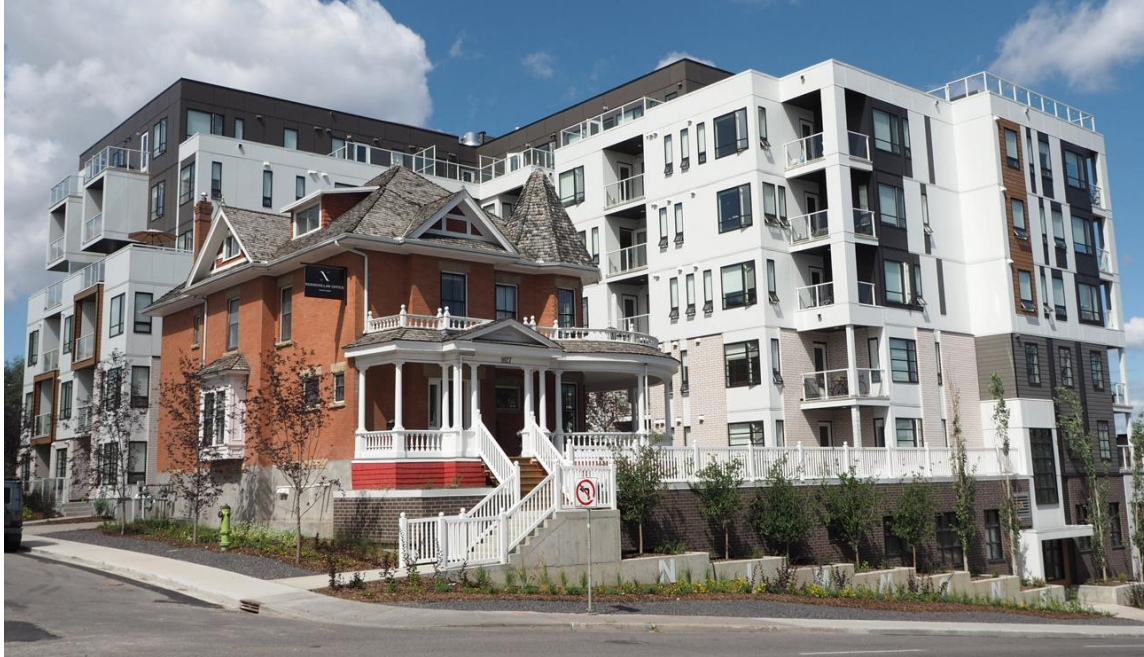
(Image 1.1 – Contemporary (2023) contextual view of the Nimmons Residence in its current siting following relocation, showing east and south façades)

- a) The red-brick exterior walls laid in stretcher bond (Image 1.2);
- b) Doorway assembly with panelled oak door with oval-shaped bevelled glazing and panelled, oak sidelights with oval-shaped, leaded and bevelled glazing; rock-faced sandstone lintel and threshold (Image 1.3);
- c) Fenestration, with 1-over-1 wooden sash windows with 4-pane wooden storm sashes; smaller, fixed-sash leaded and stained-glass window; rock-faced sandstone lintels and sills (Images 1.1-1.6);
- d) Open, full-width, wraparound veranda and balcony of wood construction with classical, Tuscan-style columns, single-bellied balusters, pedimented entrance tongue-and-groove ceiling, and wood-shingle-clad base (Images 1.1, 1.2, 1.7-1.14);
- e) Polygonal corner turret (Images 1.1, 1.8); and
- f) Wood-shingle-clad gable with mock-half timbering detail (Image 1.2).

- a) The hipped roof with lower cross gables with wooden tongue-and-groove soffits and short, turned, wooden roofline finials (Images 1.1, 2.0, 3.2, 4.0);
- b) Polygonal turret roof at north-east corner of the building (Images 1.8, 5.0); and
- c) Tall, red-brick chimney with corbelled cap at southwest corner of the building (Image 5.2).

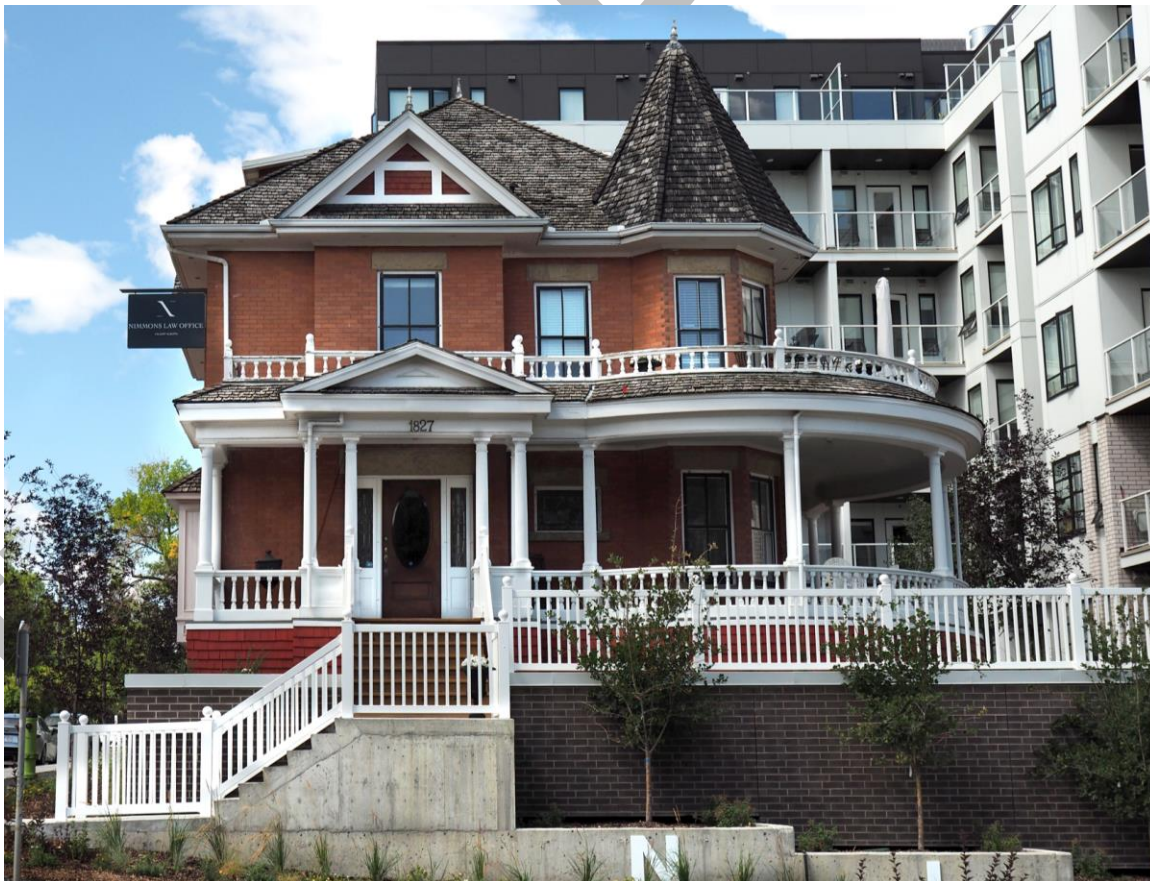
(Image 1.2 – East façade of the Nimmons Residence; contemporary L-shaped stair accessing veranda is non-regulated)

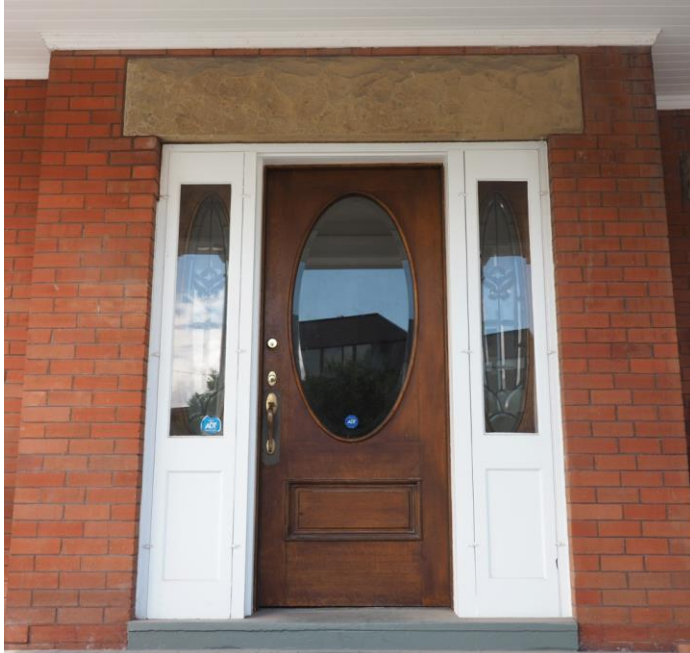
(Image 1.3 – Main entrance, showing doorway assembly)

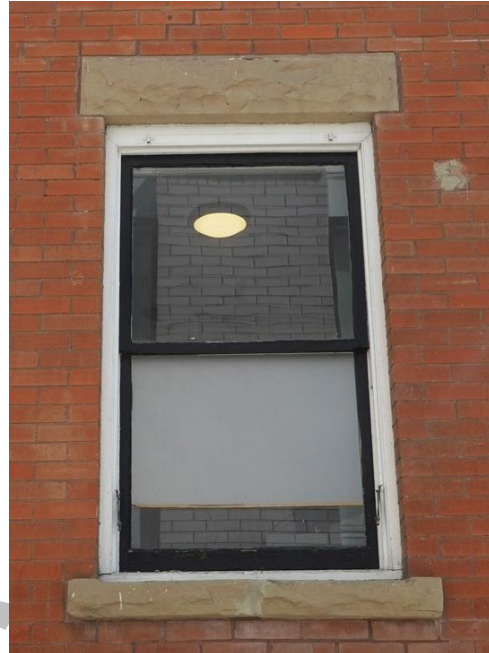
(Image 1.4 – Example of a typical 1-over-1 wooden-sash window; sandstone lintel above the window opening and sill below)

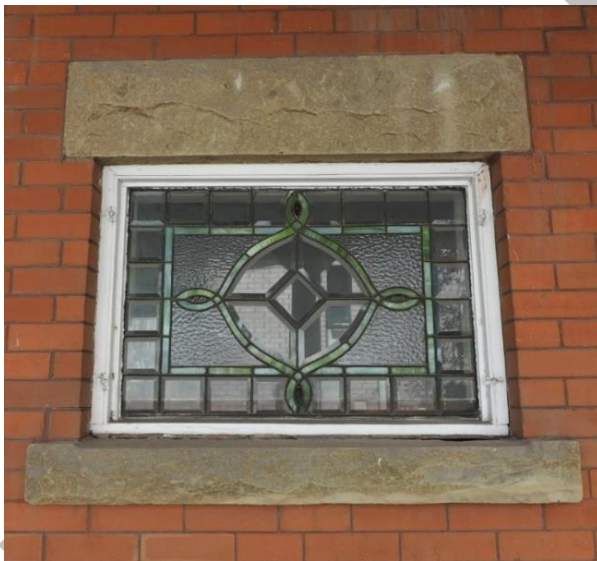
(Image 1.5 – Example of smaller leaded and stained-glass windows)

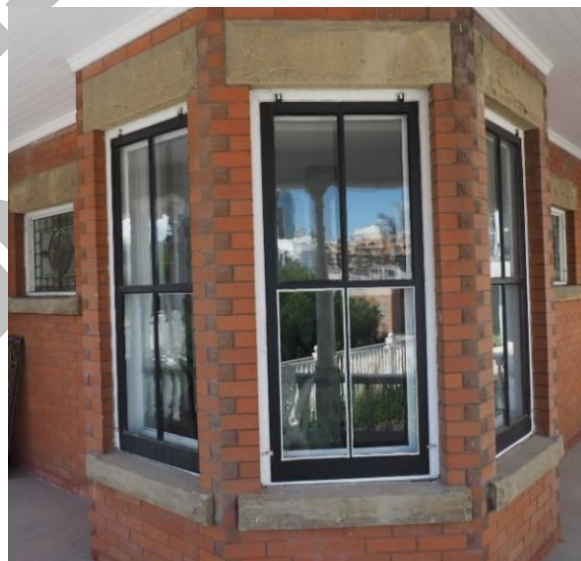
(Image 1.6 – Corner turret, showing examples of window with 4-pane wooden storm sash; rough-faced pitched brick detail at corners)

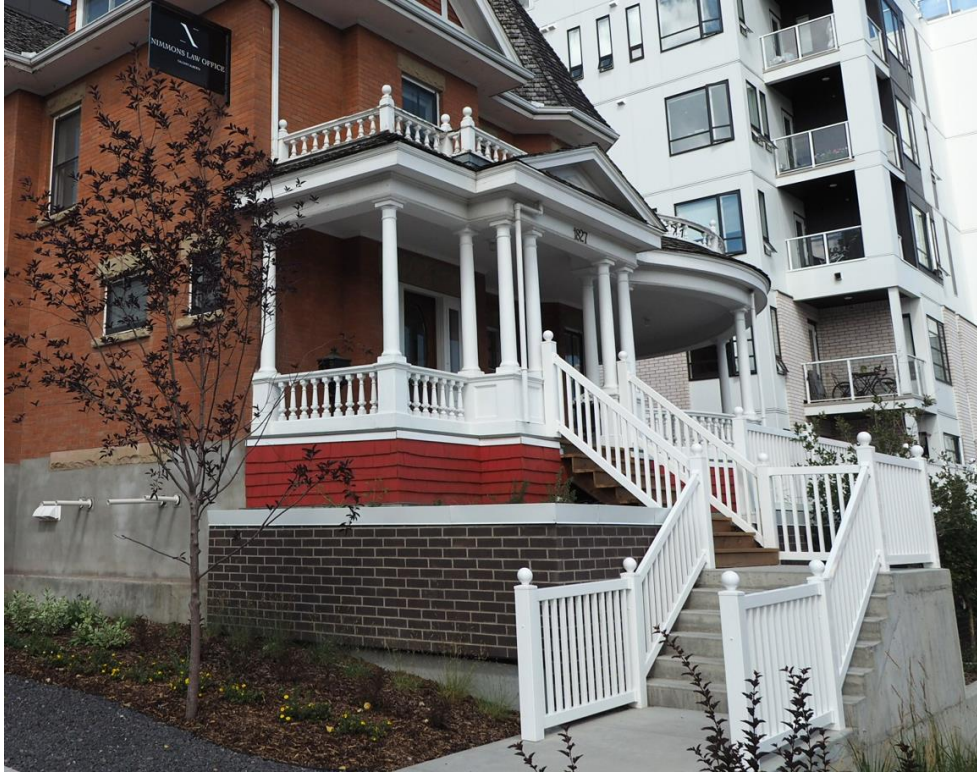
(Image 1.7 – Detail view of the veranda, looking northwest, showing balustrade and Tuscan-style columns; contemporary L-shaped stair accessing veranda is non-regulated)

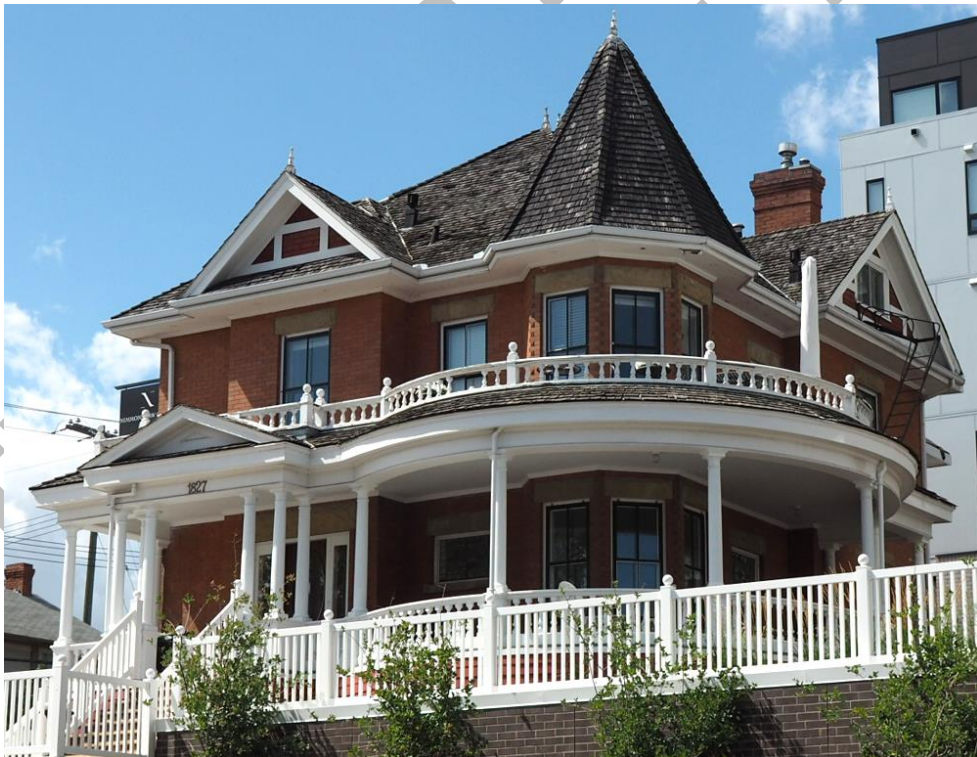
(Image 1.8 – Detail view of the veranda, looking southwest, showing balustrade and Tuscan-style columns)

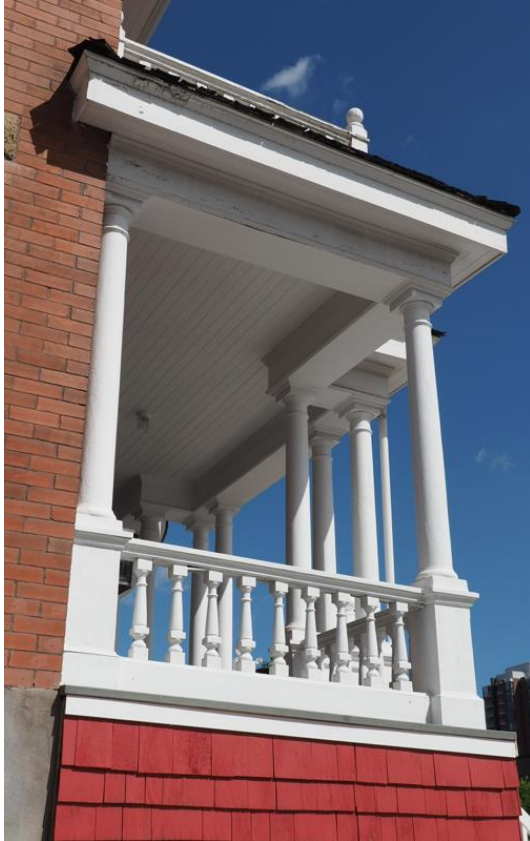
(Image 1.9 – South facade of the veranda, showing column detail and tongue-and-groove ceiling)

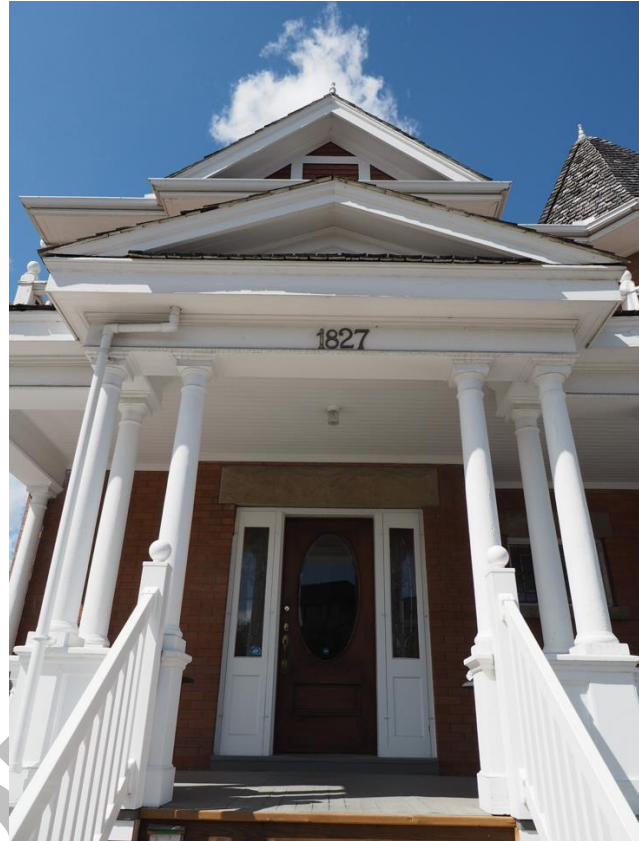
(Image 1.10 Detail of entrance pediment on veranda)

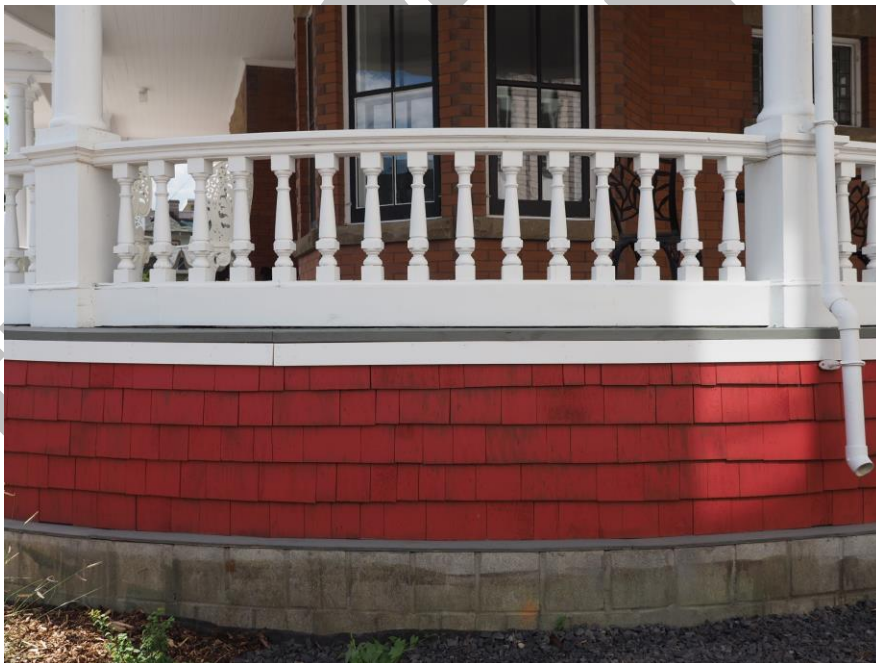
(Image 1.11 – Detail view of veranda skirt at northeast corner of the Nimmons Residence, showing baluster and column profile)

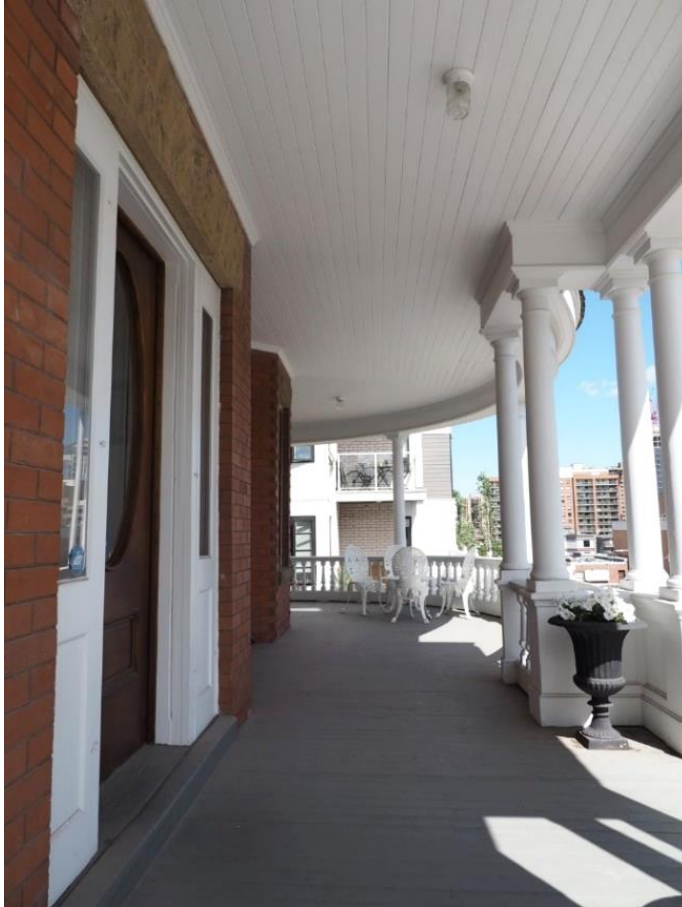
(Image 1.12 – Detail view of the veranda, looking north, showing tongue-and-groove ceiling)

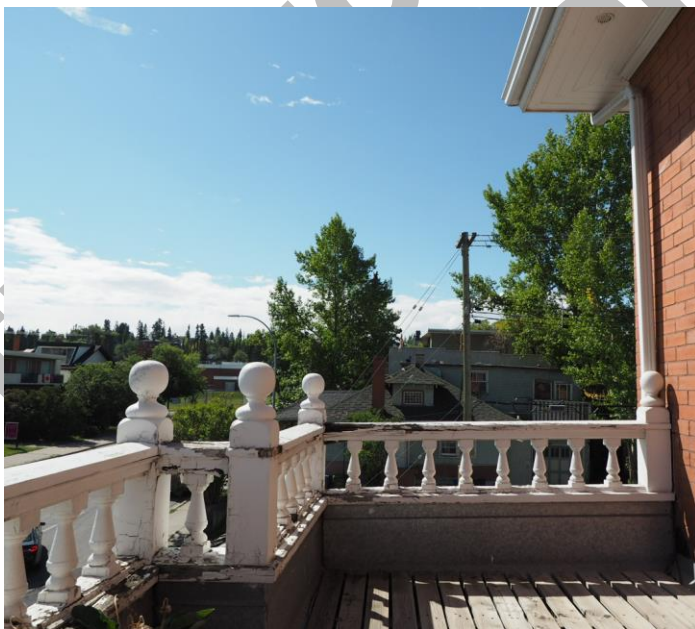
(Image 1.13 – Balustrade at balcony level, looking south)

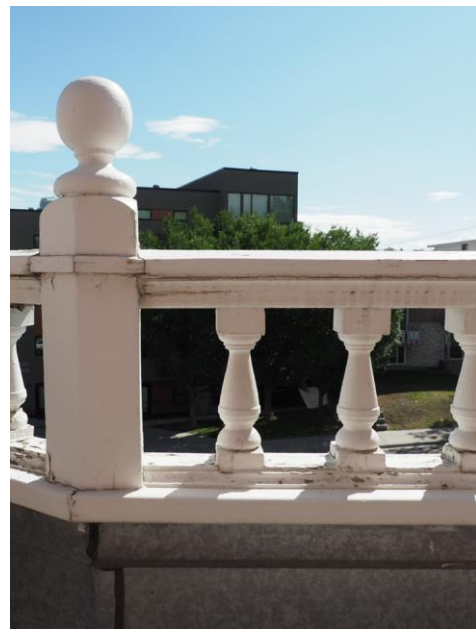
(Image 1.14 – Detail view of balustrade at balcony level, looking east)

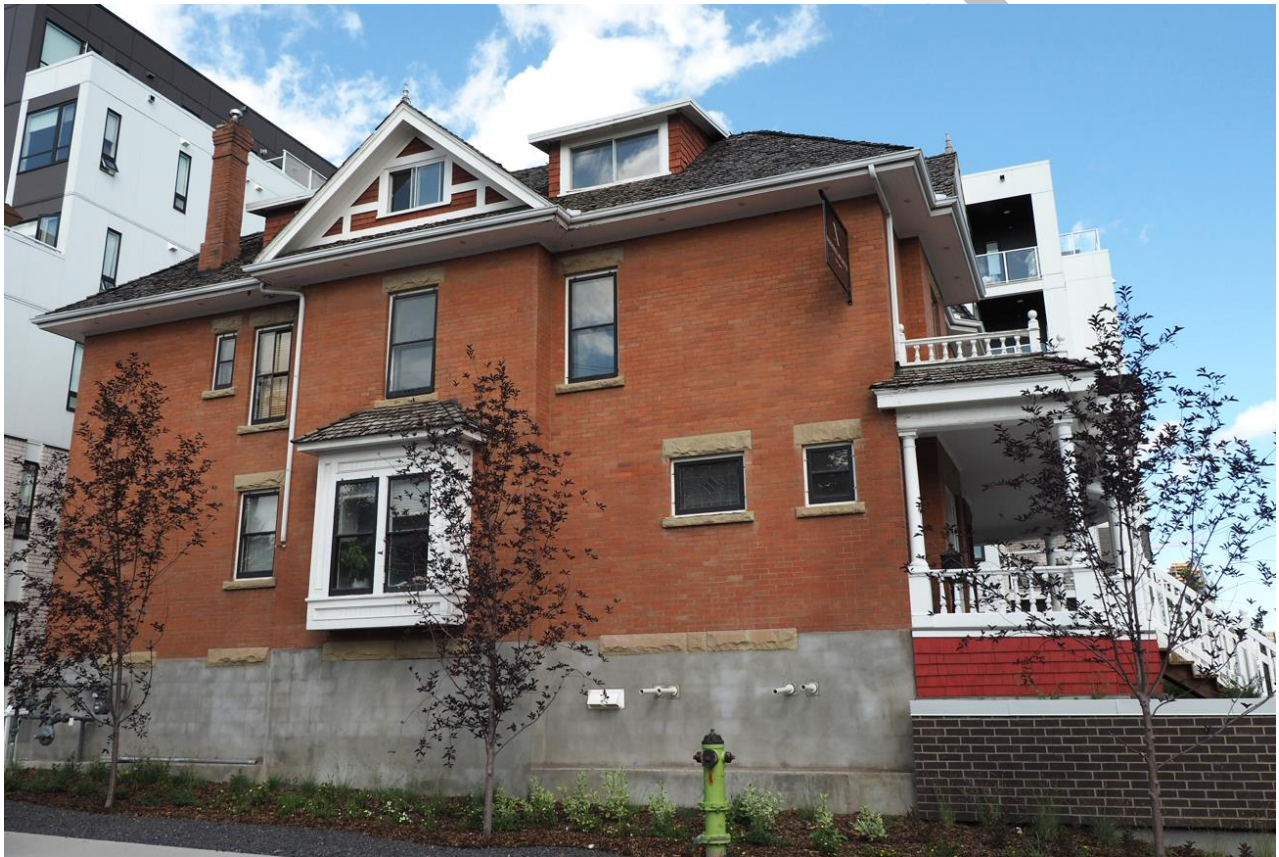
(Image 2.0 – South façade of the Nimmons Residence)

- a) The red-brick exterior walls laid in stretcher bond (Image 2.0);
- b) Rock-faced sandstone lintels below main floor, indicating fenestration from original foundation (Images 2.0, 2.1);
- c) Fenestration, with 1-over-1 wooden sash windows and wooden 1-over-1 and 4-pane storm sashes; smaller, fixed-sash leaded, stained-glass window; rock-faced sandstone lintels and sills (Images 2.0, 2.1);
- d) Bay (oriel) window clad in wood with multiple tongue-and-groove panels and a hipped roof (Images 2.1, 2.2); and
- e) Wood-shingle-clad gable with mock-half timbering detail (Image 2.0).

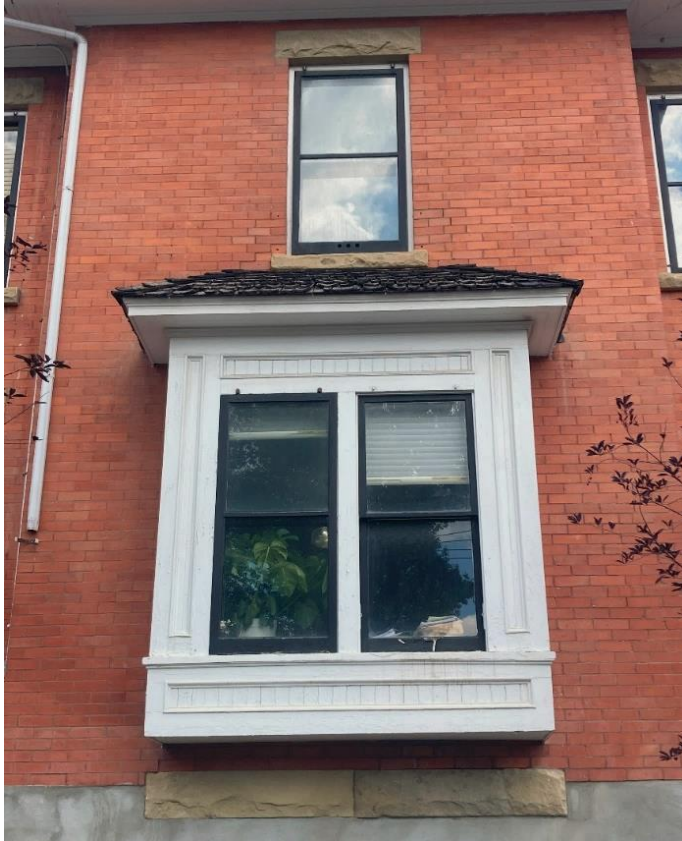
(Image 2.1 – Wood-panelled bay (oriel) window)

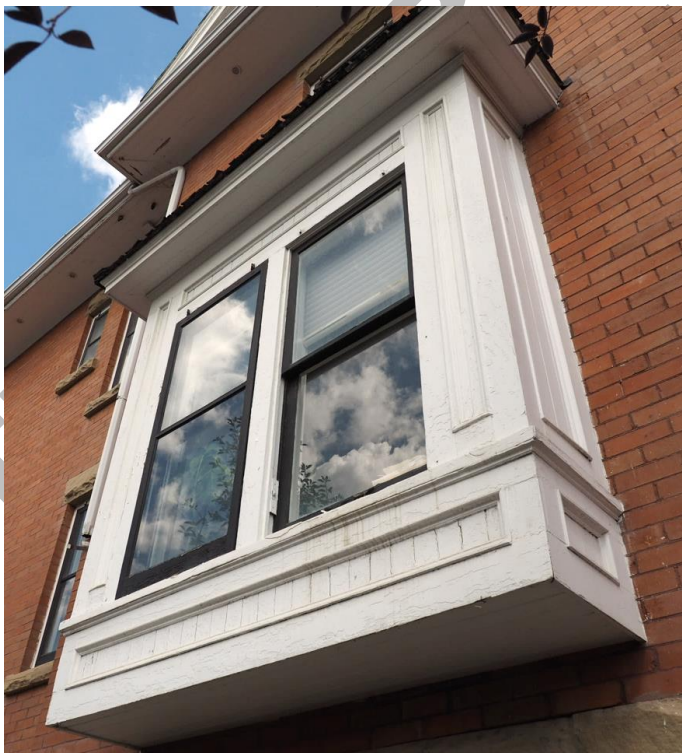
(Image 2.2 – Oblique view of Wood-panelled bay (oriel) window)

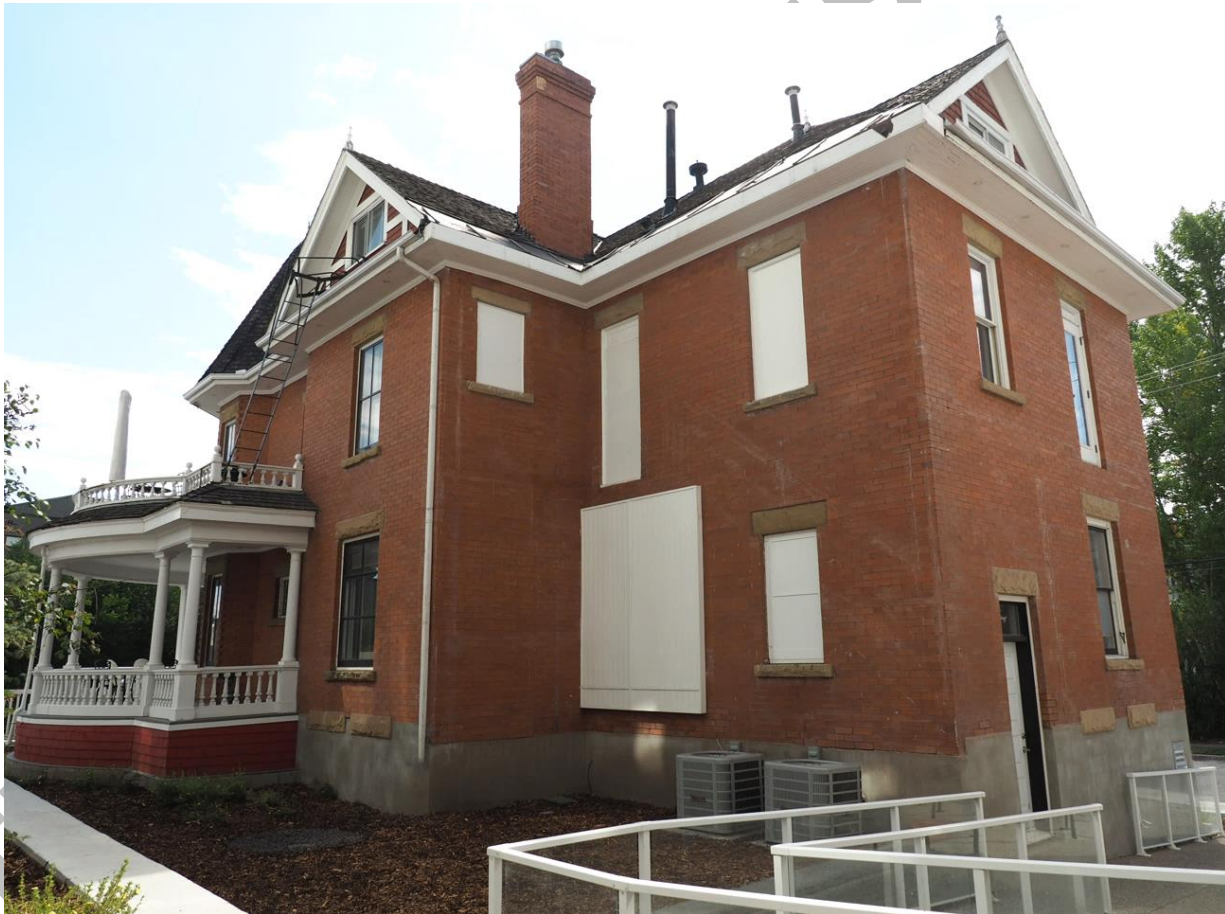
(Image 3.0 – Oblique view of the Nimmons Residence, looking southeast)

- a) The red-brick exterior walls laid in stretcher bond (Images 3.0);
- b) Rock-faced sandstone lintels below main floor, indicating fenestration from original foundation (Image 3.3);
- c) Polygonal turret roof at north-east corner of the building (Image 3.2);
- d) Fenestration, with 1-over-1 wooden sash windows with 4-pane wooden storm sashes; smaller, fixed-sash leaded, stained-glass window with 'jewelled' insets; large wood-sash window with patterned and stained-glass upper sash over a single pane; single sash rock-faced sandstone lintels and sills (Images 3.0-3.4);
- e) The open, wraparound veranda and balcony of wood construction with classical, Tuscan-style columns, single-bellied balusters, tongue-and-groove ceiling, and wood-shingle-clad base (Image 3.2); and
- f) Wood-shingle-clad gable with mock-half timbering detail (Image 3.2).

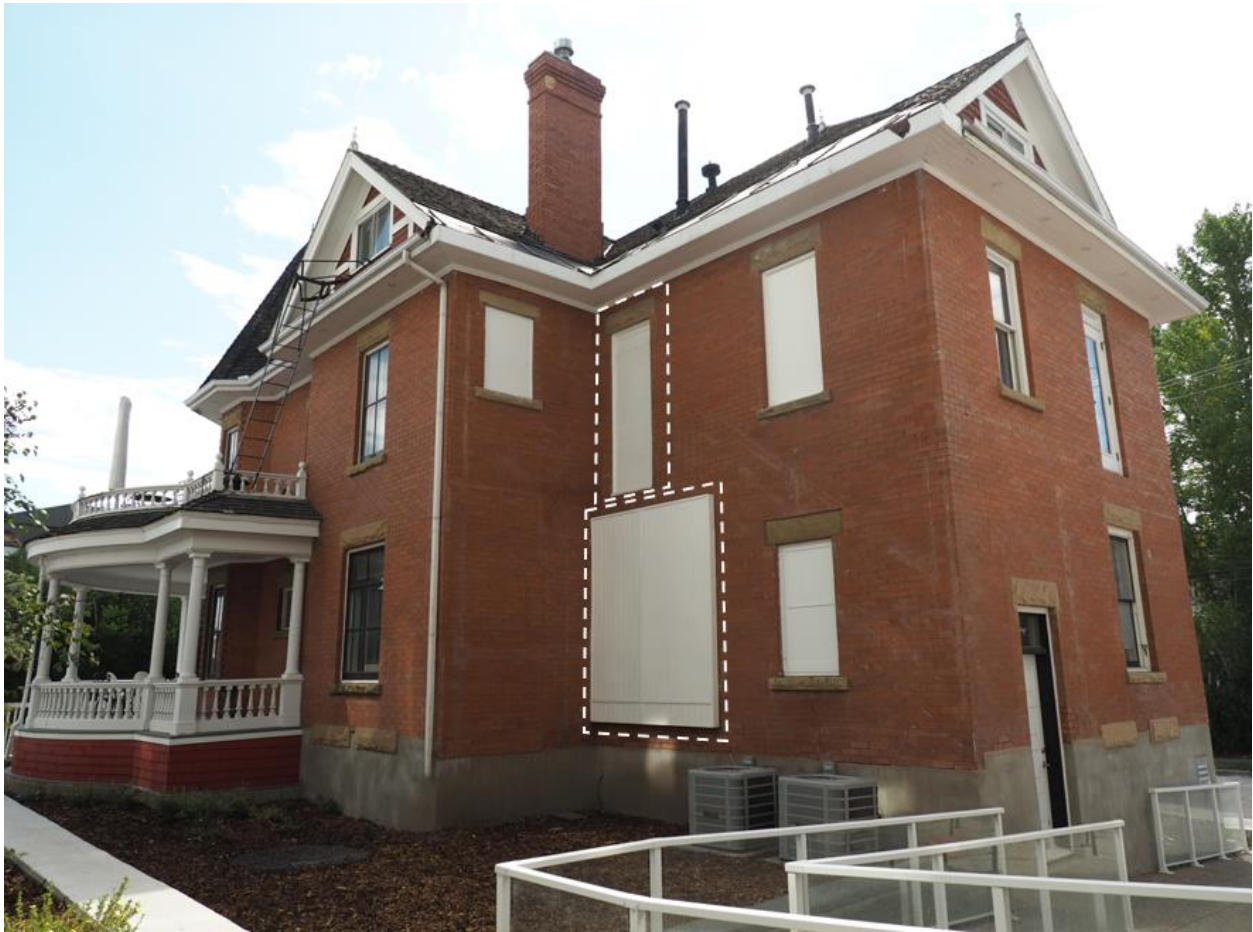
(Image 3.1 – Oblique view of the Nimmons Residence, looking southeast; dotted outlines indicate alterations to north façade from prior contemporary addition; all openings and historic windows, including those painted-over in white are regulated)

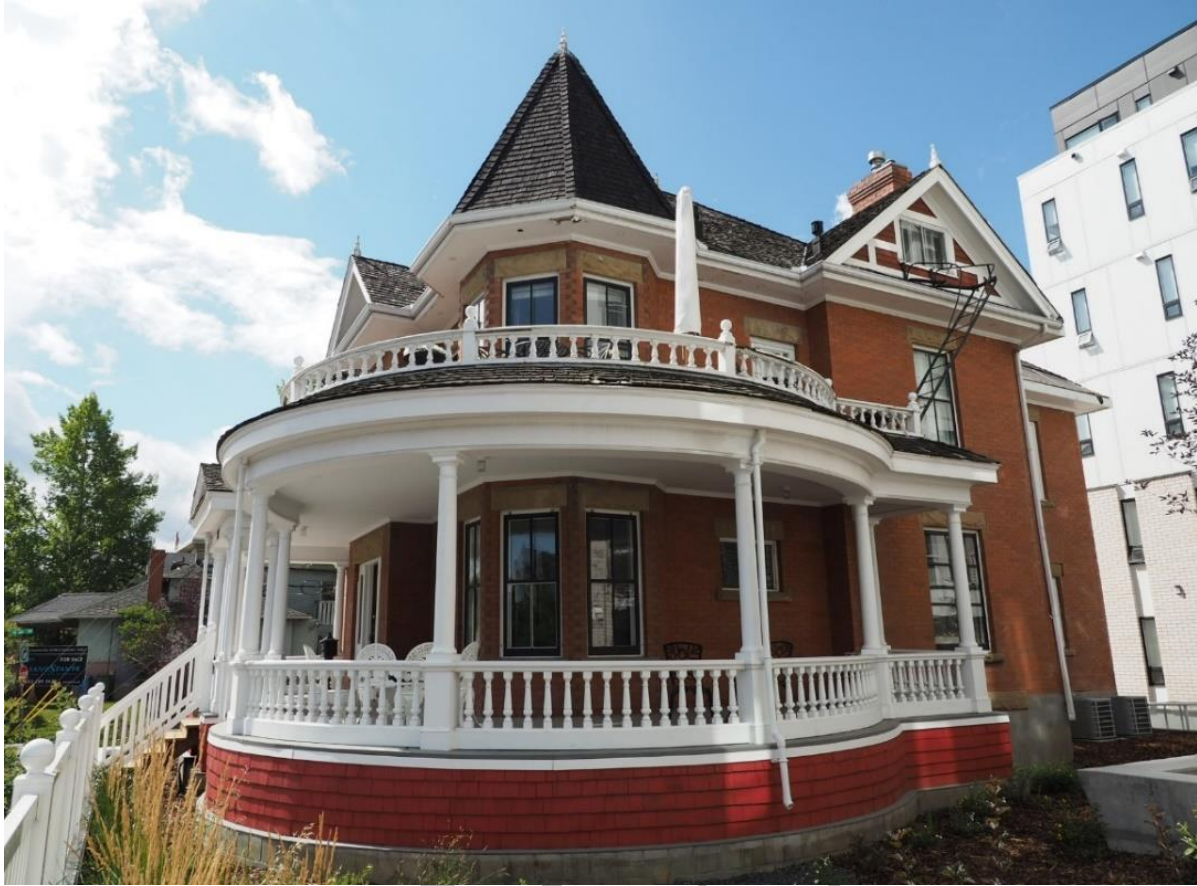
(Image 3.2 – Oblique view of the Nimmons Residence, looking southwest)

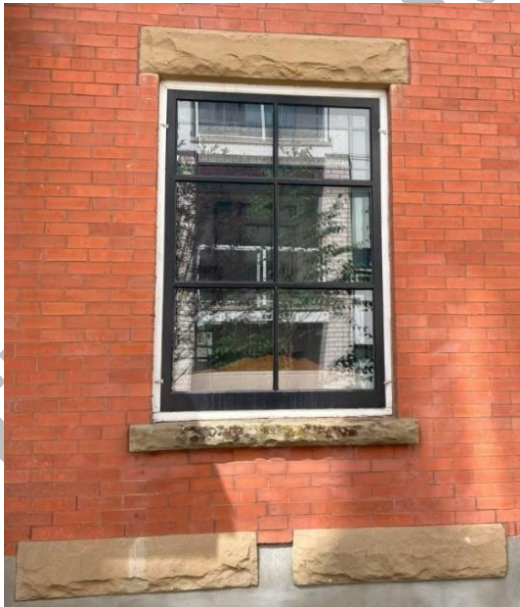
(Image 3.3 – Large north façade window with decoratively patterned upper sash)

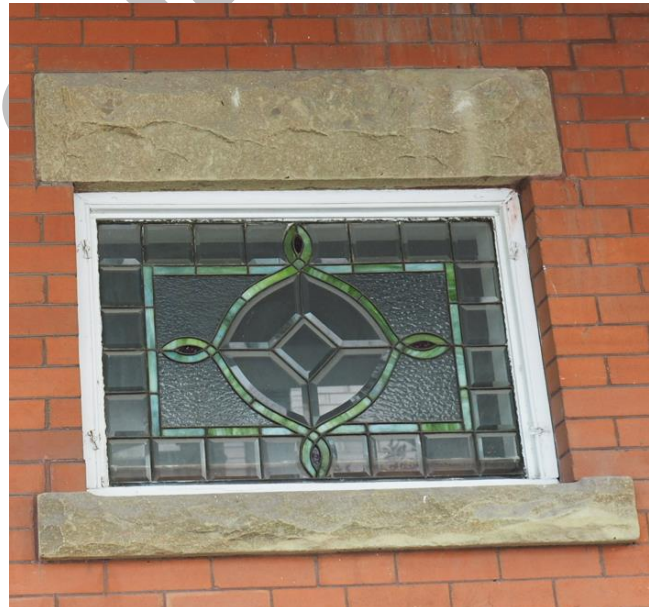
(Image 3.4 – Leaded glass window on north façade)

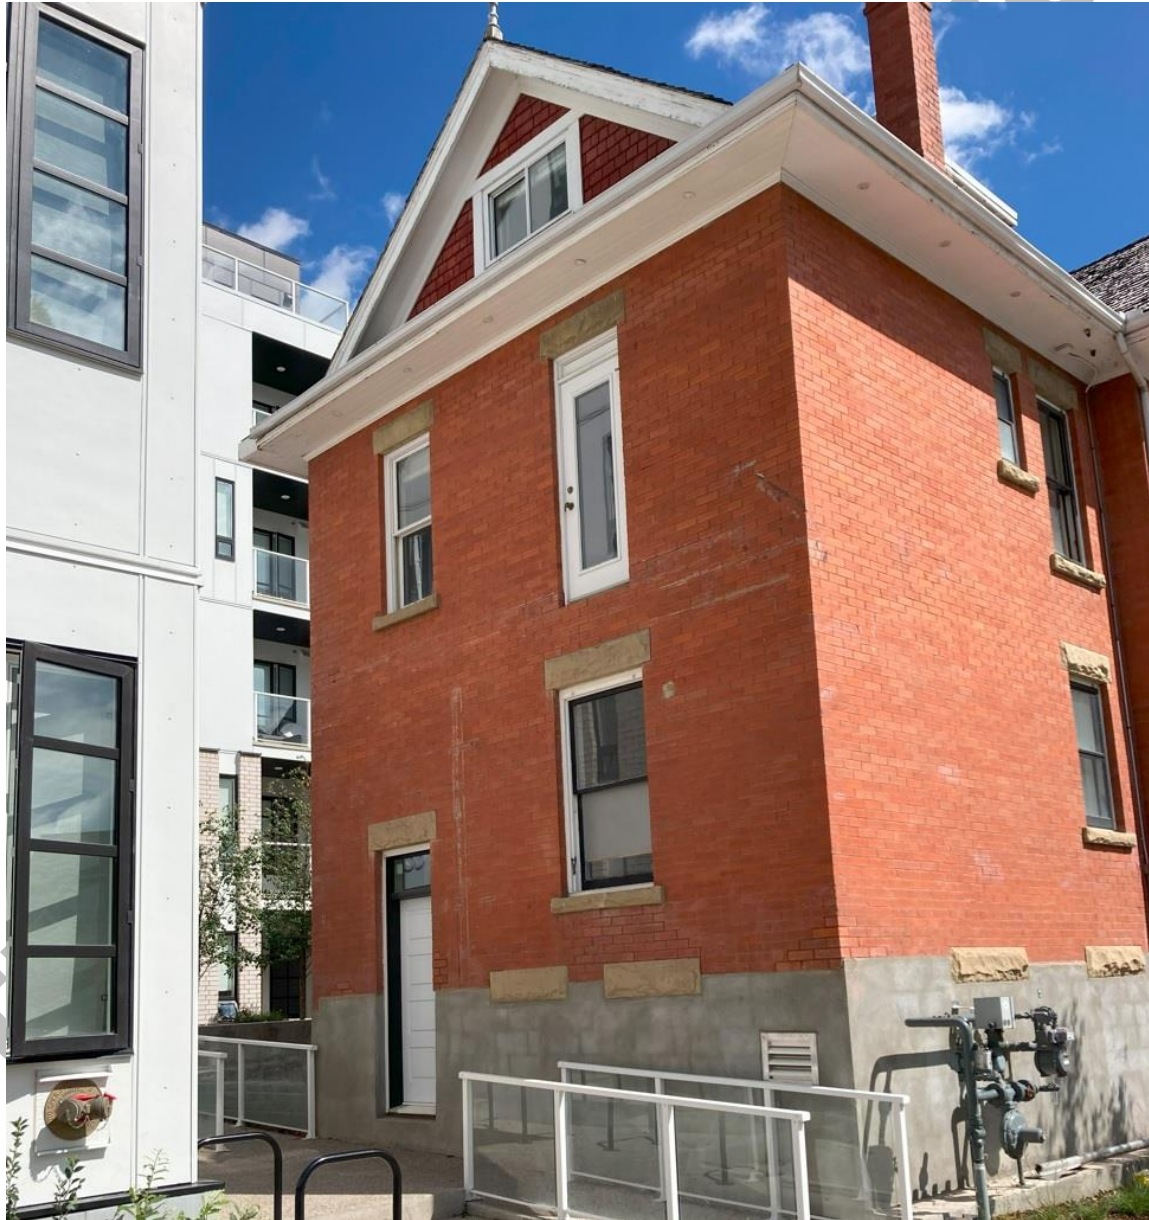
(Image 4.0 – Oblique view of the Nimmons Residence, looking northeast)

- a) The red-brick exterior walls laid in stretcher bond (Image 4.0);
- b) Rock-faced sandstone lintels below main floor, indicating fenestration from original foundation (Image 4.0);
- c) Fenestration, with 1-over-1 wooden sash windows; rock-faced sandstone lintels and sills (Images 4.0, 4.1);
- d) Second-storey doorway with transom and rock-faced sandstone lintel (Image 4.0); and
- e) Wood-shingle-clad gable with mock-half timbering detail (Image 4.0).

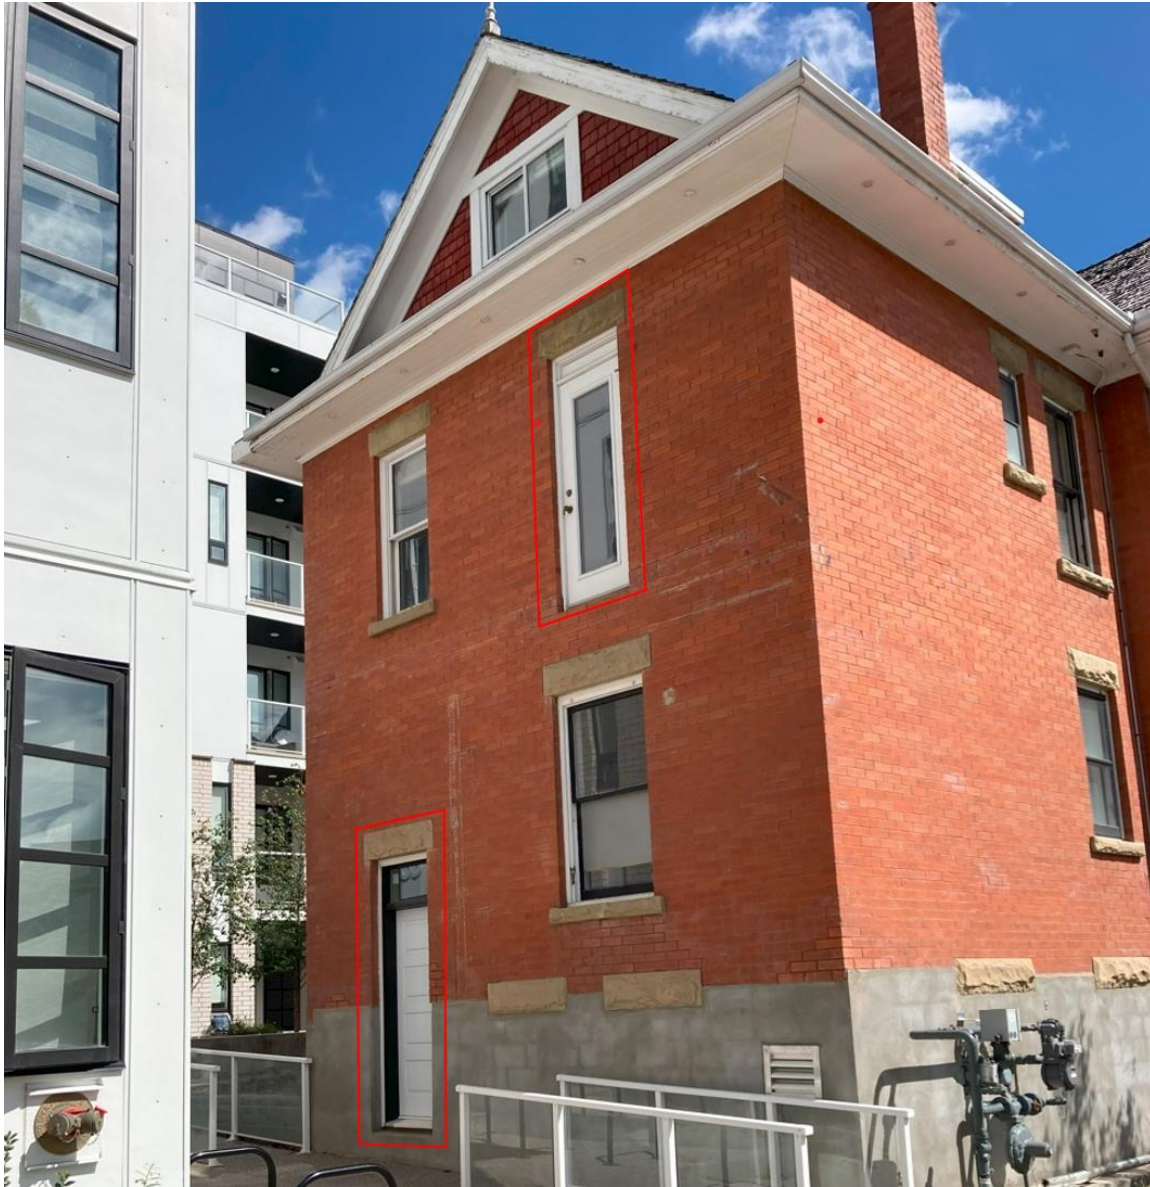
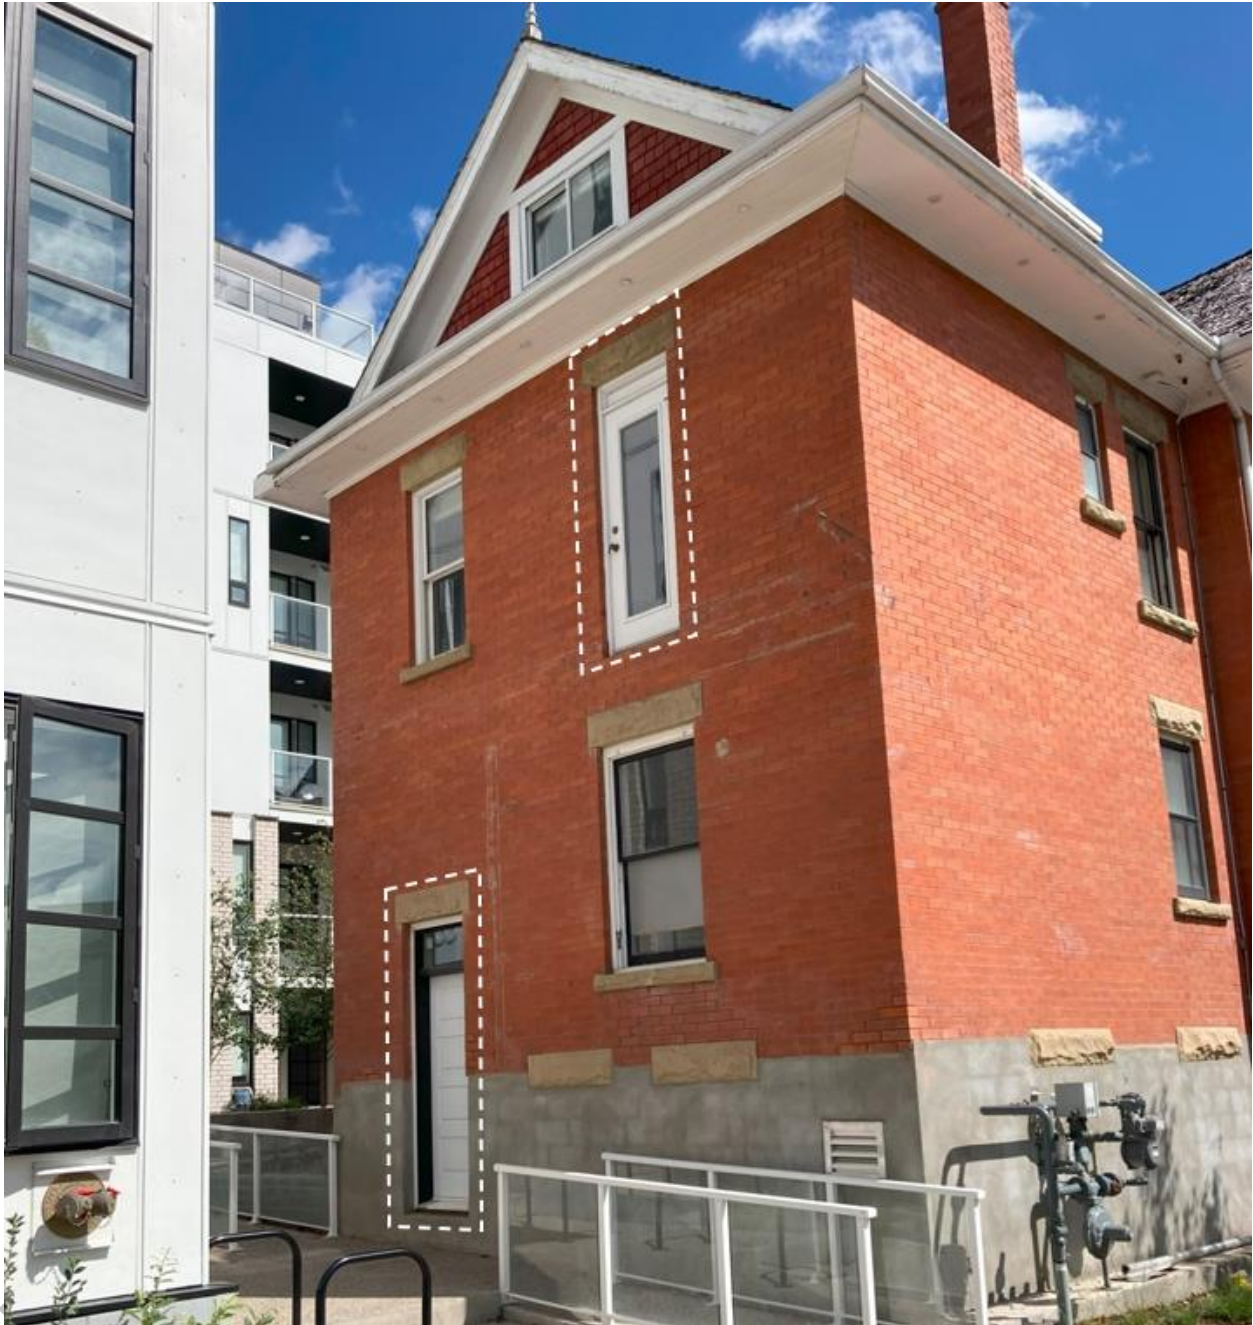
(Image 4.1 – Oblique view of the Nimmons Residence, looking northeast; dotted outlines indicate alterations to west façade from prior contemporary addition)

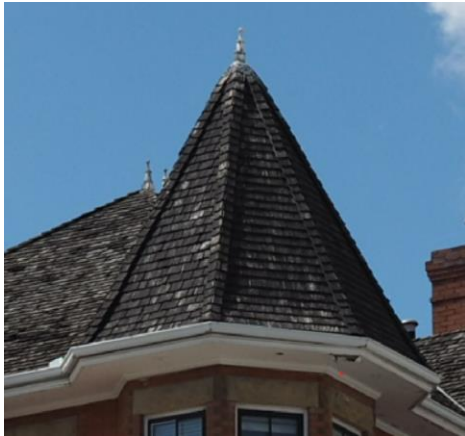
(Image 5.0 – Detail view of turret roof)

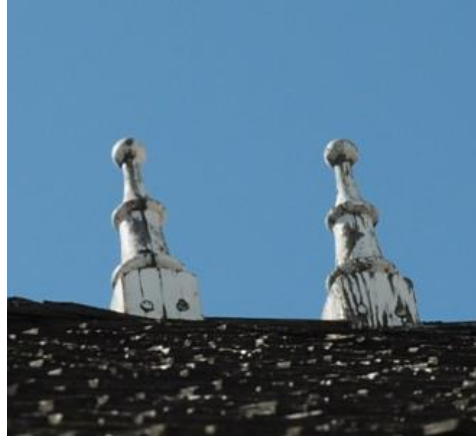
(Image 5.1 – Detail view showing typical finial profile)

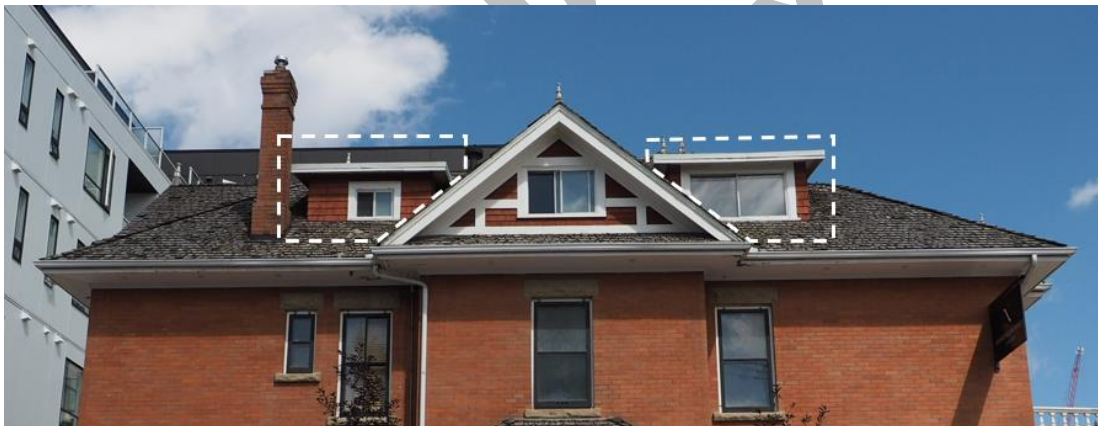
(Image 5.2 – Upper floor & roof detail of south façade; non-regulated shed-roof dormers indicated with dotted outline)

Note – The shed-roof dormers are not original and are non-regulated (Image 5.2).

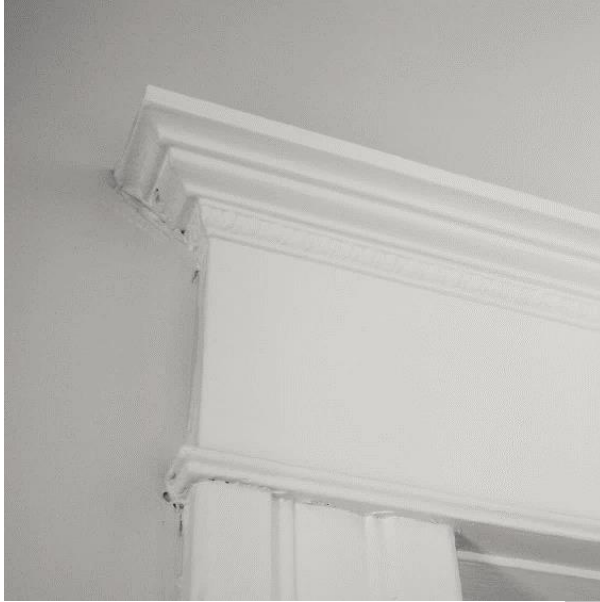
(Image 6.0 – Detail view showing more-ornate window casing entablature)

- a) The original window casings throughout (Images 6.0-6.4); and
- b) Main staircase placement, and balustrade including newel posts (Images 6.5-6.8).

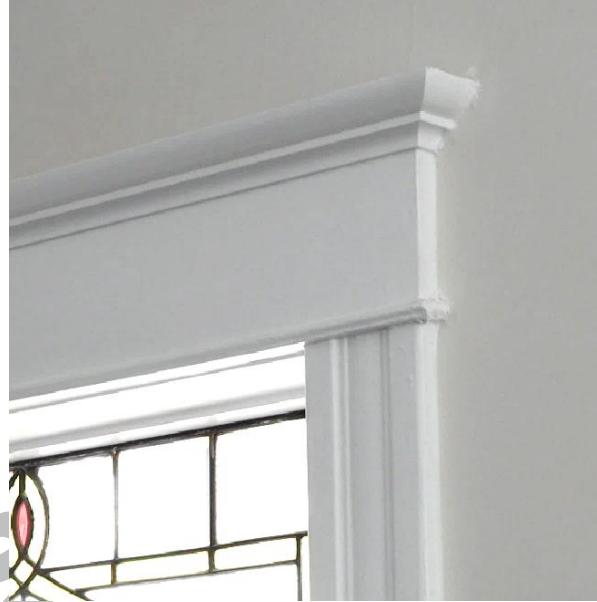
(Image 6.1 – Detail view showing less-ornate example of window casing entablature)

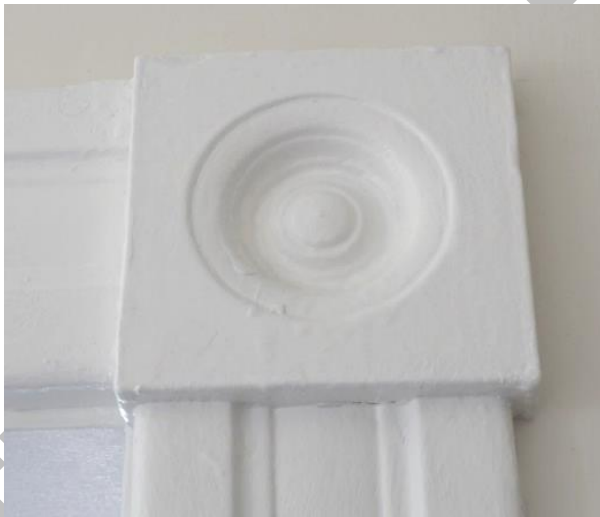
(Image 6.2 – Detail view showing example of doorway casing)
