Proposed Wording for a Bylaw to Designate the Nimmons Residence as a Municipal Historic Resource

1. This Bylaw may be cited as “City of Calgary Bylaw to Designate the Nimmons Residence as a Municipal Historic Resource”.

2. The building known as the Nimmons Residence, located at 1420 19 AV SW, and the land on which the building is located being legally described as Plan 1610440; Block 1; Lot 23 as shown in the attached Schedule “A” (the “Historic Resource”), are hereby designated as a Municipal Historic Resource.
3. The specific elements of the Historic Resource possessing heritage value are hereafter referred to as the Regulated Portions (the “Regulated Portions”). The Regulated Portions are identified in the attached Schedule “B”.

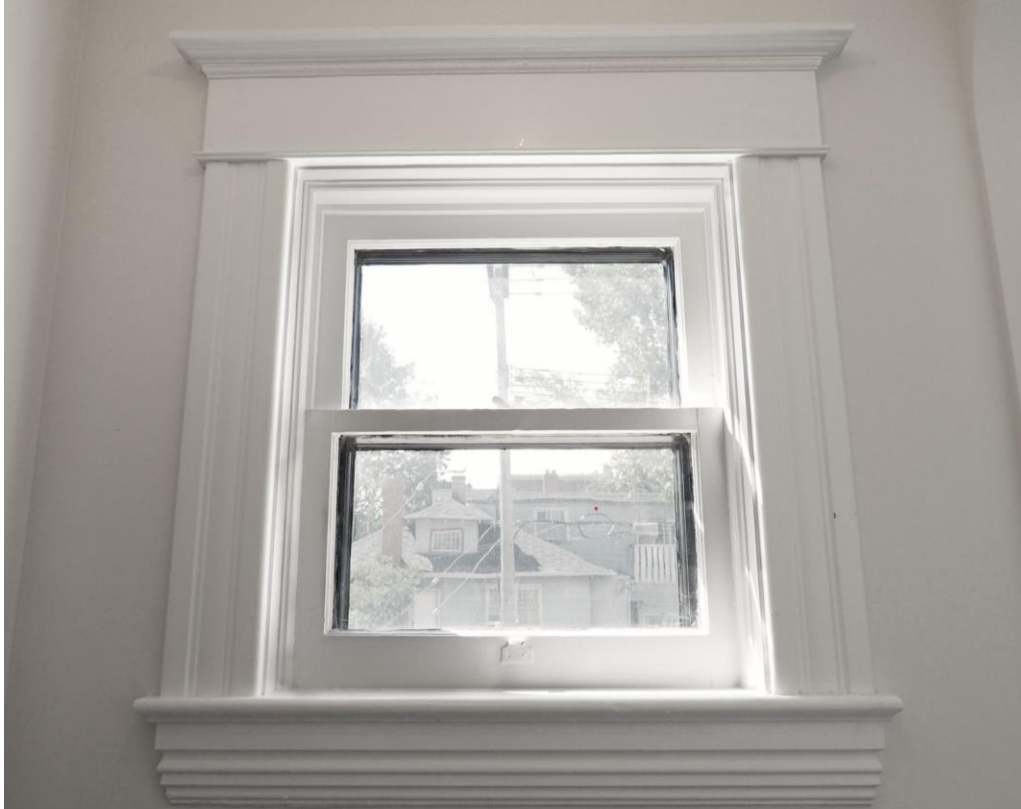
(Image 6.3 – Detail view showing more-ornate example of complete window casing)

- a) The original window casings throughout (Images 6.0-6.4); and
- b) Main staircase placement, and balustrade including newel posts (Images 6.5-6.8).

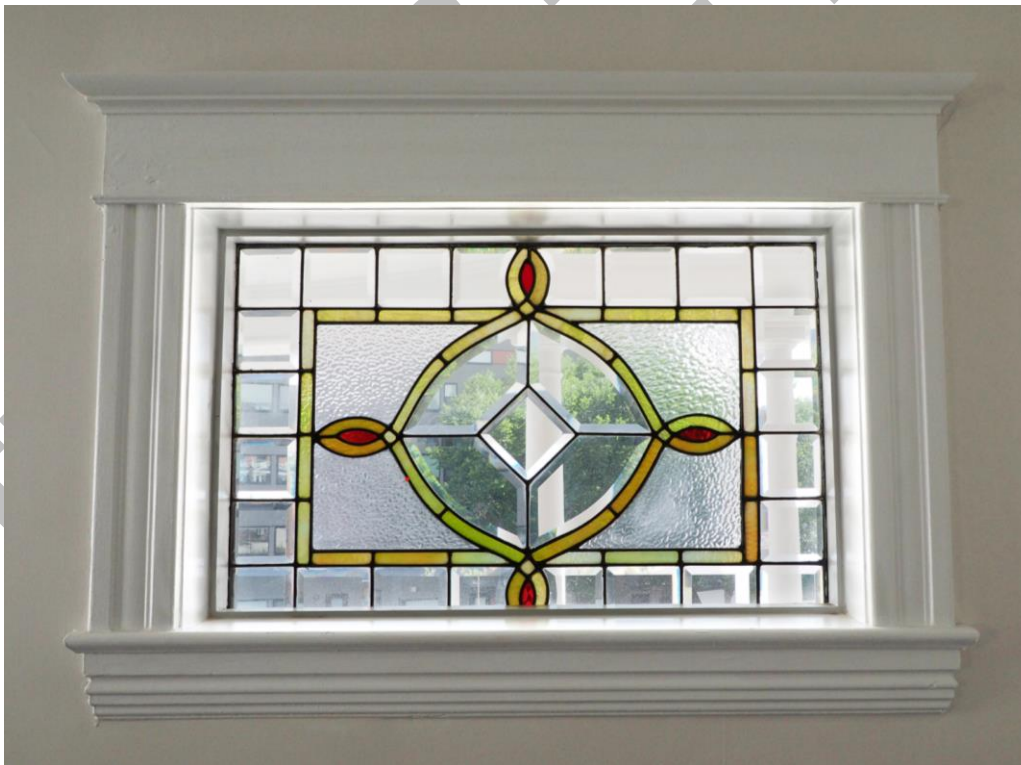
(Image 6.4 – Detail view showing less-ornate example of complete window casing)

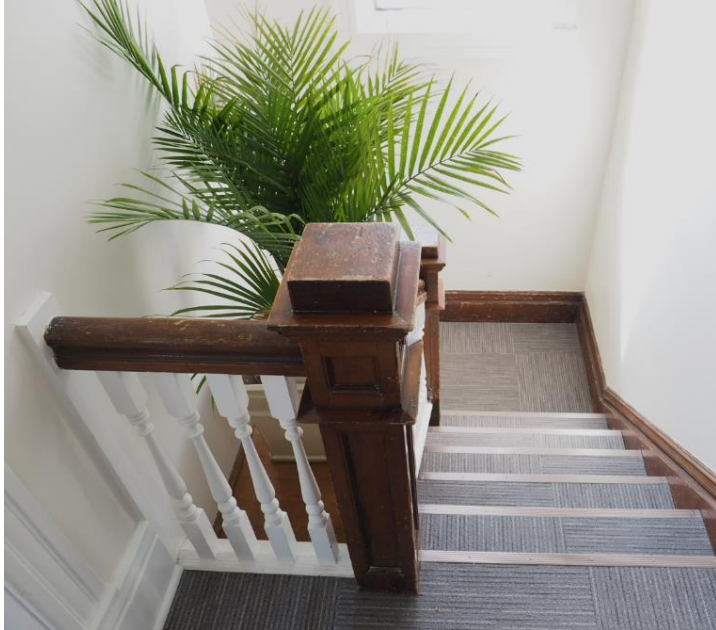
(Image 6.5 – Main staircase, looking from top of stairs, showing second-storey newel post)

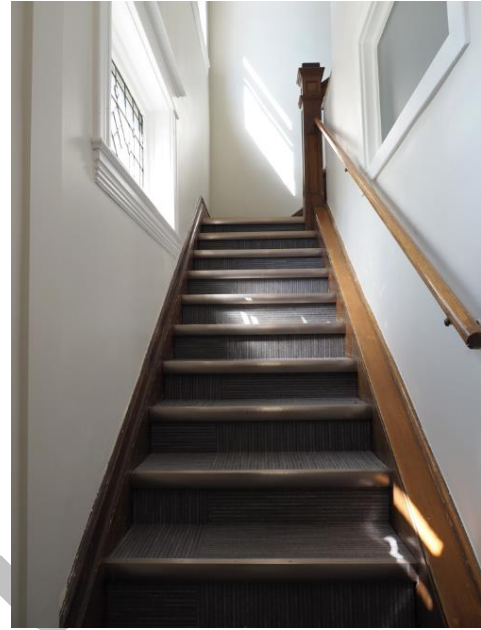
(Image 6.6 – Main staircase from bottom of stairs, showing newel post at landing between first and second storeys; plain rounded handrail is non-regulated)

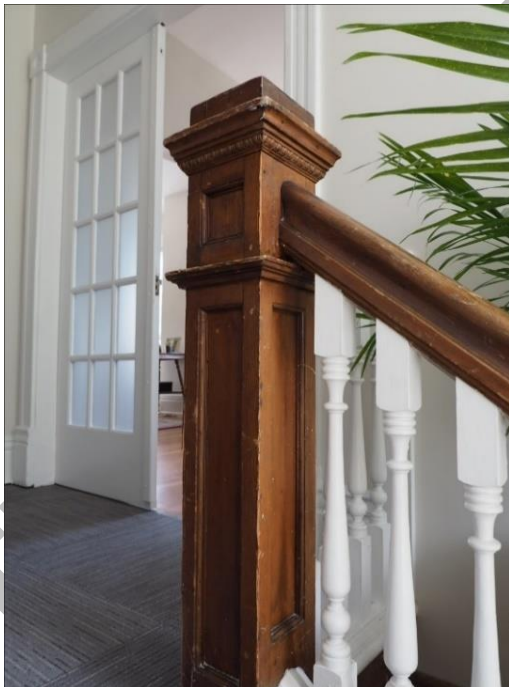
(Image 6.7 – Detail of second-storey newel post showing baluster and handrail profile)

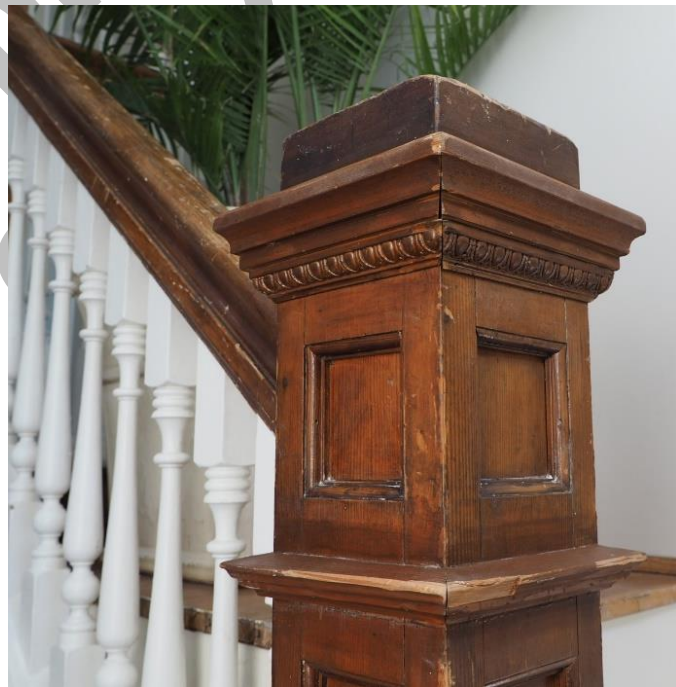
(Image 6.8 – Detail showing newel post at landing between first and second storeys)
