## Proposed Wording for a Bylaw to Designate the Cross Residence as a Municipal Historic Resource

1. This Bylaw may be cited as “City of Calgary Bylaw to Designate the Cross Residence as a Municipal Historic Resource”.

2. The building known as the Cross Residence, located at 1240 8 AVE SE, and the land on which the building is located being legally described as PLAN A3 BLOCK 3 LOTS 28 TO 34 INCLUSIVE, as shown in the attached Schedule “A”, are hereby designated as a Municipal Historic Resource.
3. The specific elements of the Historic Resource possessing heritage value are hereafter referred to as the Regulated Portions (the “Regulated Portions”). The Regulated Portions are identified in the attached Schedule “B”.

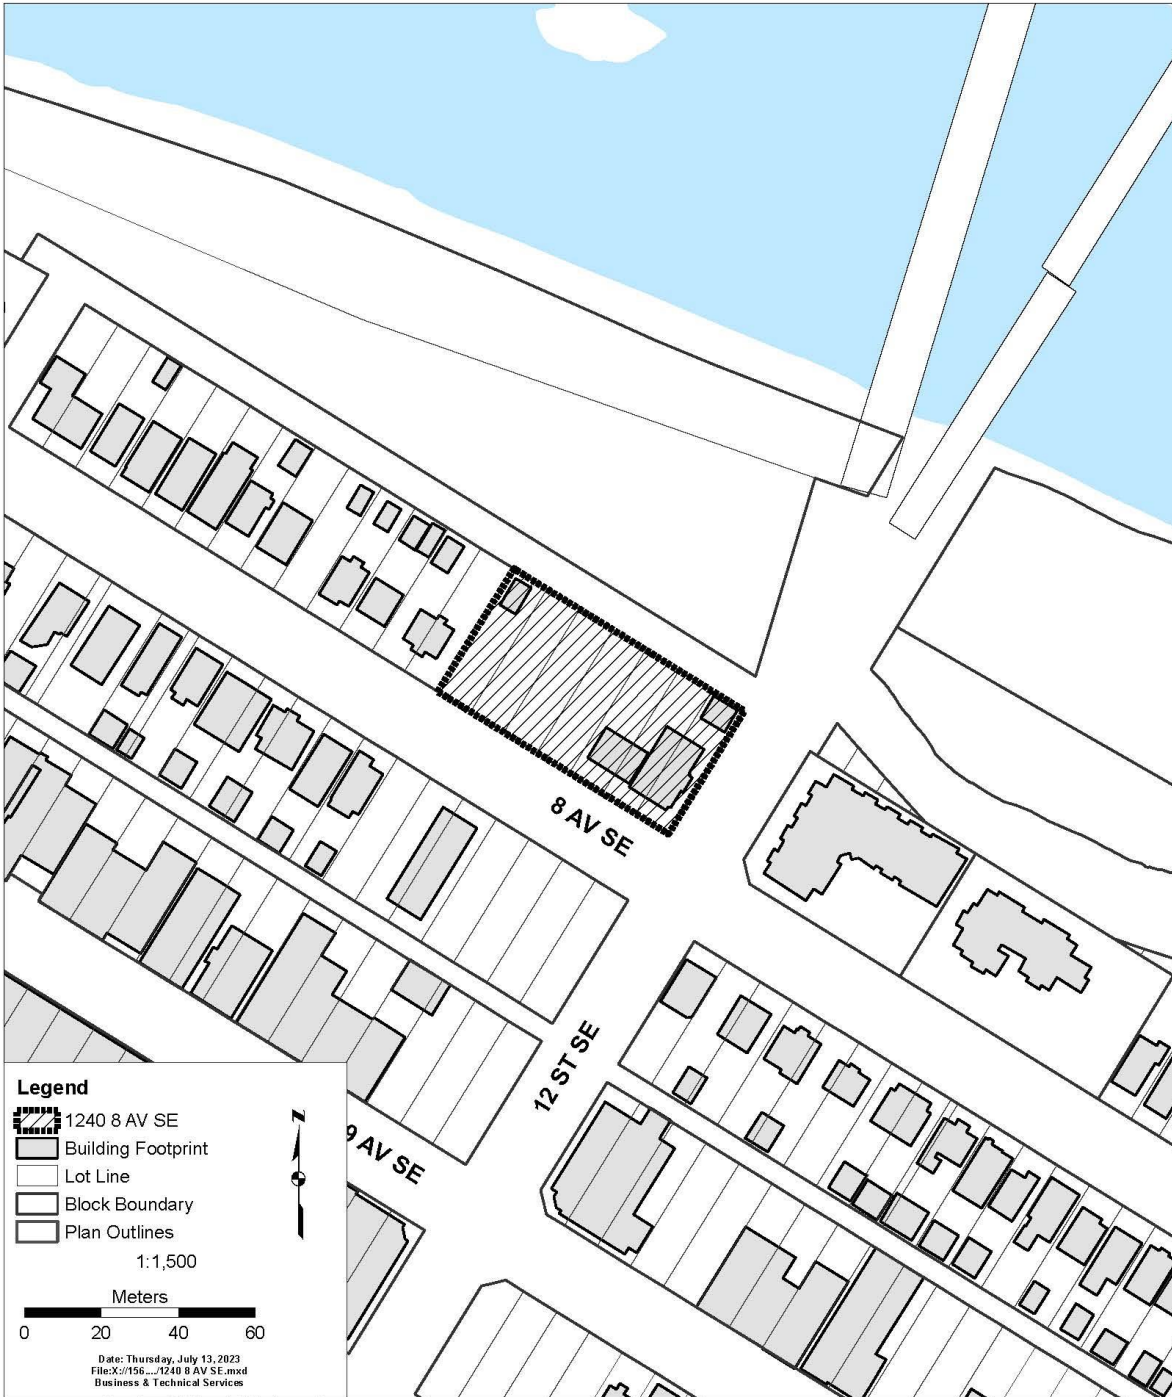
SCHEDULE "A"

1240 8 AV SE

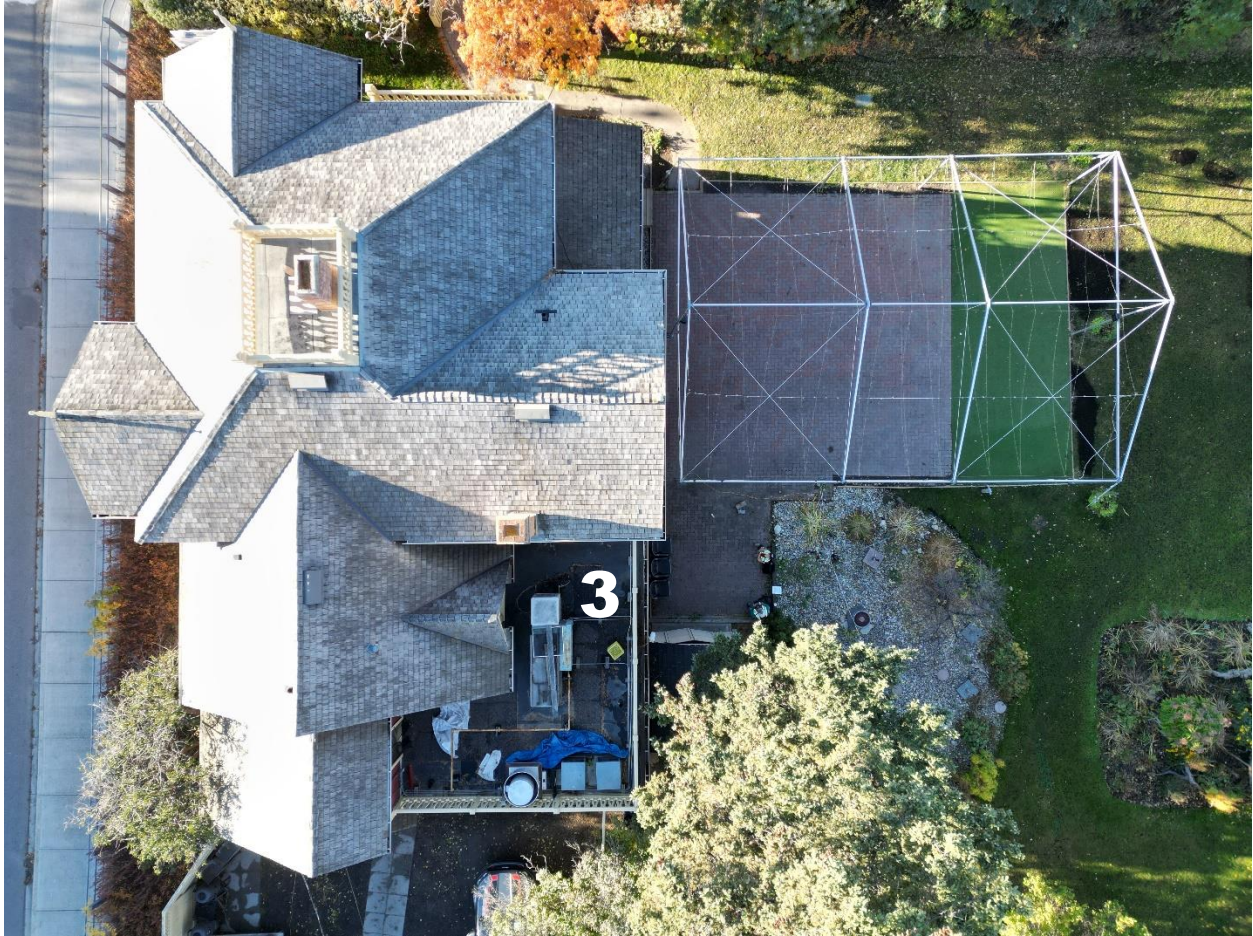
(Image 2.1: Plan view of the Cross Residence. The area denoted in dotted lines is Building Section 3, and is not regulated)

- a) Two-storey massing and asymmetrical rectangular form defined by:
  - **Building Section 1:** projecting two-storey bays on south and east facades, projecting two-storey addition on west façade, south-facing enclosed verandah including second-level balcony, and west-facing sunroom (Images 1.1 & 2.1); and

- **Building Section 2:** two-storey north addition (Images 1.1 & 2.1);
- b) Roofs:
  - Building Section 1 – original building roofs:**
    - Hipped roof with overhanging eaves with profiled wooden frieze, plain wooden fascia, tongue-and-groove wooden soffits (Images 2.1 & 2.2);

Note: The flat roof over the enclosed verandah, together with low-profile balustrade, forms the second-level balcony. The balustrade on the balcony, while sympathetically replaced, is not regulated and a return to original configuration/appearance would not be precluded where documentation of original configuration exists. Building Section 3, as denoted in Images 1.1 and 2.1, is not regulated.

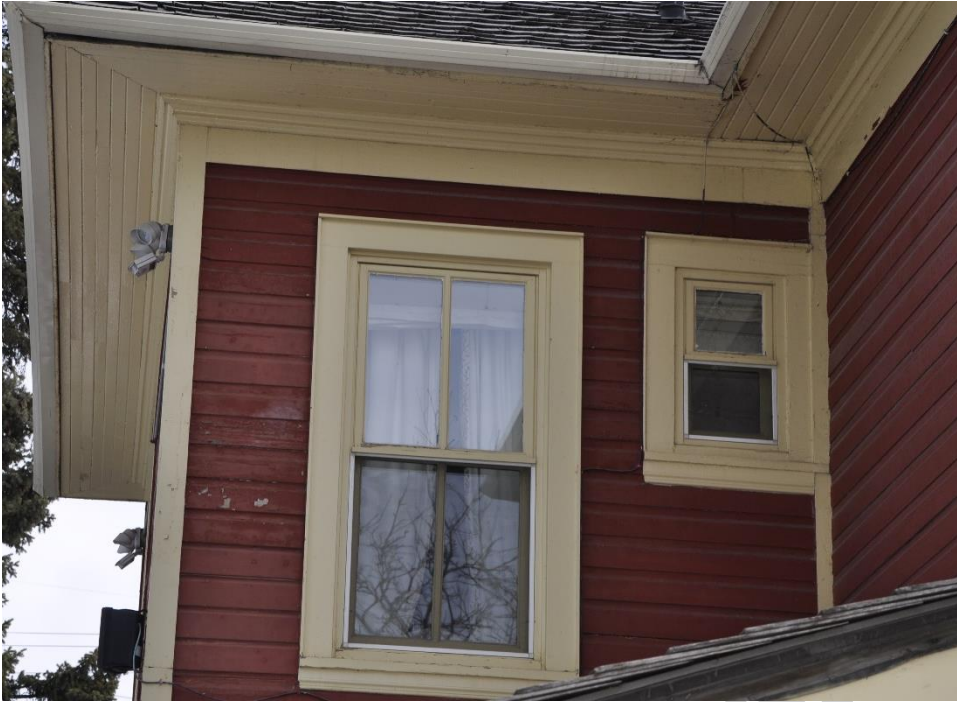
(Image 2.2: Example of overhanging eaves with profiled wooden frieze, plain wooden fascia, tongue-and-groove wooden soffits)

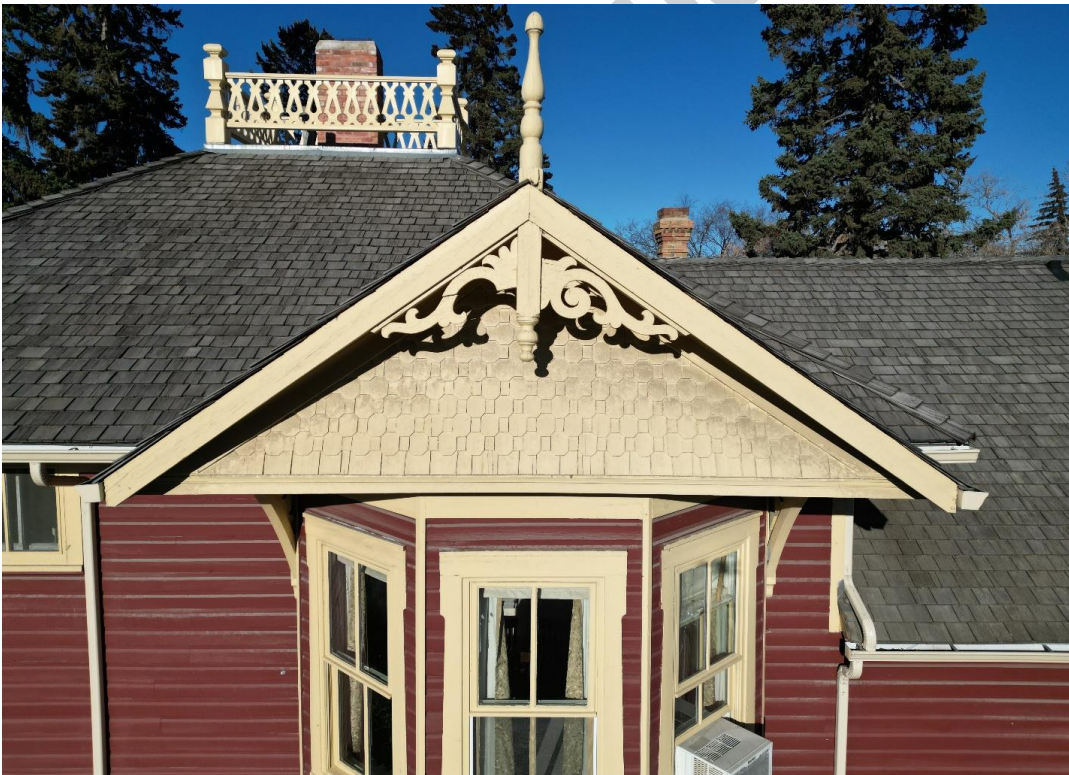
(Image 2.3: Example of one of two projecting two-storey bays with angled gable pediment, clad in wooden octagonal and square shingles, projecting verge with profiled wooden frieze, tongue-and-groove wooden soffits, plain wooden bargeboard, decorative scrollwork and finial, and supported by wooden brackets with decorative panel inlay)

- Pedimented gables over south and east-facing projecting two-storey bays and west-facing two-storey addition:
      - o South and east-facing gables: angled pedimented gables clad in alternating wooden octagonal and square shingles, projecting verges with profiled wooden friezes, tongue-and-groove wooden soffits, plain wooden bargeboards, decorative scrollwork and finials supported by wooden brackets with decorative panel inlay (Images 2.3 & 2.4);

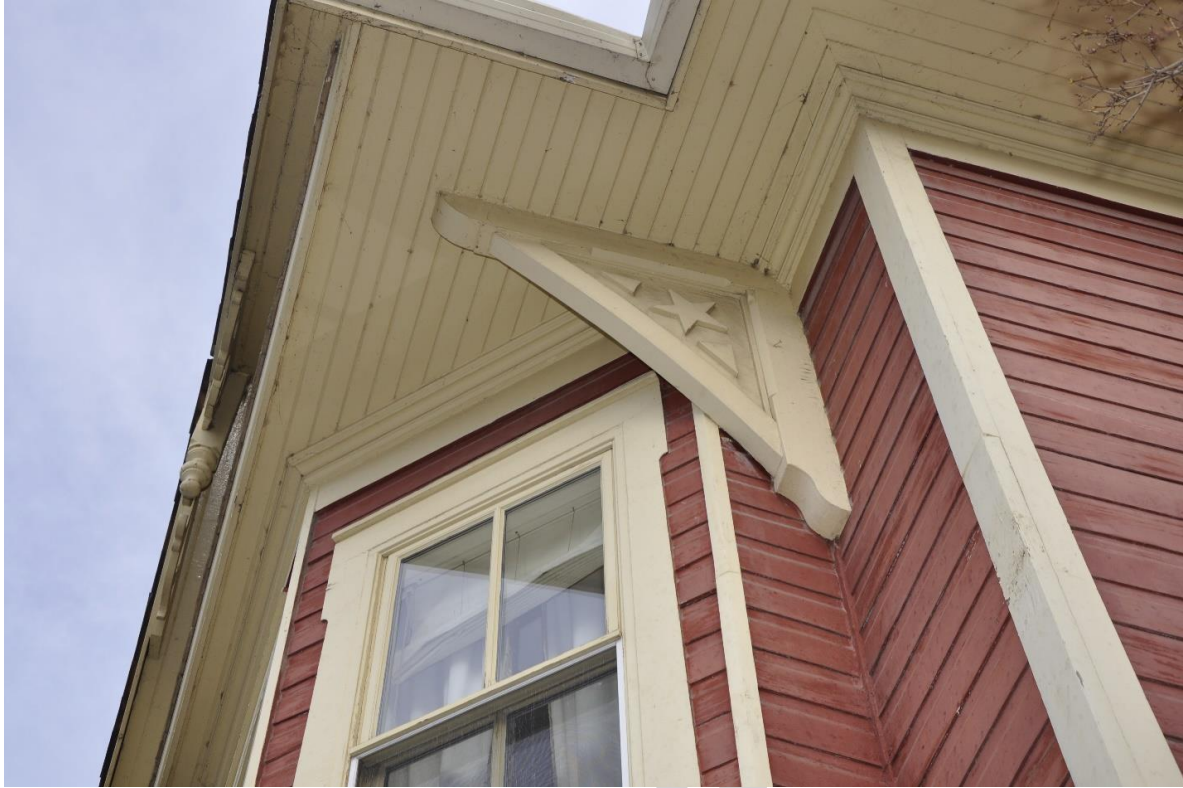
(Image 2.4: Example of wooden bracket with decorative inlay)

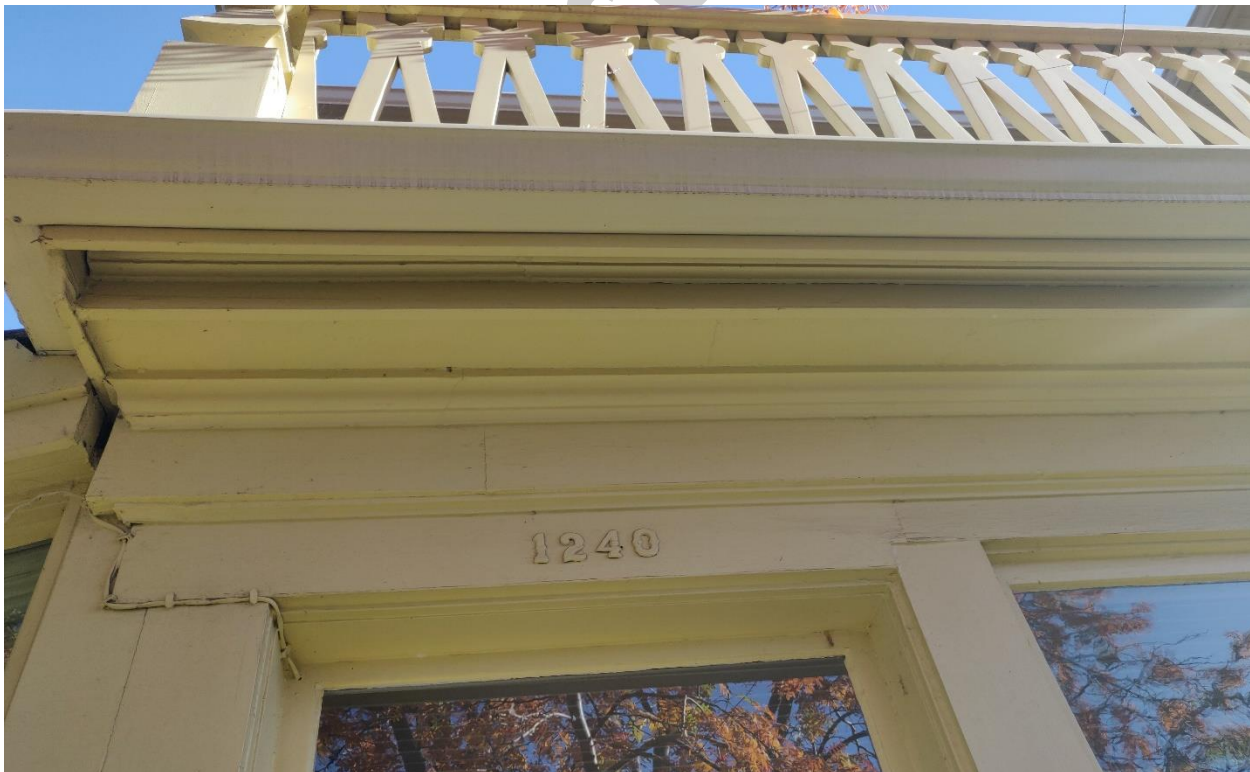
(Image 2.5: South-facing enclosed verandah: eaves, built-up wooden soffit, profiled wooden frieze and plain wooden fascia)

- Shed roof over west-facing sunroom addition, narrow eaves (Images 3.4, 4.1 & 4.2);
    - Flat roof over south-facing enclosed verandah, eaves, built-up wooden soffits, profiled wooden frieze and plain wooden fascia (Images 2.5 & 3.4);

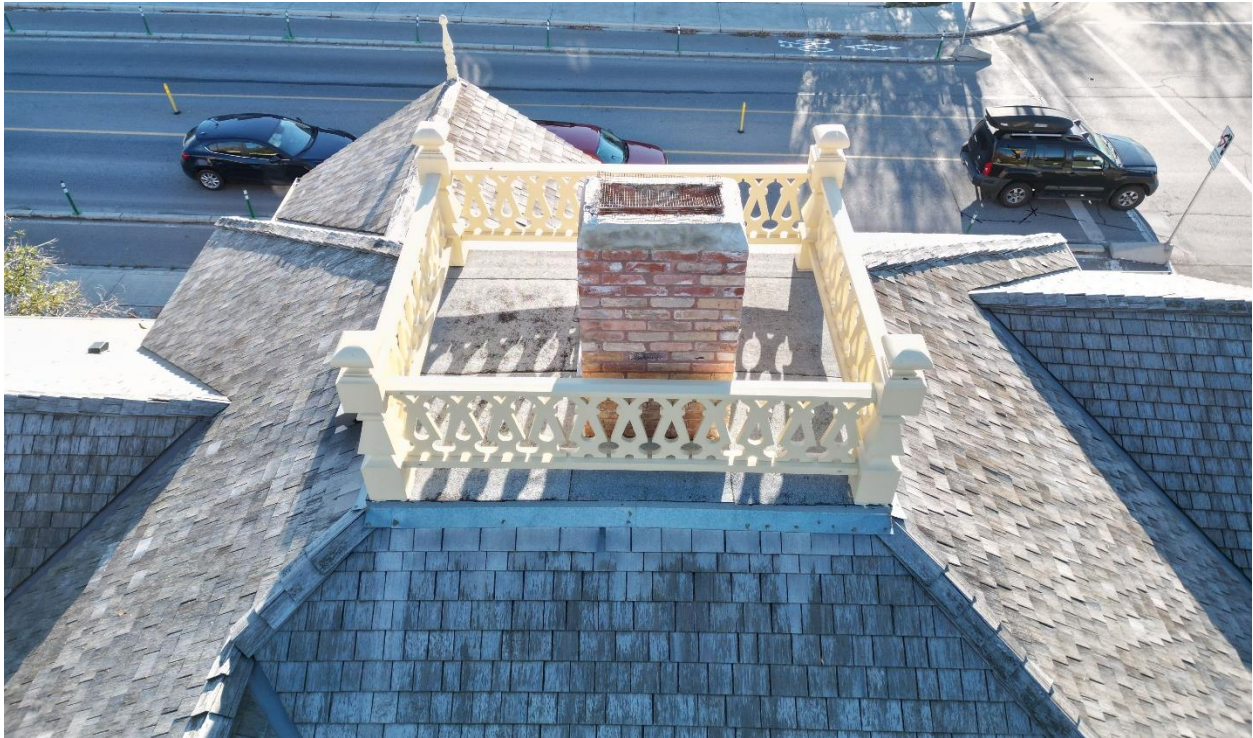
(Image 2.6: Widow's walk with secondary brick chimney)

- Widow's walk with stylized wooden lyre balustrade (Image 2.6);
  - Building Section 2:**
    - West-facing gabled dormer: clad in wooden siding, projecting verge with profiled wooden frieze, tongue-and-groove wooden soffits, plain wooden bargeboard, finial (Images 2.7 & 2.8);

- North-facing gable roof and profile (Image 2.9); and
- c) Original red brick chimney with heavily corbelled top and secondary chimney atop widow's walk (Images 2.6 & 2.8).

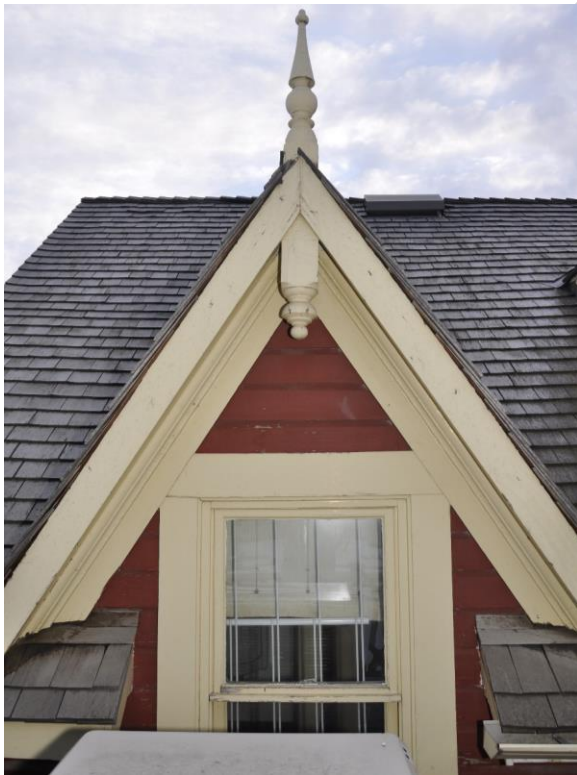
(Image 2.7: West-facing gabled dormer clad in wooden siding, projecting verges with profiled wooden frieze, tongue-and-groove wooden soffits, plain wooden bargeboard, finial)

- Gabled dormer: 1-over-1 hung sash window, wooden casing and sills (Images 2.7, 2.8 & 4.2)

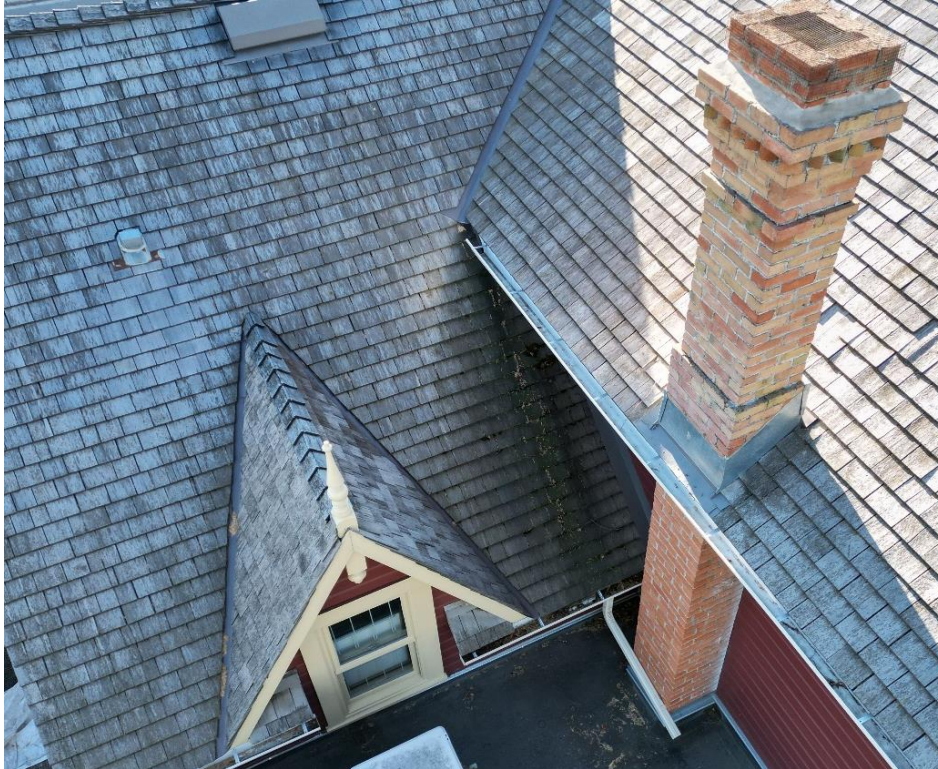
(Image 2.8: Original red brick chimney with heavily corbelled top. West-facing gable dormer with single-hung sash window can also be seen in this photo)

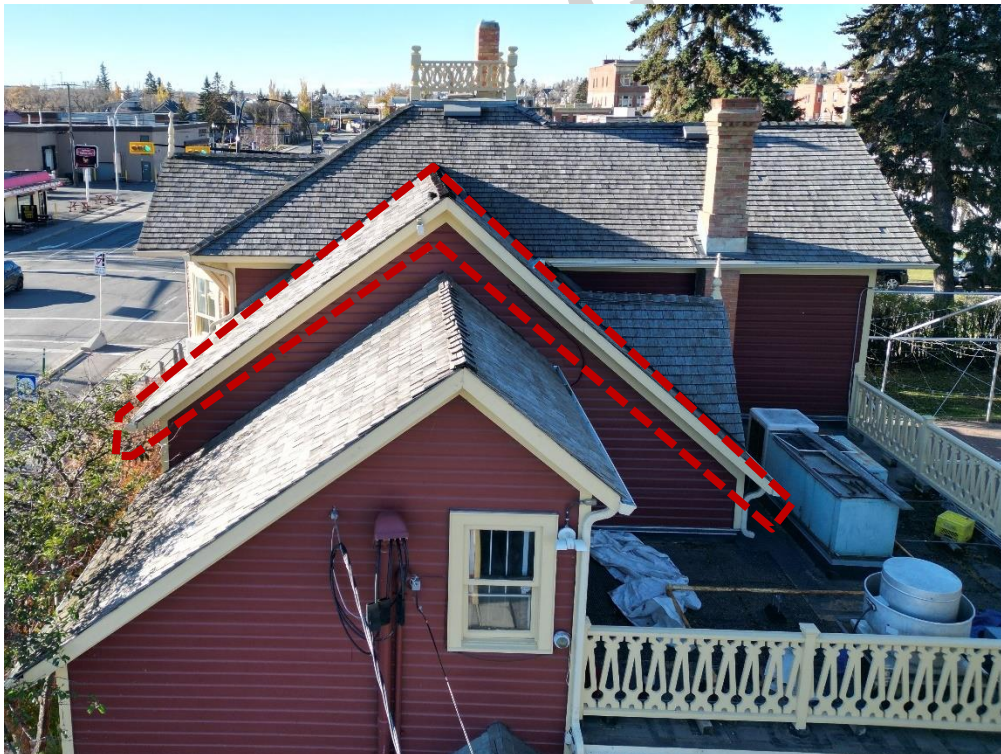
(Image 2.9: North-facing gable roof and profile, outlined in dotted lines)

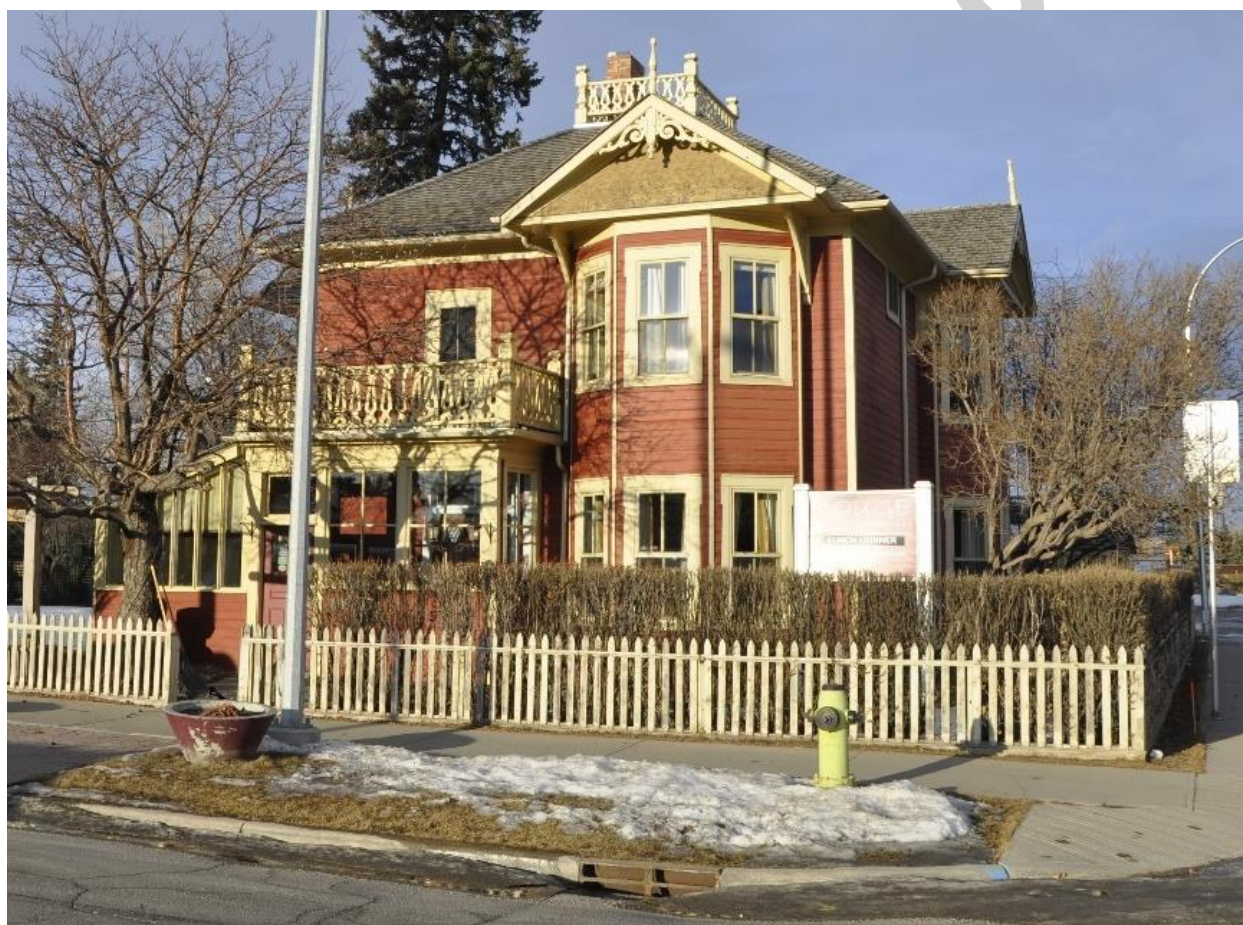
(Image 3.1: South façade showing pedimented gable over projecting two-storey bay, enclosed verandah, balcony and widow's walk)

- a) Wood drop siding cladding, wooden corner boards (Images 3.1 & 3.2); and
- b) Fenestration:
  - Projecting two-storey bay: original south, east and west-facing 2-over-2 hung sash windows, wood casing with eared corners at the top of window frames (Images 3.1 – 3.2);
  - Second-level balcony: door opening and wood casing (Image 3.3);
  - Verandah Exterior: south and east-facing 4-light double-assembly wooden window sashes evenly segmented by wooden mullions, heads and sills; transom window and door opening including wood casings (Image 3.4);
  - Verandah Interior: profiled wooden double-doors inlaid with diamond-patterned glass surmounted with two-pane transom, wood casing with eared corners, and west-facing 1-over-1 wooden hung sash, wooden casing and sill (Images 3.5 & 3.6).

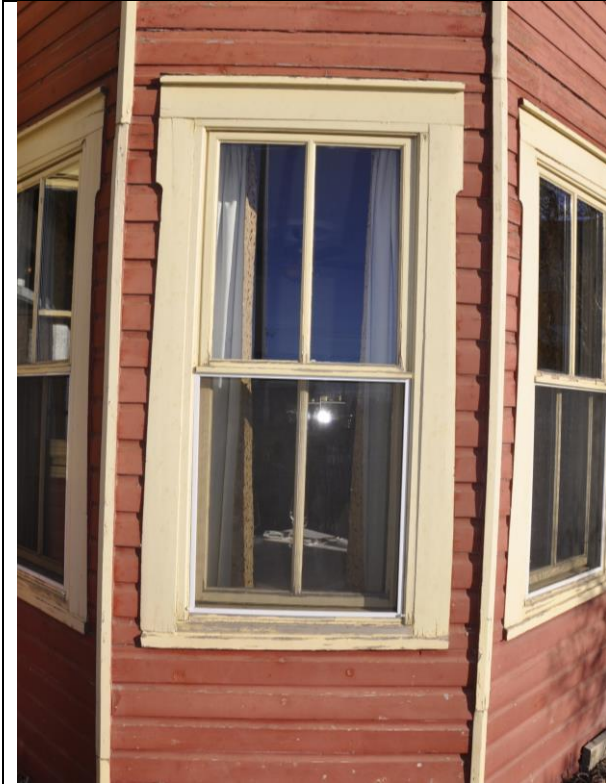
(Image 3.2: Projecting Bay – original 2-over-2 hung sash windows, wood casing with eared corners at the top of window frames; wood drop siding cladding, wooden corner boards)

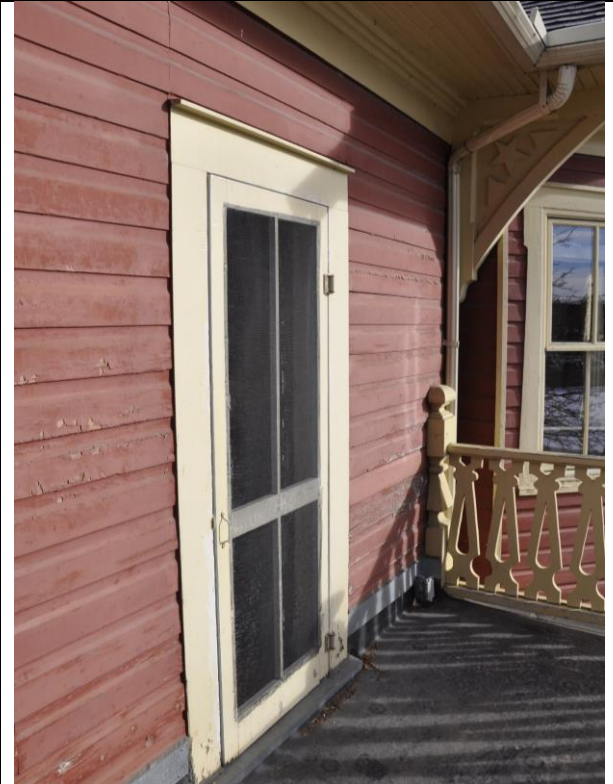
(Image 3.3: Second-level balcony: door opening and wood casing)

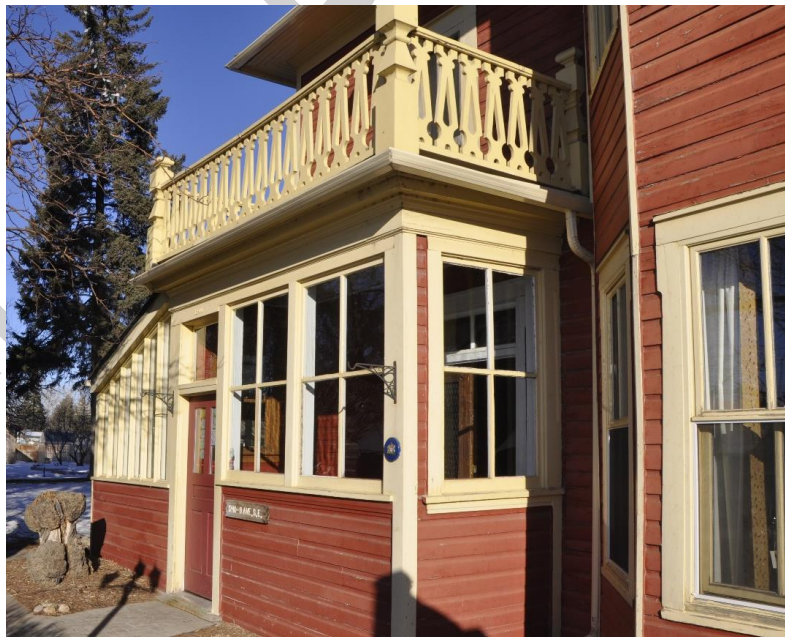
(Image 3.4: Oblique view of enclosed verandah, balcony and sunroom. Verandah exterior: East and south-facing 4-light double-assembly wooden window sashes evenly segmented by wooden mullions, heads and sills; transom window and door opening including wood casings)

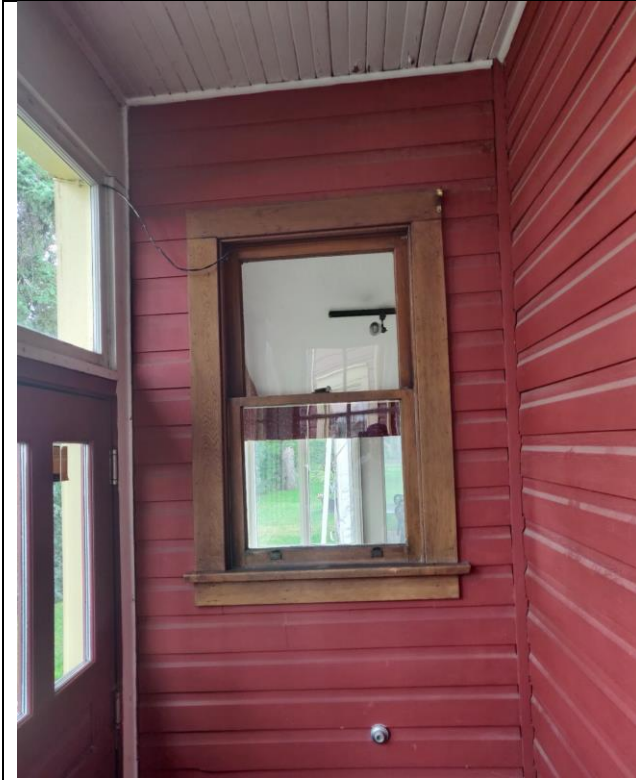
(Image 3.5: West-facing 1-over-1 wooden hung sash, wooden casing and sill inside enclosed verandah)

a) Verandah interior: tongue-and-groove wood ceiling; original wood drop siding cladding; wood-drop siding walls, wooden corner board (Images 3.5 & 3.6); and

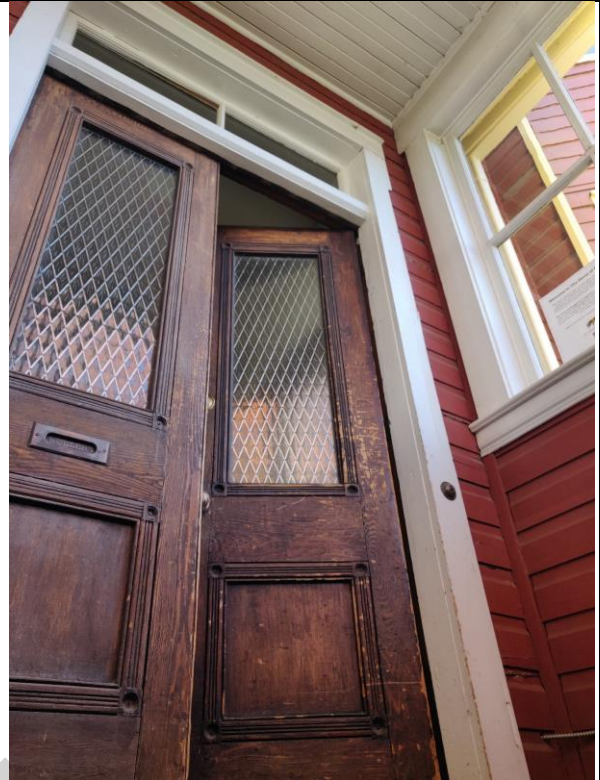
(Image 3.6: Profiled wooden double-doors inlaid with diamond-patterned glass surmounted with two-pane transom, wood casing with eared corners)

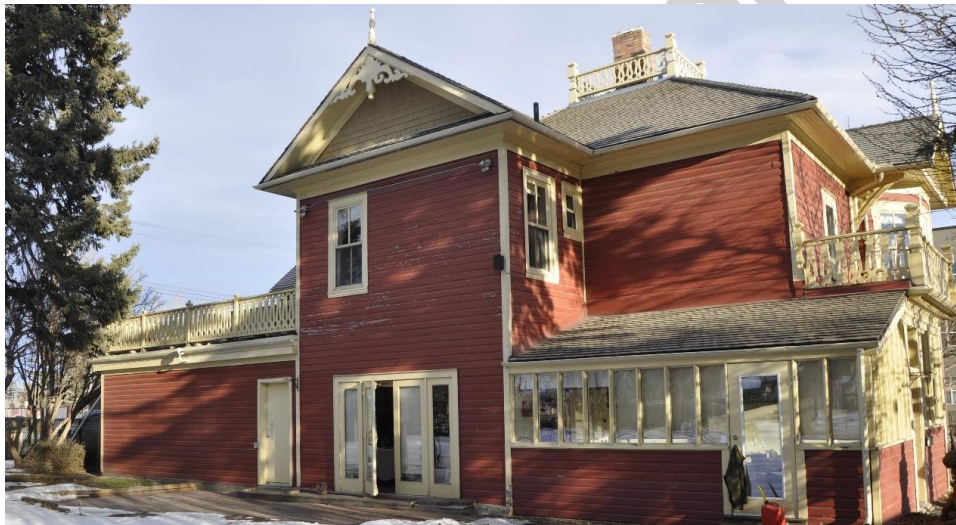
(Image 4.1: Building Section 1 – West façade showing sunroom addition with narrow eaves and projecting two-storey addition with pedimented gable clad in wooden square shingles, projecting verge with profiled wooden frieze, tongue-and-groove wooden soffits, plain wooden bargeboard, decorative scrollwork and finial)

- o West-facing gable: pedimented gable clad in wooden square shingles, projecting verge with profiled wooden frieze, tongue-and-groove wooden soffits, plain wooden bargeboard, decorative scrollwork and finial (Images 4.1 & 4.2);

- a) Wood drop siding cladding, wooden corner boards (Images 4.1 & 4.2); and
- b) Fenestration:

- Sunroom: south-facing tall vertical narrow window patterns with tapered ends, evenly segmented by narrow wooden mullions, upper band, sills, corner post and verandah door/transom casings; west-facing door opening and window pattern evenly segmented by narrow wooden mullions, upper band, sills, and door casing (Images 3.4, 4.1 & 4.2);
- Projecting two-storey addition: west and south-facing 2-over-2 hung sash windows, south-facing 1-over-1 hung sash window, wooden casing and sills (Images 2.2, 4.1 & 4.2);

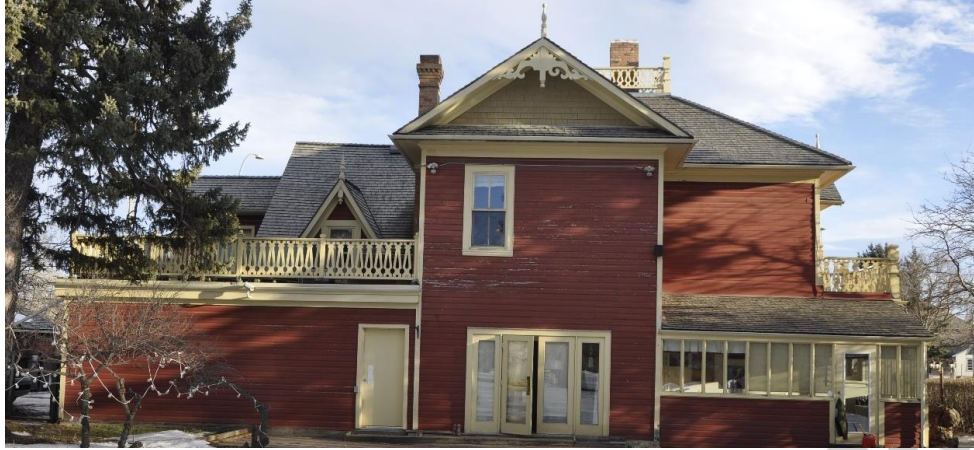
(Image 4.2: Building Section 1 – west façade showing sunroom addition with narrow eaves and projecting two-storey addition with pedimented gable clad in wooden square shingles, projecting verge with profiled wooden frieze, tongue-and-groove wooden soffits, plain wooden bargeboard, decorative scrollwork and finial. Building Section 2 – gabled dormer)

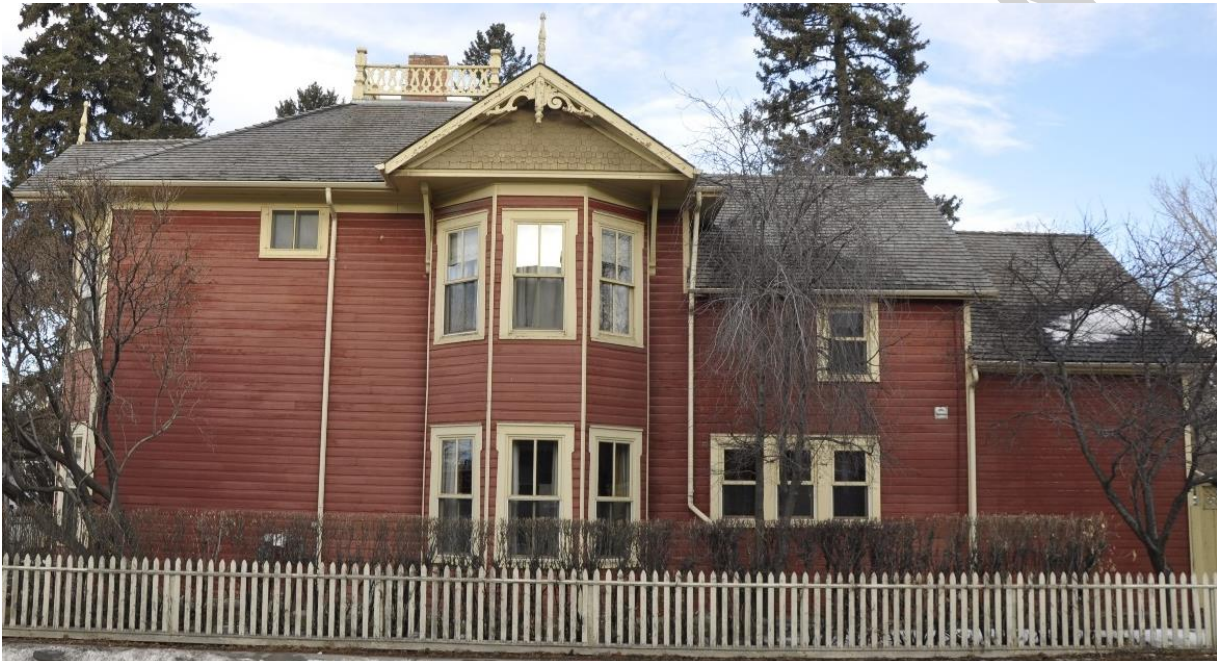
(Image 5.1: East façade showing projecting two-storey bay, widow's walk and Building Section 2)

- a) Wood drop siding cladding, wooden corner boards (Image 5.1); and
- b) Fenestration:

- Two-pane fixed window, wooden mullion; wood casing and sill (Image 5.1);
- Projecting two-storey bay: original east, south and north-facing 2-over-2 hung sash windows, wood casing with eared corners at the top of window frames (Image 5.1);

- 1-over-1 hung sash window, wooden mullion, casing and sill; triple-assembly 1-over-1 hung sash window, wooden mullion, casing and sills (Image 5.1).

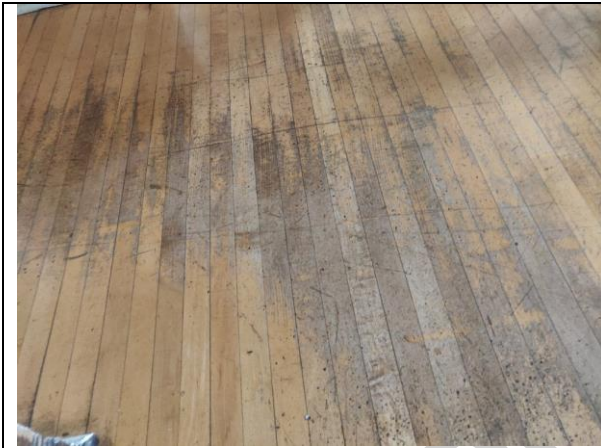
(Image 6.1: Example of original hardwood flooring on the second level)

- Hardwood flooring, profiled wooden baseboards, chair rails, and crown mouldings on first and second level (Images 6.1 – 6.5);
- Carved fir newel posts and balusters on stairway (Images 6.6 – 6.8);
- Brick fireplace with tiled hearth, profiled wooden mantle and surround (Image 6.9);
- Arched wall openings framing the projecting bays (first and second levels), central wall curvature in the main room (second level) (Images 6.10 & 6.11);
- Wooden doors and profiled frames (Image 6.12);
- Ceiling pendant light fixture (Image 6.13);
- Vault door (Images 6.14 & 6.15).

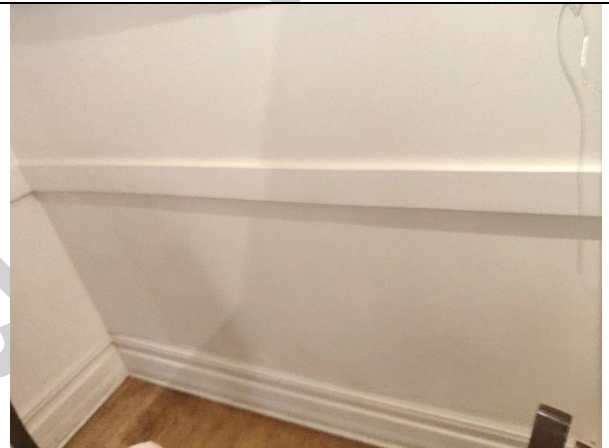
(Image 6.2: Example of chair rail and profiled wooden baseboards)

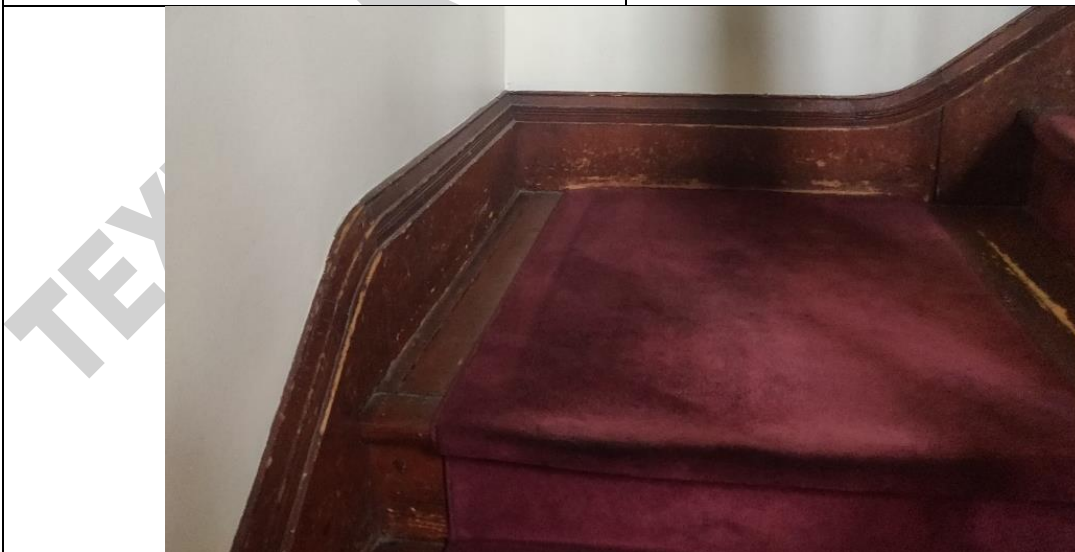
(Image 6.3: Example of staircase's profiled wooden baseboard and hardwood flooring)

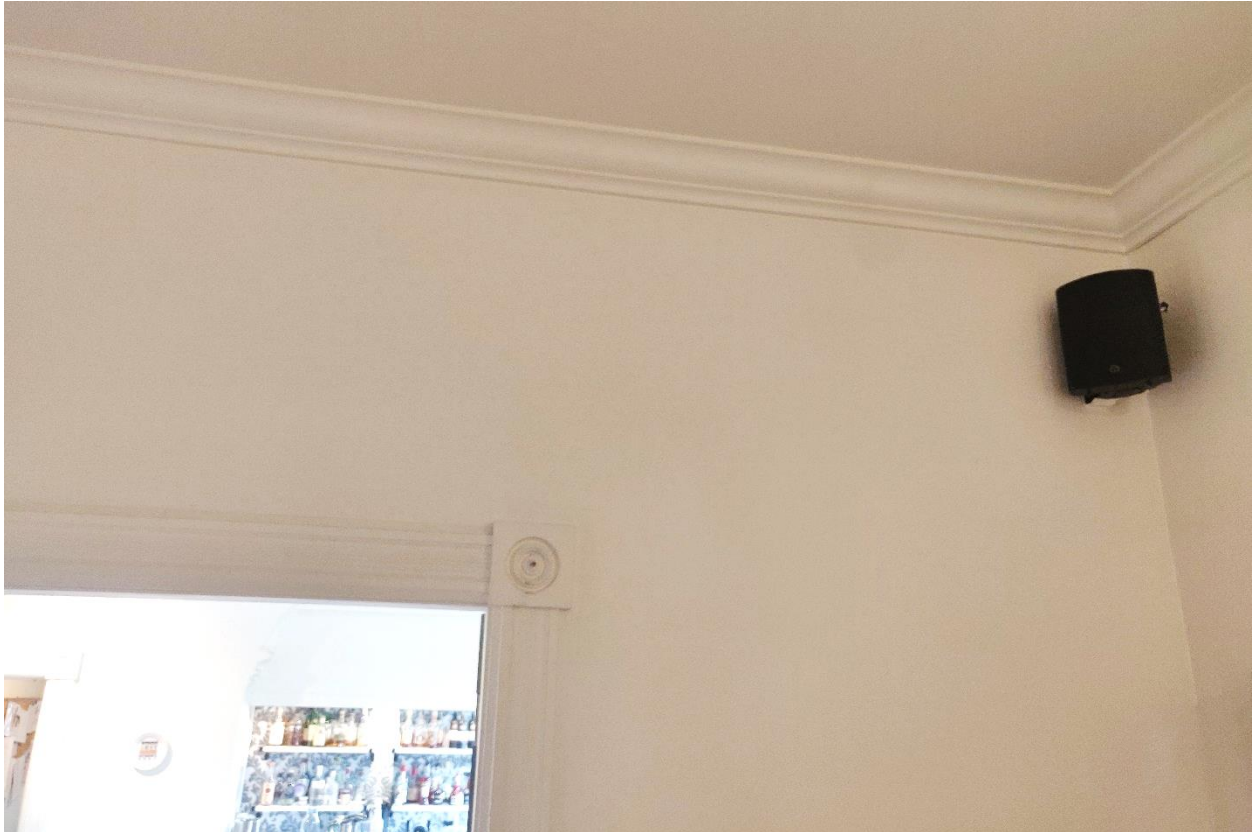
(Image 6.4: Example of crown moulding on ceiling. Partial door frame casing visible)

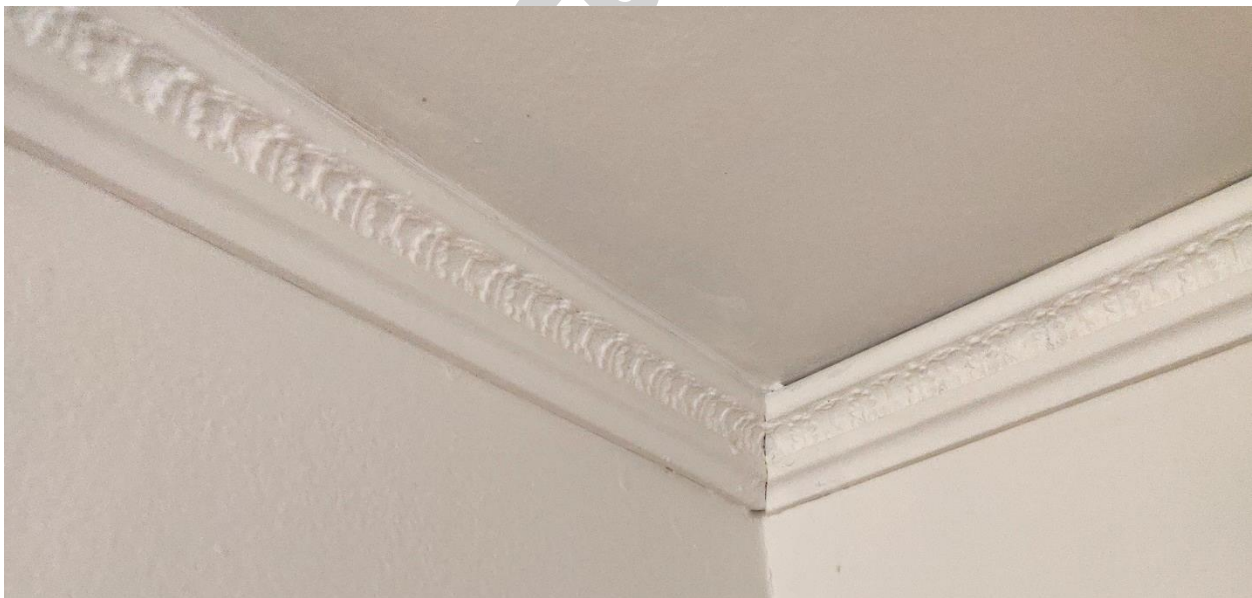
(Image 6.5: Another example of crown moulding with different articulation)

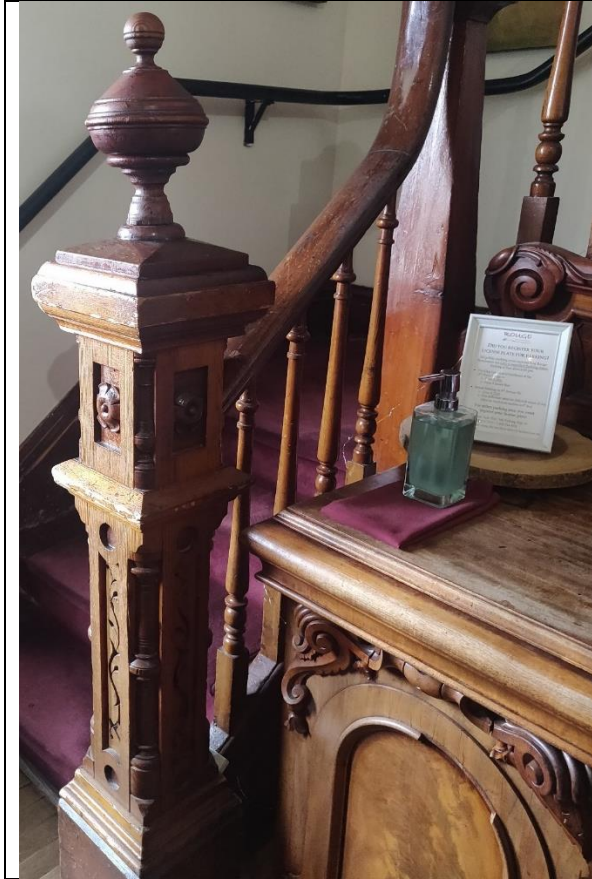
(Image 6.6: Carved fir newel posts and balusters on stairway)

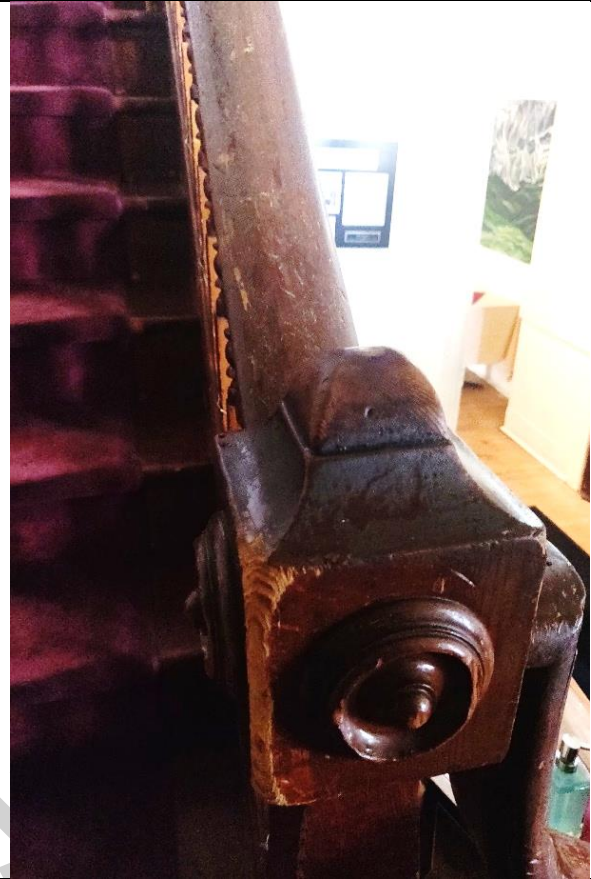
(Image 6.7: Carved fir newel posts and balusters on stairway)

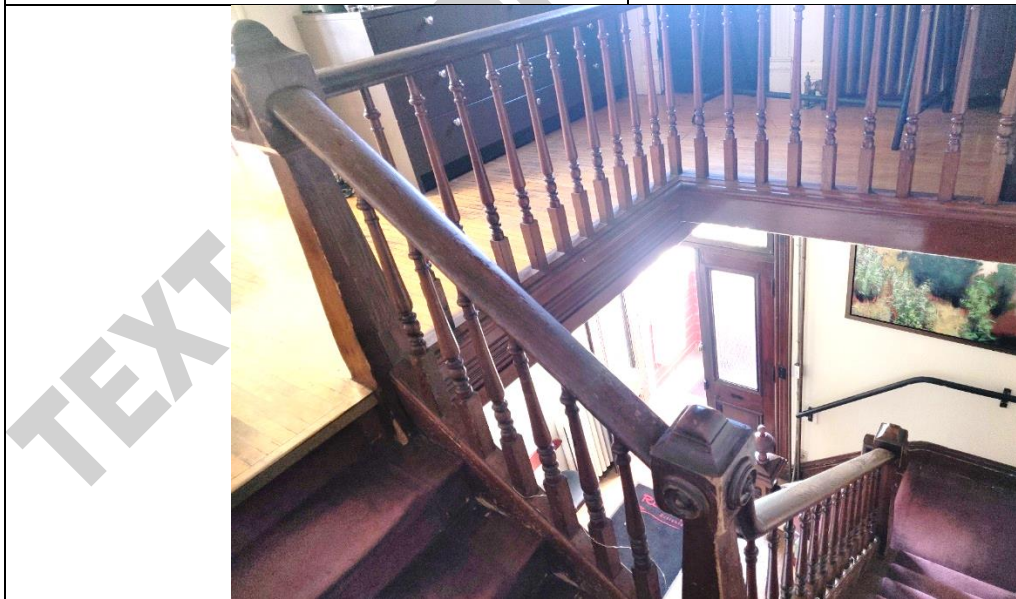
(Image 6.8: Carved fir newel posts and balusters at top of stairway)

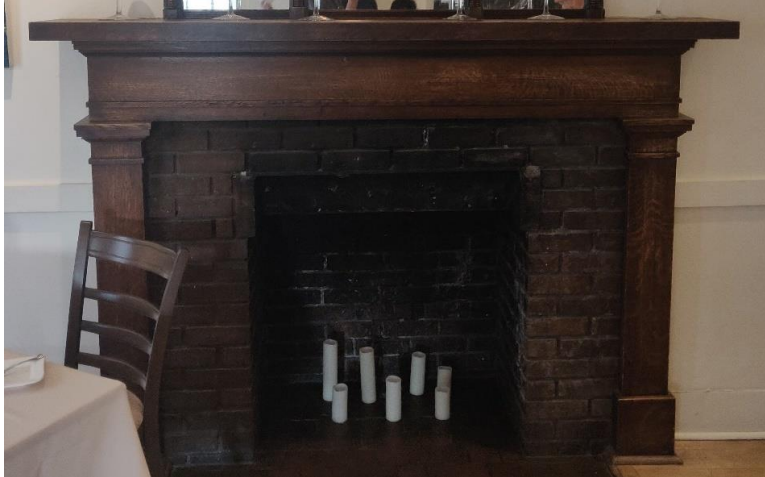
(Image 6.9: Brick fireplace with tiled hearth, profiled wooden mantle and surround)

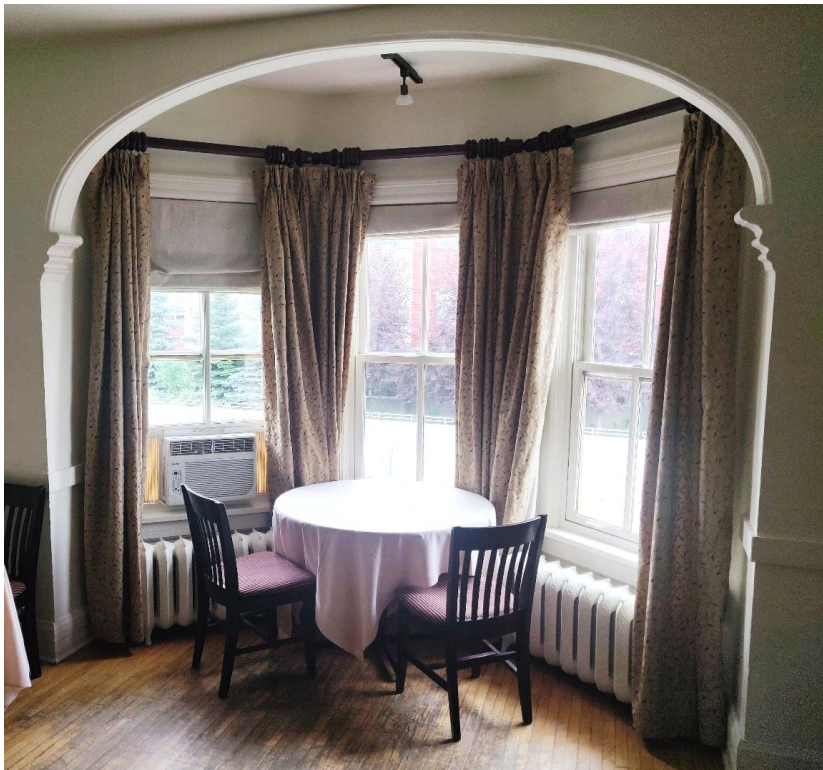
(Image 6.10: Example of typical arched wall opening framing the projecting bay)
