## Proposed Wording for a Bylaw to Designate the Cross Residence as a Municipal Historic Resource

1. This Bylaw may be cited as “City of Calgary Bylaw to Designate the Cross Residence as a Municipal Historic Resource”.

2. The building known as the Cross Residence, located at 1240 8 AVE SE, and the land on which the building is located being legally described as PLAN A3 BLOCK 3 LOTS 28 TO 34 INCLUSIVE, as shown in the attached Schedule “A”, are hereby designated as a Municipal Historic Resource.
3. The specific elements of the Historic Resource possessing heritage value are hereafter referred to as the Regulated Portions (the “Regulated Portions”). The Regulated Portions are identified in the attached Schedule “B”.

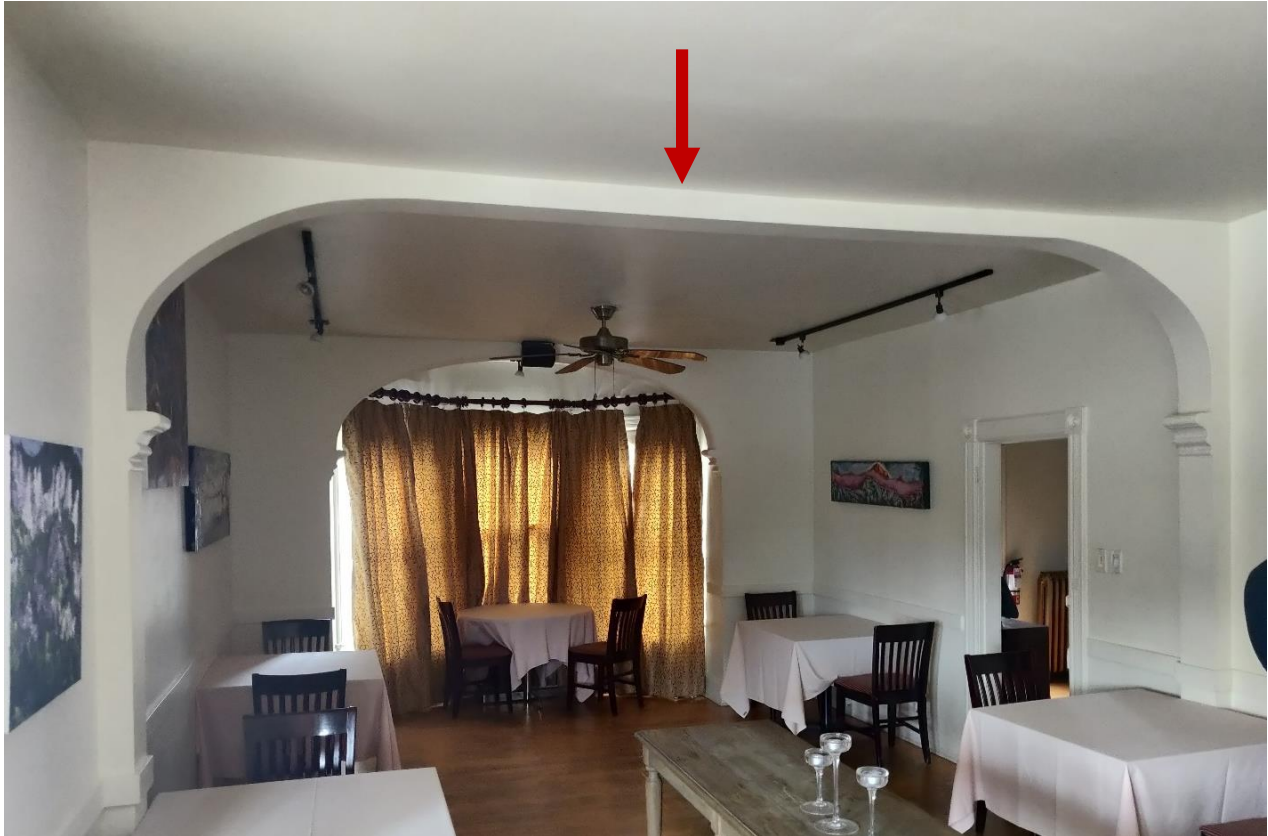
(Image 6.11: Example of central wall curvature in the main room at second level, as denoted with arrow)

- Hardwood flooring, profiled wooden baseboards, chair rails, and crown mouldings on first and second level (Images 6.1 – 6.5);
- Carved fir newel posts and balusters on stairway (Images 6.6 – 6.8);
- Brick fireplace with tiled hearth, profiled wooden mantle and surround (Image 6.9);
- Arched wall openings framing the projecting bays (first and second levels), central wall curvature in the main room (second level) (Images 6.10 & 6.11);
- Wooden doors and profiled frames (Image 6.12);
- Ceiling pendant light fixture (Image 6.13);
- Vault door (Images 6.14 & 6.15).

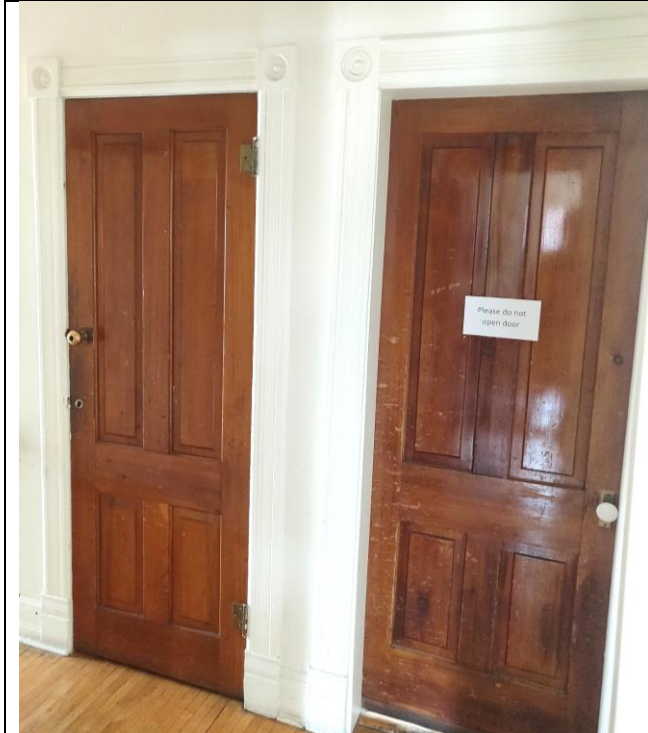
(Image 6.12: Example of wooden doors and profiled frames)

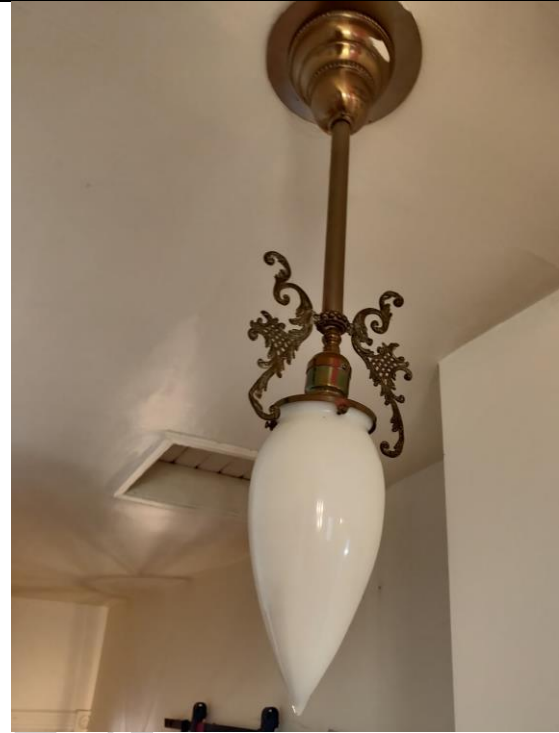
(Image 6.13: Historic pendant ceiling light)

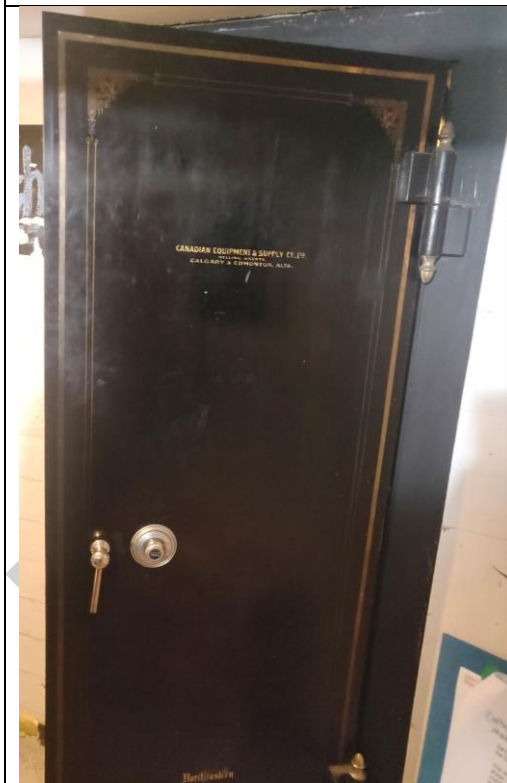
(Image 6.14: Vault door, located in basement)

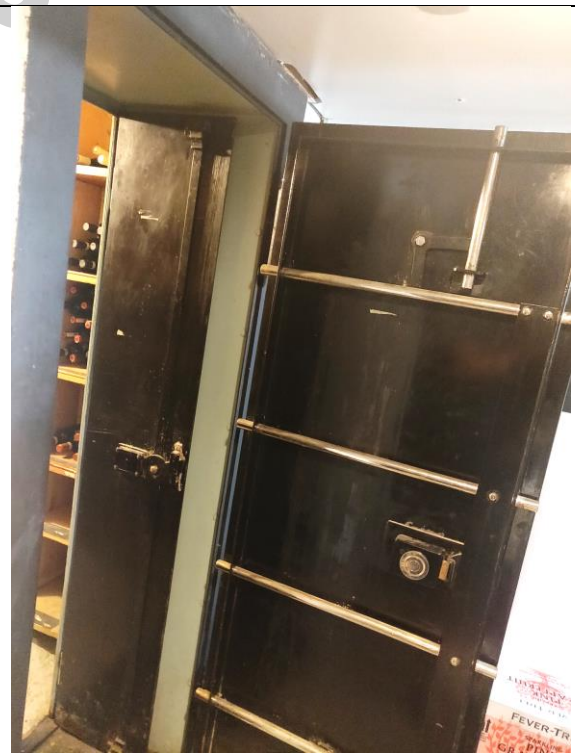
(Image 6.15: Vault door, located in basement)
