Structural Collapse Model

Attachment 2 PFC2017-1211

PFC2017-1211 - Municipal Complex Structural Upgrade Att 2 ISC: Unrestricted The new transfer beam distributes the shoring tower load from Truss 'A' to three existing columns of the Administration Building, with one of the existing columns of the Administration Building further reinforced to carry the shoring loads.

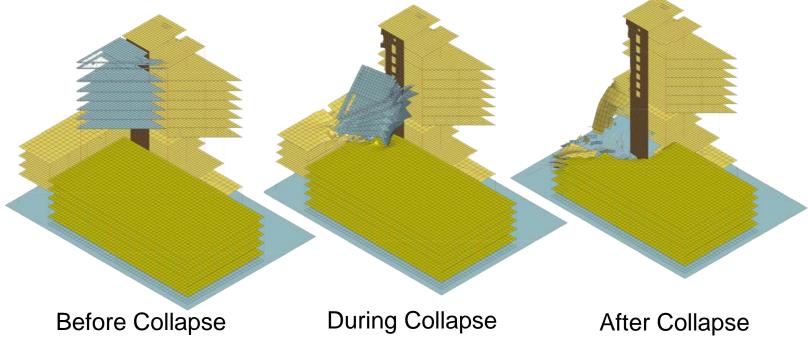
Isometric 3-D View (Looking North-East)

The objective of the Structural Collapse Model was to determine the impacted area due to the collapse of the north end of the Calgary Municipal Building in the extreme event of the failure of Truss A. The computer model was developed using the finite element software LS-DYNA and was based on the structural drawings of the Calgary Municipal Building and the Administration Building. Analysis results indicated a collapse of the suspended floors of the Municipal Building impacts the adjacent Annex Building and the Administration Building.

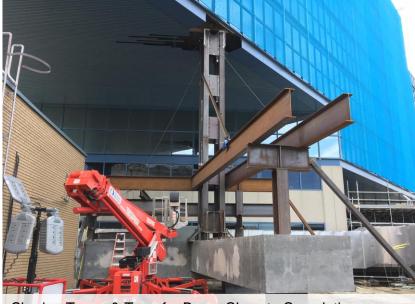
Shoring Tower & Transfer Beam Close to Completion

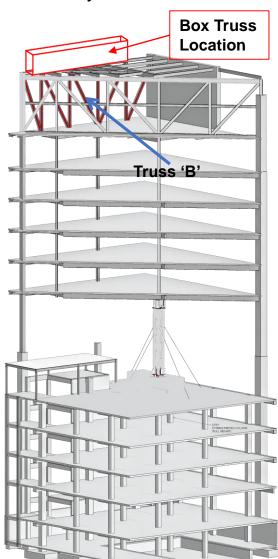
The temporary box truss is located on the roof of the Municipal building to support Truss 'B' remediation efforts. A controlled jacking process was then used to transfer the weight of Truss 'B' onto the temporary box truss assembly.

Box Truss Installation

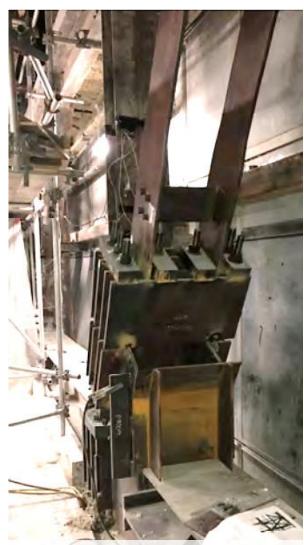
Truss 'A' Modification Completed with "Stiffeners"

To upgrade the structural integrity of Truss 'A' and 'B' a significant number of additional steel plates, or "stiffeners", were welded into place to support the connections between the truss and surrounding structure. For Truss A, 61 "stiffeners" have now been welded into place supporting eight joints. For Truss B, 80 "stiffeners" of varying sizes and shapes have been welded into place on nine separate joints ensuring enhanced structural stability and safety code compliance.

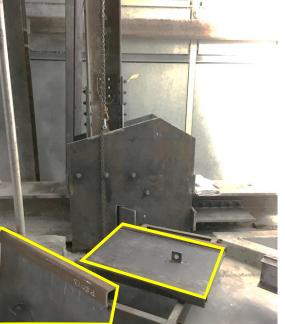
Example of Steel plates prior to installation; "Stiffeners"
