BYLAW NUMBER 42M2017

BEING A BYLAW OF THE CITY OF CALGARY TO DESIGNATE THE KING EDWARD SCHOOL AS A MUNICIPAL HISTORIC RESOURCE

- The "King Edward School" comprises a three-storey Queen Anne Revival style sandstone school built in 1912-13 and is located at 1721 29 Ave S.W., legally described as PLAN 1612680; BLOCK 30; LOT 47 EXCEPTING THEREOUT ALL MINES AND MINERALS as shown on attached Schedule "A".
- 3. The King Edward School is hereby designated as a Municipal Historic Resource as defined in the *Act*.
- 4. The heritage value of the King Edward School is hereby described in the attached Schedule "B".
- 5. The specific elements of the King Edward School possessing heritage value are hereby known as the Regulated Portions (the "Regulated Portions"). The Regulated Portions are specifically described or identified in the attached Schedule "C".

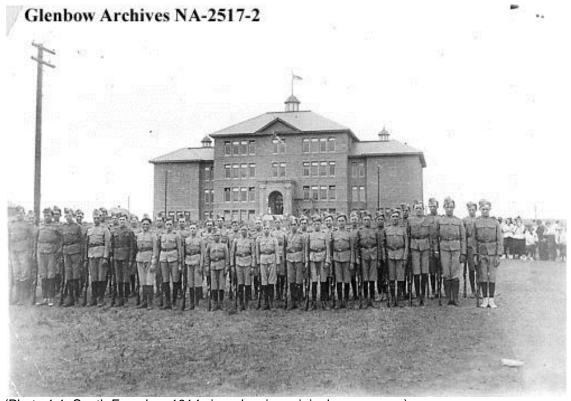
(Photo 1.1: South Façade – 1914 view showing original appearance)

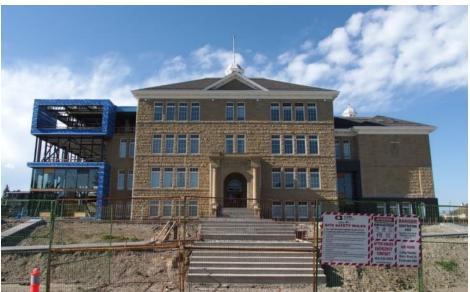
- The sandstone façade cladding consisting of rock-faced sandstone laid in regular courses (Photo 1.2);
- The fenestration (window pattern); nine-pane, wooden-sash windows with 3-pane transom lights; and six-pane, wooden-sash windows with 2-pane transom lights. (Photos 1.2, 1.4, 1.5);
- The one-storey porch with a rounded-arch, central entrance framed by smoothly finished sandstone voussoirs, engaged classical columns and entablature with "1912 KING EDWARD SCHOOL" inscription (Photo 1.3); and
- Straight-flight entrance steps with squared, paneled sandstone newels and closed balustrades (Photo 1.3).

(Photo 1.2: South Façade – contemporary additions/alterations are not regulated

- Compound hipped roof (Photos 1.2, 3.1);
- The two wood-frame cupolas each with louvered rounded-arch openings, polygonal bell-cast roofs, flagpole a finial (Photo 5.1);
- Pressed-metal cornice with brackets and block-modillion detailing; raked pressed-metal block-modillion cornices forming north and south façade pediments (Photo 5.2); and
- Stone chimney (relocated to northeast corner of the building) (Photos 3.1, 4.1).

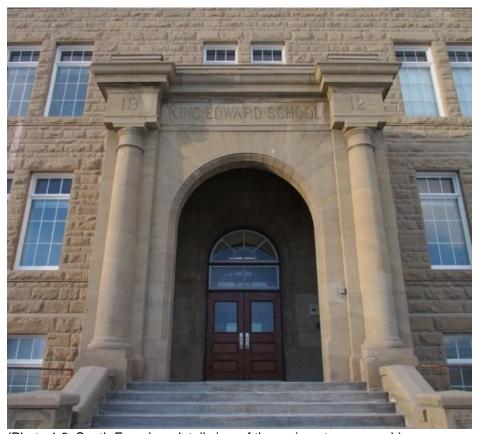
(Photo 1.3: South Façade – detail view of the main entrance porch)

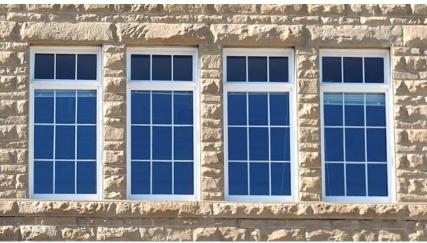
(Photo 1.4: An example of the wooden-sash, nine-pane windows with three-pane transom lights)

- The sandstone façade cladding consisting of rock-faced sandstone laid in regular courses (Photo 4.1, 4.2); and
- The fenestration (window pattern); the profile of nine-pane wooden-sash windows with three-pane transom lights. (Photo 4.1, 4.2, 1.4, 1.5).

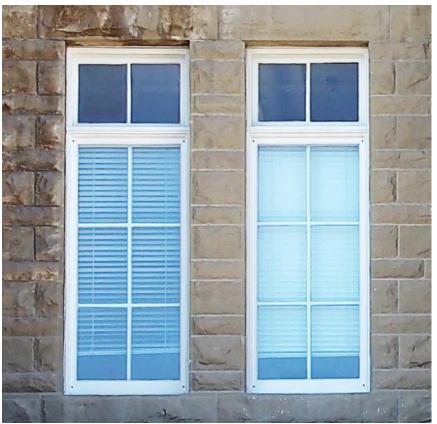
(Photo 1.5: An example of the wooden-sash, six-pane windows with two-pane transom lights)

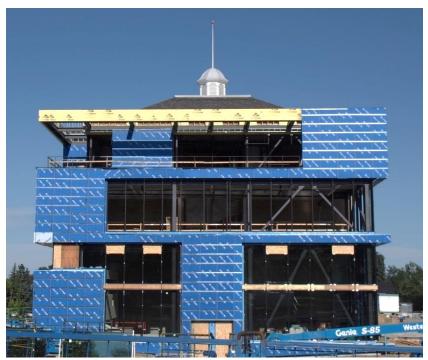
(Photo 2.1: West façade, showing contemporary addition under construction)

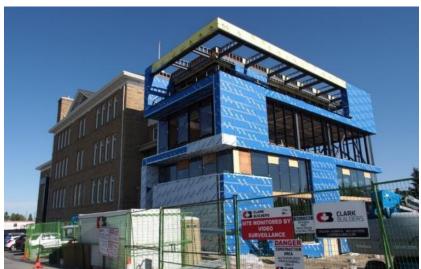
- The sandstone façade cladding consisting of rock-faced sandstone laid in regular courses (contemporary addition and associated elements are not regulated) (Photo 2.2); and
- The two inlaid plaques in sculptural relief (Photos 2.2-2.4).

(Photo 2.2: Oblique view of west façade, under construction)

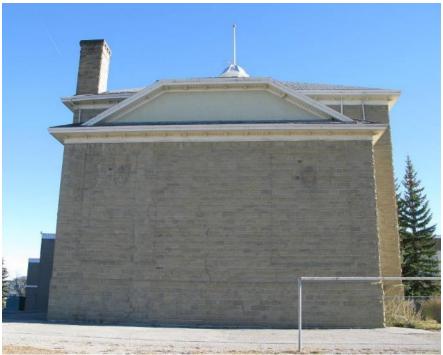
(Photo 2.3: West Façade, prior to construction of contemporary addition)

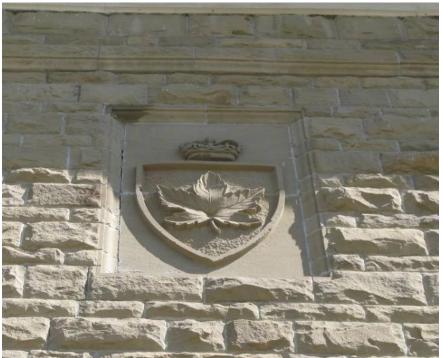
(Photo 2.4: Inlaid plaque on original west façade in sculptural relief, now concealed from exterior by contemporary addition)

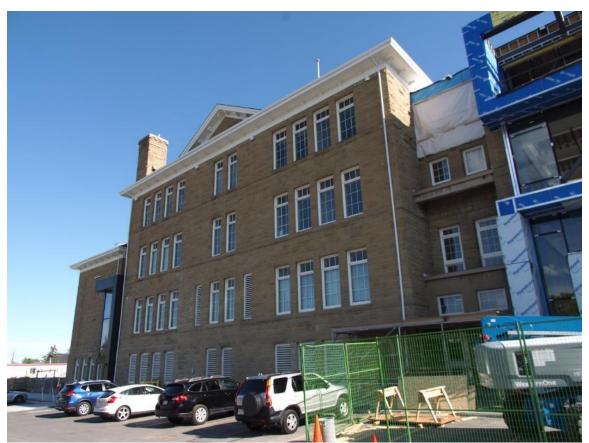
- The sandstone façade cladding consisting of rock-faced sandstone laid in regular courses (Photos 3.1, 3.2);
- The fenestration (window pattern); the profile of nine-pane, wooden-sash windows with three-pane transom lights (excluding the basement windows), and six-pane wooden-sash windows with two-pane transom lights (Photo 3.1, 1.4, 1.5); and
- The secondary entrance porch of the west wing with smoothly finished sandstone cladding and two doorway openings (originally open, but now enclosed); the "BOYS" inscription above the doors (Photo 3.3, 3.4).

(Photo 3.1: North Façade - new construction on the north façade, and west façade contemporary addition are not regulated)

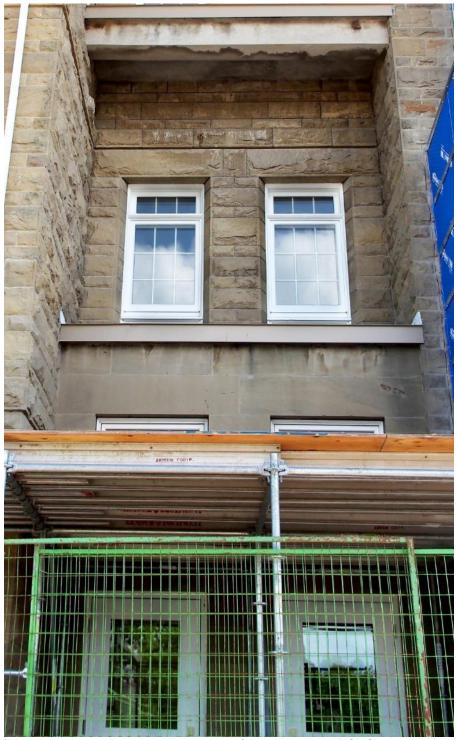
(Photo 3.2: North Façade – detail view of the secondary 'BOYS' entrance porch)

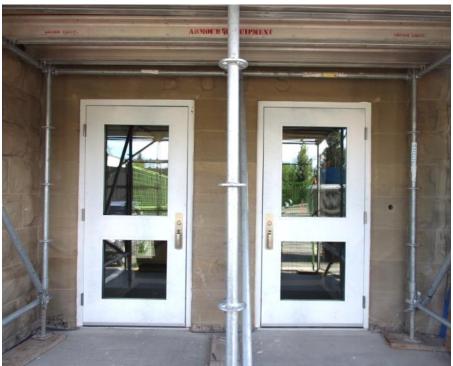
(Photo 3.3: North Façade – detail view of 'BOYS' entrance porch)

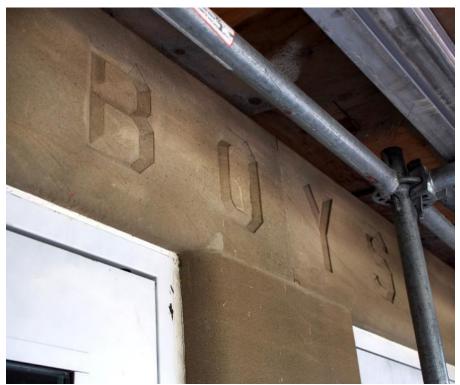
(Photo 3.4: North Façade – detail view of 'BOYS' entrance inscription)

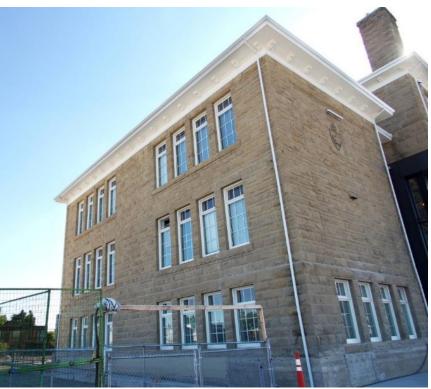
(Photo 4.1: East façade of the King Edward School)

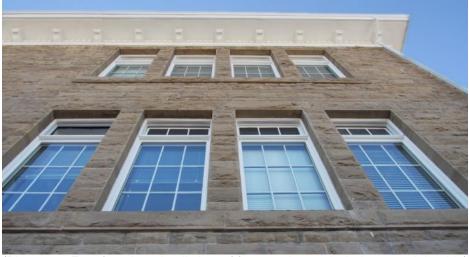
(Photo 4.2: East façade – detail view of fenestration and windows on right side)

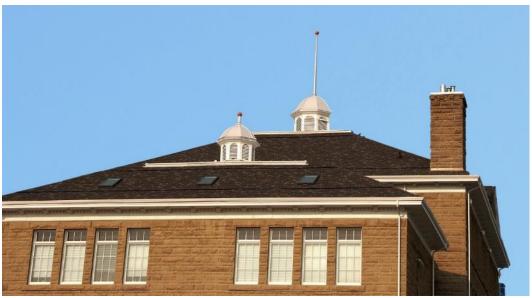
(Photo 5.1: Roof elements – detail view showing the two extant cupolas)

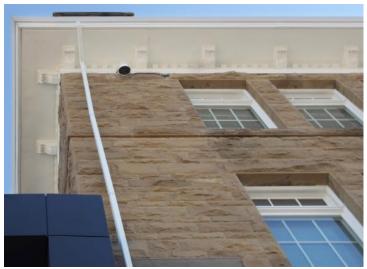
(Photo 5.2: Roof elements – detail view showing a portion of the pressed-metal cornice)

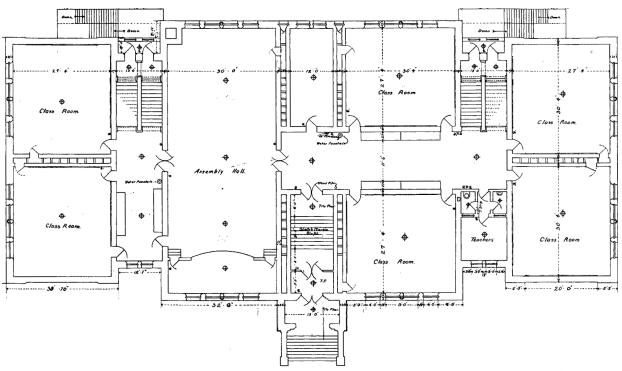
- Those features of the original floor plan / configuration that are also extant in the rehabilitation plan / configuration (Compare Images 6.1.01 & 6.1.0.2);

(Image 6.1.01: First Floor - original plans)

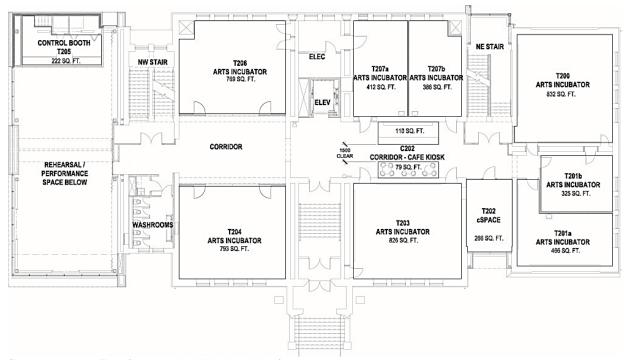
(Image 6.1.02: First floor - rehabilitation plans)

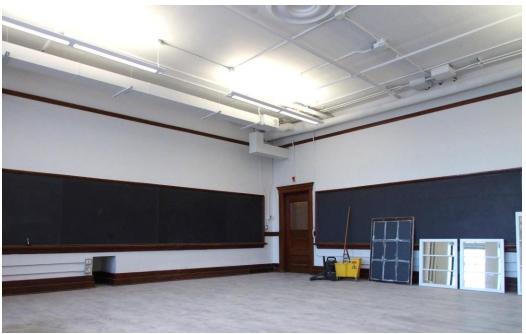
- Classroom and corridor finishes throughout including backboards with casings, wood baseboards, chair rails, picture rails, and door casings (Photos 6.1.03, 6.1.04, 6.1.05, 6.1.06, 6.1.07, 6.2.3);

(Photo 6.1.03: An example of classroom detailing/ finishes)

- Those features of the original floor plan / configuration that are also extant in the rehabilitation plan / configuration (Compare Images 6.2.1 & 6.2.2); and
- Classroom and corridor finishes throughout including backboards with casings, wood baseboards, chair rails, picture rails, and door casings (Photos 6.1.03, 6.1.04, 6.1.05, 6.1.06, 6.1.07, 6.2.3, 6.2.4).

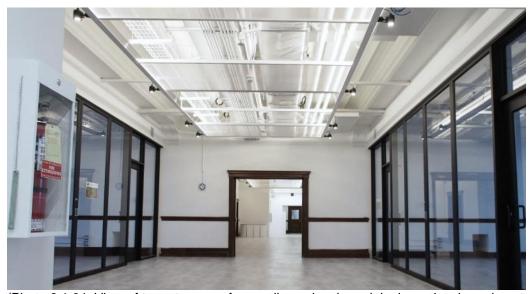
(Photo 6.1.04: View of tenant spaces from gallery, showing original woodwork, and contemporary materials)

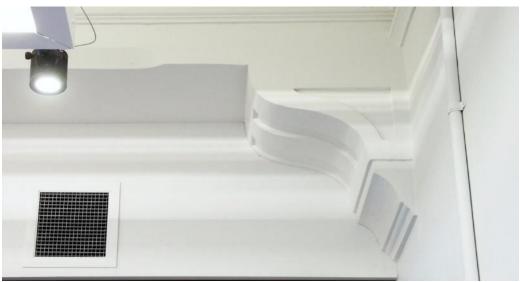
- Decorative plaster features of the original auditorium comprising moulded ceiling beam brackets (Photo 6.1.05);
- Main entrance consisting of the porch interior (originally open) with smoothly finished sandstone ashlar walls with dark mortar joints; an inner foyer; foyer features and finishes including the straight-flight stairs with slate treads and risers; white unglazed porcelain tile flooring with red Greek-key-pattern border; inner and outer foyer oak doorway assemblies with compound transom and fanlights; inner doorway containing panelled, oak, double doors with glazing; (Photos 6.1.08, 6.1.09); and

(Photo 6.1.05: First Floor – former auditorium space showing plaster ceiling beams and decorative brackets)

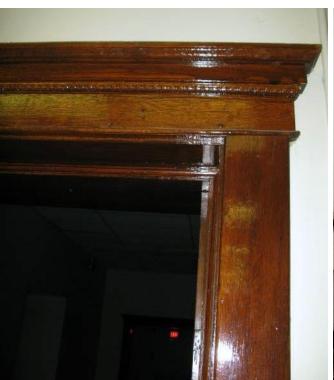
(Photo 6.1.06: An example of door casings common throughout the building)

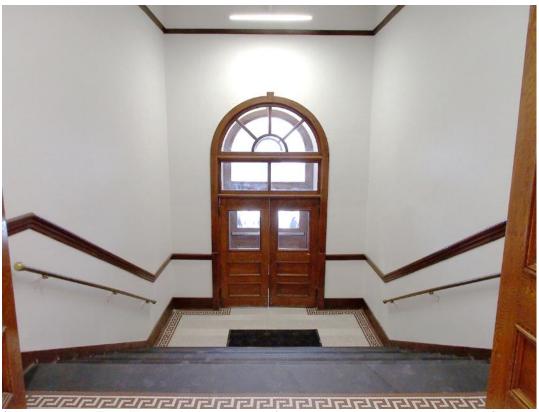
(Photo 6.1.08: First Floor – Main entrance foyer showing patterned porcelain flooring and interior doorway assembly with transom lights and fanlights)

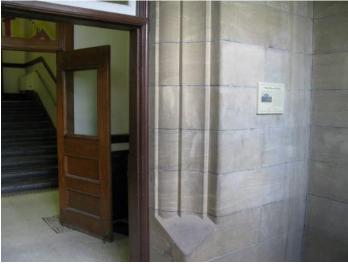
(Photo 6.1.09: First Floor - Main entrance porch and foyer showing ashlar sandstone wall finishes)

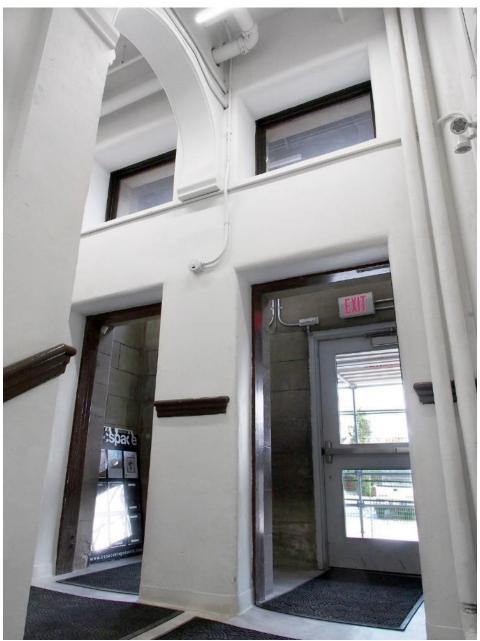
- Side entrance ('BOYS' entrance west wing) features and finishes comprising an inner and outer foyer; outer foyer with ashlar, sandstone walls with dark mortar-joints; wall between inner and outer foyer containing two doorway openings each surmounted by an interior window; decorative plaster inner-foyer ceiling arch; arched stairway opening; enclosed straight-flight staircases (Photos 6.1.10, 6.1.11).

(Photo 6.1.10: First Floor – 'BOYS' side entrance stairwell showing finishes and features)

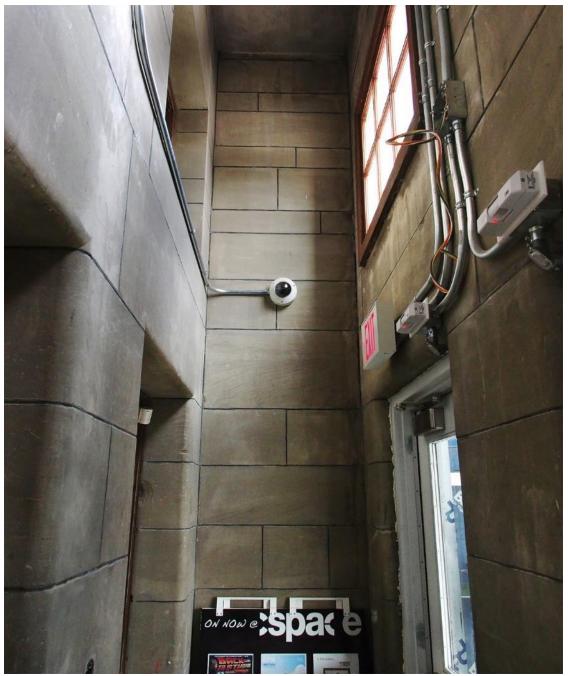
(Photo 6.1.11: First Floor - 'BOYS' side entrance showing outer foyer ashlar sandstone wall finish)

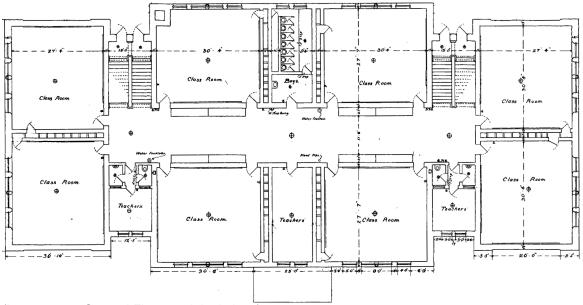
(Image 6.2.1: Second Floor – original plans)

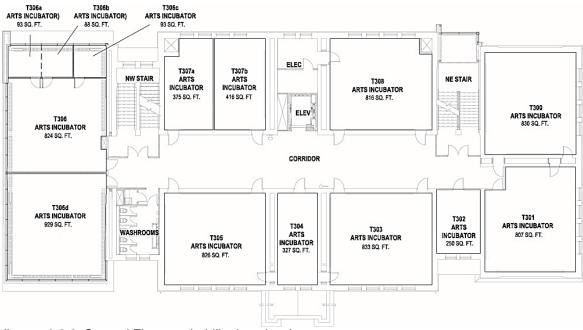
(Image 6.2.2: Second Floor – rehabilitation plans)

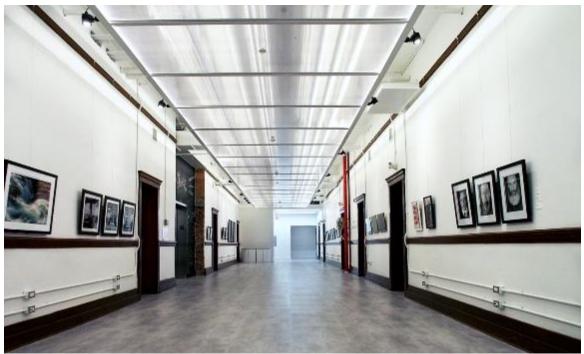
(Photo 6.2.3: An example of an upper floor corridor showing features and finishes)

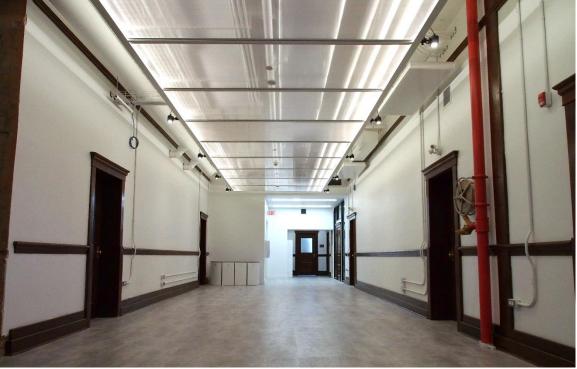
(Photo 6.2.4: An example of an upper floor corridor showing features and finishes)

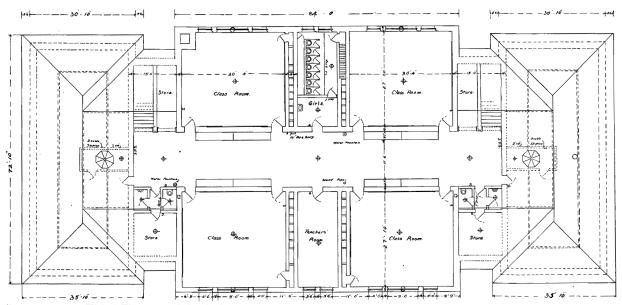
- Those features of the original floor plan / configuration that are also extant in the rehabilitation plan / configuration (compare Images 6.3.1 & 6.3.2); and
- Classroom and corridor finishes throughout including backboards with casings, wood baseboards, chair rails, picture rails, and door casings (Photos 6.1.03, 6.1.04, 6.1.05, 6.1.06, 6.1.07, 6.2.3).

(Image 6.3.1: Third Floor - original plans

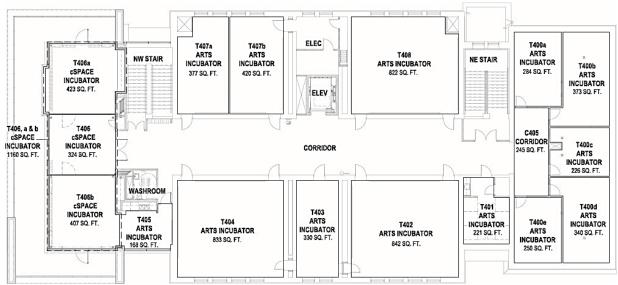
(Image 6.3.2: Third Floor - rehabilitation plans)

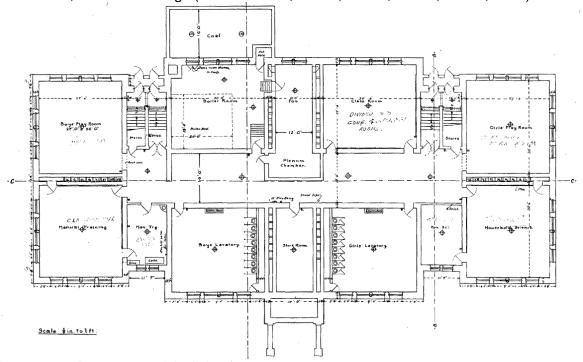
- Those features of the original floor plan / configuration that are also extant in the rehabilitation plan / configuration (compare Images 6.4.1 & 6.4.2); and
- Finishes throughout including backboards with casings, wood baseboards, chair rails, picture rails, and door casings (Photos 6.1.03, 6.1.04, 6.1.05, 6.1.06, 6.1.07, 6.2.3).

(Image 6.4.1: Basement - original plans)

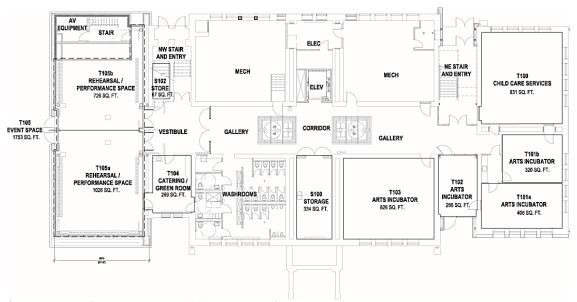
(Image 6.4.2: Basement - rehabilitation plans)
