BYLAW NUMBER 3M2018

BEING A BYLAW OF THE CITY OF CALGARY TO DESIGNATE THE NIMMONS RESIDENCE AS A MUNICIPAL HISTORIC RESOURCE

SCHEDULE "B"

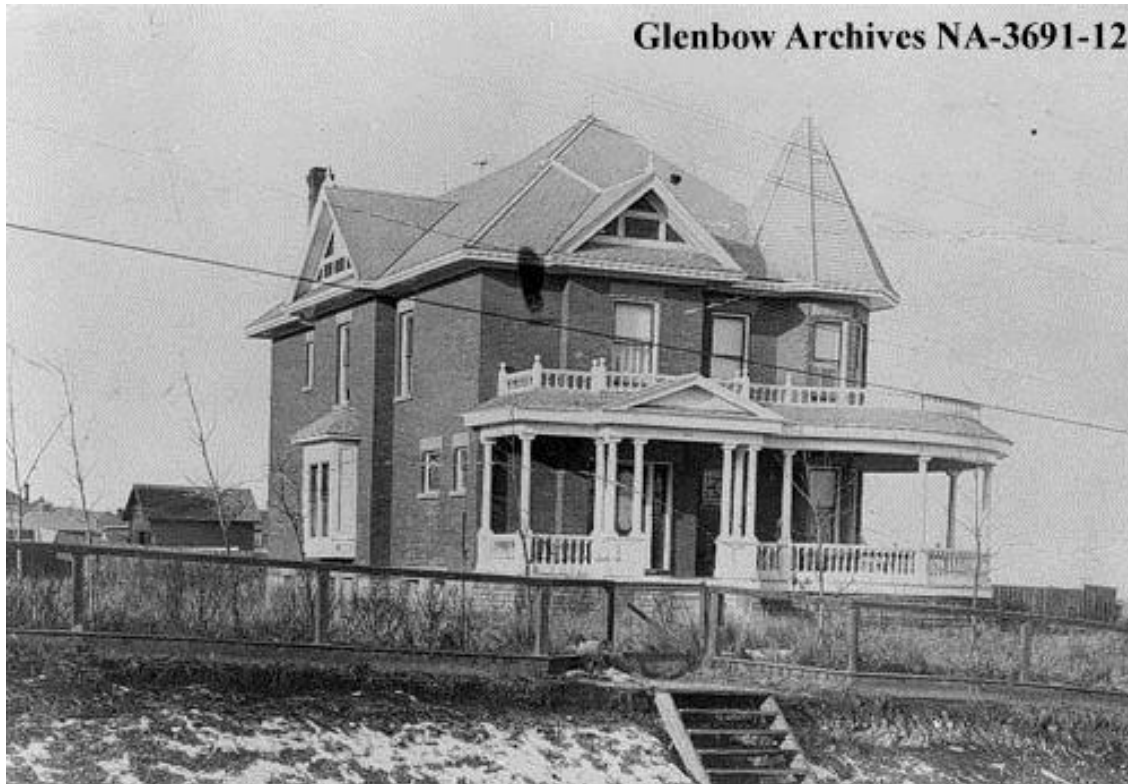
(Image #1.0 – Historic (1912) view of East and South Facades; courtesy Glenbow Archives)

- The red-brick exterior walls laid in stretcher bond (Images #1.1, #1.2);
- Doorway assembly with panelled oak door with oval-shaped bevelled glazing and panelled, oak sidelights with oval-shaped, leaded and bevelled glazing; rock-faced sandstone lintel and threshold (Image #1.2);
- Fenestration, with 1-over-1 wooden sash windows with 4-pane wooden storm sashes; smaller, fixed-sash leaded and stained glass window; rock-faced sandstone lintels and sills (Images #1.0, #1.1, #1.3, #1.4, #1.5);

- Open, full-width, wraparound veranda and balcony of wood construction with classical, Tuscan-style columns, single-bellied balusters, pedimented entrance tongue-and-groove ceiling, and wood-shingle-clad base (Images #1.0, #1.1, #1.6);
- Polygonal corner turret (Images #1.0, #1.1); and
- Wood-shingle-clad gable with mock-half timbering detail (Images #1.0, #1.1).

- The hipped roof with lower cross gables with wooden tongue-and-groove soffits and short, turned, wooden roofline finials (Images #1.0, #1.1, #2.0, #3.0, #3.1, #4.0);
- Polygonal turret roof at north-east corner of the building (Images #1.0, #1.1); and
- Tall, red-brick chimney with corbelled cap at southwest corner of the building (Image #2.0).

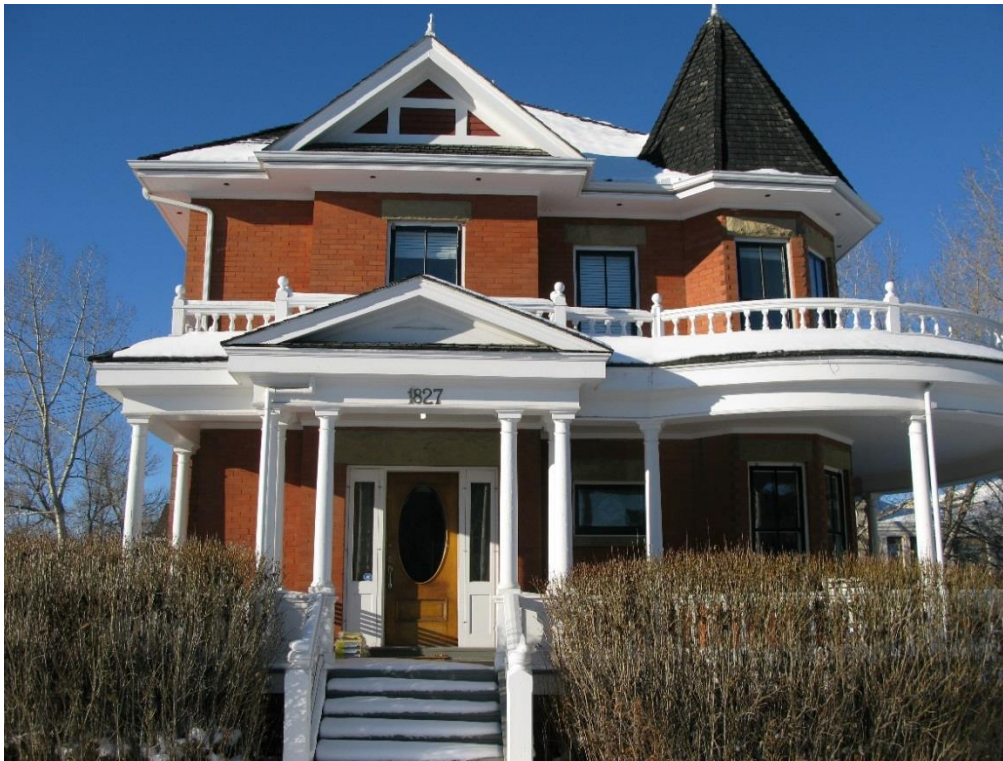
(Image #1.1 – East façade of the Nimmons Residence)

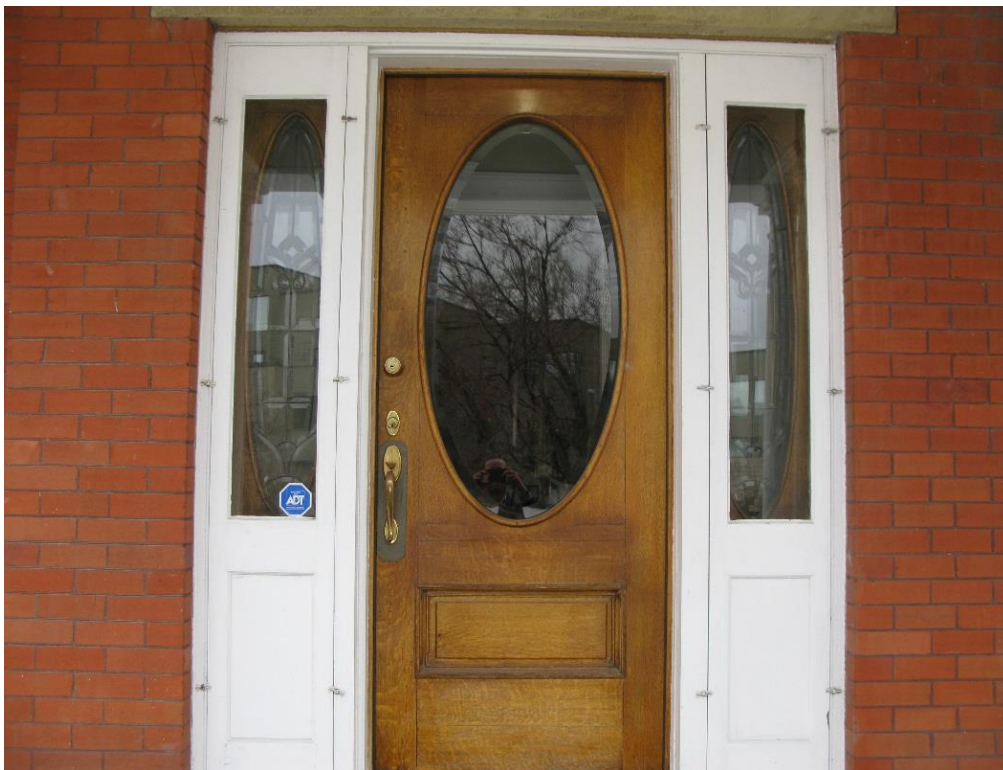
(Image #1.2 – Main entrance, showing doorway assembly)

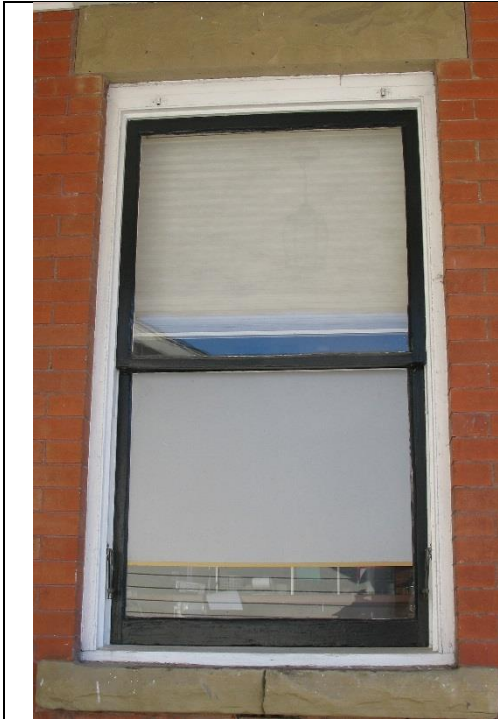
(Image #1.3 – Example of a 1-over-1 wooden-sash window common to all façades; sandstone lintel above the window opening and sill below)

- Fenestration, with 1-over-1 wooden sash windows with 4-pane wooden storm sashes; smaller, fixed-sash leaded, stained glass window with ‘jeweled’ insets; large wood-sash window with patterned and stained glass upper sash over a single pane; single sash rock-faced sandstone lintels and sills (Images #3.1, #3.3, #1.3, #1.4, #1.5);

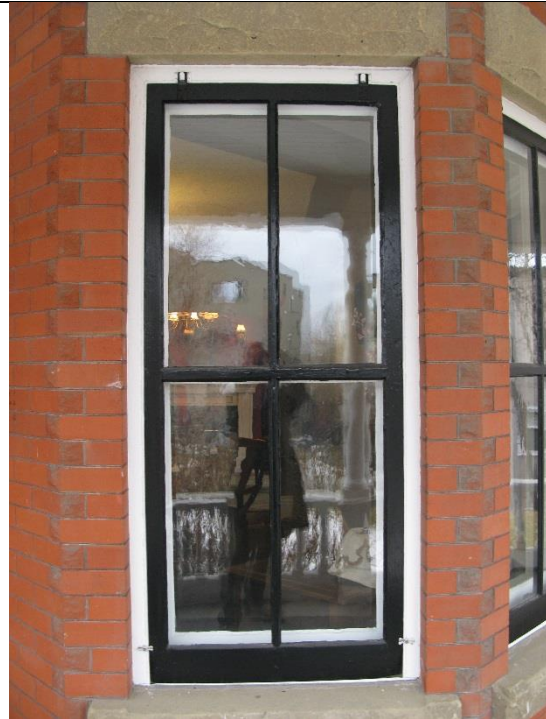
(Image #1.4 – Example of a window with 4-pane wooden storm sash)

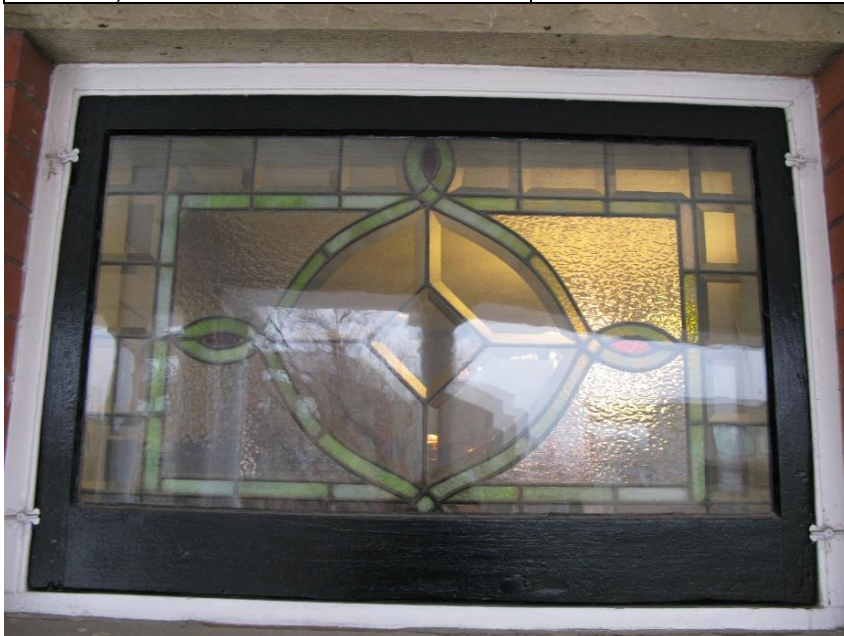
(Image #1.5 – Example of one of the smaller leaded and stained glass windows)

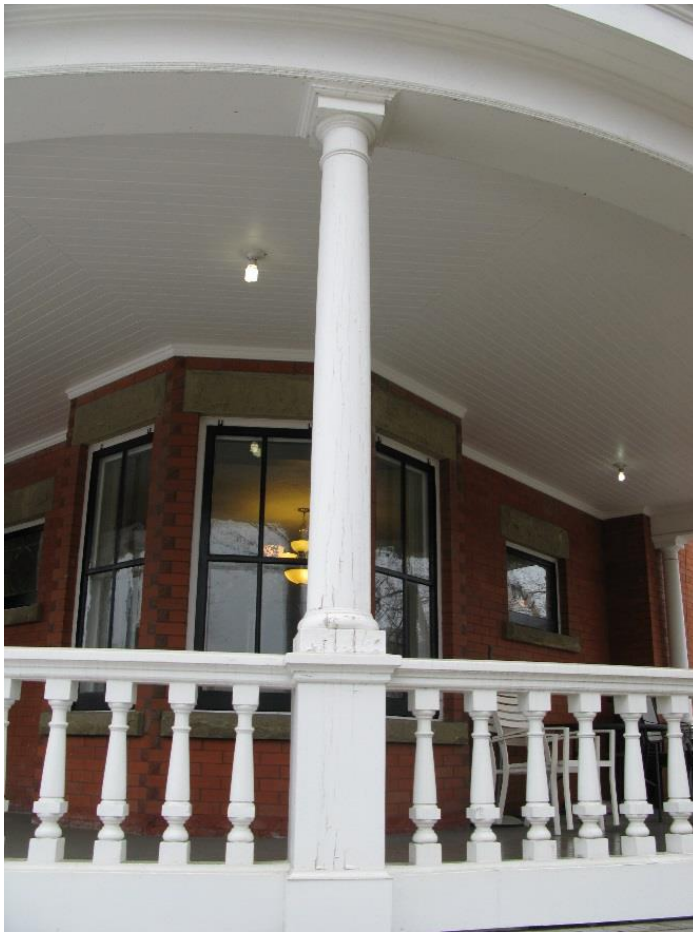
(Image #1.6 – Detail view of the veranda, showing balustrade, Tuscan-style column and wooden tongue-and-groove ceiling)

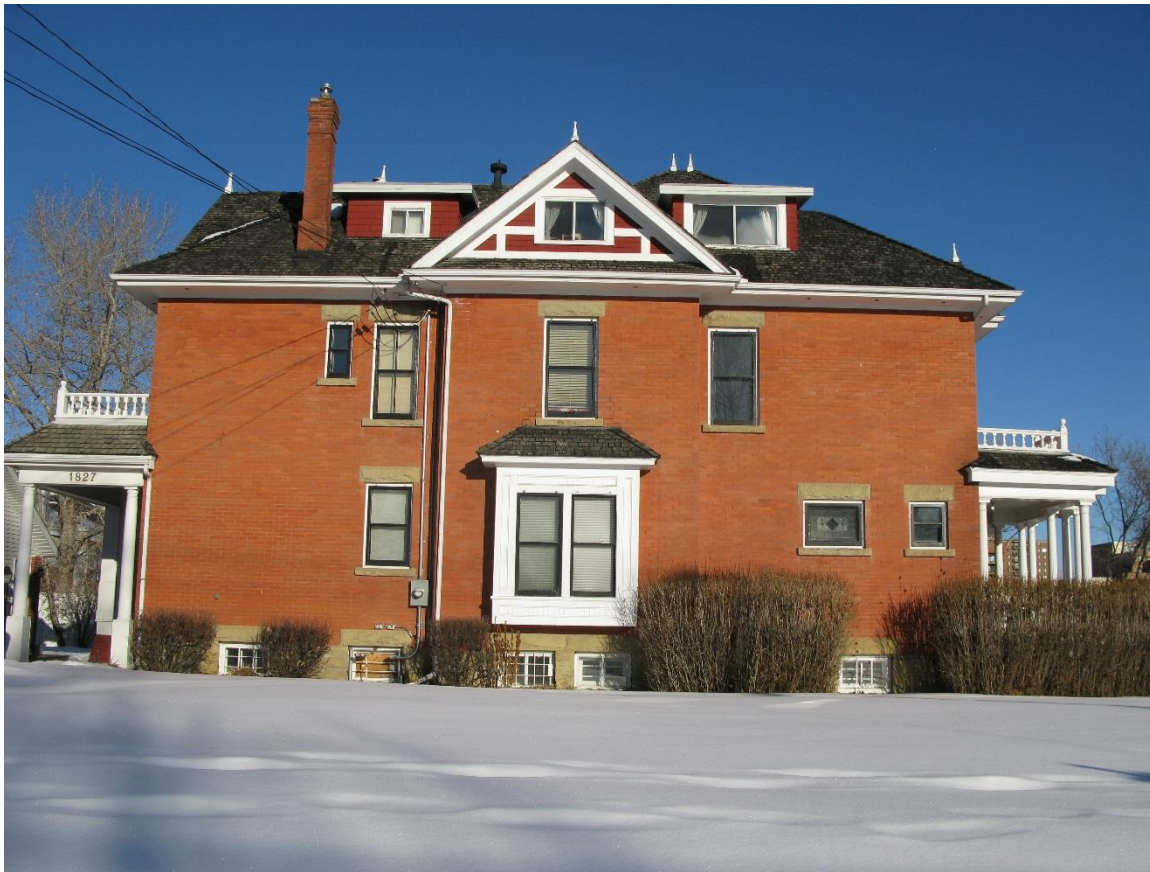
(Image #2.0 – South façade of the Nimmons Residence)

- The red-brick exterior walls laid in stretcher bond (Image #2.0);
- 25-30" of an irregularly coursed, rock-faced sandstone foundation and its six window openings;
- Fenestration, with 1-over-1 wooden sash windows and wooden 1-over-1 and 4-pane storm sashes; smaller, fixed-sash leaded, stained glass window; rock-faced sandstone lintels and sills (Images #2.0, #1.3, #1.4, #1.5);
- Bay (oriel) window clad in wood with multiple tongue-and-groove panels and a hipped roof (Image #2.1); and
- Wood-shingle-clad gable with mock-half timbering detail. (Image #2.0).

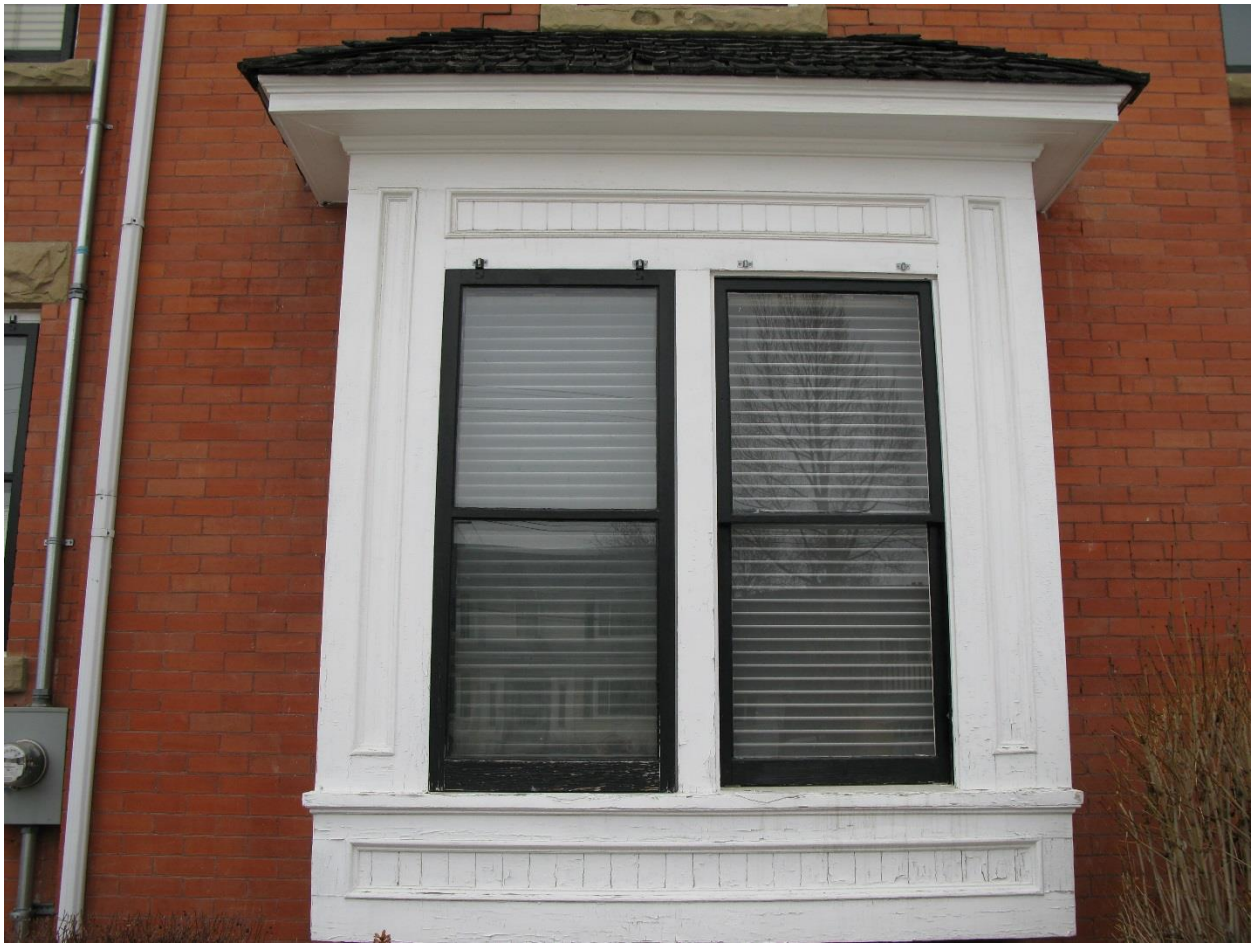
(Image #2.1 – Wood-panelled bay (oriel) window)

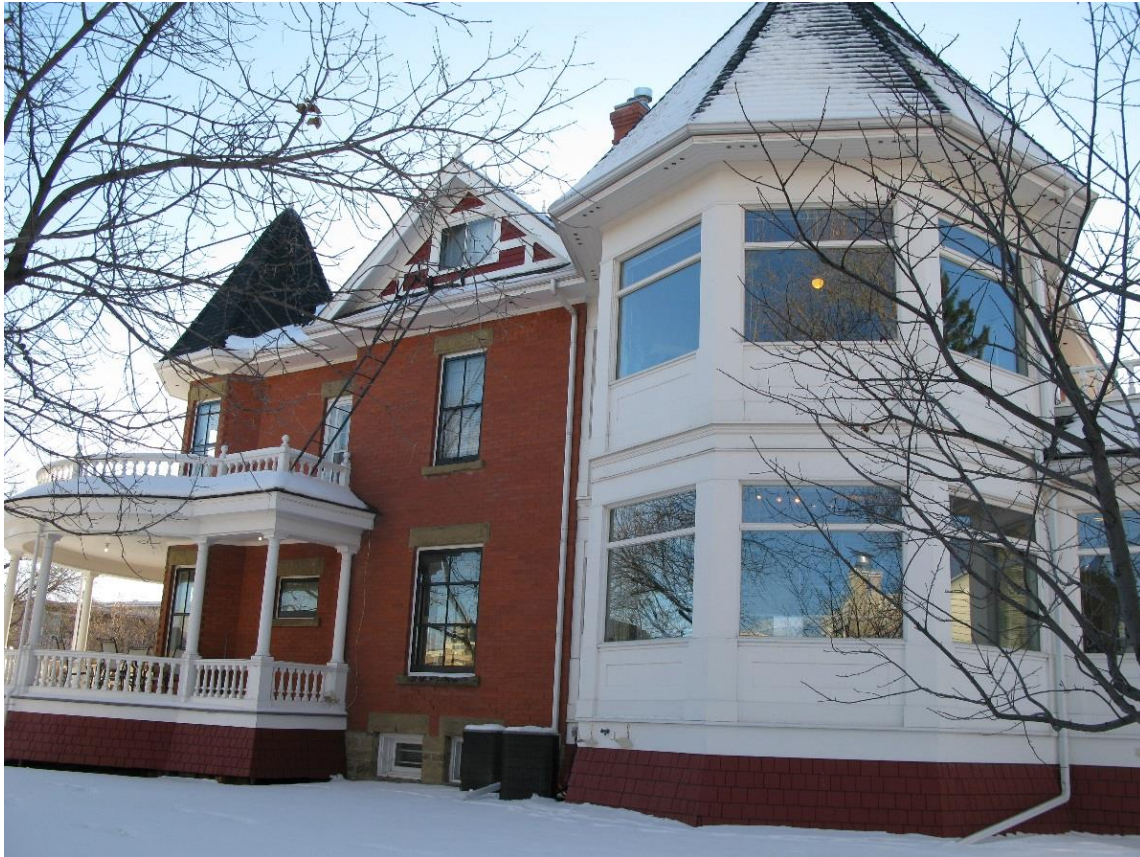
(Image #3.0 – North façade of the Nimmons Residence; photo includes modern turret addition at northwest corner of the building which is Non-regulated)

- The red-brick exterior walls laid in stretcher bond (Images #3.0, #3.1);
- 25-30” of an irregularly coursed, rock-faced sandstone foundation and its two window openings (Images #3.0, #3.1);

Note - The large, wood-frame polygonal corner turret at the north-west corner of the building is of modern design and is Non-regulated.

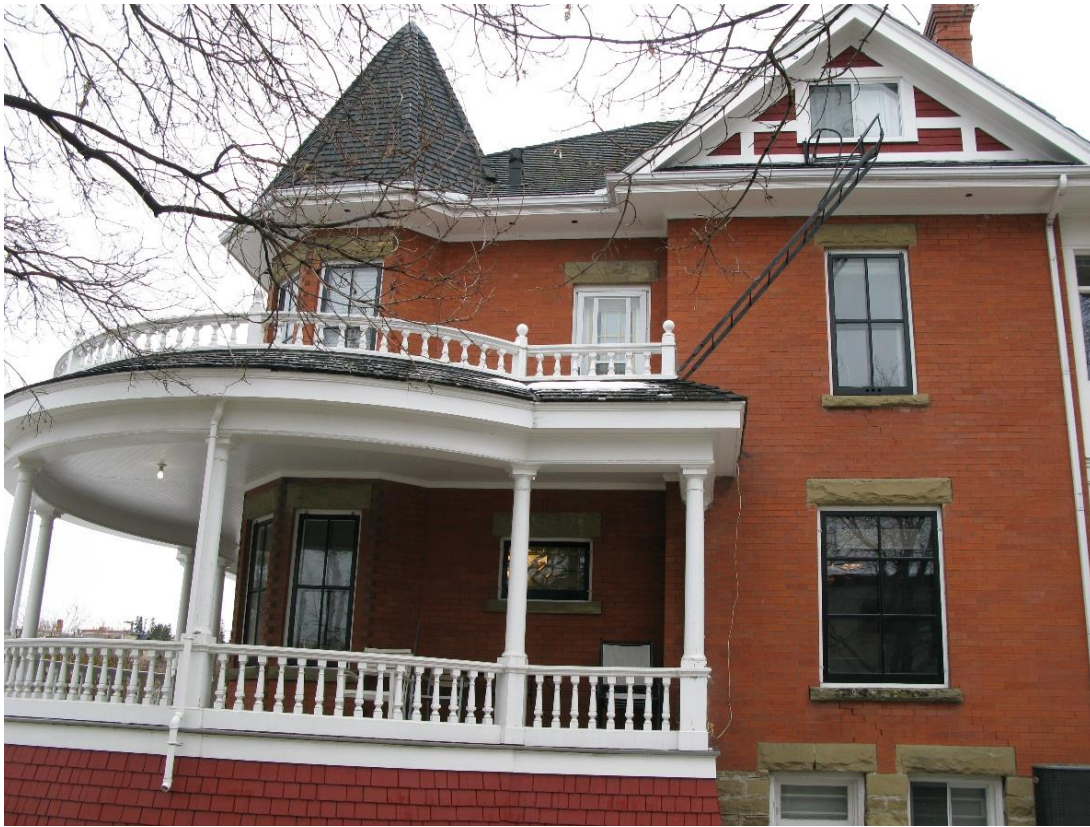
(Image #3.1 – Portion of north façade of the Nimmons Residence)

- Eastern polygonal corner turret with polygonal roof (Image #3.1); and
- Wood-shingle-clad gable with mock-half timbering detail (Image #3.1).

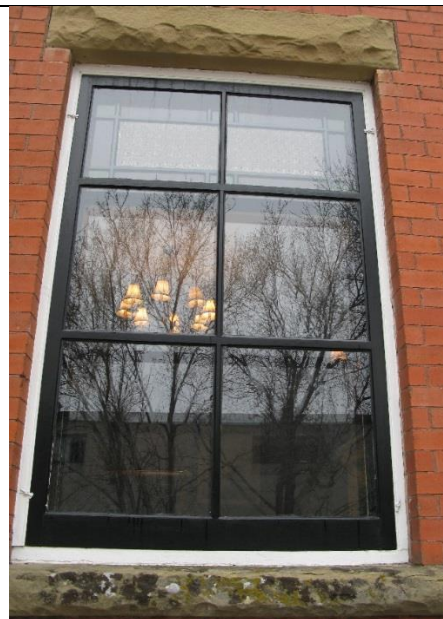
(Image #3.3 – Large north façade window with decoratively patterned upper sash)

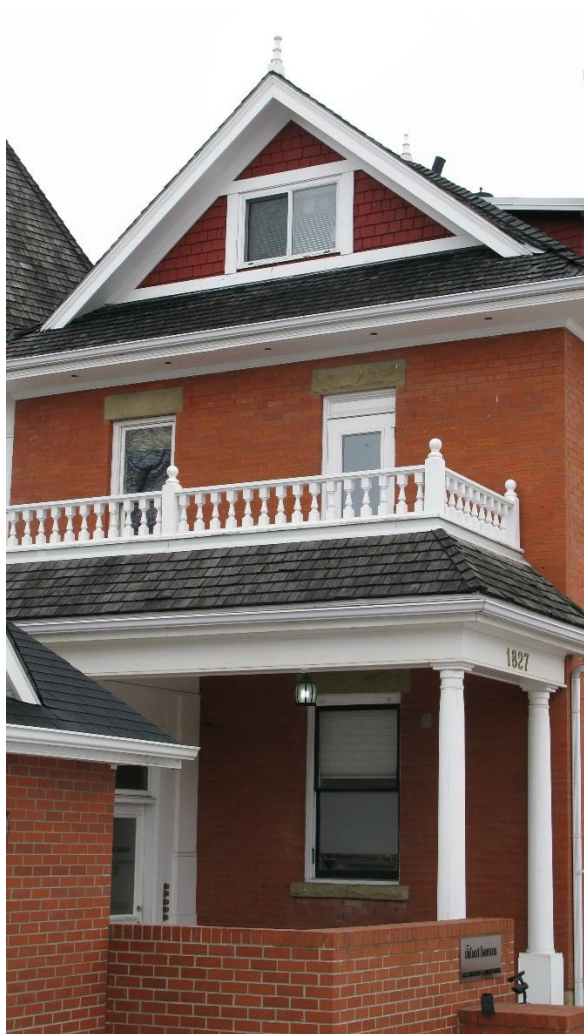
(Image #4.0 – Portion of west façade of the Nimmons Residence)

- The red-brick exterior walls laid in stretcher bond (Image #4.0);
- 25- 30" of an irregularly coursed, rock-faced sandstone foundation;
- Fenestration, with 1-over-1 wooden sash windows; rock-faced sandstone lintels and sills (Image #4.0);
- Those portions of the building enclosed within the modern porch and turret addition, which were originally exterior elements, including the red-brick walls laid in stretcher bond, original window and door openings and their associated sandstone lintels and sills (Image #4.1);
- Second-storey doorway with transom and rock-faced sandstone lintel (Image #4.0); and
- Wood-shingle-clad gable with mock-half timbering detail (Image #4.0).

Note - The large, wood-frame polygonal corner turret at the northwest corner of the building and the enclosed rear porch, partial veranda and second-storey balcony are all of modern design and are Non-regulated.

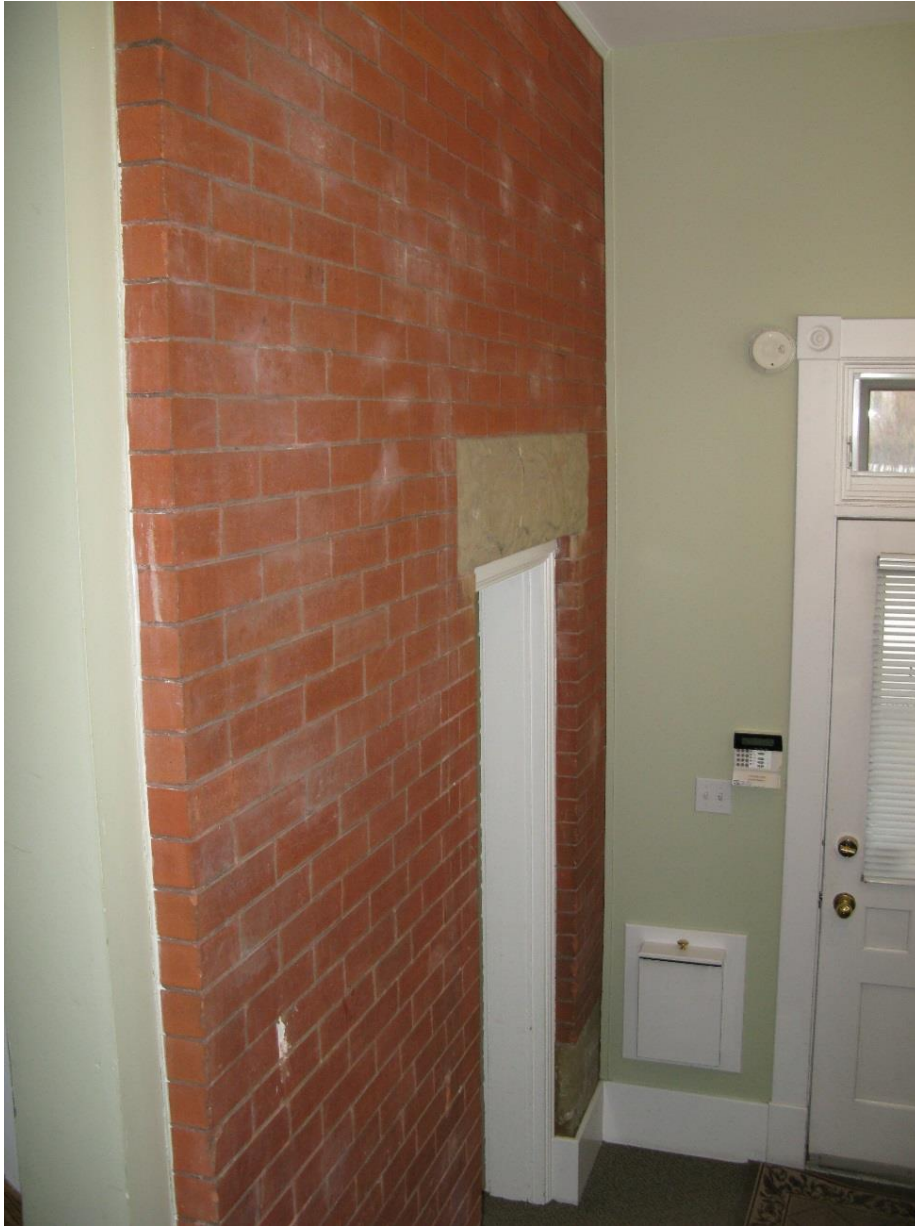
(Image #4.1 – Portion of west façade now enclosed within modern rear porch addition)

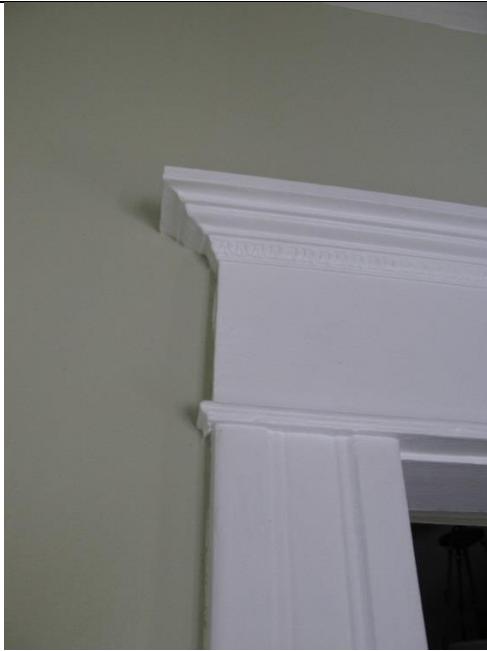
Image #6.0 – Example of the window casings in the primary (public) rooms of the house

- The original window casings throughout (Images #6.0-6.2); and
- Main staircase placement and newels and balustrades (Image #6.3).

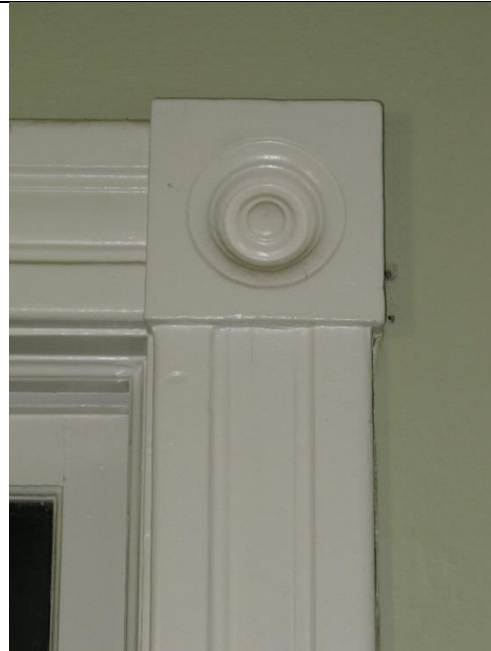
Image #6.1 – Example of the window and door casings in the secondary rooms of the house

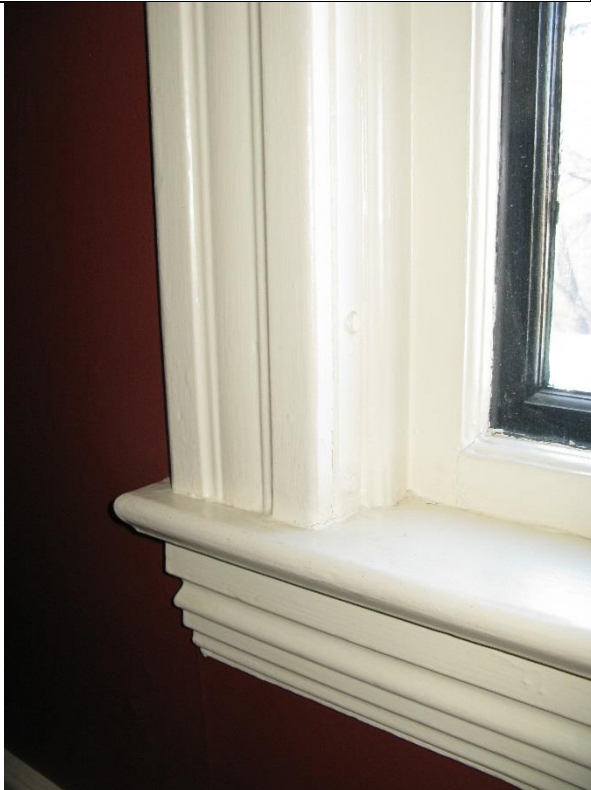
Image #6.2 – Example of a portion of the window casings used throughout the house

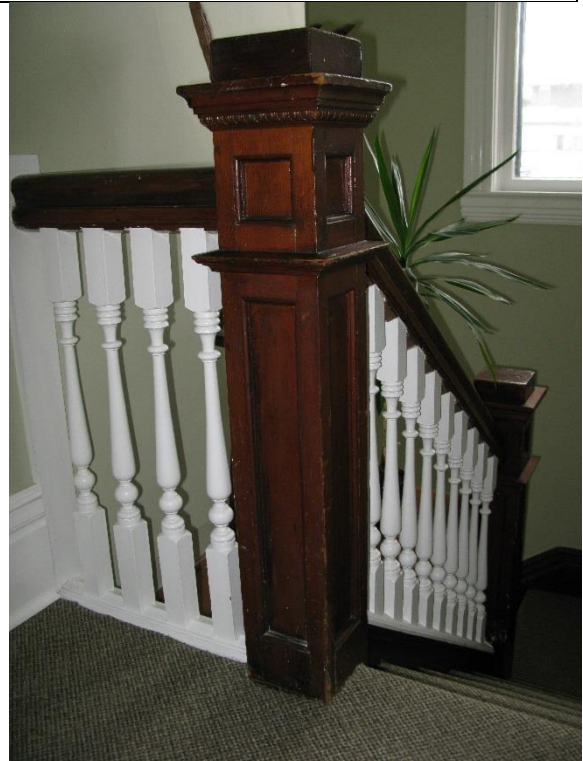
Image #6.3 – The main staircase balustrade
