# **Notice of Motion: Sidewalk Damage and Poplar Tree Review**

Prepared by: Urban Forestry, Parks and Open Spaces, and  
Life Cycle Management, Mobility  
FEBRUARY 26, 2026

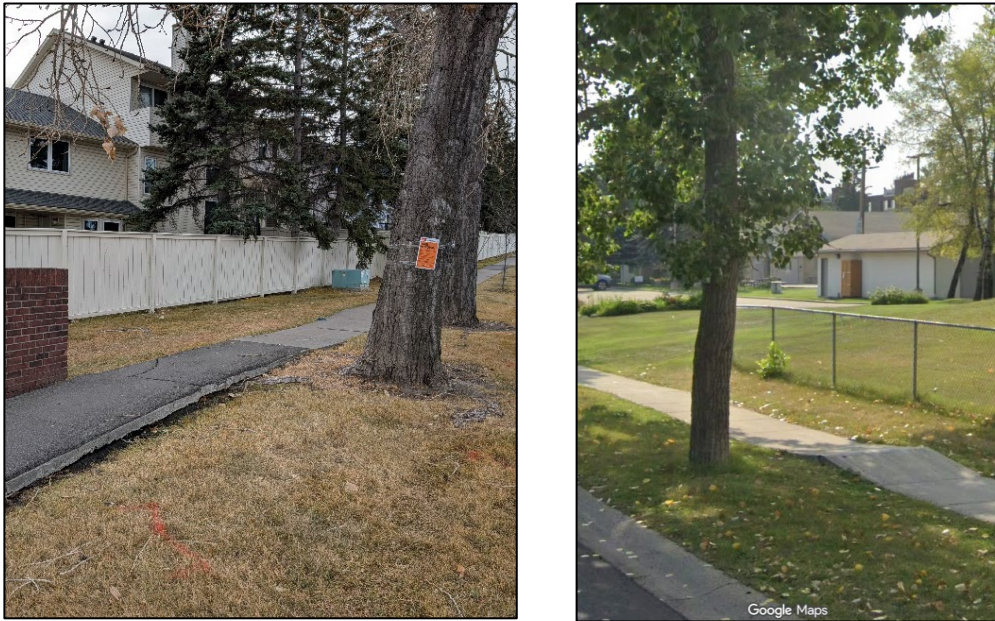
**Figure 1:** Sidewalk heaving damage due to the proximity of a shallow root system. This type of sidewalk damage is observed through many established communities across Calgary.

- Concrete damage was flagged at a severity rating of 3-5 on the asset condition scale. See Figure 1 for examples of sidewalk concrete damage.
- Poplar trees within 10 m of pathways have the potential to cause damage.

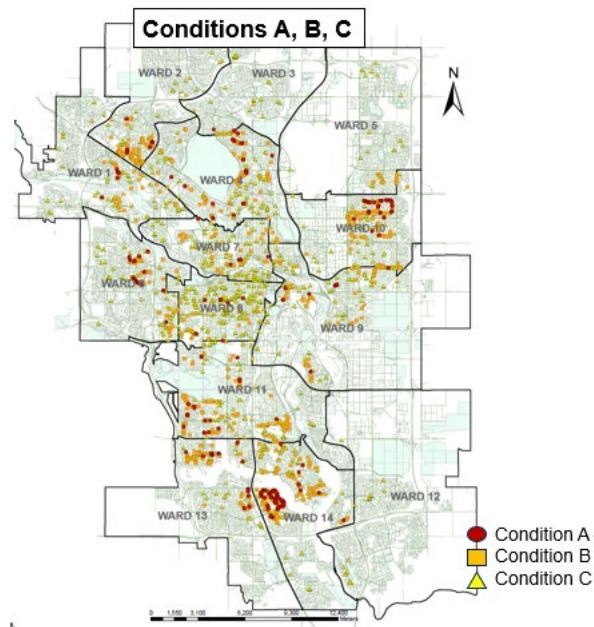
**Figure 2:** Declining poplars within 5 m of poor condition sidewalk concrete.

Desktop scoping was completed by analyzing the GIS asset data sets to identify potential locations where poplar tree roots are causing damage to sidewalks and pathways. All species of poplar trees (eg. *Populus* sp.: *angustifolia*, *balsamifera*, *canescens*, *deltoides*, *deltoides/balsamifera*, *grandidentata*, *jackii*, *nigra*, *salicaceae*, *tremula*, *tremuloides*, *tristis*, *X cultivars*) were buffered by a 5 m proximity to sidewalks and a 10 m proximity to pathways. Ground truthing was conducted at select sidewalk concrete locations to assess assumptions, and this found a positive correlation between sidewalk damage severity 3-5 and poplar tree presence within 5 m. This initial screening provided the target areas for site-specific assessments which would further identify tree health concerns, sidewalk and pathway damage, and provide contextual information to develop damage mitigation processes. Wards 4, 6, 10, 11, 13 and 14 currently have the most sidewalk concrete locations impacted by poplar trees (Fig. 2).

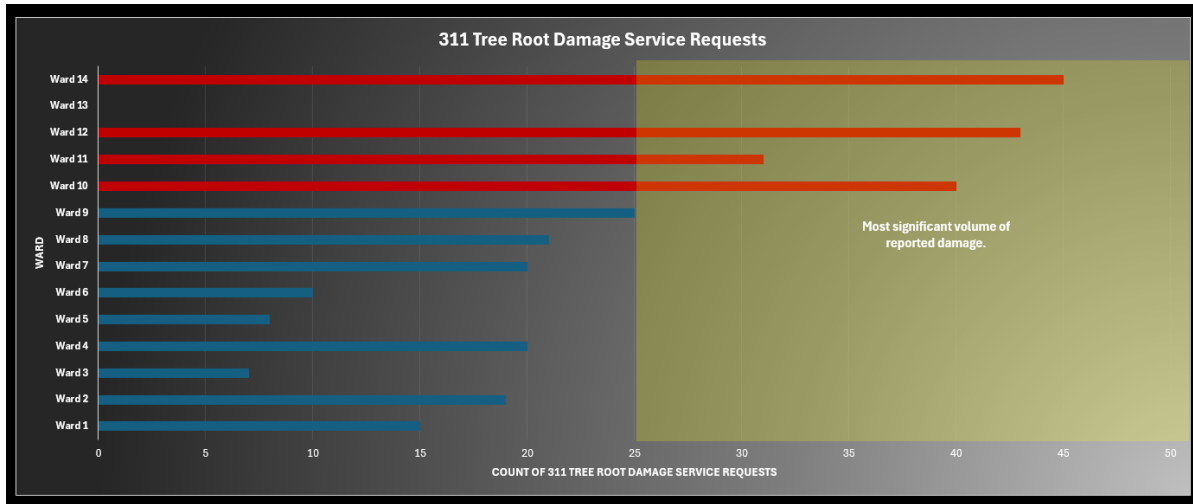
Figure 3: 311 service request log 2024/2025 regarding tree root damage to concrete and private property.

Through a review of 311 service requests, wards 10, 11, 12, and 14 have the most significant volume of reported issues relating to sidewalk and pathway damage from tree root systems, with these wards contributing to over 160 311 Service Requests in a 13-month period from July 2024 through August 2025 (Figure 3). Commonly noted resident concerns include;

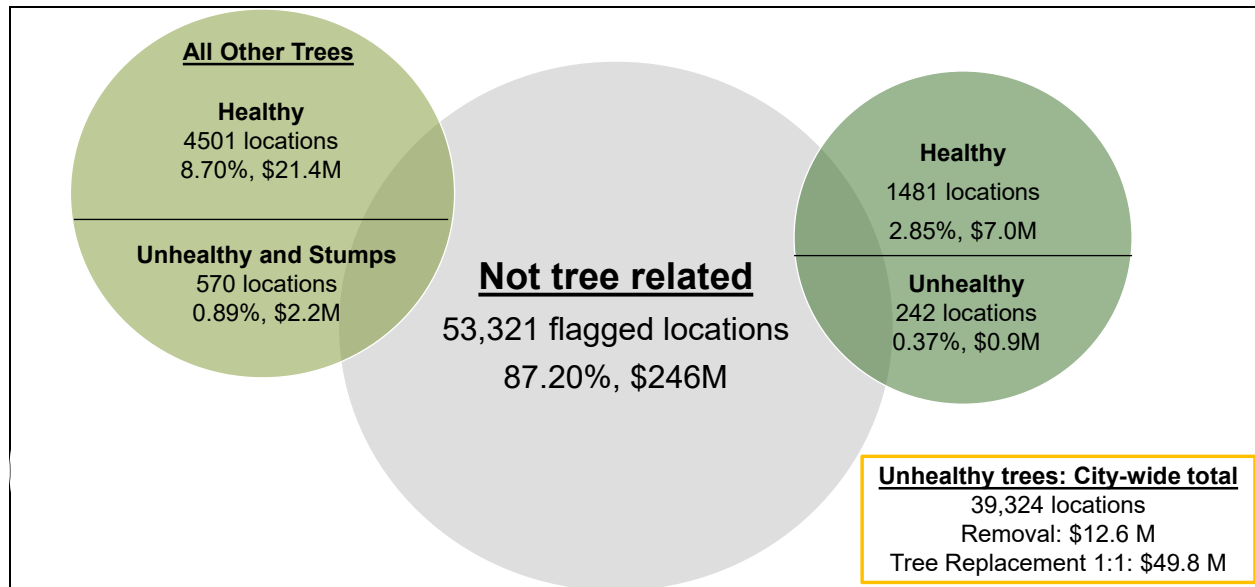
**Figure 4:** Poor condition sidewalk concrete associated with poplar trees, all trees, and unhealthy trees and stumps, and the concrete replacement costs.

Sidewalk condition assessment is completed at a block level as part of the annual life cycle program. Data analysis shows that up to 3.22% of sidewalk concrete damage occurs within a 5 m proximity to poplar trees, with other tree species and stumps responsible for another 9.59% of city-wide sidewalk damage (Figure 4).

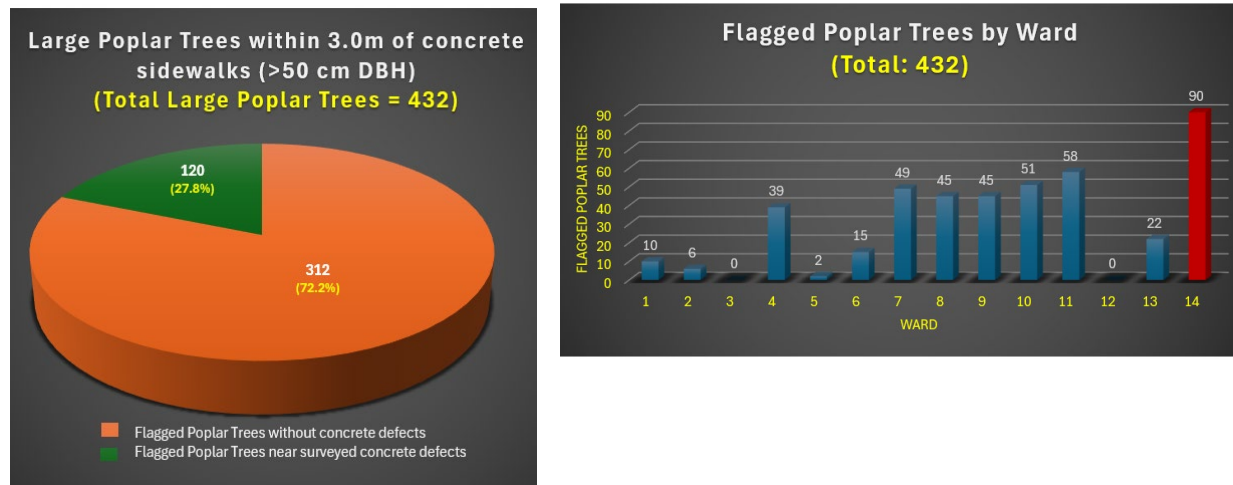
**Figure 5:** Of 432 large poplar trees (eg. >50 cm DBH) within 3 m of sidewalk concrete, approximately 30% of the sidewalk concrete is damaged (e.g. severity 3-5). Ward 14 has the largest number of large poplar trees within 3 m of sidewalks.

A further evaluation was conducted to estimate a method of future sidewalk damage near mature poplar trees. There are 432 large poplar trees (e.g. DBH >50 cm), within 5 m of sidewalk concrete with concrete defects present in 120 locations, an approximately 27% rate of damage (Figure 5). This analysis provides a method to estimate future sidewalk damage near mature poplar trees in the range of a 30% occurrence rate. This anticipation of future damage in proximity to mature poplars can assist UF, Mobility, and Pathways in developing forecasts for repairs and removals as poplar trees age.

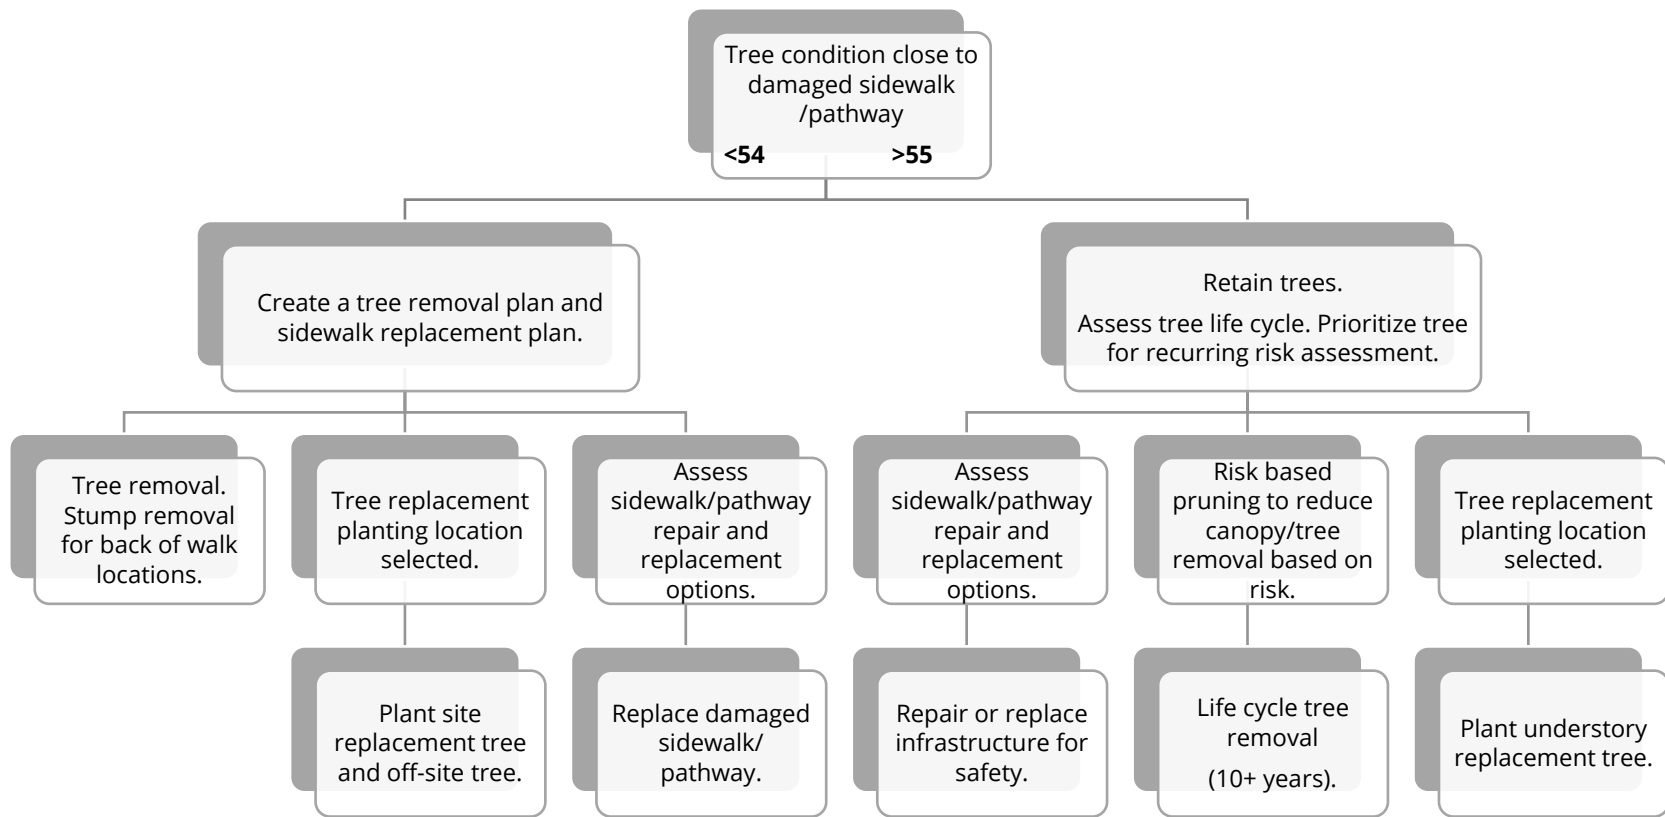
Figure 6: Outline of the poplar tree and sidewalk/pathway assessment and life cycle management process.

A general protocol has been developed to identify life cycle management approaches for tree management, sidewalk and pathway repair and replacement that address concerns of safety, accessibility, and tree canopy succession (Figure 7). Where a poplar tree is in poor condition, in addition to poor sidewalk/pathway condition, the tree would be prioritized for removal. For efficiency, proximate locations of other poplar trees and associated concrete damage would be managed in conjunction with these tree removals. Efficient and aligned mitigation measures may include staggered removals, block-based pruning for canopy reduction and streetscape understory planting to develop the conditions for canopy regeneration as sidewalk conditions are improved.

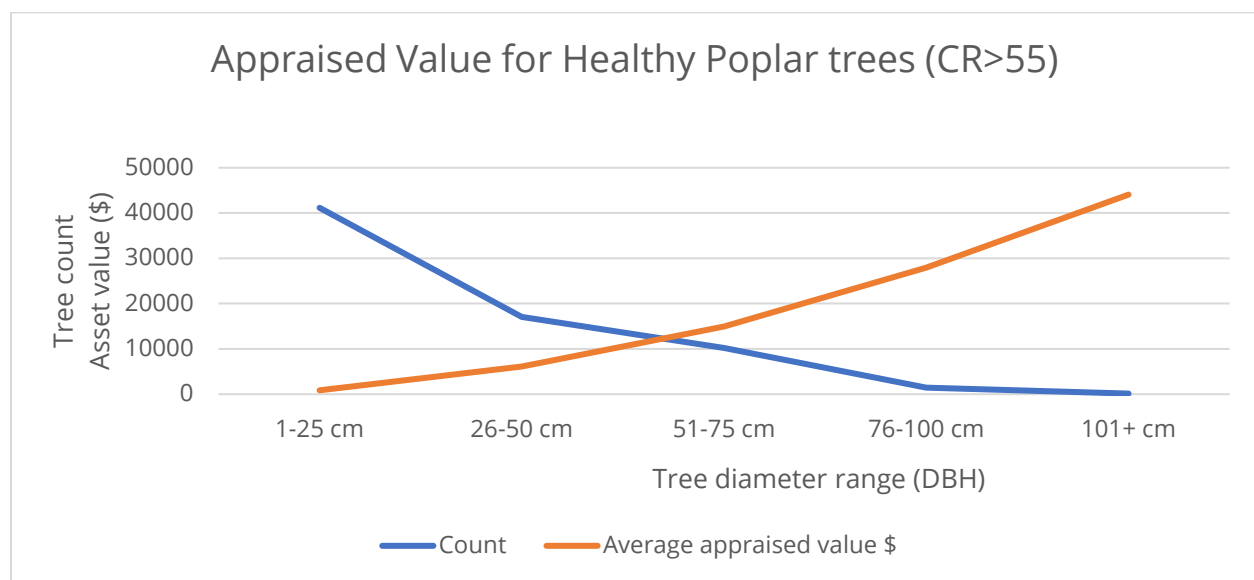
**Figure 8:** Calgary's poplar tree count by size range and corresponding average appraised asset value.

The overall poplar canopy contributes substantially to the urban canopy, as well as to The City's tree asset value, with the largest healthy poplars having the highest value (e.g. Class D and E, \$30 000+) and small, new poplars (e.g. Class A) assessed at \$565, equivalent to the value of a new tree asset (Figure 7).

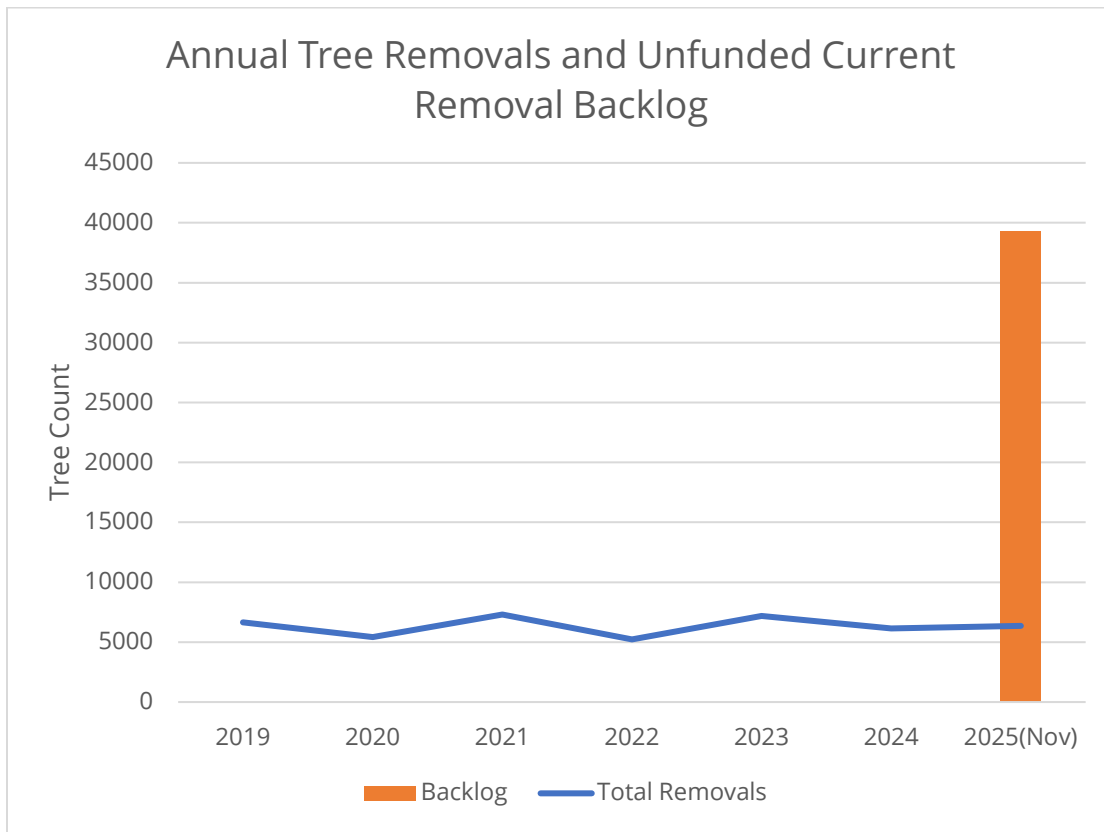
Figure B.1: Summary of the annual tree removal count and current (2025) removal backlog of dead and poor condition assets.

There is a backlog of dead and poor condition trees across the City, in every size class and across many species (Table B.1). Urban Forestry is undertaking an expedited process of dead and poor condition tree removals, beginning with the Class A assets, where a large number of small, developer planted trees, have a negative aesthetic impact on community perception. The 2025/2026 winter target is to remove 10,000 dead Class A trees. The 10-year Urban Forestry Capital Plan has been developed to address the risks associated with dead and poor condition trees, and further work to remove and replace dead and dying tree assets will progress as funding is made available.
