Rectangular Rapid Flashing Beacon (RRFB) Pilot Project Summary Report

Authors: A. Meacham and J. Domarad
Date: 2013/06/12

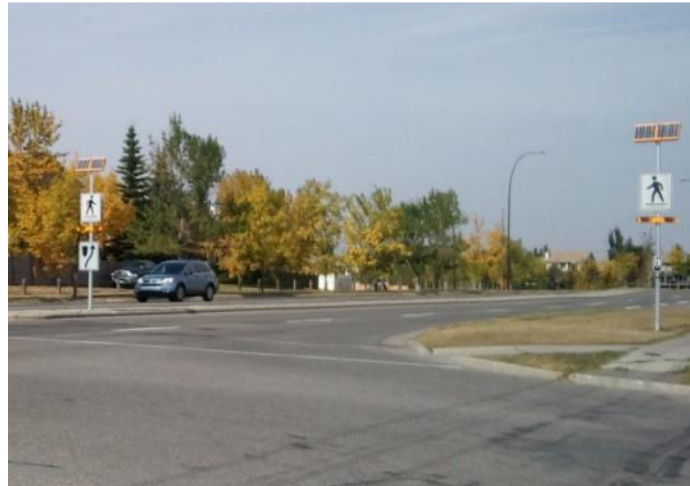
Figure 1: RRFB Treatments

The RRFB is an active control that uses rapidly flashing beacons to alert motorists when a pedestrian is crossing. As shown in Figures 1 and 2, RRFBs are typically installed below the side-mounted pedestrian crosswalk signs on both sides of the roadway (and median if present). They use dual rectangular LED lights to display intermittent rapid flashes and they use solar energy for power.

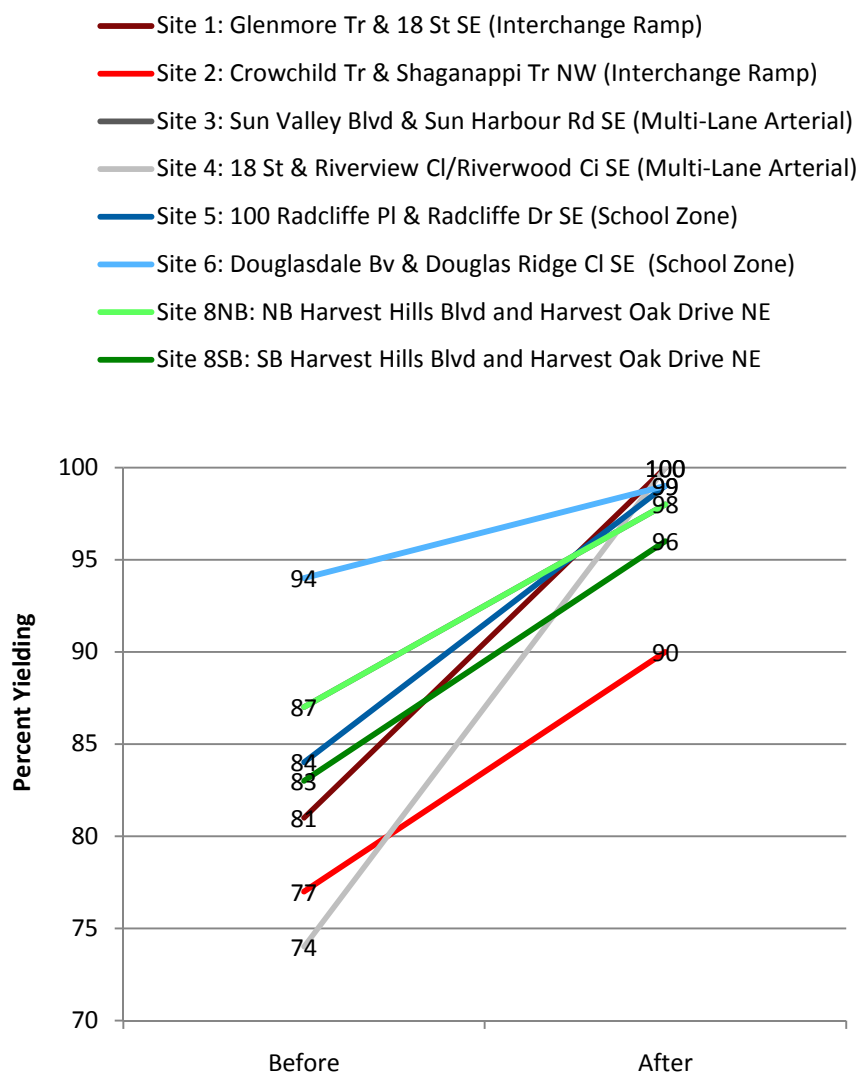
Figure 3: Yielding Compliance Improvements

Results are graphically represented in Figure 3. The highest increase in yielding compliance occurred at Site 4 (18 Street and Riverview Close SE) followed by Site 1 (Glenmore Trail and 18 Street SE). The school zone sites had a better than average yielding compliance during the before period followed by the ramps and the multi-lane arterial site. Site 3 (Sun Valley Boulevard and Sun Harbour Road SE) also had better than average yielding which could be attributed to the proximity to a recreation area with less visual stimulus surrounding the installation.

One location that did not reach close to 100 percent yielding after the installation of the RRFB is Site 2 (Crowchild Trail and Shaganappi Trail NW). The yielding at this location improved for pedestrians crossing eastbound, but there was no improvement for pedestrians crossing westbound. The curvature of the approach along this ramp is likely a contributing factor, as it reduces the intensity of the flasher brightness to an approaching motorist.
