Proposed Wording for a Bylaw to Designate the Riviera Apartments as a Municipal Historic Resource

1. This Bylaw may be cited as “City of Calgary Bylaw to Designate the Riviera Apartments as a Municipal Historic Resource”.

Description of the Historic Place

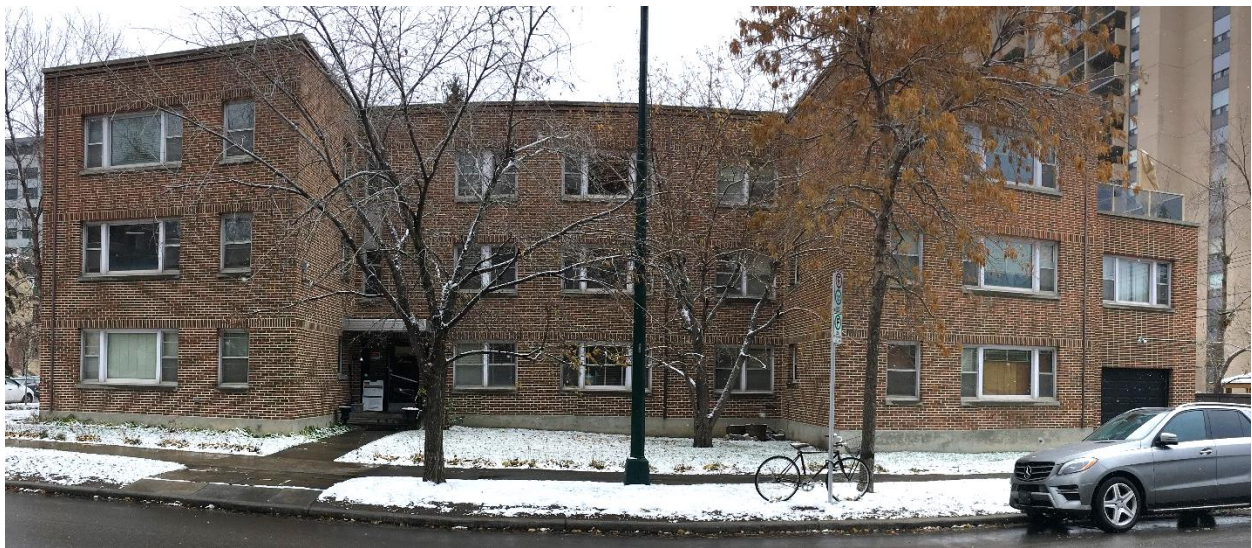
(Image 1.1: west façade)

- a) Red/ brown vertical scored brick exterior wall in running bond; cement parged foundation base (Images 1.1, 1.2);
- b) Brick details including soldier course band above windows at all storeys; stacked bond surrounding stairwell window and on garage wing (Images 1.1, 1.2, 1.3);
- c) Fenestration comprising single and double-assembly wooden frame windows with one-over-one profiles; triple assembly wooden frame windows with one-over-one profiles flanking a fixed sash; concrete window sills (Images 1.1, 1.2, 1.7, 1.8, 1.9); and
- d) The main central entrance with wood doorway assembly, sidelight and overhang (Images 1.1, 1.10).

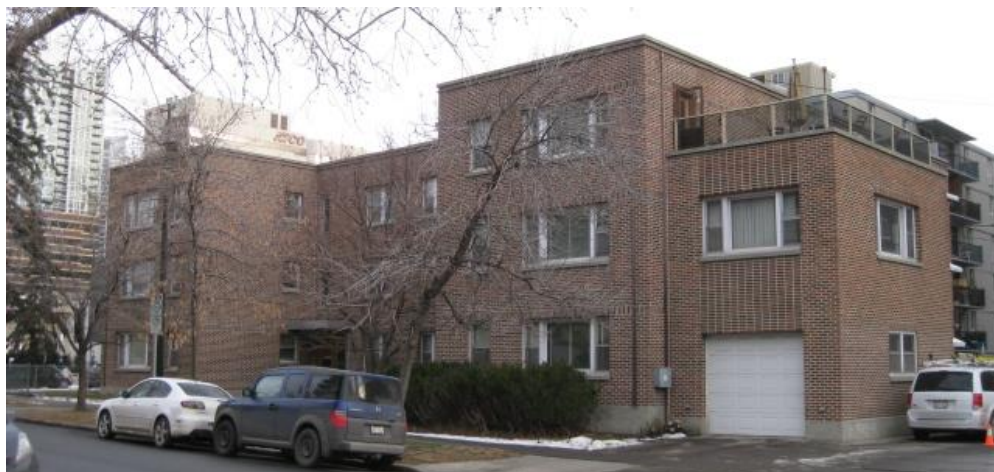
(Image 1.2: oblique view of west façade)

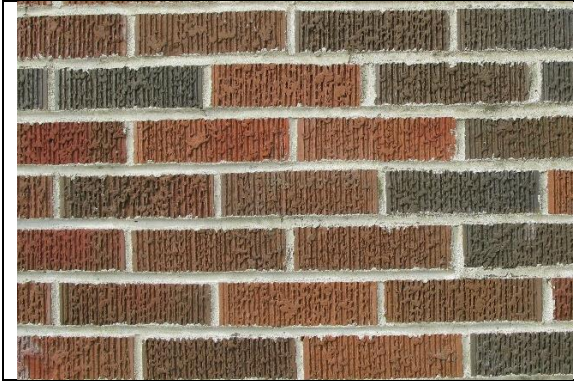
(Image 1.3: example of red/ brown vertical scored brick exterior wall in running bond)

- a) Red/ brown vertical scored brick exterior wall in running bond; cement parged foundation base (Images 2.1, 2.2);
- b) Brick details including soldier course band above windows at all storeys (Images 1.3, 2.1, 2.2); and
- c) Fenestration comprising double-assembly wooden frame windows with one-over-one profiles; triple assembly wooden frame windows with one-over-one profiles flanking a fixed sash; concrete window sills (Images 2.1, 2.2, 1.8, 1.9).

- a) Red/ brown vertical scored brick exterior wall in running bond; cement parged foundation base (Images 3.1, 1.3);
- b) Brick details including soldier course band above windows at all storeys; soldier lintel on garage wing windows (Images 3.1, 1.4);
- c) Fenestration comprising double-assembly wooden frame windows with one-over-one profiles; triple assembly wooden frame windows with one-over-one profiles flanking a fixed sash; concrete window sills (Images 3.1, 1.8, 1.9); and
- d) Third storey rooftop deck over the garage wing (Image 3.1).

- a) Red/ brown vertical scored brick exterior wall in running bond; cement parged foundation base (Images 4.1, 1.3);
- b) Brick details including soldier course band above windows at all storeys (Images 4.1, 1.4);
- c) Fenestration comprising single and double-assembly wooden frame windows with one-over-one profiles; triple assembly wooden frame windows with one-over-one profiles flanking a fixed sash; concrete window sills (Images 4.1, 1.7, 1.8, 1.9); and
- d) Second storey open balcony (Image 4.1).

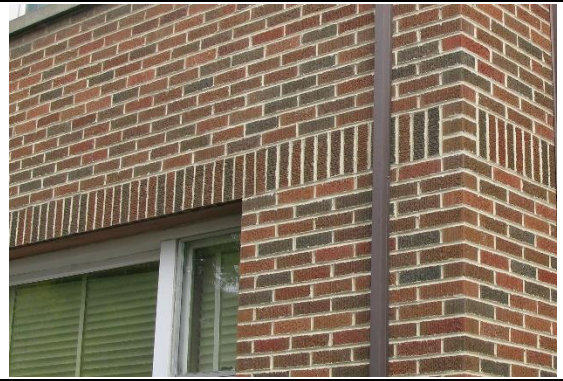
(Image 1.4: example of solid course band above windows)

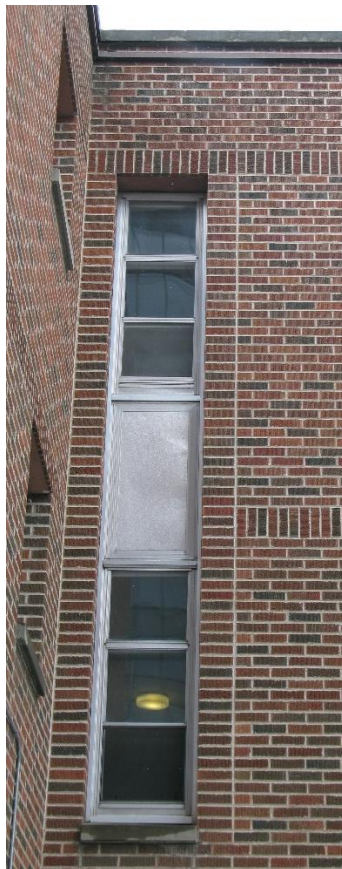
(Image 1.5: stacked bond surrounding stairwell window)

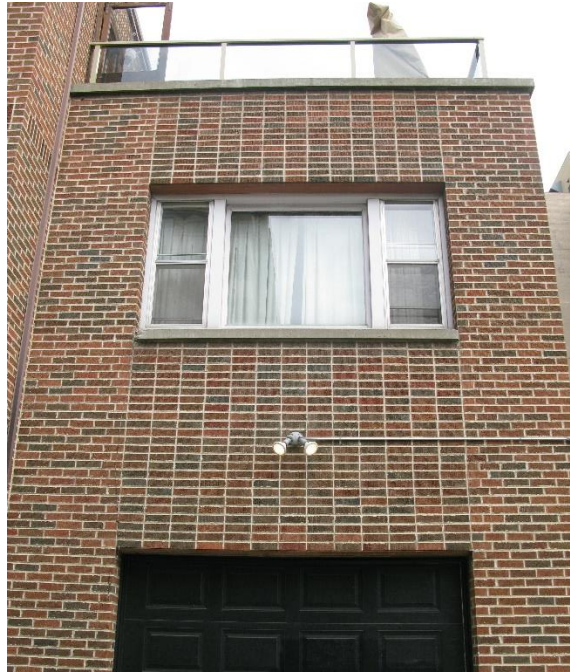
(Image 1.6: stacked bond brick detail on garage wing)

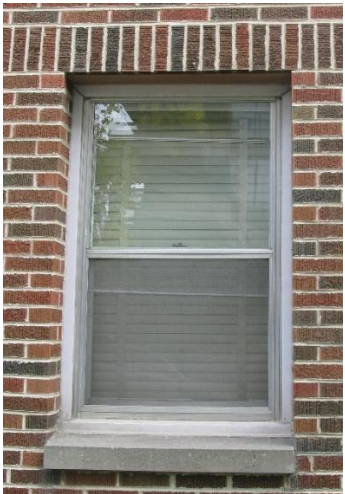
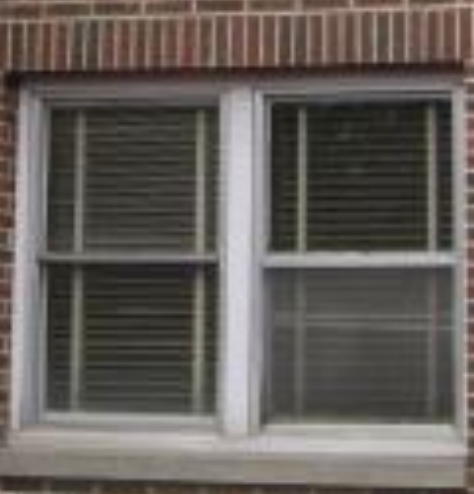
<p>(Image 1.7: example of single assembly wooden frame windows with one-over-one profiles; concrete window sill)</p>	<p>(Image 1.8: example of double assembly wooden frame windows with one-over-one profiles; concrete window sill)</p>

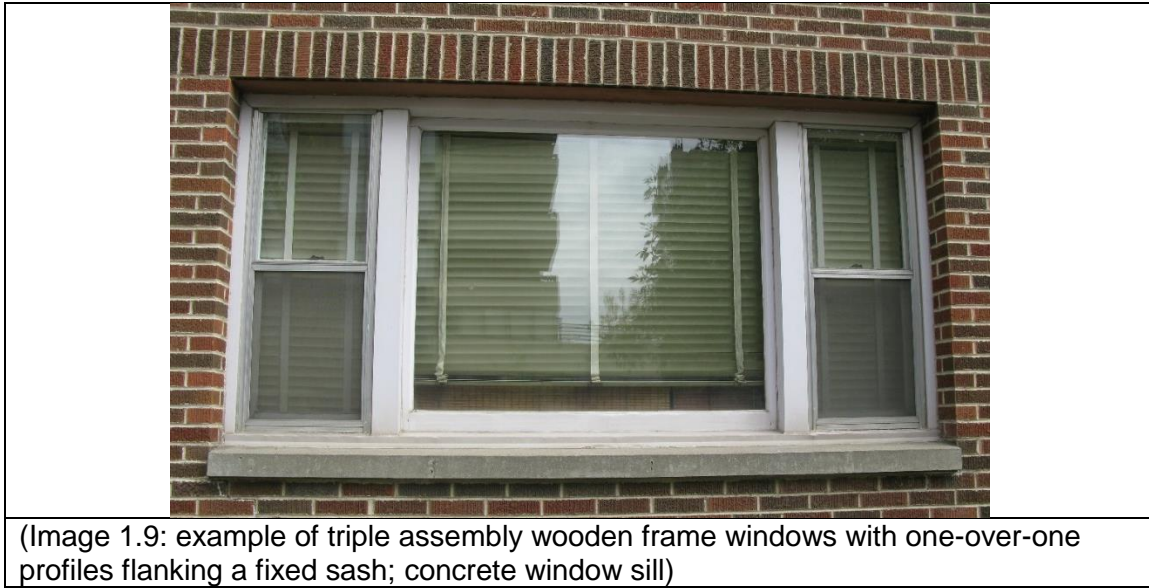
(Image 1.9: example of triple assembly wooden frame windows with one-over-one profiles flanking a fixed sash; concrete window sill)

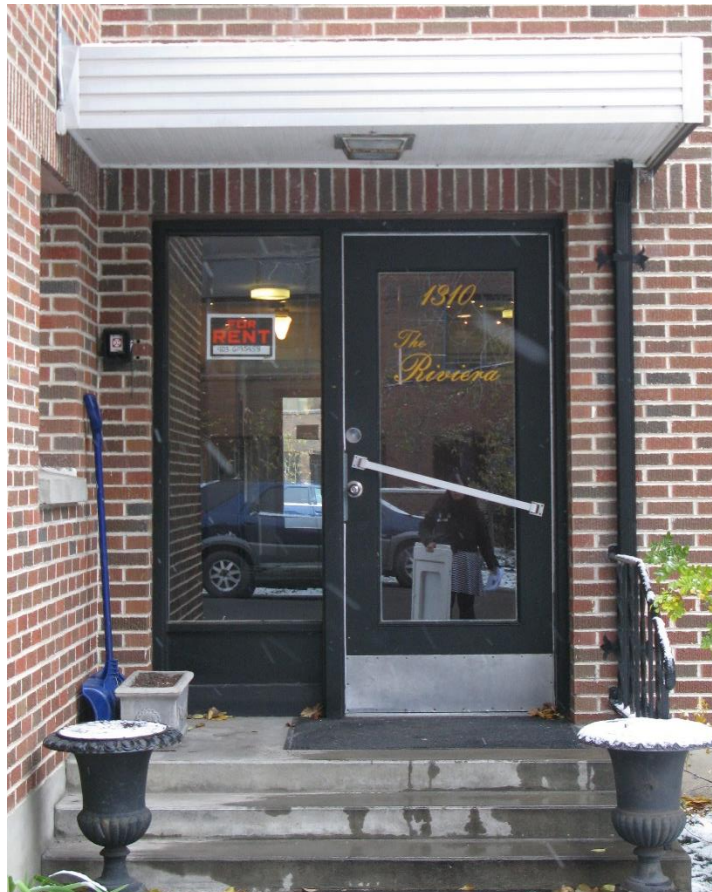
(Image 1.10: the main central entrance with wood doorway assembly, sidelight and overhang)

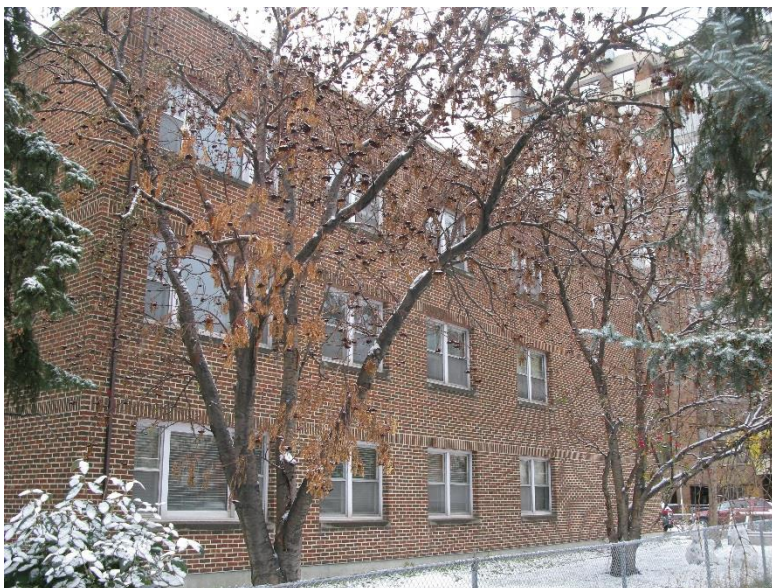
(Image 2.1: oblique view of the north façade)

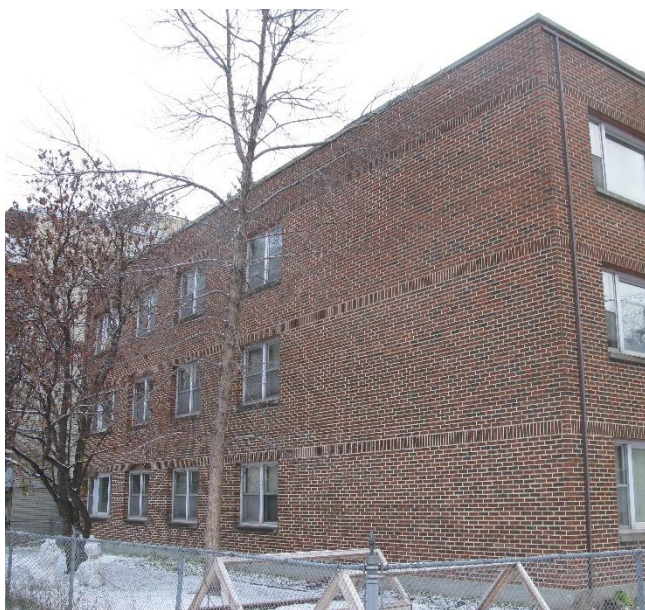
(Image 2.2: oblique view of the north façade)

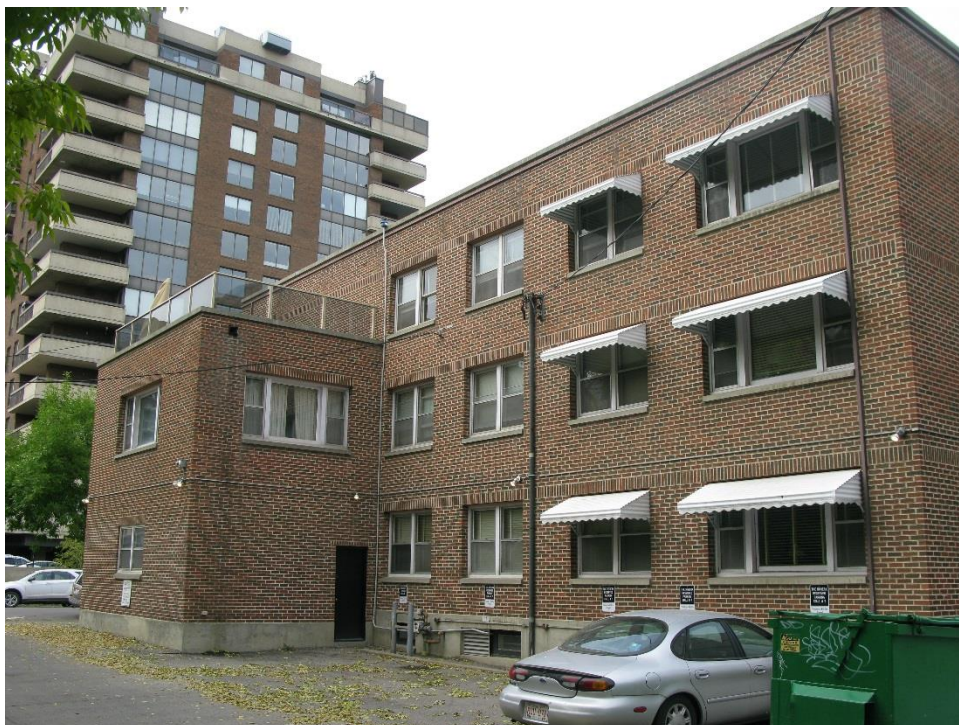
(Image 3.1: south façade)

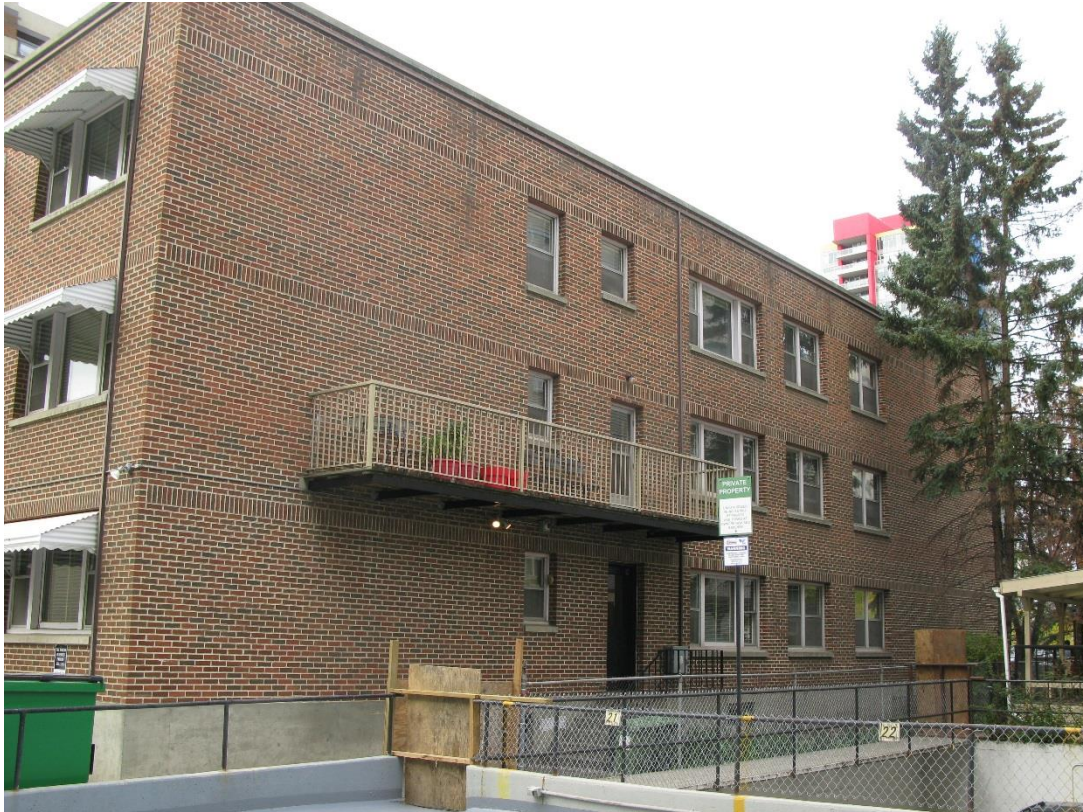
(Image 4.1: east façade)

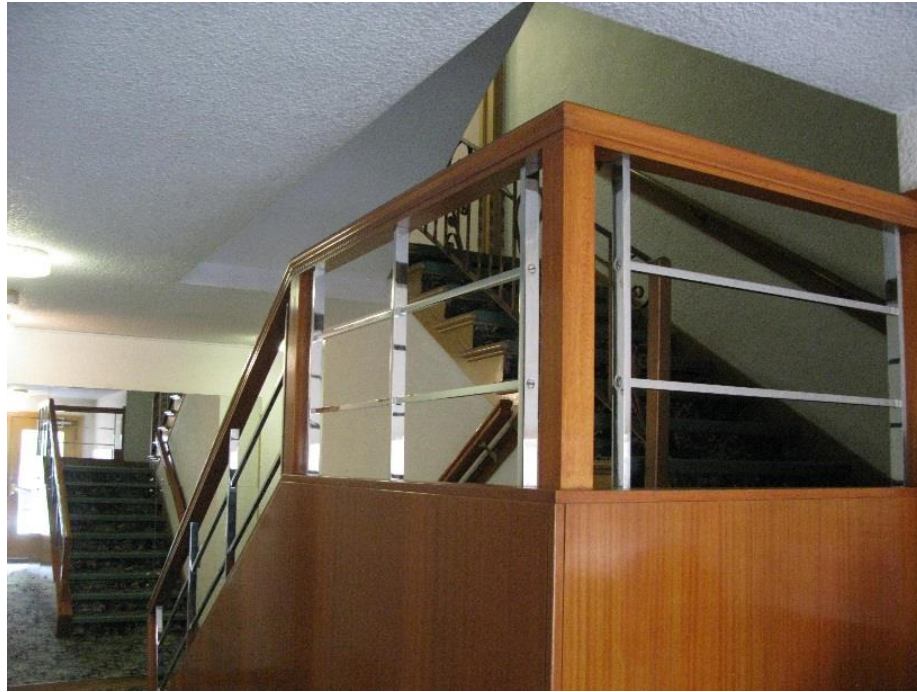
(Image 7.1: lobby main staircase)

- a) Ground floor foyer layout including open staircase with wood handrail and posts, decorative cast iron newels and balusters, and varnished wood panelled base (Images 7.1, 7.2).

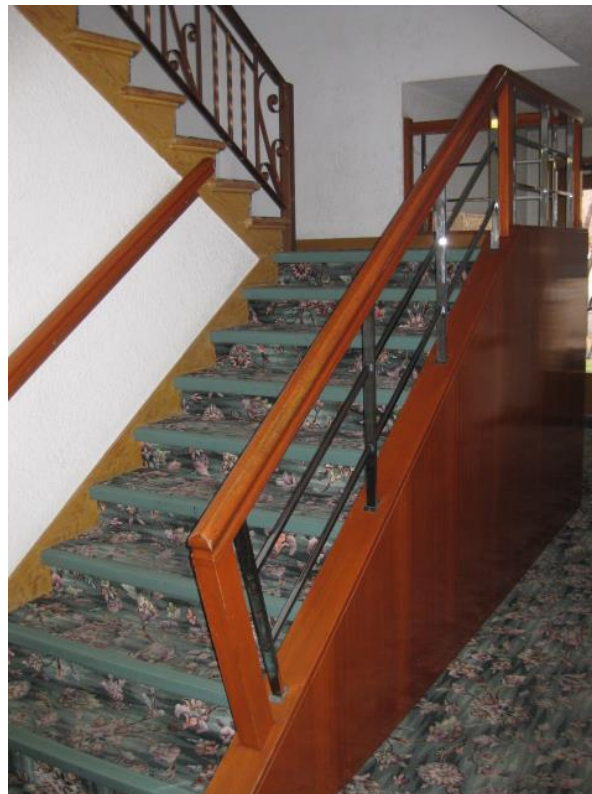
(Image 7.2 lobby main staircase)
