**City of Calgary  
LRT Crossing Safety Review  
Final Report**

## Executive Summary

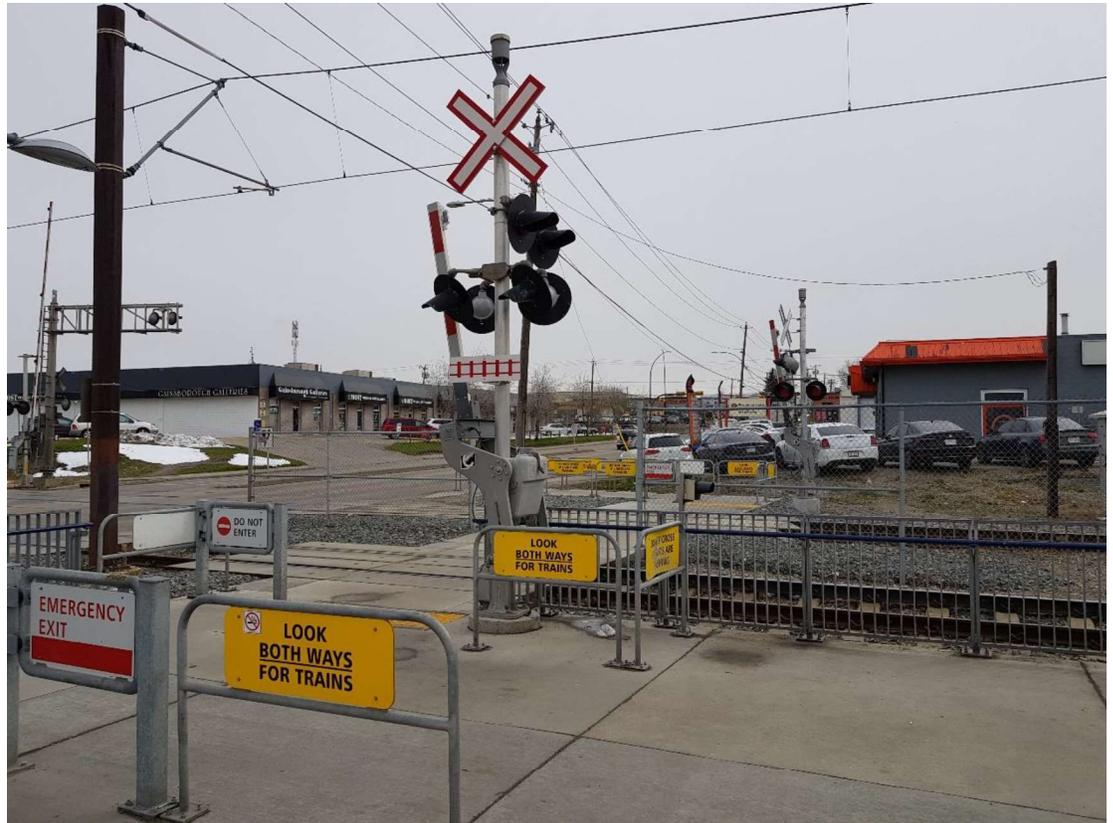
**Figure 6-1 Chinook Station Pedestrian Crossing of Inbound LRT and CPR**

Automatic pedestrian gates were installed on the east and west sides of the center load station platform. The automatic gates replaced bedsteads, with the intent of increasing the compliance with the at-grade crossing warning system. Additional barrier channelization was provided, especially on the CP side. This has proven effective.

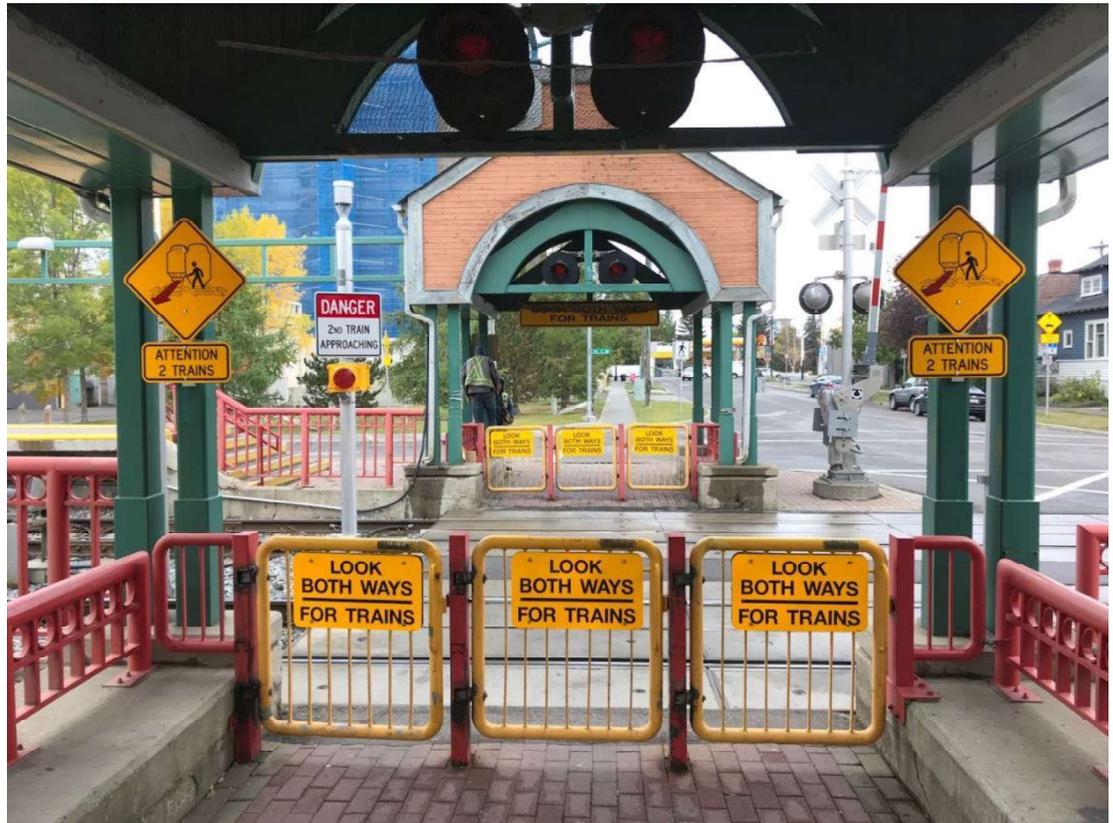
**Figure 6-2 Second Train Warning Signage at Sunnyside Station (Calgary Transit)**

While not common, the use of such active signs is not new to Calgary; the signs installed at SAIT Station were indicated as an innovative feature of the Calgary Transit system in TCRP 69. Calgary Transit has not installed active second train warning signs where pedestrian automatic gates are present. This should be considered as a further enhancement.

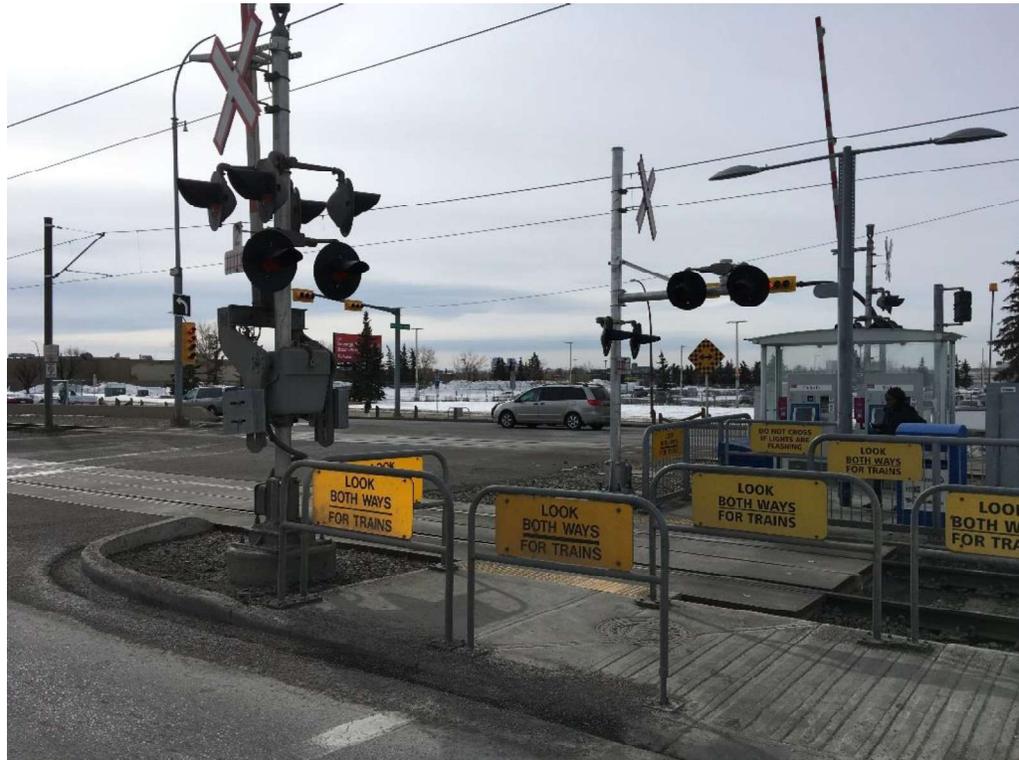
**Figure 6-3 Revised Crossing Signals at Whitehorn Station (Calgary Transit)**

The flashing light signals for the pedestrian at Whitehorn drive have been lowered and a cantilevered signal installed so that the warning devices directly face the pedestrians. Similar changes were previously made at 61 Avenue SE (Chinook Station) and at 25 Ave SE (Erlton/Stampede Station) and found to reduce non-compliance. Additional bedsteads were also installed at Whitehorn to create overlap and better channelization. Additional warning time was provided for outbound train movements at Whitehorn.

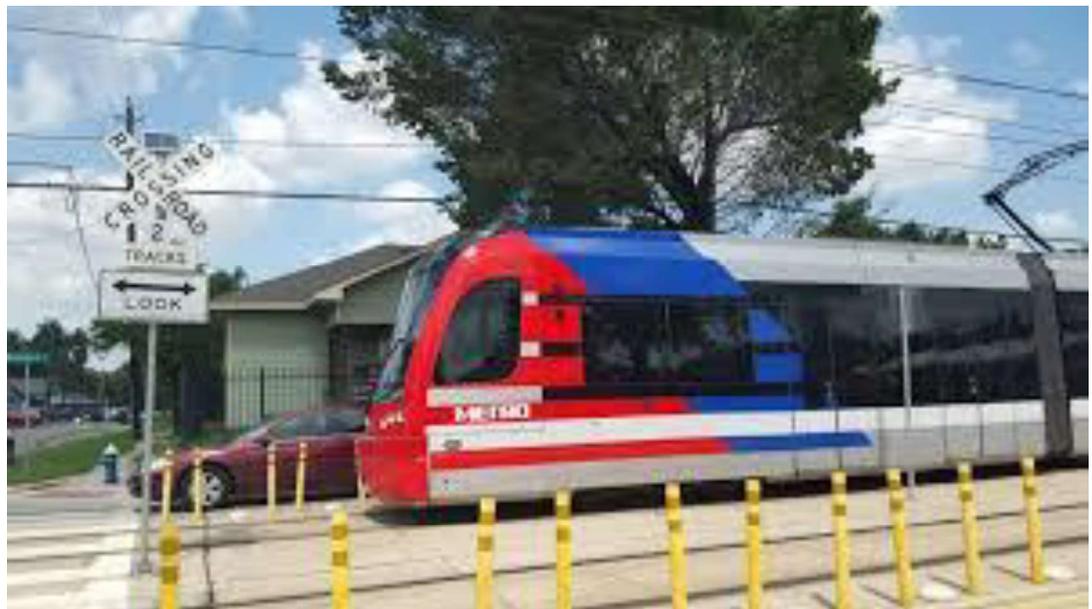
**Figure 7-1 Passive Crossing Warning Signals (houstonpublicmedia.org)**

The US MUTCD recommends flashing light signals with an audible device for pedestrian crossings where it is determined that the sight distance is not sufficient for pedestrians to complete their crossing prior to the arrival of the LRT at the crossing or where LRT speeds exceed 55 km/h (35 mph). The treatments applied at pedestrian crossings vary greatly, with many agencies only installing passive signage only.

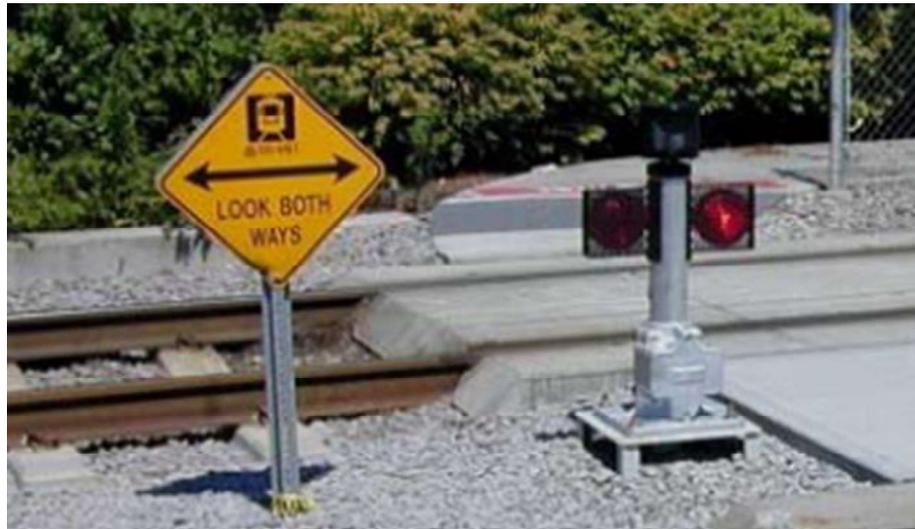
**Figure 7-3 “Portland Style” Pedestrian Flasher**

It is noted that, there is also a wide variety of flashing light signals for pedestrian applications employed by US transit agencies. The US MUTCD does show smaller pedestrian warning signals. The various TCRP reports have identified a variety of alternative pedestrian signals; in all instances they locate the warning signals much lower so that they are in the pedestrian's cone of vision.

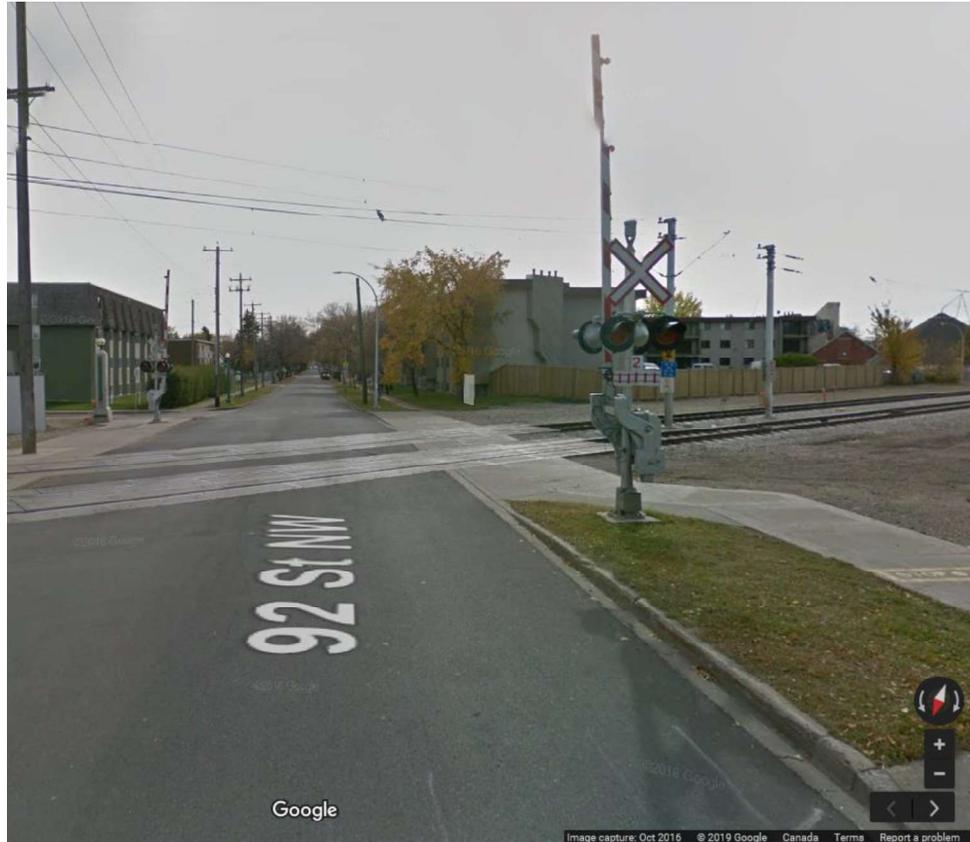
**Figure 7-6 Warning Devices at 92 St NW LRT Crossing (Google)**

Analysis Report. Train speeds at most at-grade crossings of the Valley Line Stage 1 are 55 km/h or less and traffic control devices will be employed instead of flashing lights with gates and bells.

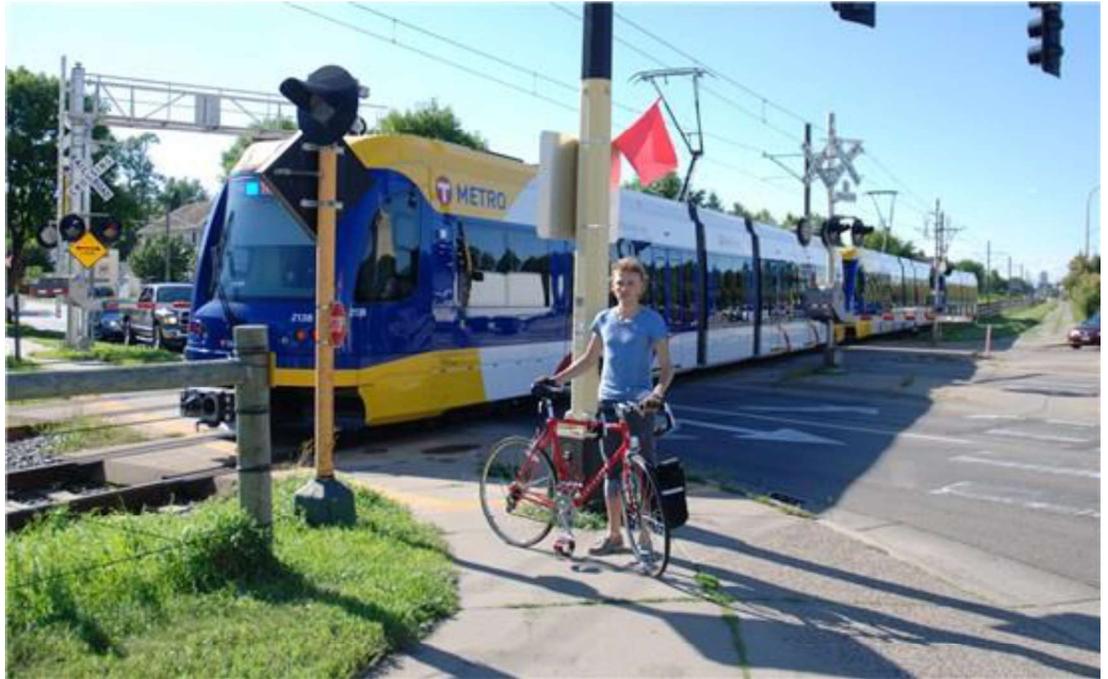
**Figure 7-7 Metro Crossing (metrotransit.org)**

In semi-exclusive alignments, flashing lights with automatic gates and bells are provided for roadway traffic. Flashing lights are provided for pedestrian traffic where necessary. Pedestrian automatic gates are also employed. This philosophy is to continue on the proposed Blue Line extension which, while providing pedestrian flashing light signals, employs bedsteads and not pedestrian automatic gates.

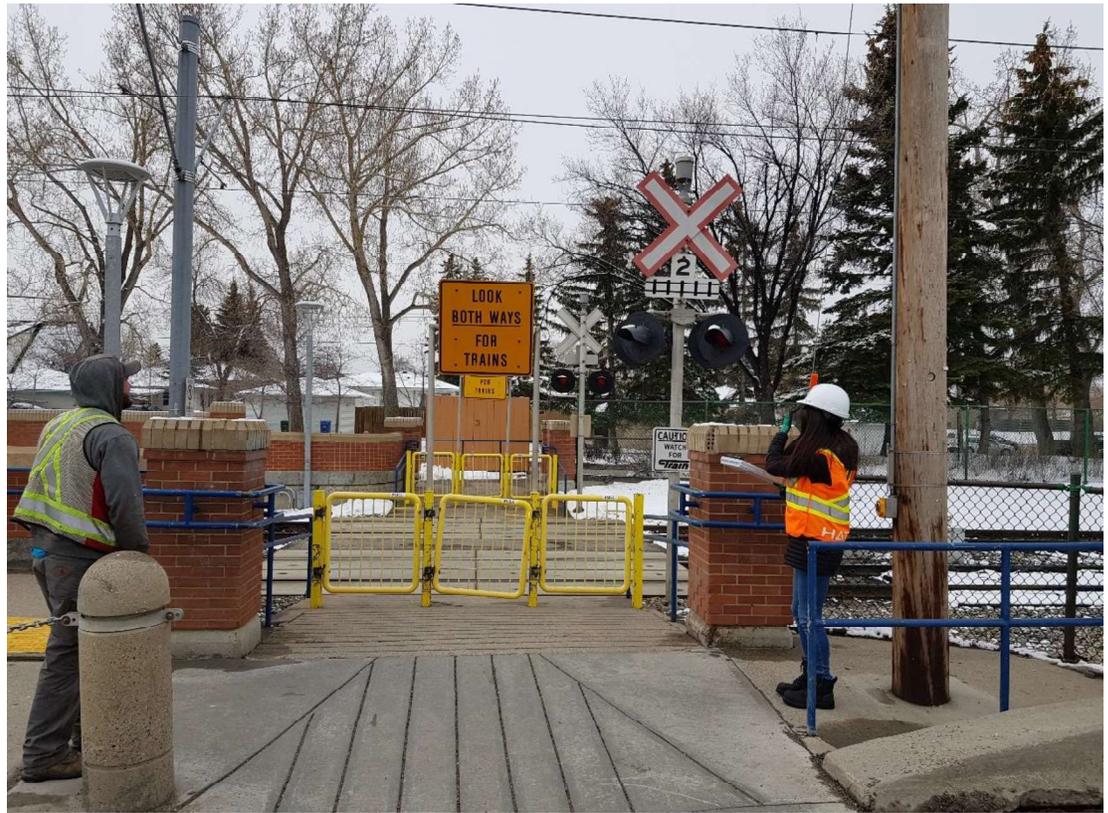
**Figure 8-2 Lions Park West End Pedestrian Crossing**

It should be noted that the swing gates are now felt to create accessibility issues for people in wheelchairs. The user must pull the gate towards themselves and maneuver past the gate.

Two minor issues were noted with the existing warning devices. The top hinge on the center swing gate on North (East) side is broken. Gate still somewhat operable but does get stuck. The crossing sign for northward direction is present but extremely faded.

The addition of active second train warning devices should be considered. The replacement of swing gates with pedestrian automatic gates should be considered.

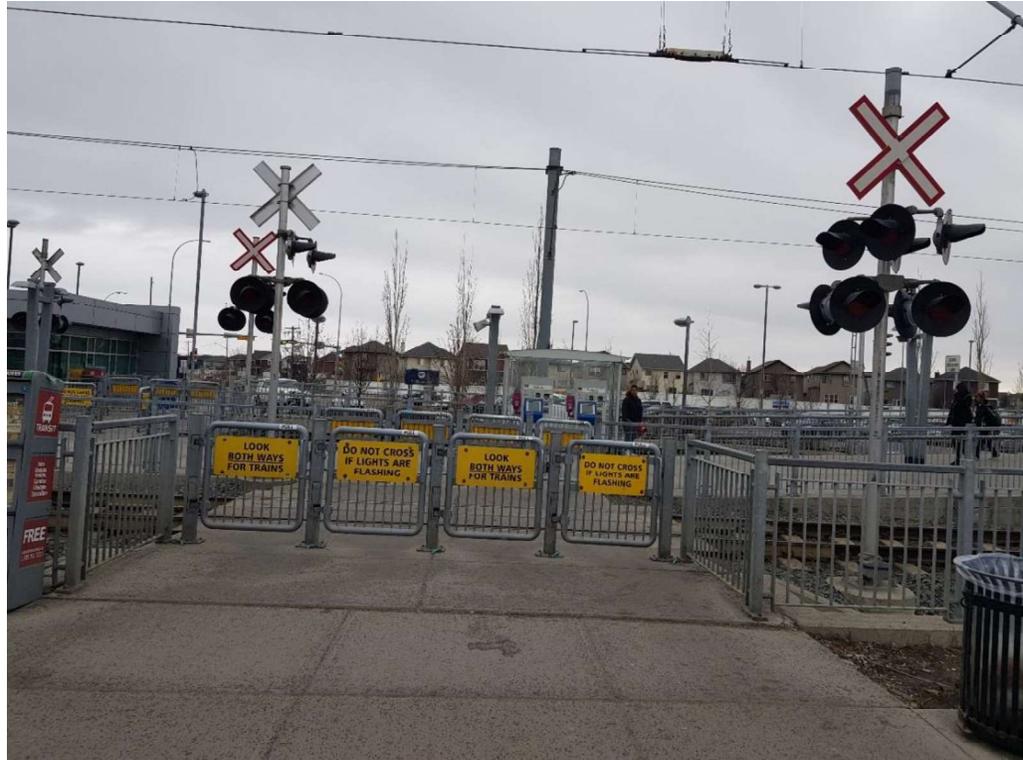
**Figure 8-3 Saddle Towne South End Pedestrian Crossing**

The warning devices for the inbound and outbound tracks operate independently.

It should be noted that the swing gates are now felt to create accessibility issues for people in wheelchairs. The user must pull the gate towards themselves and maneuver past the gate.

One minor issue was noted with the existing warning devices. One of the swing gates remained open and would not return to closed position on its own..

The replacement of swing gates with pedestrian automatic gates should be considered.

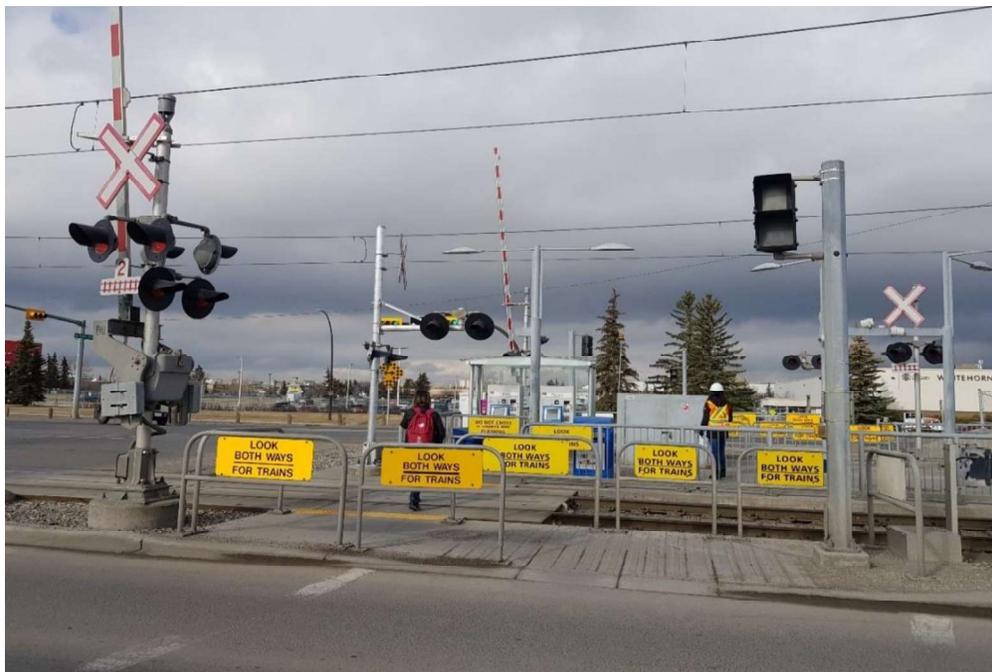
**Figure 8-4 Whitehorn Drive Crossing**

This location has a significant number of near miss reports. Information concerning pedestrian fatalities is found in Appendix C: Confidential Data.

The pedestrian flashing light signals have been lowered and extra cantilever assemblies have been installed.

Pedestrian compliance with traffic and at-grade crossing warning signals would benefit from splitting the operation of the at-grade crossing warning signals so that the inbound and outbound tracks operate independently. PSE has noted that pedestrians are ignoring the warning signals, resulting in an undesirably high number of near miss reports. This operation would be similar to that at 25 Ave SE (Erlton/Stampede Station). Changes are planned as soon as funding is available.

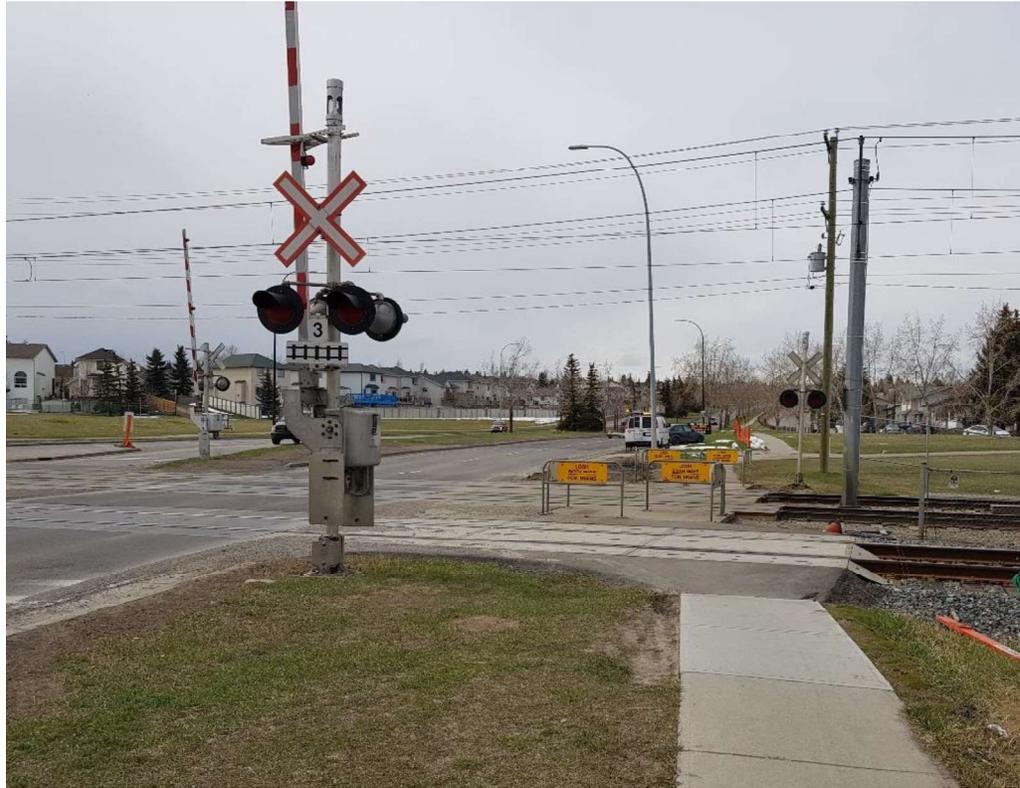
**Figure 8-5 162 Ave SW Crossing**

This location does not have a significant number of near miss reports. Pedestrian traffic is light. Information concerning pedestrian fatalities is found in Appendix C: Confidential Data.

The addition of active second train warning devices should be considered. The replacement of bedsteads with pedestrian automatic gates should be considered.

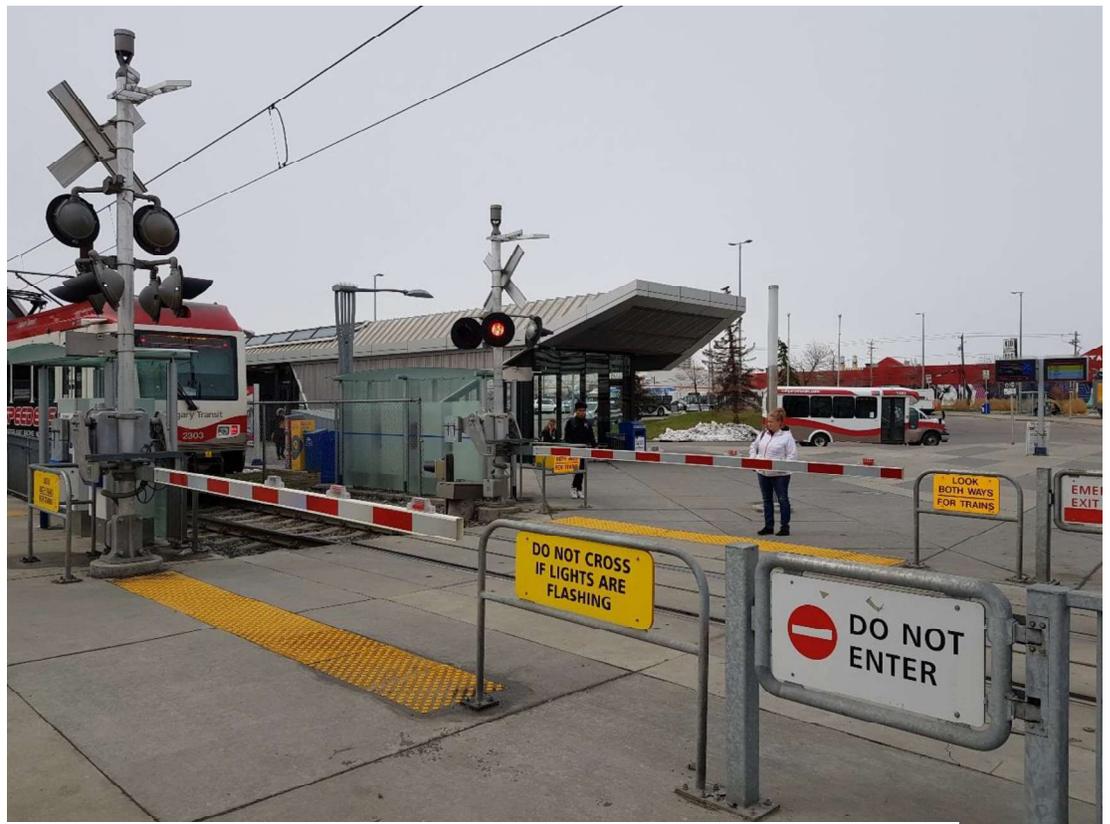
**Figure 8-6 61 Ave SE Crossing**

The pedestrian warning devices on the south side of 61 Ave for the inbound and outbound tracks operate independently.

Signal Masts C&D are missing the "2" tracks signs.

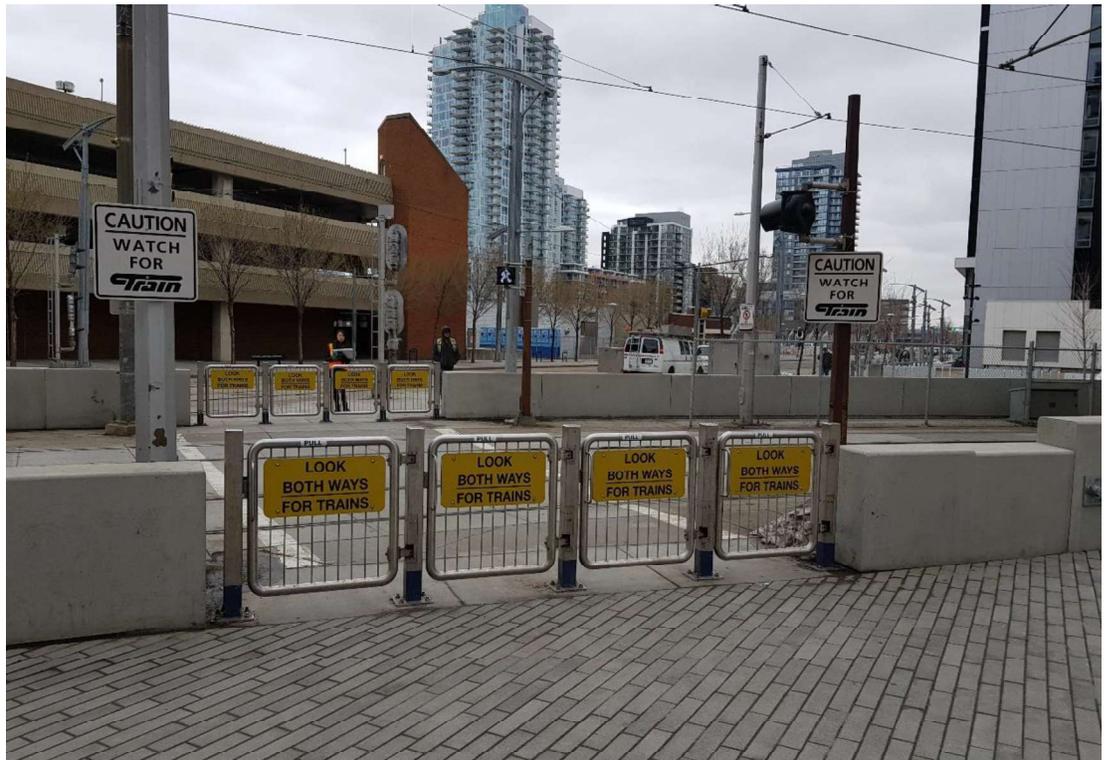
**Figure 8-7 7 Ave at 3 St SE Library Pedestrian Crossing**

- A pedestrian crossing on the west side of 3rd Street which crosses both the Red Line and the Blue Line. This crossing is controlled by traffic lights and walk/don't walk indicators.
- A pedestrian crossing on the east side of 3rd Street which crosses the Blue Line. This crossing is controlled by traffic lights and walk/don't walk indicators.
- A pedestrian crossing slightly east of 3rd Street which crosses the Red Line, near the library. This crossing is protected by a warning system consisting of walk/don't walk indicators, swing gates and a bell.

This crossing is located at the eastward extent of the in-street limits.

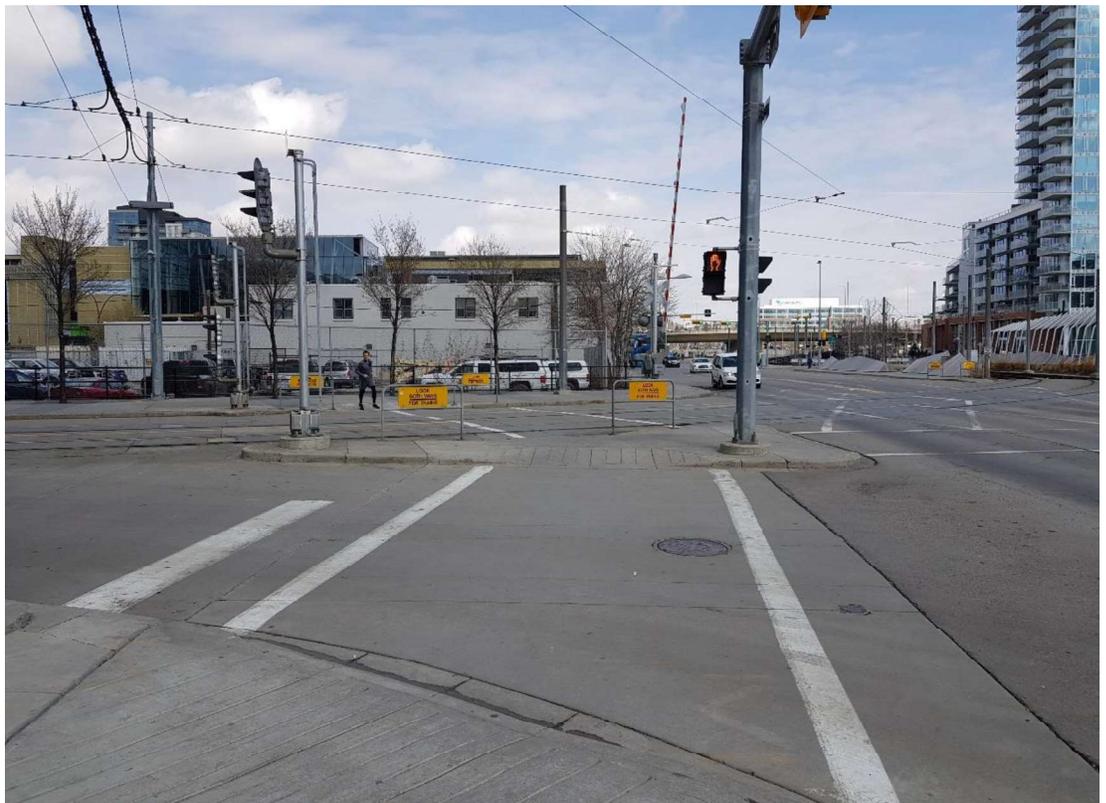
**Figure 8-8 7 Ave at 4 St SE Pedestrian Crossing**

While looking at the approaches for the 3 St SE crossing, it was noticed that there is a pedestrian crossing located just west of 4th Street East that only has some channelization; there are no pedestrian signals or crossing warning signals provided. The adjacent road crossing has flashing lights with bell and gates and the pedestrian crossing on the east side of the road has bedsteads. We recommend that this pedestrian crossing be assessed and warning devices added as appropriate.

This issue has also been identified by Calgary Transit and Calgary Roads. The addition of flashing lights with pedestrian automatic gates, bells and second train warning signs is under review. The addition of cantilevered flashing light signals and bedstead barriers is currently being considered as a nearer term improvement.

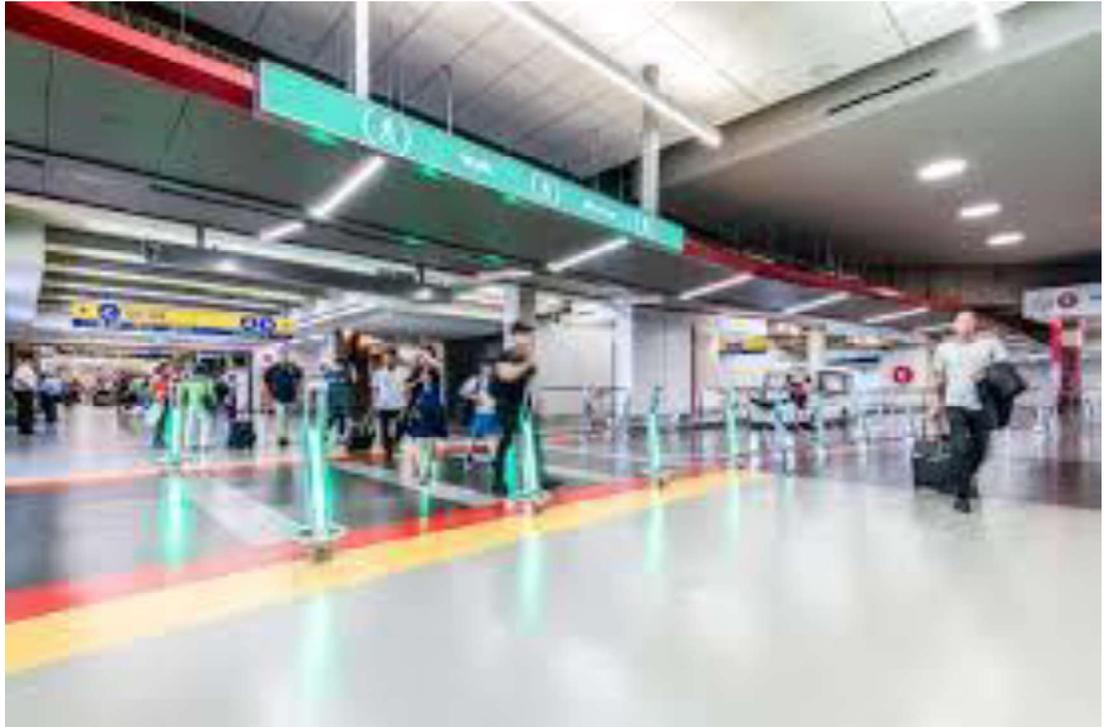
**Figure 10-2 Non-traditional Warning Lights – YYC Airport Link (GEC Architecture)**

Solutions include mounting warning devices lower. Alternative treatments have been employed elsewhere as shown in Figure 10-2 and Figure 10-3. The example treatments place LED lights in barriers or in the pavement. While these solutions would be problematic due to Calgary's climatic conditions, they have the potential to address placement of warning information in the pedestrian's cone of vision.

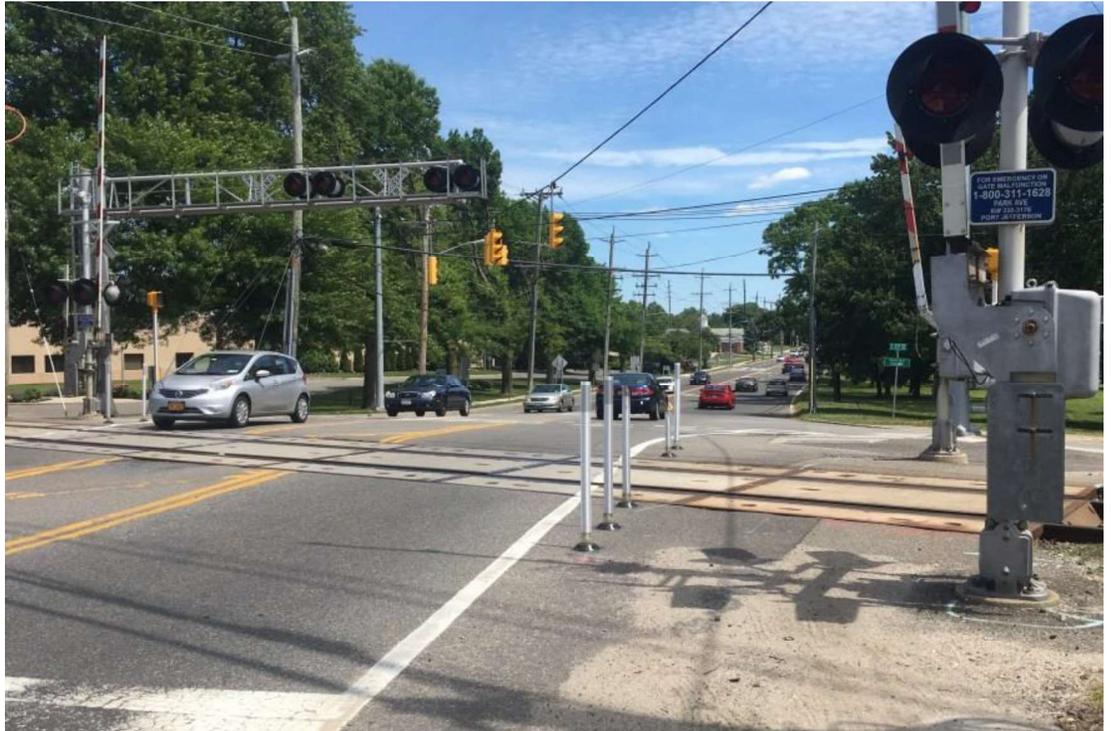
**Figure 10-4 Crossing Edge Markings on LIRR (Huntington NOW)**

LIRR has employed extended roadway markings, flexible, four-foot high reflective delineators and additional reflective devices to better alert drivers. that they should not make a turn onto the tracks. LIRR has also partnered with Waze to alert motorists using the app that they are approaching a grade crossing.

Within Calgary, this issue is most evident along 7 Avenue SE and SW and 36 Street NE. Calgary Transit is coordinating improvements to street lighting and is examining the installation of delineators.

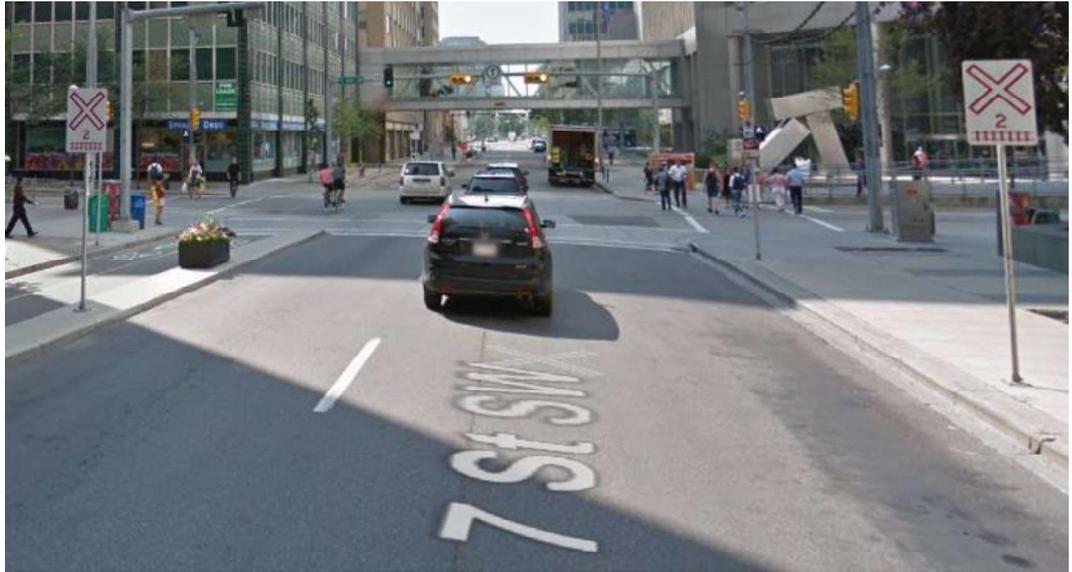
**Figure 10-5 7 Ave at 7 St LRT Signage (Google)**

In the case of 7 Avenue, each intersection is bounded by clearly marked crosswalks, with overhead signage indicating that turns onto 7 Avenue are not permitted (RB-15 Turns Prohibited Sign). Due to busses and emergency vehicles employing 7 Avenue, it is not possible to square off the corners of the intersection to further discourage turning movements.

The LRT crossing signage near 7 Avenue is inconsistent (both in terms of the signs employed and placement) and should be standardized. Signage is missing for the cycle tracks in one direction (opposing direction to road traffic). Calgary Transit and Calgary Roads have conducted a review of signage for the LRT system in downtown and have developed a plan to address this issue.

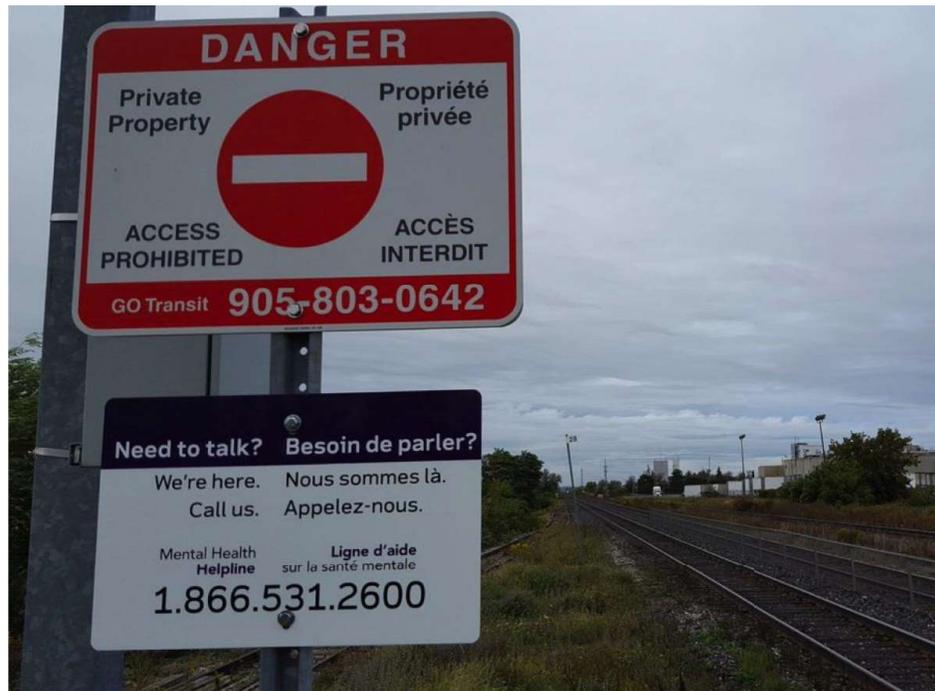
**Figure 10-8 Mental Health Helpline (Metrolinx)**

To supplement the access prohibited signs, Metrolinx (GO Transit) now posts mental health helpline numbers at points of access to the ROW, including at the end of station platforms. The effectiveness of such signs is currently not known.

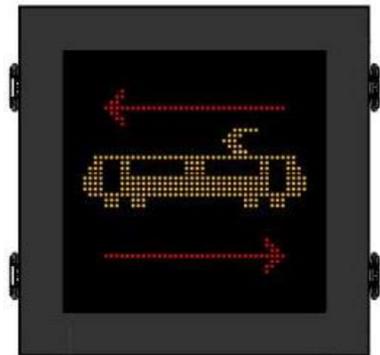
**Figure 11-1 Active Blankout Second Train Warning Sign**

For the Green Line Stage 1, active blank-out signs, similar to those employed in Portland, are being recommended.

The use of second train warning signage is intended to supplement the current Calgary Transit practice of training drivers to pass each other while in the crossing surface.

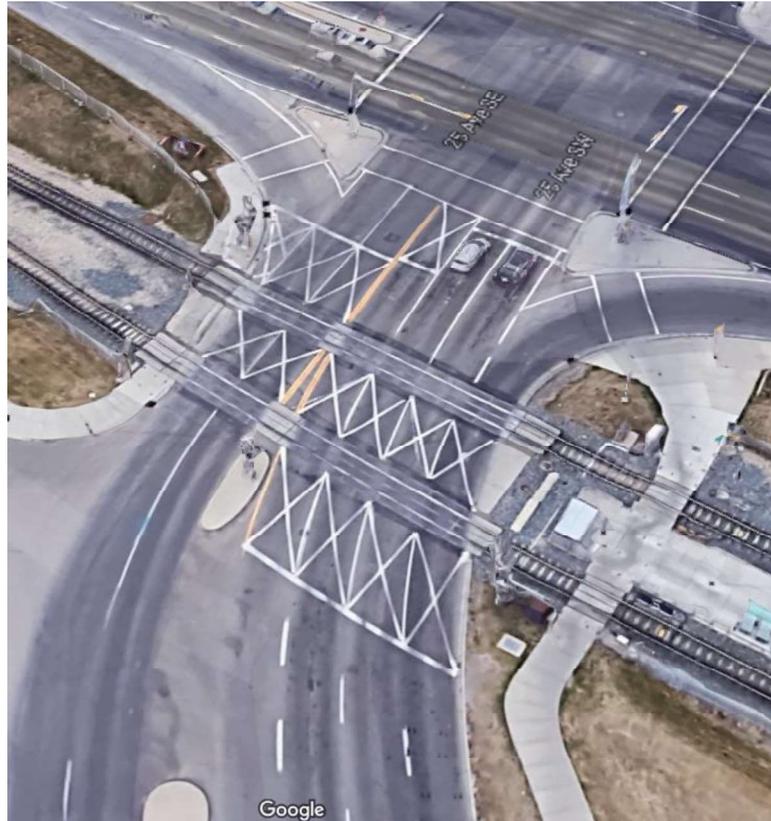
**Figure 11-4 Keep Clear Zone Markings**

To provide mitigation against motorists stopping on tracks, the "Keep Clear" zone should be indicated. Historically, this has been done in Calgary as shown in Figure 11-4. Do Not Stop on Tracks Signs (RB-59) should be installed in conjunction with the pavement markings.
