1. This Bylaw may be cited as "City of Calgary Bylaw to Designate the Gerlitz Residence as a Municipal Historic Resource".

SCHEDULE "B"

Description of the Historic Place

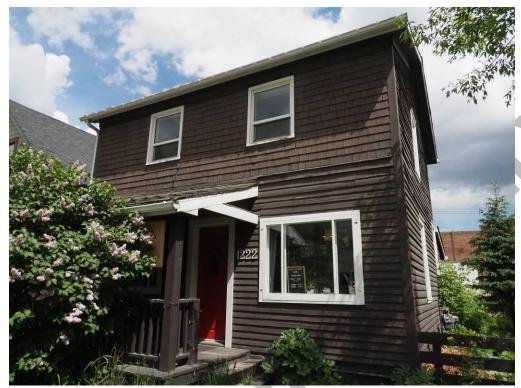
(Image 2.0 – South façade)

- The two-storey form and configuration with a rectangular plan, and rear full-width one-storey extension (Images 2.0-2.3);
- The wood-frame construction on a concrete block foundation:

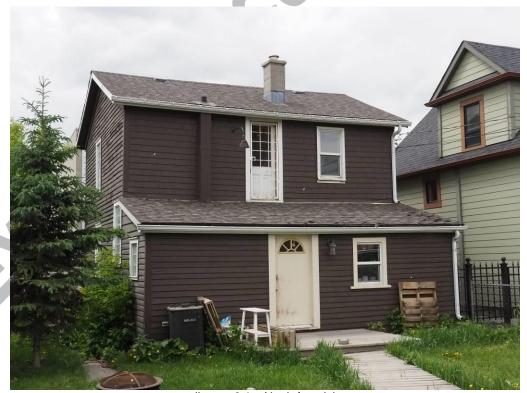
(Image 2.1 – North façade)

- The medium-pitched, side-gable roof; shed roof above one-storey extension and front verandah; overhanging eaves with plain wooden soffits and frieze; plain fascia and verge boards (Images 2.8-2.9); internal rear chimney (Image 2.1);

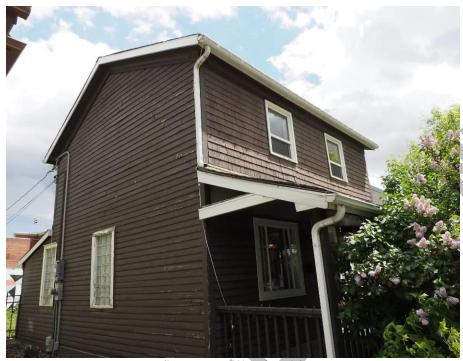
(Image 2.2 – West façade)

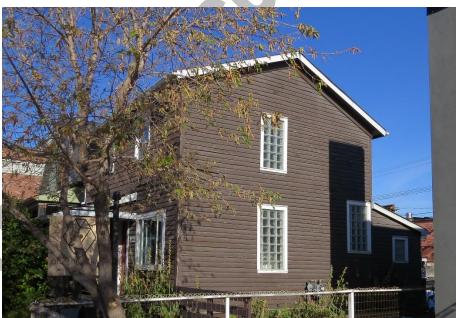
(Image 2.3 - East façade)

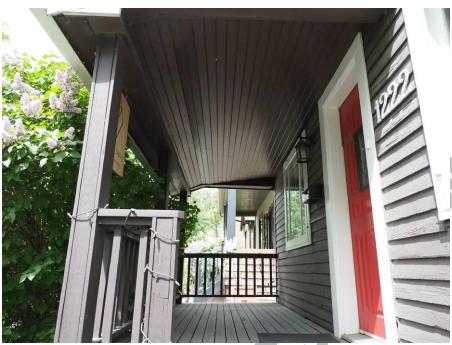
(Image 2.5 - Front verandah, looking west)

- Historic fenestration pattern on all façades; wooden fixed-sash, three-light picture windows with three-light wooden storm sashes on first storey of south façade (Images 2.5-2.7); location and wooden surrounds of entrance doors on south façade and second-storey north façade; second-storey north façade entry door with wooden and glazed panels (Image 2.11); and

- Offset front verandah with wood tongue-and-groove ceiling, posts and balustrade (Images 2.5-2.6); east-facing stairs on east end.

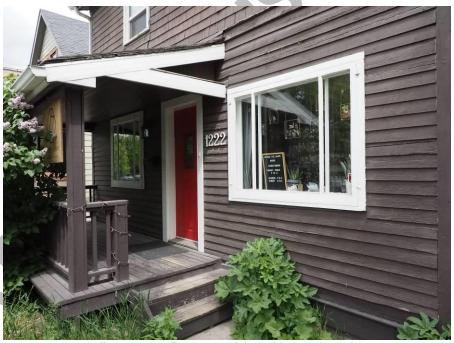
(Image 2.6 – Front verandah, looking northwest)

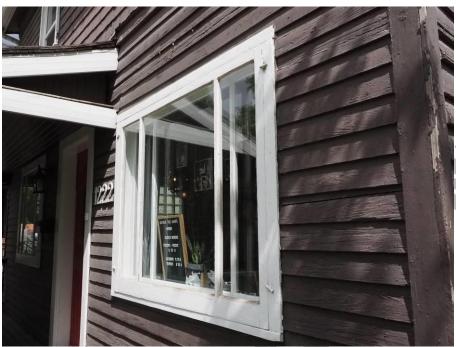
(Image 2.7 – Window detail on south façade with storm sash)

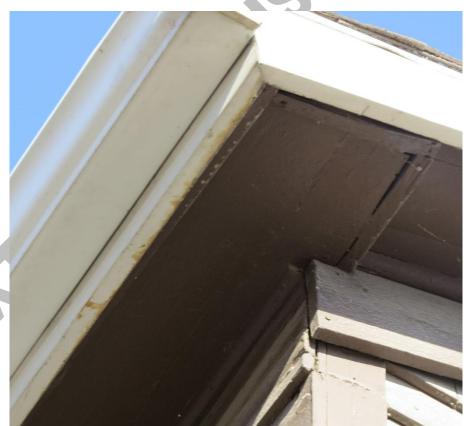
(Image 2.8 – Detail of wood soffits, fascia, verge boards and frieze)

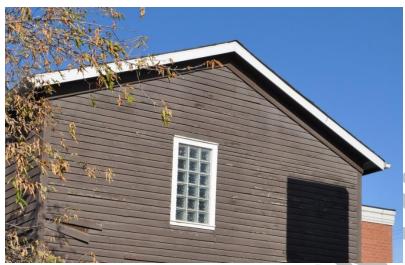
(Image 2.9 – West façade showing verge boards)

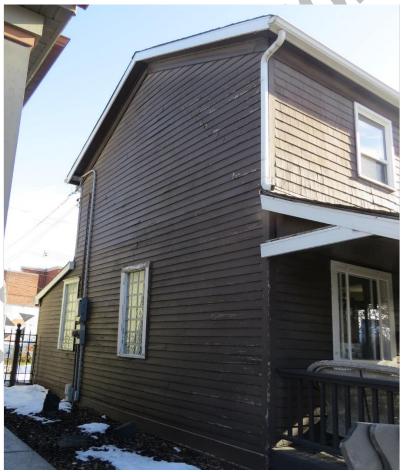
(Image 2.10 – South and west façades, showing beveled wood siding, and wood shingle cladding on south façade second storey)

- The exterior cladding: Beveled-wood cladding, and wooden-shingle cladding on second storey of north and south façades; wooden cornerboards and trim (Image 2.10);

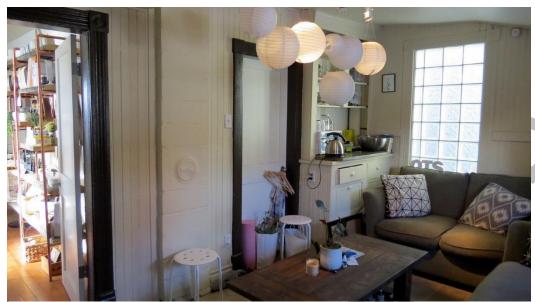
(Image 3.1 – First-storey extension, looking southwest)

- The layout and configuration of the first storey including staircase between first and second storey (Image 3.0); and
- The historic woodwork on the first-storey: flooring (Image 3.4), built-in cabinet in extension (Image 3.1; Image 3.5), doors, door and window surrounds (Images 3.1-3.2; Image 3.6), tongue-and-groove paneling and chair rail (Images 3.3).

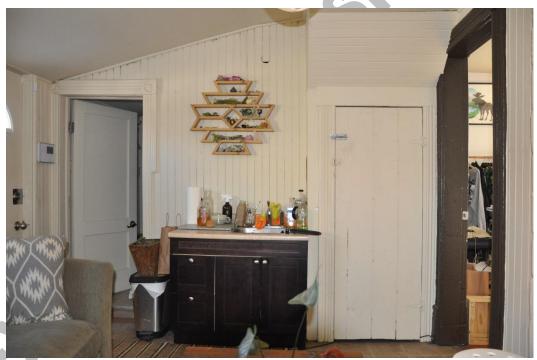
(Image 3.2 - First-storey extension, looking east)

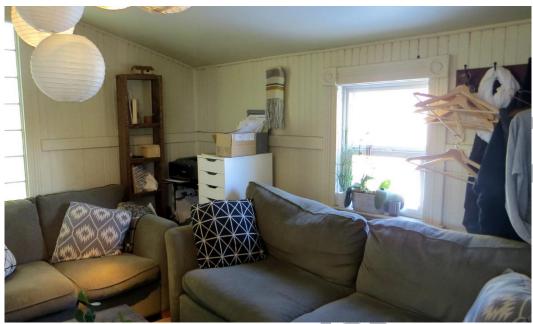
(Image 3.3 – First-storey extension, looking southwest)

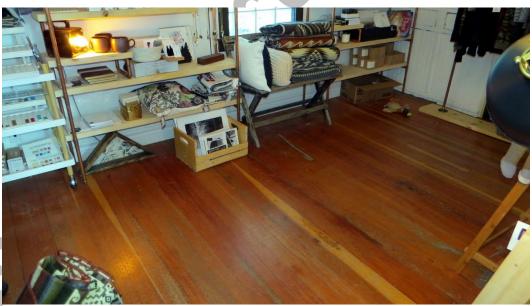
(Image 3.4 – Detail of wood flooring on first storey)

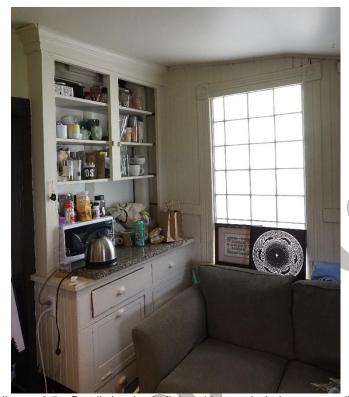
(Image 3.5 – Detail showing built-in cabinet and window surround)

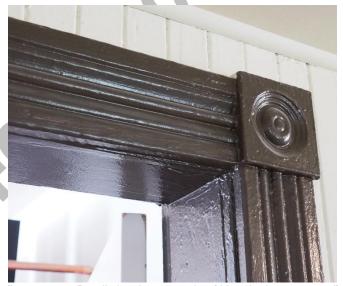
(Image 3.6 – Detail showing example of historic door surround)
