PFC2020-0510 ATTACHMENT 2

FEASIBILITY STUDY

Bow River Regional Pathway Douglasdale/McKenzie Lake Calgary, Alberta

Report Number: 11-1321-0003.2200 Distribution:

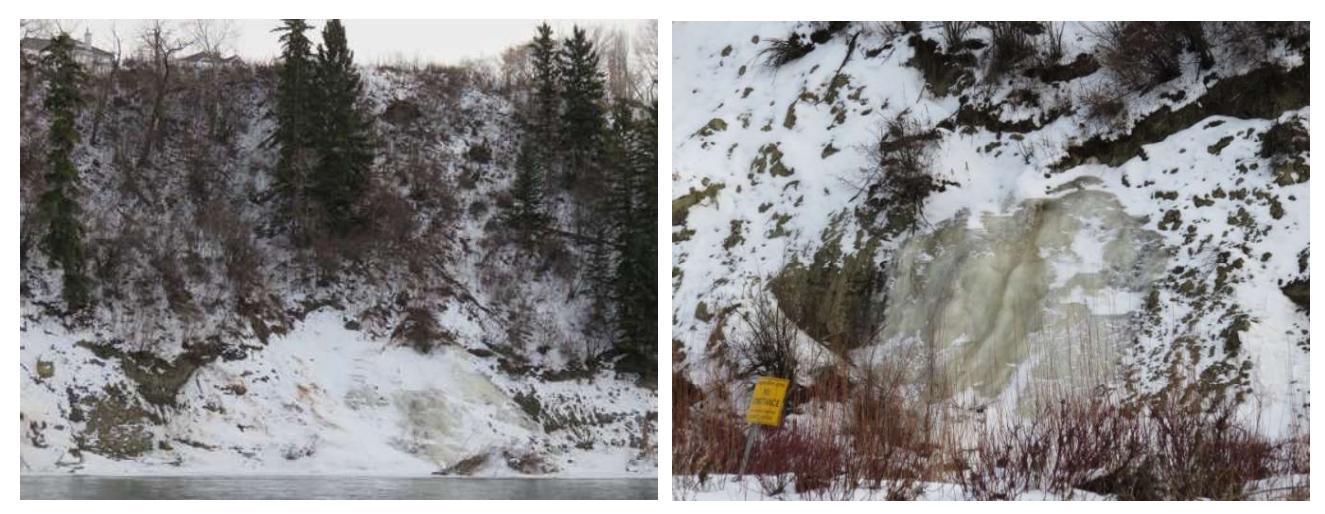
A supplementary site visit was made by Golder on January 19, 2015 to obtain additional seepage data from frozen groundwater discharge points to supplement the existing data. Photographs were taken across the river in Fish Creek Park along the majority of the southern portion of the Site. Seepage point elevations were approximated and are included in the field observations shown on Figure 6. Example photographs are provided in Figure 8.

Figure 8: Frozen groundwater seepage observation located at interpreted overburden-bedrock contact (Left: approximately located at Station 2+650, Right: approximately located at Station 2+400).

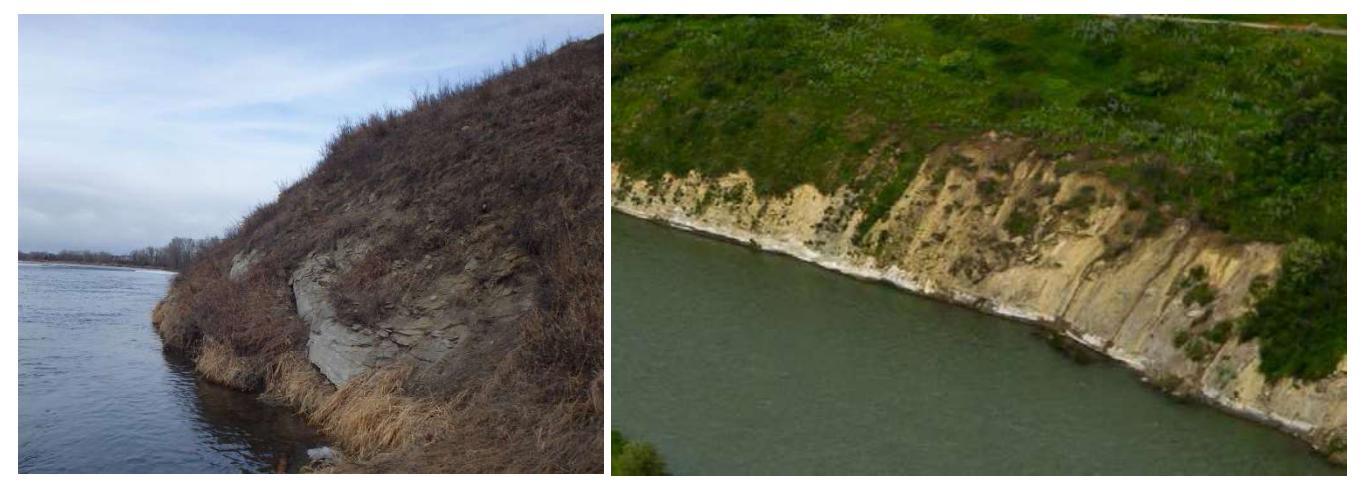
The study area is broken into three distinct areas along the river bank for the purposes of the hydrological study. Upstream Area 1 has low lying banks and is largely vegetated with large mature trees. The river bank along Area 2 is largely vegetated with some bedrock outcrops, and the downstream river bank in Area 3 is steep with exposed bedrock (see Figures 10 and 11).

Figure 11: River Bank Sections along the Site (Left - Area 1 (~ Stn. 1+150), Right - Area 3 (~ Stn.2+100))
