# **Bearspaw South Feeder Main Pipe Investigation Findings**

IP2024-1237

December 11, 2024

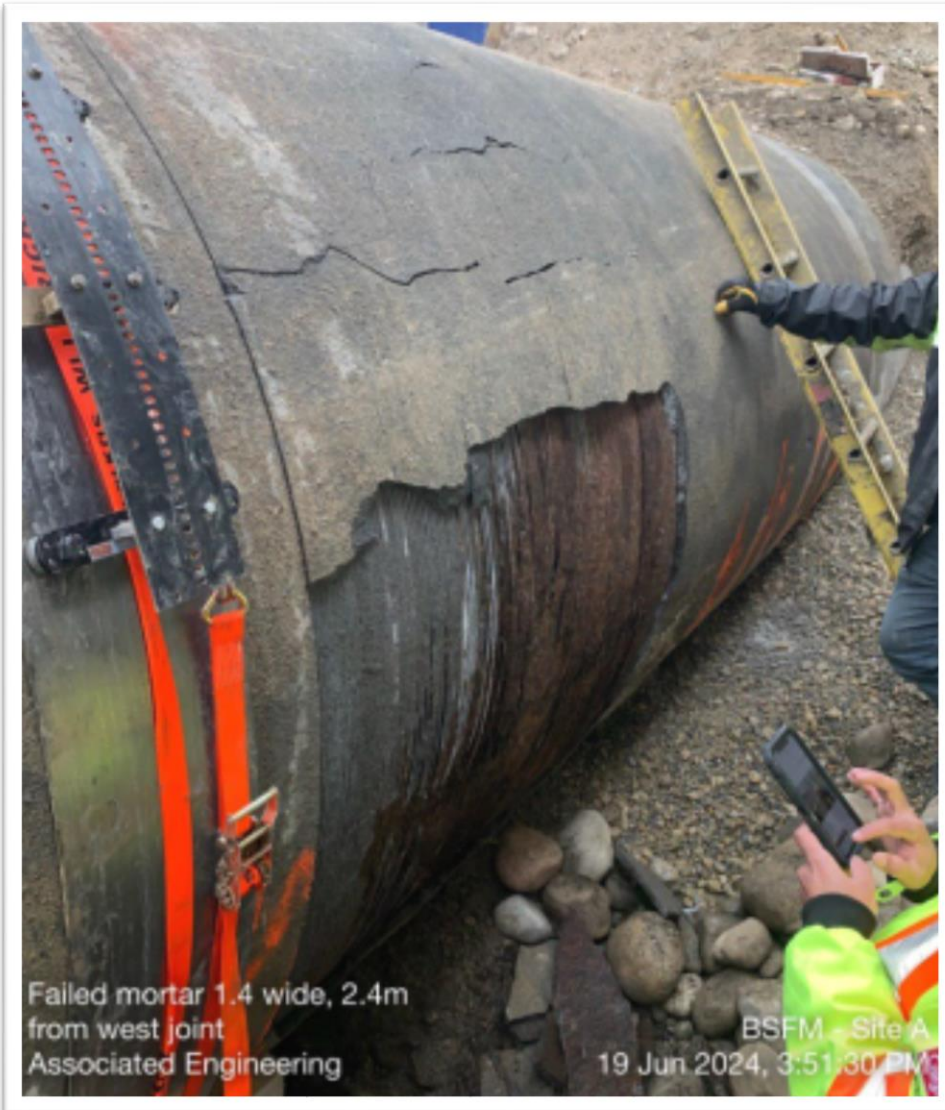
"The cause of the June 5 failure was the **breakage of a sufficient number of prestress wires** in a pipe segment causing loss of pressure resisting capability in the pipe."

"...the ruptured pipe experienced **microcracking or previous mortar damage** allowing soil interaction with the prestress wires. The compromised mortar allowed **Stress Corrosion Cracking and/or Hydrogen Embrittlement** of the prestress wires resulting in brittle wire failures/fractures."

Factors believed **not** to have contributed to the failure:

- No information indicates that the **manufacturing standards** in 1975 were not followed.
- **Live loading** subsequent to the construction in 1975 is not believed to be a contributing factor.
- **Stray current induced corrosion** does not appear to be present.
- Operations did not create an over or under **pressure situation** that contributed to the failure.
- A **transient pressure** event did not occur immediately before the rupture.

The investigation report yielded the following observations relative to the ruptured and distressed portions of pipe:

- Some pipes showed visible **mortar cracking**, while other pipe had intact mortar.
- Some distressed pipes did have **chlorides penetrate** the mortar, while others showed none.
- Soil testing showed **high chloride soils** in certain areas.
- Severe **pitting and corrosion of the prestress wires** was present, as well as significant quantities of **brittle wire failure**.
- Evidence of **Hydrogen Embrittlement and Stress Corrosion Cracking** due to chloride penetration of the mortar and/or microcracking.
