STAGE 1 - CONFEDERATION GOLF COURSE

i. EXECUTIVE SUMMARY

PFC2019-1227 ATTACHMENT 3C

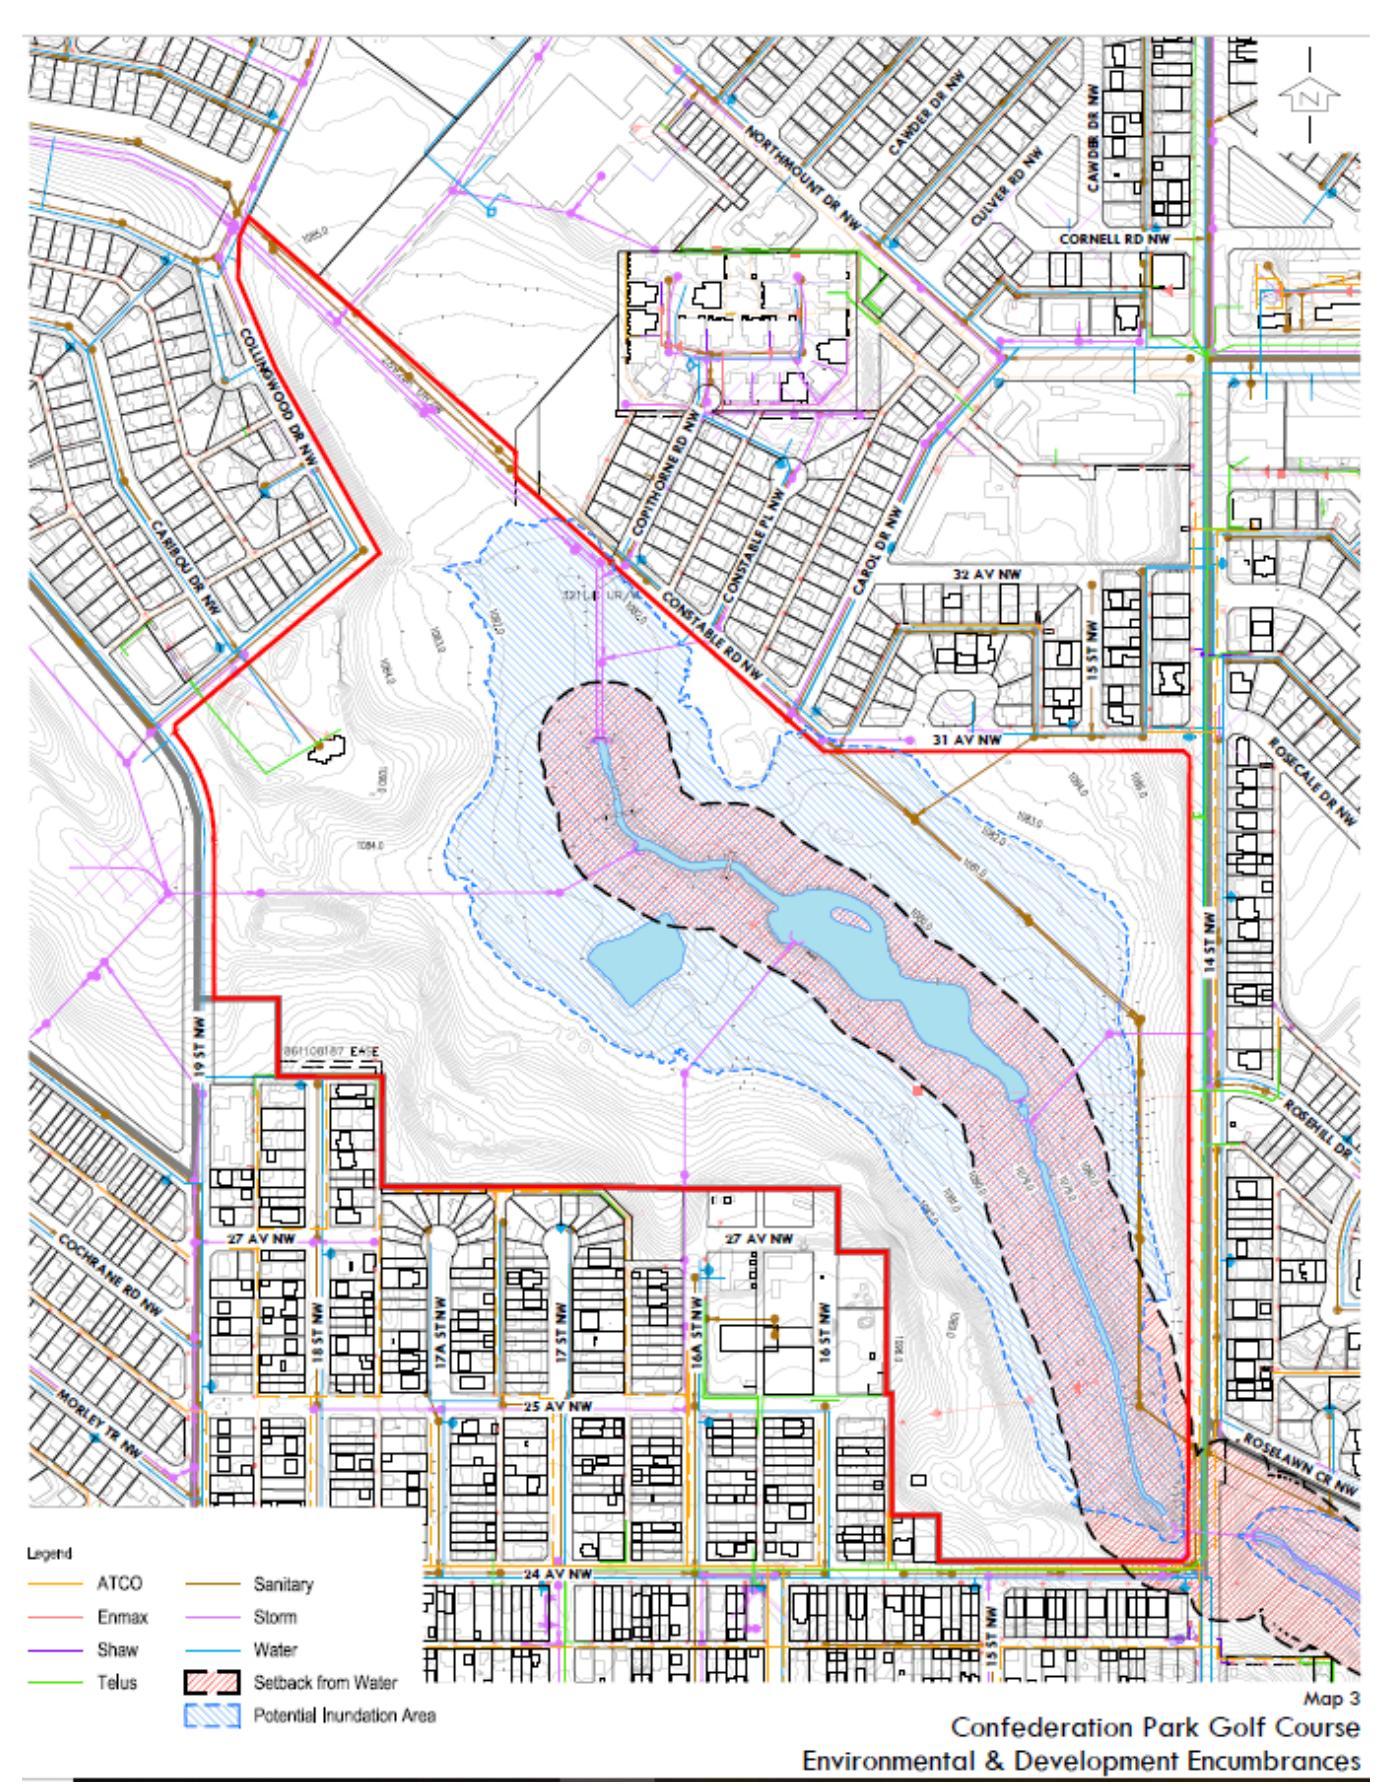
The results of the Stage 1 feasibility analysis at Confederation Golf Course indicate that the land should not be decommissioned, divested of, or repurposed by the Corporation. The reason for this recommendation is based mostly on the stormwater issues that pertain to Confederation Creek, the lower Confederation Trunk, and the Confederation Valley. As detailed in the *Confederation Creek Drainage Study* ('The Study') which was done in response to the proposed Highland Park mixed-use redevelopment, there is significant issues with overland flooding in this region. The Study completed by The City and its consultant (Associated Engineering) determined that Option 4 was the best stormwater mitigation strategy for this area. Option 4 includes storing a significant amount of water at Confederation Golf Course. Please see the map below for the inundation area at our site.

Should Option 4 be implemented and should a weather event trigger the amount of water shown in the map below to be stored at Confederation Golf Course, The City can revisit the real estate potential at the course at that time. Additionally, should something change in the future regarding the Highland Park Golf course redevelopment, The City can revisit the extent of water storage needed at Confederation and determine later if there is any real estate potential available at the course.
