PUD2020-0915 ATTACHMENT 2

BYLAW NUMBER 30M2020

BEING A BYLAW OF THE CITY OF CALGARY TO DESIGNATE THE EAST CALGARY TELEPHONE EXCHANGE BUILDING AS A MUNICIPAL HISTORIC RESOURCE

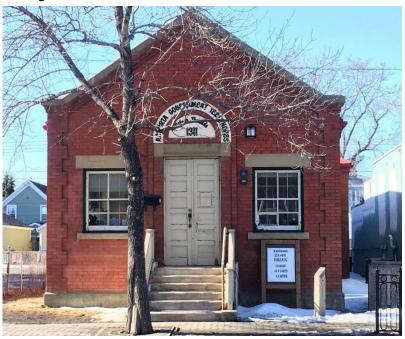
(Image 1.1: North façade)

- a) The exterior masonry walls of red brick laid common bond pattern with red-pigmented mortar and gabled parapets with sandstone coping (Images 1.1 and 1.3);
- b) The fenestration with single, 2-over-4 multi-pane wooden sash storm windows and 1-over-1 wooden sash windows and sandstone lintels and sills (Images 1.1 and 2.2);
- c) The brick detailing comprising corbelled cornice along gable edge and projecting quoins (at building corners) (Images 1.1, 1.3 and 2.2); and
- d) The central front entrance with sandstone lintel and surmounted by brick relief in Romanarch design and wooden paneled door (Images 1.1, 1.2 and 1.4).

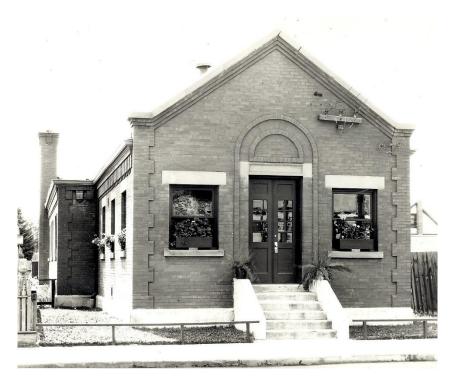
(Image 1.2: Historic image of north façade showing the original 1-over-1 sash windows and Roman arch above the central front entrance, ca. 1910-1920, Copyright AGT Archive)

Note: This does not preclude a return to the original 1-over-1 sash window style or the door style as seen in Image 1.2.

Note: This does not preclude a return to the original 1-over-1 sash window style as seen in Image 1.2.

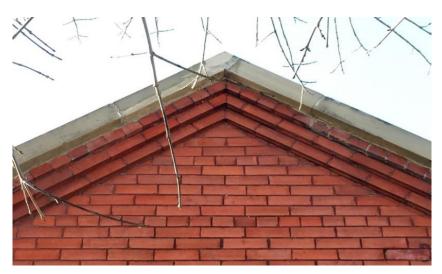
(Image 1.3: Detail of common bond pattern red brick with red-pigmented mortar and corbelled cornice at gable edge with sandstone cap)

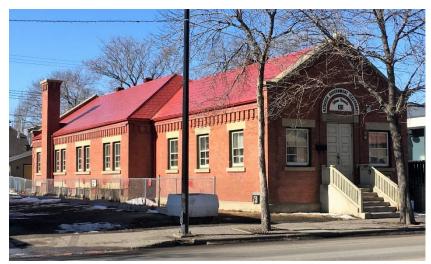
(Image 2.1: Oblique view of east façade with rear addition added 1912-1913)

- a) The exterior masonry walls of red brick laid common bond pattern with red-pigmented mortar (Image 2.1);
- b) The fenestration with 2-over-4 multi-pane wooden sash storm windows and 1-over-1 wooden sash windows and sandstone lintels and sills (Images 2.1 and 2.2);
- c) The brick detailing comprising corbelled cornice and corbelled modillions at roof line and projecting quoins (at building corners) (Images 2.1 and 2.3); and
- d) Tall, exterior red-brick chimney on east elevation of rear addition with corbelled modillions and sandstone cap (Images 2.1 and 2.4).

- a) The long, symmetrical, one-storey rectangular form with medium pitched, front-gable roof; rear addition which mirrors form of original with tall red-brick chimney on east elevation with corbelled modillions and sandstone cap (Image 2.1); and
- b) The double wall construction with concrete and terra cotta brick interior walls with void of approximately 46cm (18") to 61cm (24") within the two walls.

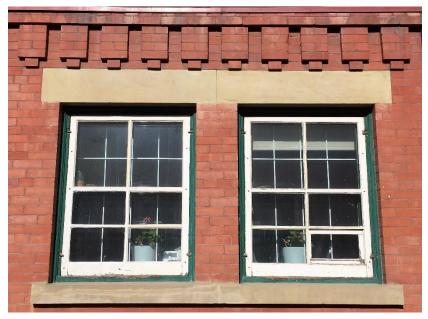
(Image 2.2: Typical fenestration and corbelled modillions on side elevations)

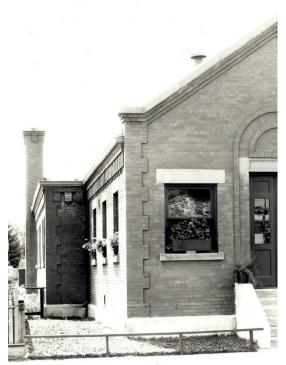
(Image 2.3: Historic image showing detail of quoins at building corner, 1910-1920, Copyright AGT Archive)

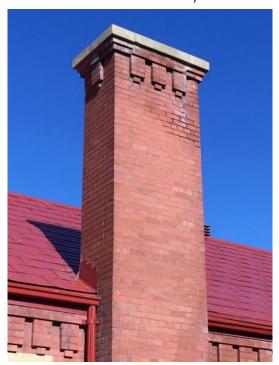
(Image 2.4: Detail of corbelled modillions and sandstone cap of red-brick chimney on east façade of rear addition)

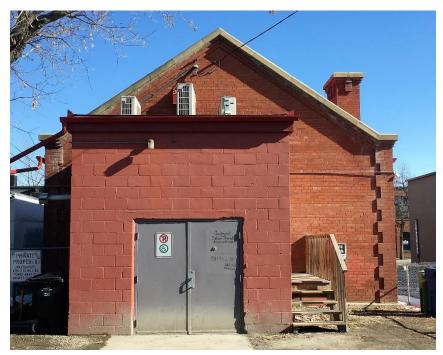
(Image 3.1: South façade with ca. 1955 cinder block rear extension)

- a) The exterior masonry walls of red brick laid common bond pattern with red-pigmented mortar and gabled parapets with stone coping (Image 3.1); and
- b) The brick detailing comprising corbelled cornice under gable and projecting quoins (at building corners) (Image 3.1)

Note: the single story extension built ca.1955, is not regulated and a return to original configuration/appearance would not be precluded where documentation of original configuration exists.

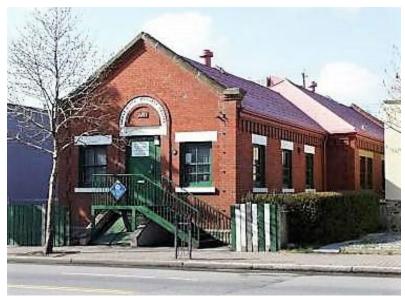
(Image 4.1: Oblique view west façade looking southeast, ca. 1990s)

- a) The exterior masonry walls of red brick laid common bond pattern with red-pigmented mortar (Images 4.1 and 4.2);
- b) The fenestration with 2-over-4 multi-pane wooden sash storm windows and 1-over-1 wooden sash windows and sandstone lintels and sills (Images 4.1 and 4.2); and
- c) The brick detailing comprising corbelled cornice and corbelled modillions at roof line and projecting quoins (at building corners) (Images 4.1 and 4.2).

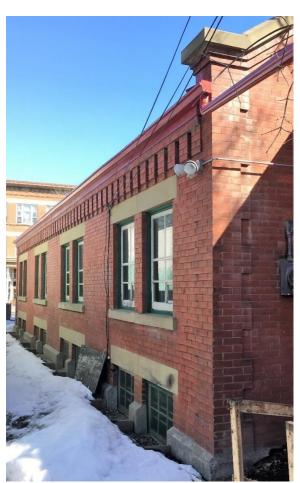
(Image 4.2: Oblique view west façade rear addition looking northeast)
