Proposed Wording for a Bylaw to Designate the Johnston Residence as a Municipal Historic Resource

SCHEDULE "B"

REGULATED PORTIONS

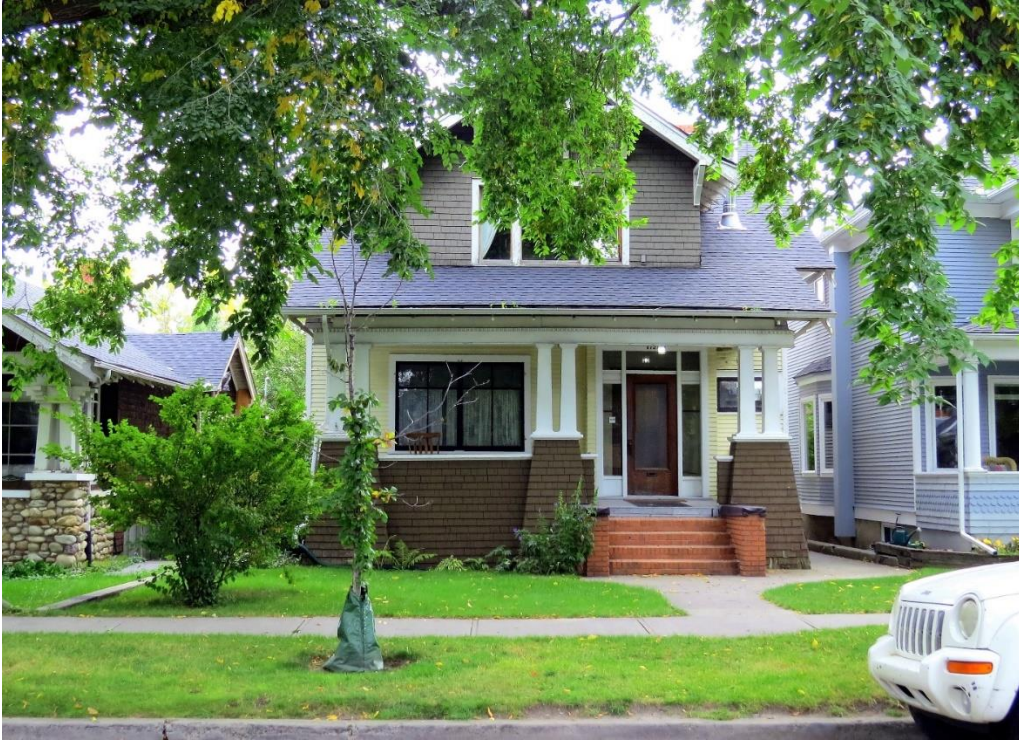
(Image 2.1: North (front) façade showing front cross-gable dormer and full-width front veranda)

- a) One and one-half storey massing, rectangular plan; bevelled wood siding on the lower storey and wood shingle cladding on the upper storey; wood belt course, water table with drip mould and cornerboards (Images 2.1, 2.5 - 2.6);

- b) Side-gable roof with front and rear cross-gable dormers; stick work (gable peaks); overhanging eaves with exposed rafter tails, wood brackets, wood tongue-and-groove soffits and moulded frieze; projecting verges with vergeboards with decorative ends (peak of gables) (Images 2.1, 2.2, 2.5 - 2.6);

- c) Full-width front veranda with closed balustrade, tapered piers and twinned, tapered posts supporting moulded entablatures; wood tongue-and-groove veranda ceiling; and upper floor closed balustrade balcony (Images 2.1 and 2.3);

- e) Original extant fenestration composed of: (one) double-assembly of 2-over-2 with leaded glass in the upper lights profile; (one) fixed, multi-light, leaded glass profile; (two) fixed, multi-light, leaded glass profiles; (one) fixed 2-light profile; (two) 2-light single hung profiles; (one) quadruple assembly of multi-light, leaded glass profile; (three) 1-over-1 hung profiles; plain lintels with drip moulds; lug and continuous sills on west bay window (Images 2.1 – 2.3 and 2.5 – 2.7) and;

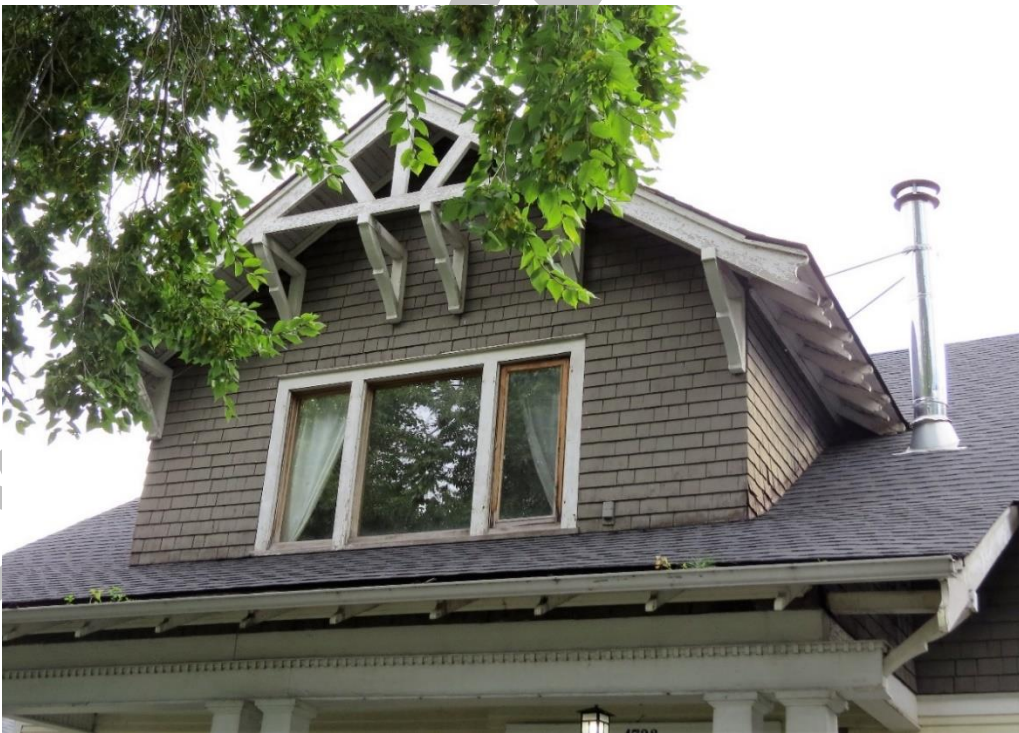
(Image 2.2: Detail of front cross-gable dormer on high-pitched, side gable roof; stick work (gable peak); overhanging eaves with exposed rafter tails, wood brackets, wood tongue-and-groove soffits and moulded frieze; projecting verges with vergeboards with decorative ends)

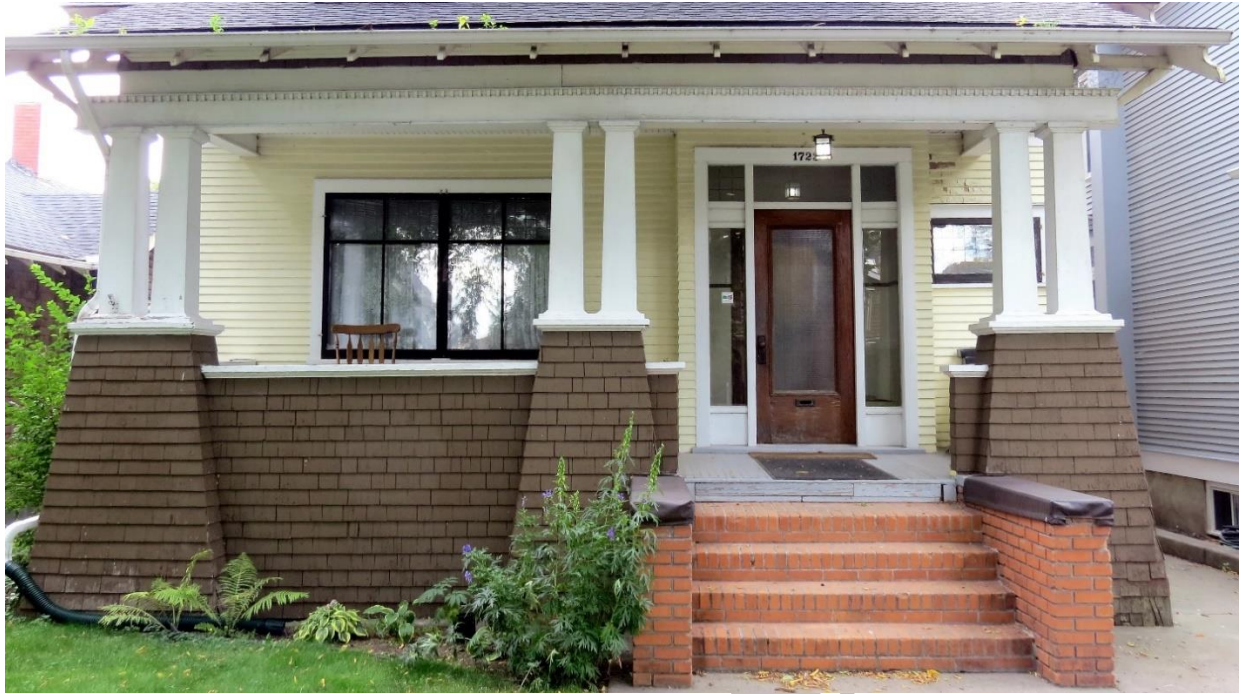
(Image 2.3: Detail of full-width shingle clad, front veranda with closed balustrade, tapered piers and twinned, tapered posts supporting moulded entablatures)

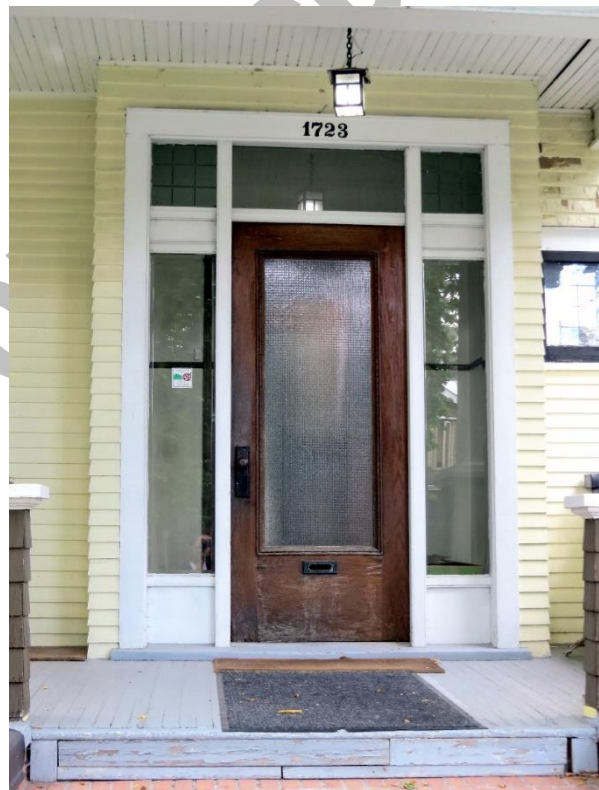
(Image 2.4: Detail of offset front entry on front veranda with side-lights, 3-light transom, wood surround, and original wood door with glazed panel and wood tongue-and-groove ceiling)

- f) Front entry with (two) side-lights, 3-light transom, wood surround, and original wood door with glazed panel (Image 2.4).

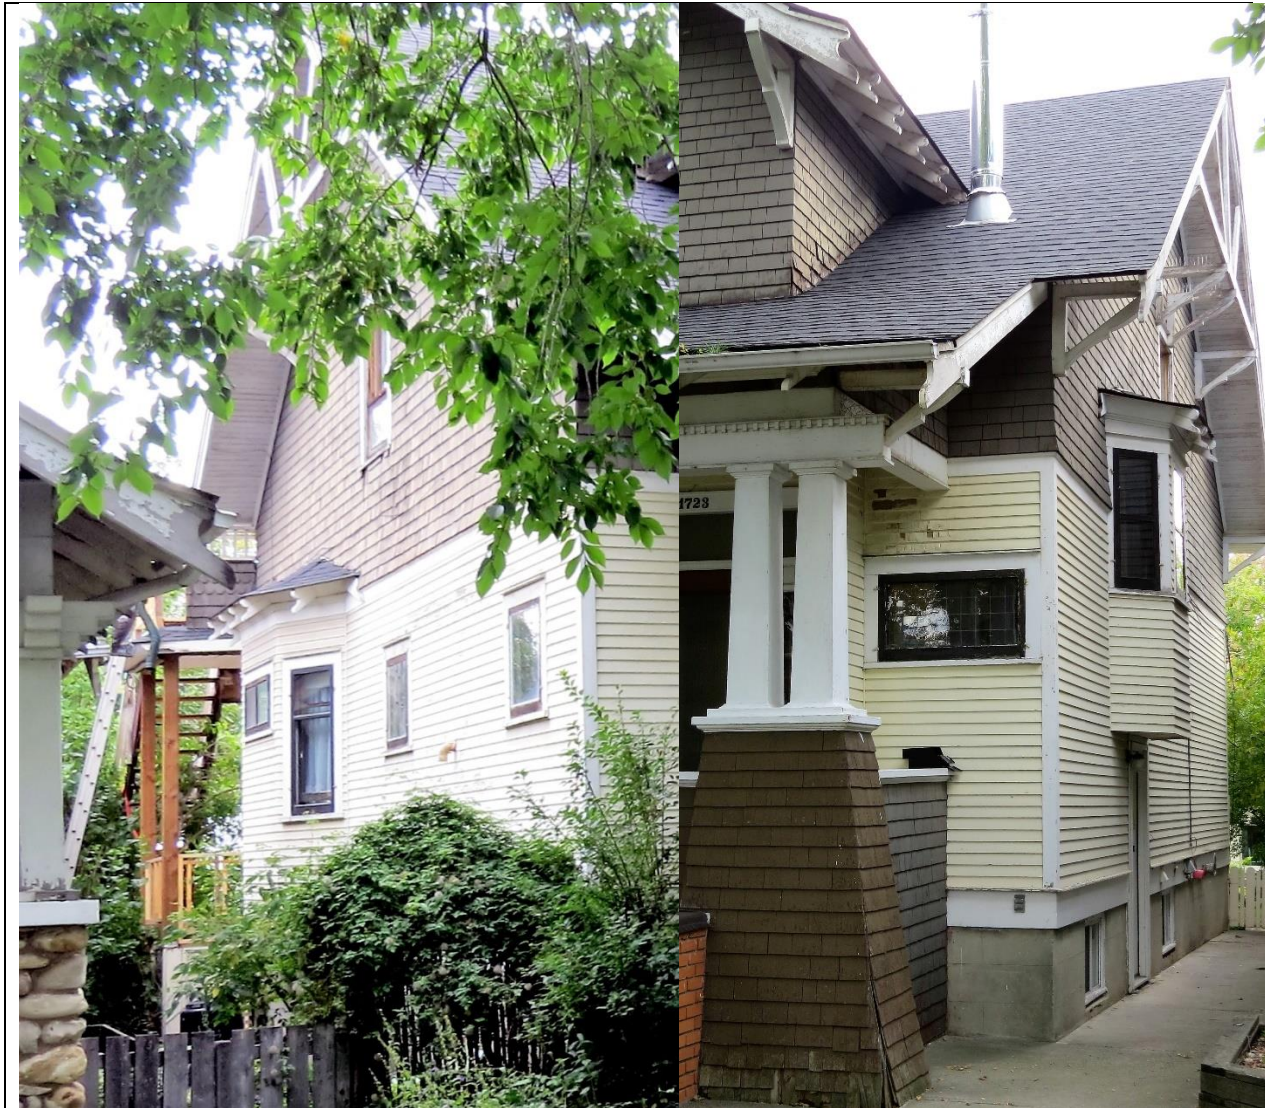
Image 2.5: Hip-roofed bump out on east façade, bevelled wood and shingle cladding, exposed rafter tail; and example of 1-over-1 single hung profile and 2-light fixed profile

Image 2.6: Shed-roofed bay window with exposed rafter tails on west façade, projecting verges in side gable with stick work in the gable peak, wood belt course, water table with drip mould and corner boards

- d) Hip-roofed bump out on east façade and shed-roofed bay window on west façade; both with overhanging eaves with exposed wood rafter tails (Images 2.5 and 2.6); and

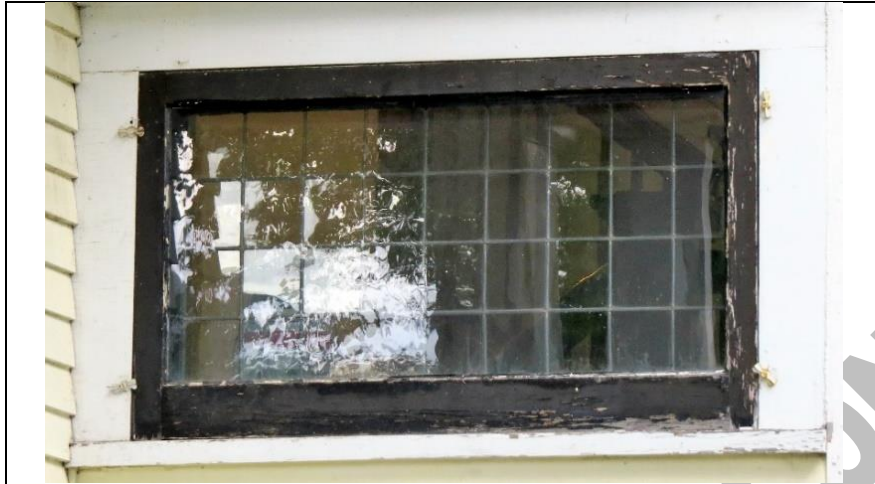
Image 2.7: Original fixed, multi-light, leaded glass profile

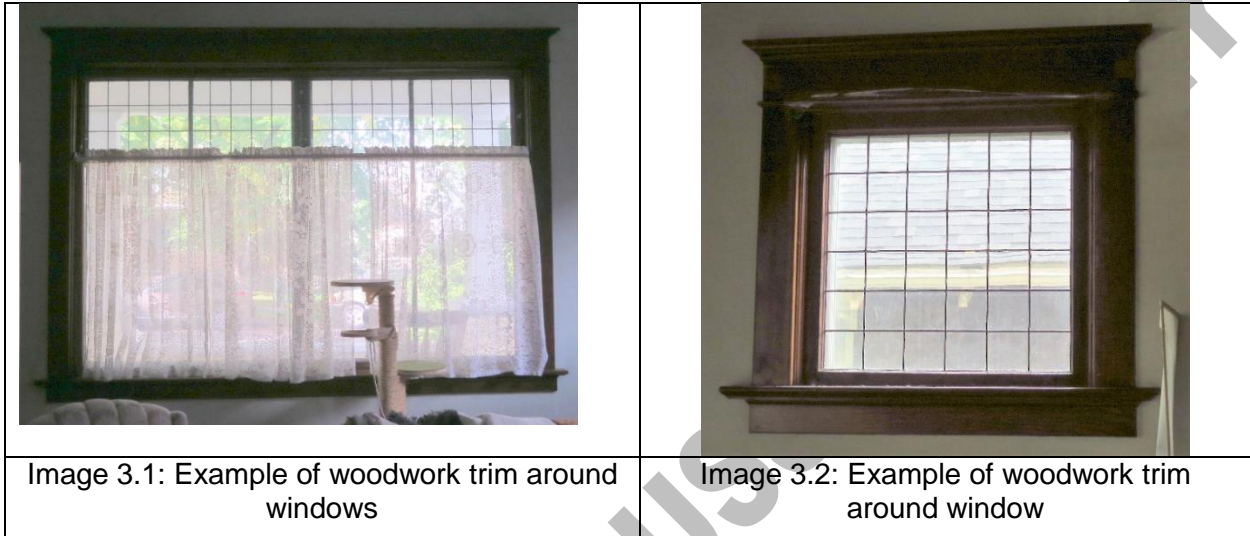
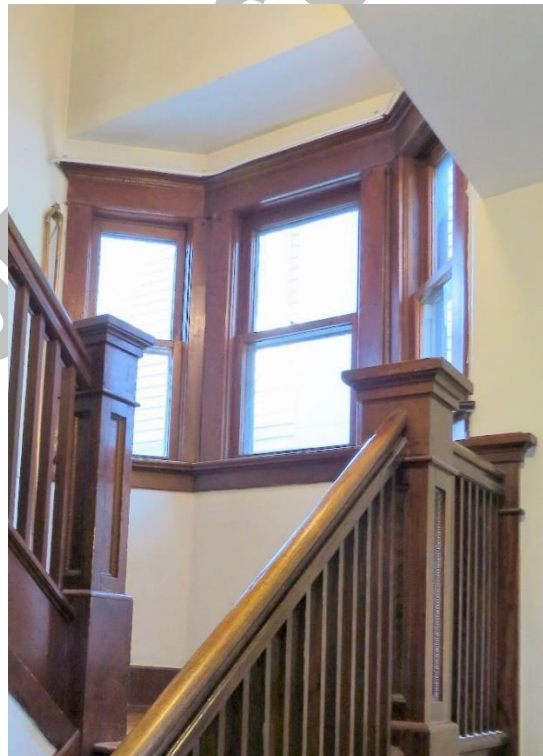
Image 3.3: Example of woodwork trim around windows

- a) Woodwork trim around windows (Images 3.1 – 3.4);
- b) Multi-light French doors with sidelights and original hardware (Image 3.5); and
- c) Wooden built-in features including; room separator with built-in cabinetry (Image 3.6), room separator - no cabinetry (Image 3.7) and built-in drawer and cabinet unit (Image 3.8).

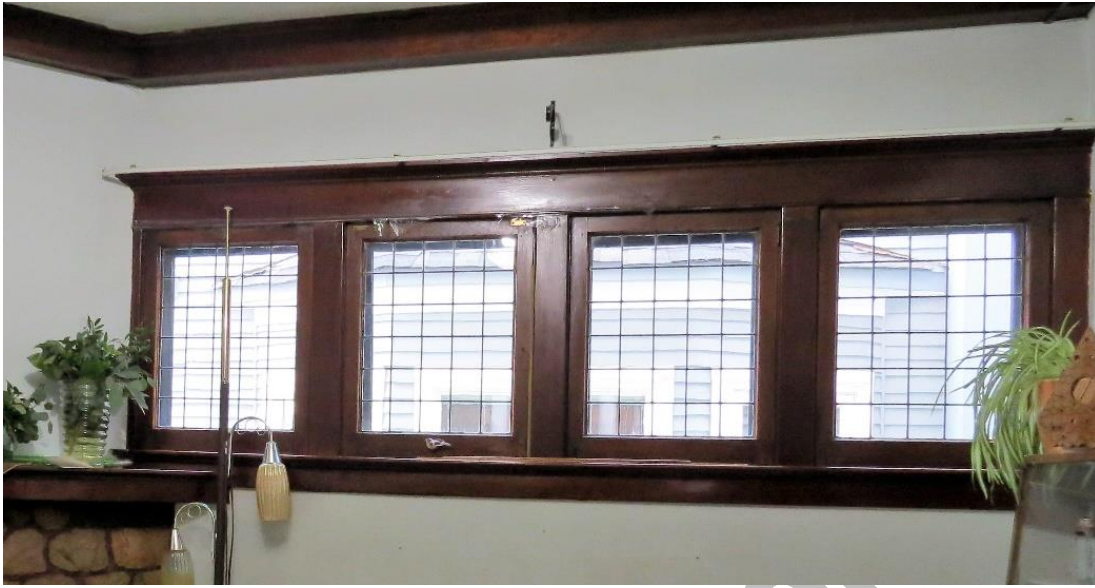
Image 3.4: Example of woodwork trim around windows

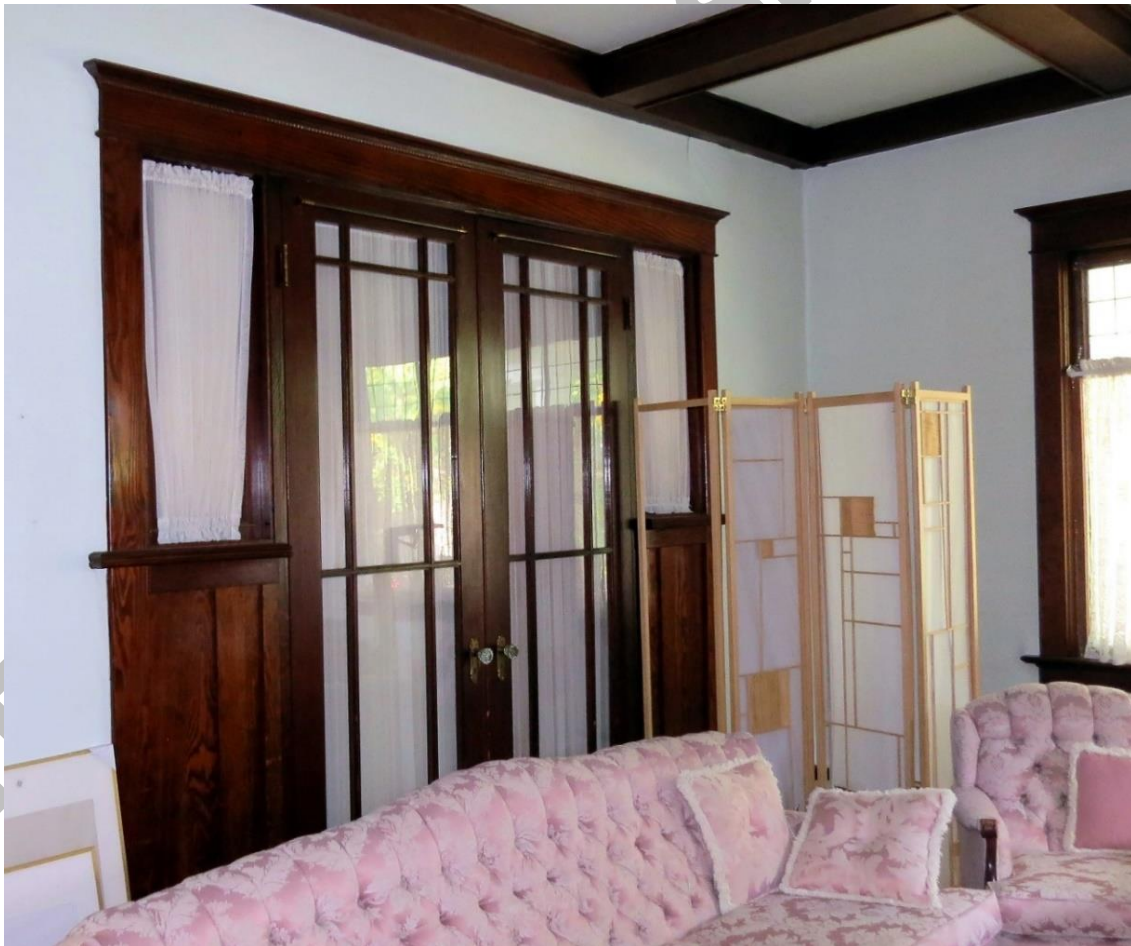
(Image 3.5: Multi-light French doors with sidelights and original hardware)

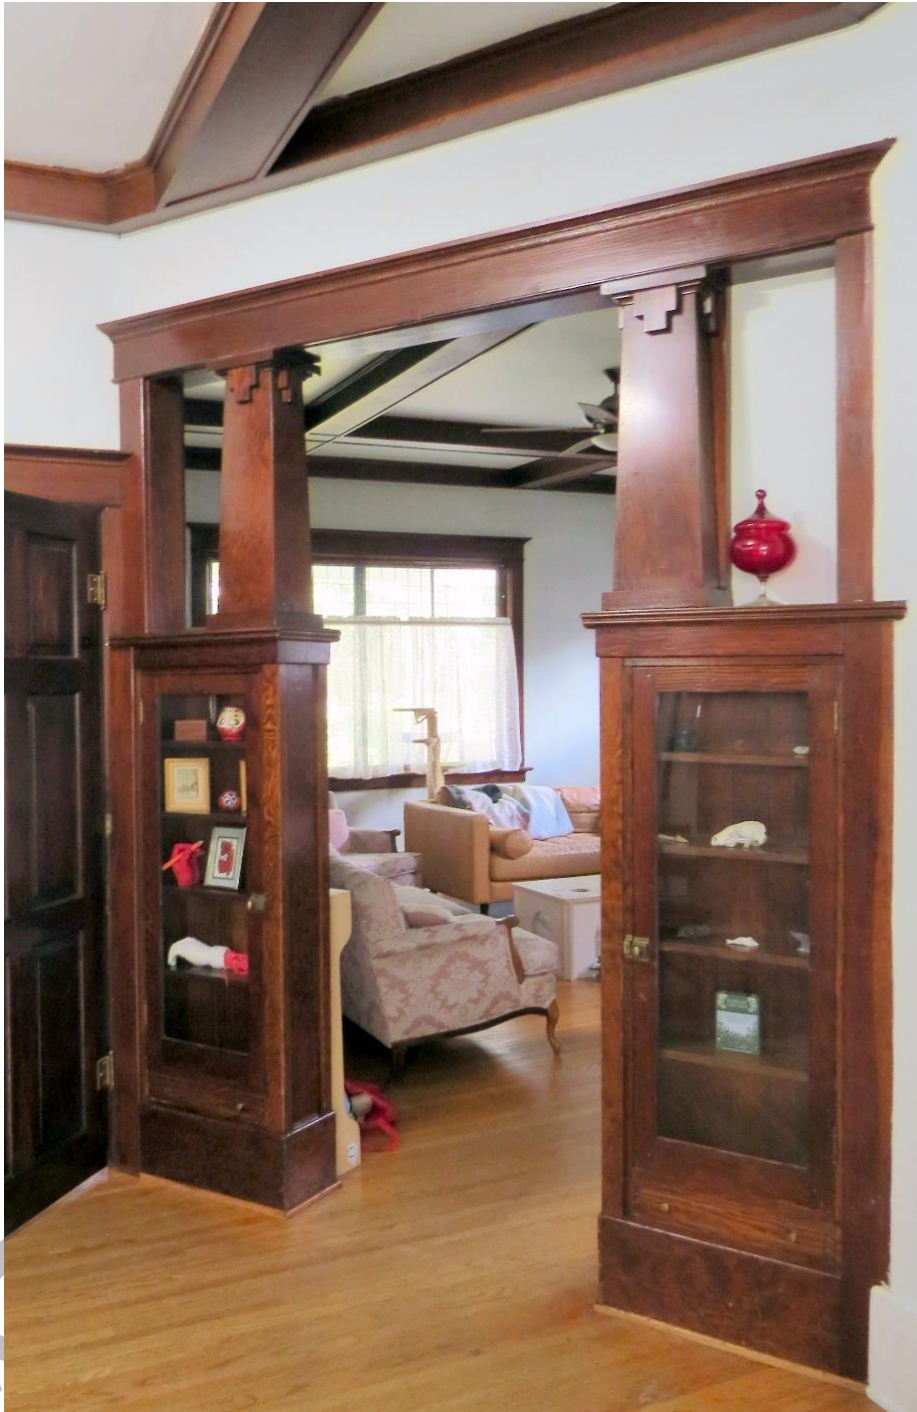
(Image 3.6: Room separator with built-in cabinetry)

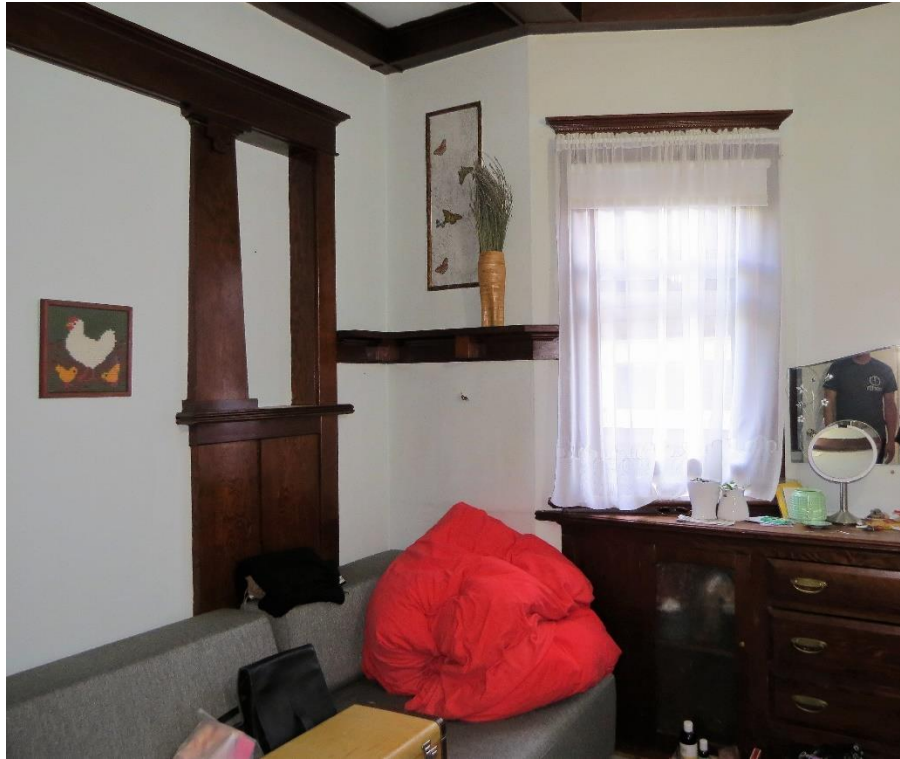
(Image 3.7: Room separator (left) with built-in drawer and cabinet unit (right))

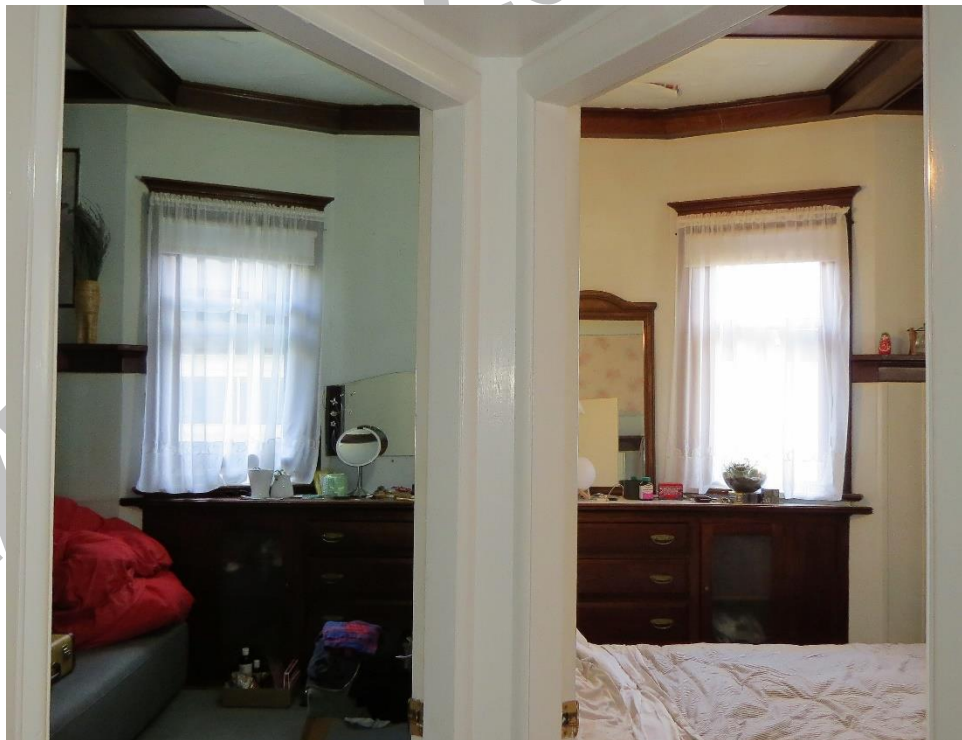
(Image 3.8: Built-in drawers and cabinet (partitioning wall constructed over built-in drawer and cabinet unit during previous renovation))
