IP2021-1502  
ATTACHMENT 3

## BYLAW NUMBER 61M2021

### BEING A BYLAW OF THE CITY OF CALGARY TO DESIGNATE THE MCPHERSON RANCH HOUSE AS A MUNICIPAL HISTORIC RESOURCE

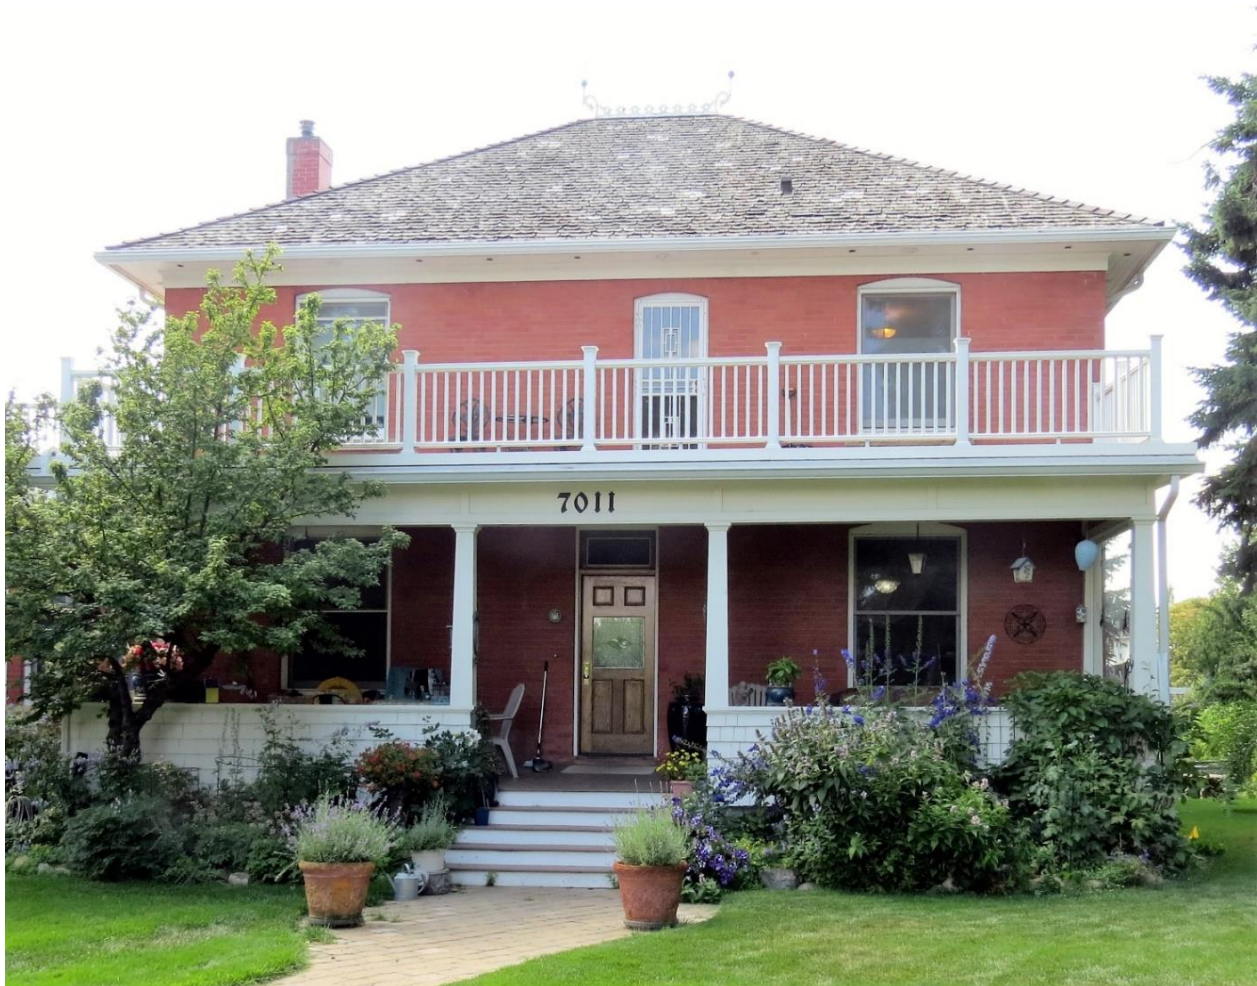
(Image 2.1: East façade)

- a) Stretcher bond brick cladding; wood trim (Images 2.1 and 2.5 - 2.7);
- b) Full-width main floor verandah; closed balustrade clad with wood shingles with flared wood shingle corners; tapered wood columns with capital; moulded entablature (Images 2.1 and 2.4 - 2.5);
- c) Full-width upper balcony with open balustrade (Image 2.1); and
- d) Original fenestration and one-over-one hung window profile; wood frames; segmental arch lintels with radiating brick voussoirs; painted camber pieces; rock-faced sandstone lug sills; main floor entry with single light transom profile (Images 2.1 - 2.3 and 2.5 – 2.7).

- a) Two-storey form on rectangular plan with long façade (Image 2.1);
- b) Steep pitched hipped roof; wood shingles; roof cresting and lightning rods on roof ridge (Images 2.1 and 3.1); and
- c) Deep overhanging eaves; wood tongue-and-groove soffits, plain wooden fascia and moulded frieze (Image 3.2).

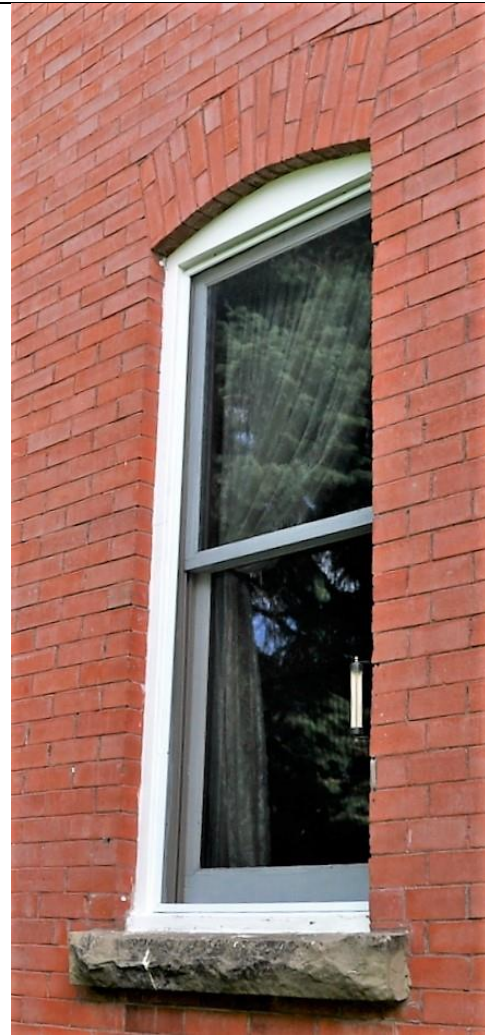
Image 2.3: Detail of typical fenestration and hung profile

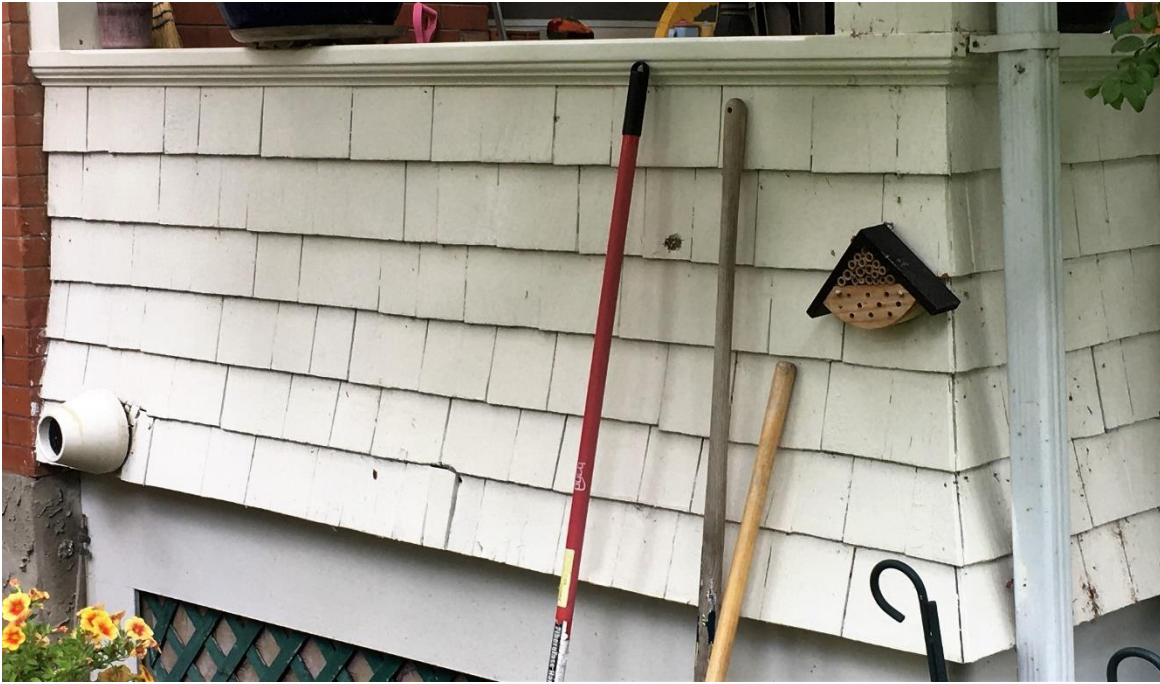
(Image 2.4: Detail of wood shingle clad verandah with flared, wood shingle corners)

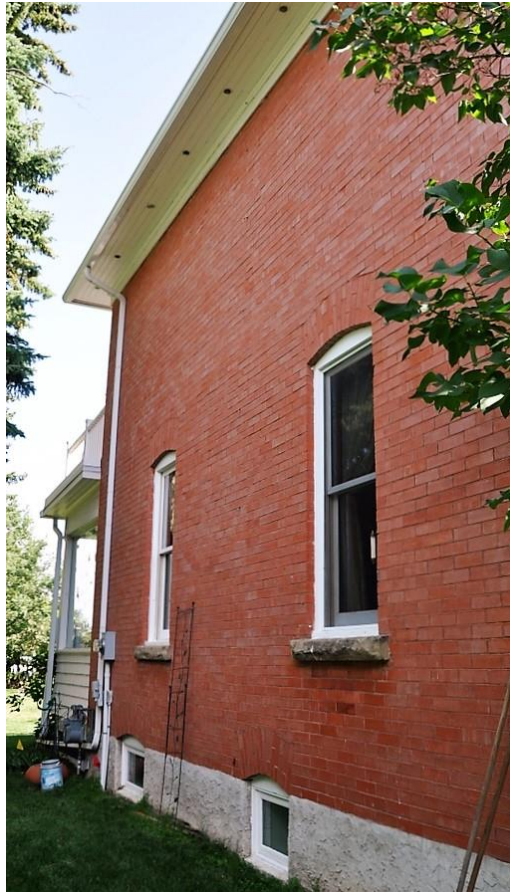
(Image 2.5: North façade)

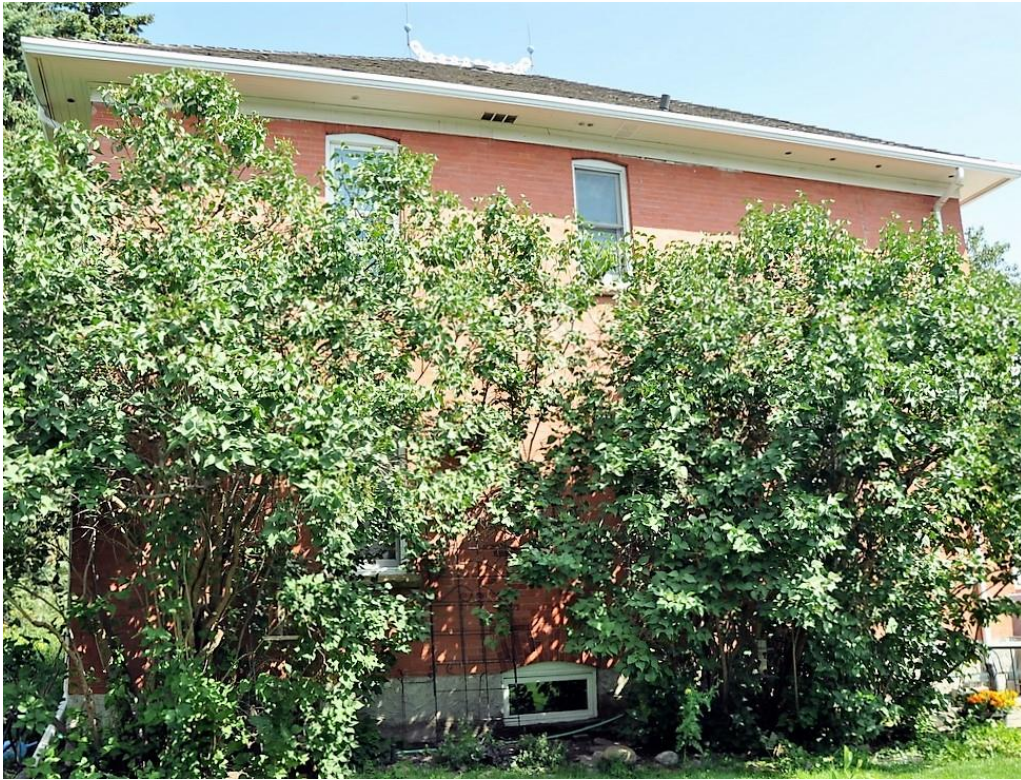
(Image 2.6: West façade.)

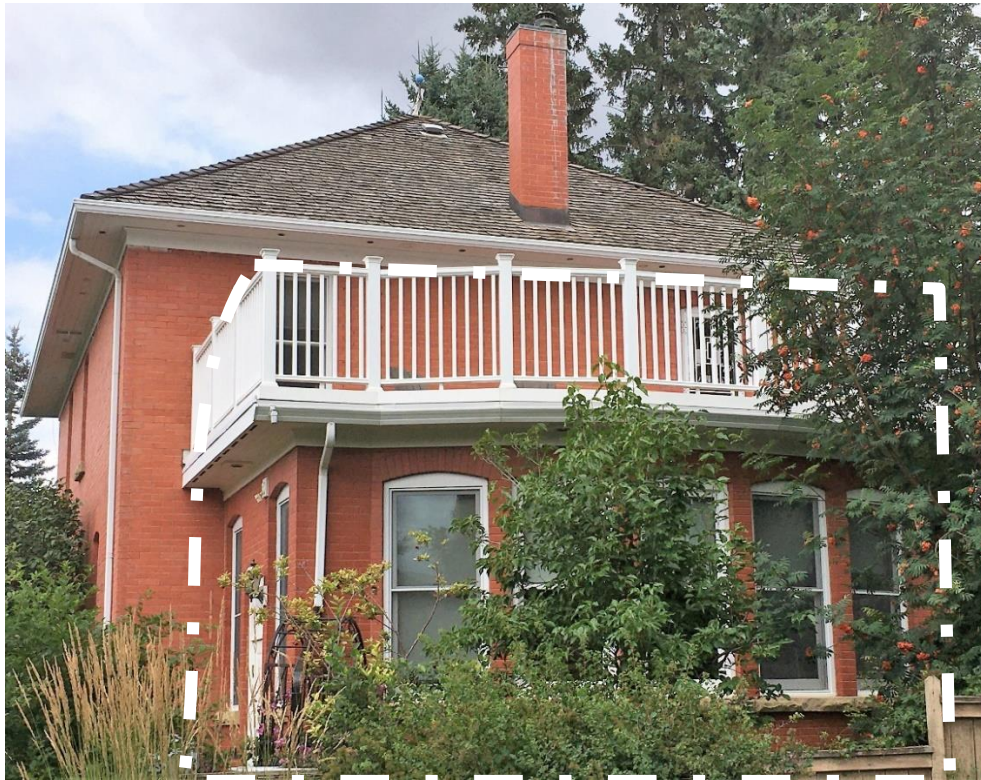
(Image 2.7: South façade. Note: White dashed line delineates unregulated portions (main floor addition and upper balcony))

Note: The main floor addition (south façade), built in 1997, is not regulated (Image 2.7). A return to the original configuration/appearance would not be precluded where documentation of original configuration exists.

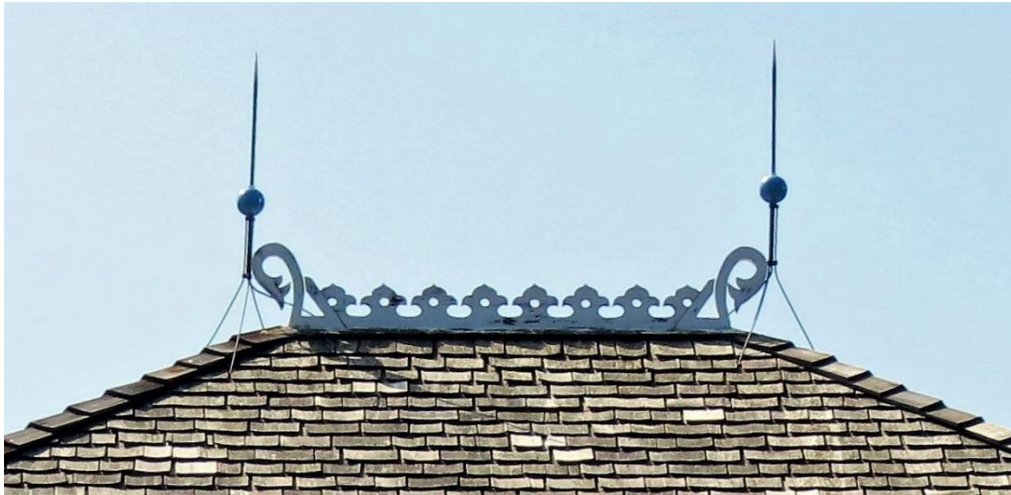
(Image 3.1: Detail of roof cresting and lightning rods)

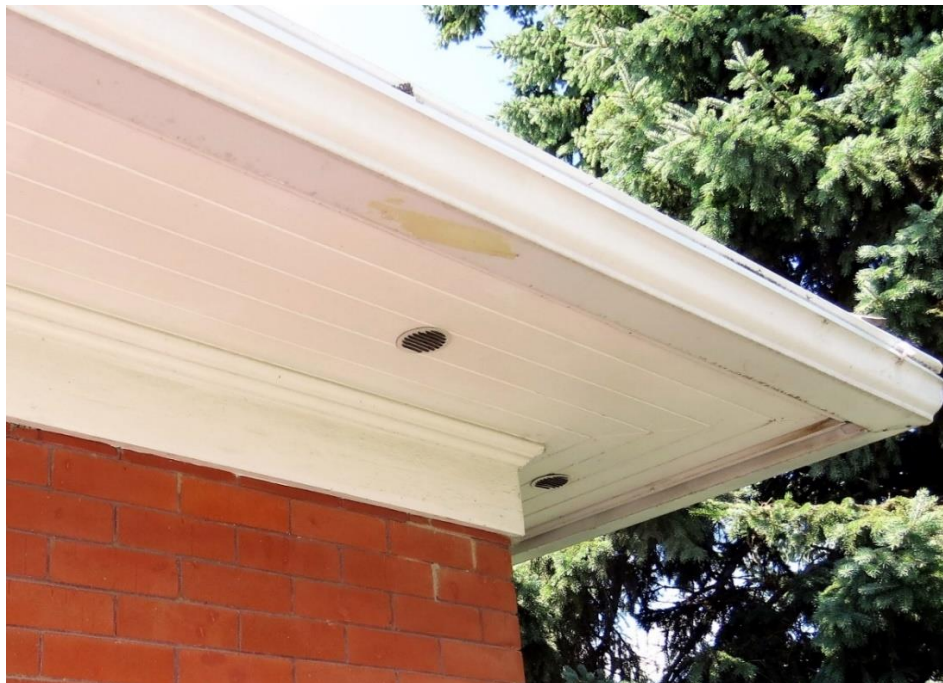
(Image 3.2: Detail of eave; wooden tongue-and-groove soffits, wooden fascia and moulded frieze)

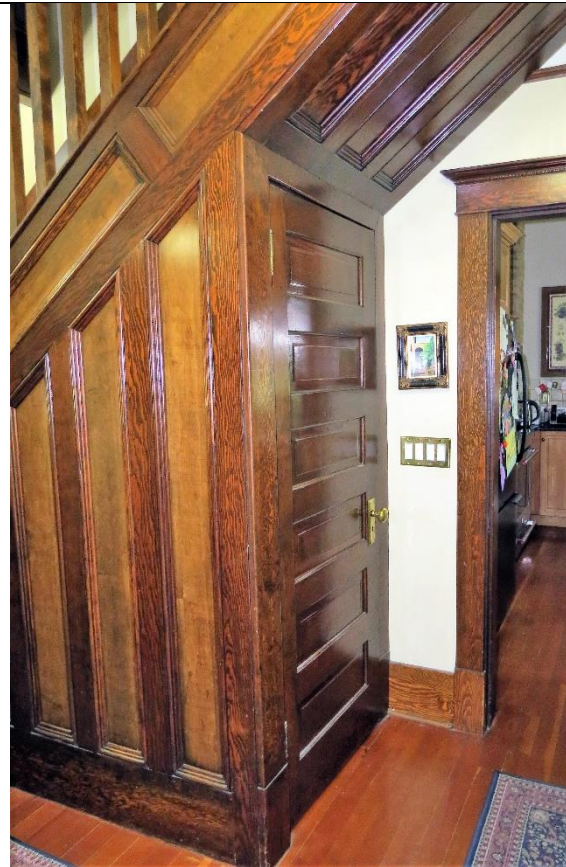
Image 4.2: Main floor staircase wood panelling; typical six panel door.

- a) Original main floor woodwork and trim: central staircase panelling; living room arch; door and window casings; six panel doors (Image 4.1 – 4.3); and
- b) Main floor plaster moulding around ceilings in foyer and living room (Images 4.3 – 4.4).

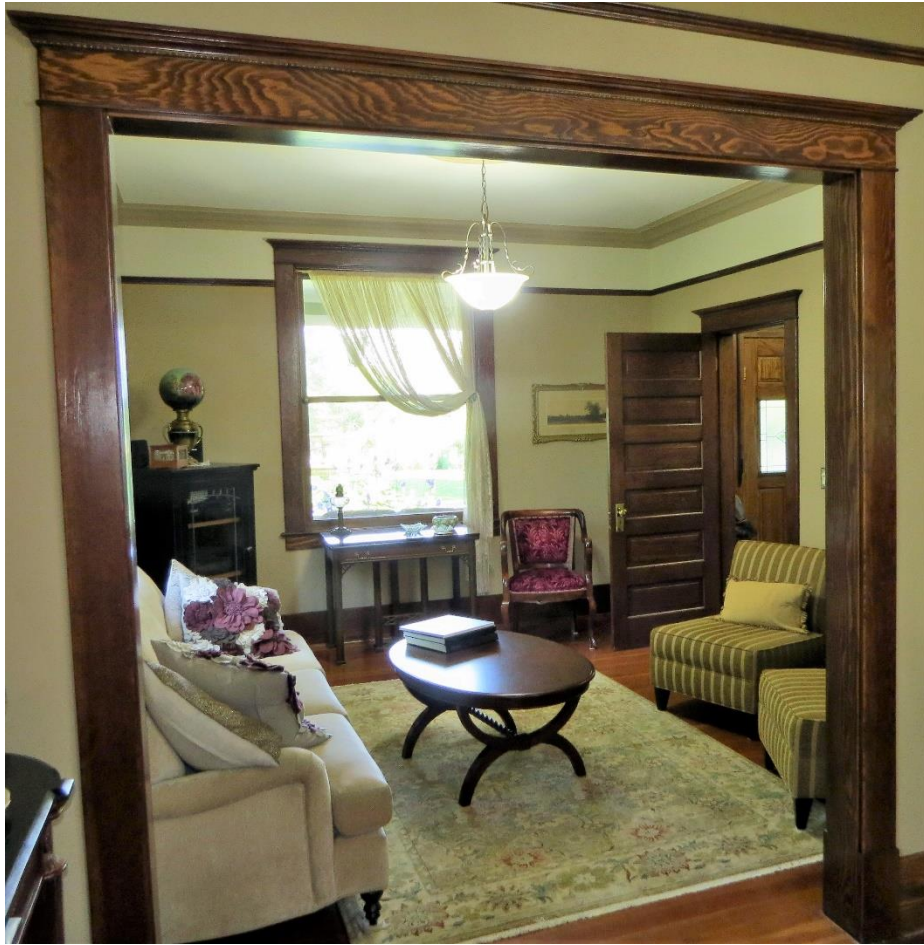
(Image 4.3: Example of wood trim including door and window casings, living room arch, typical six panel door plaster moulding around edge of living room ceiling)

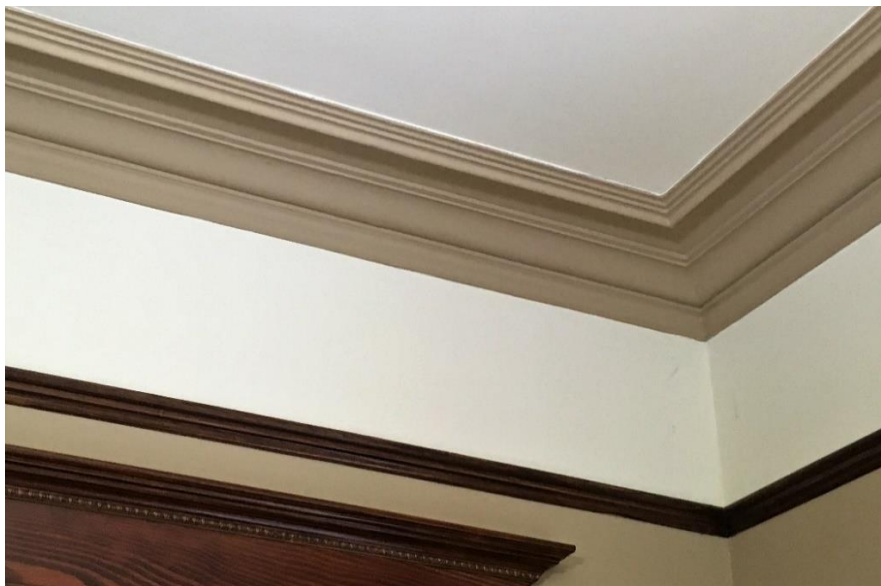
(Image 4.4: Detail of plaster moulding around edge of living room ceiling)
