## **Proposed Wording for a Bylaw to Designate the McAdam Residence as a Municipal Historic Resource**

2. The building known as the McAdam Residence, located at 105 Scarboro Avenue SW, and the land on which the building is located being legally described as PLAN 5700AG BLOCK 224 LOT 13 (the “Historic Resource”), as shown in the attached Schedule “A”, are hereby designated as a Municipal Historic Resource.
3. The specific elements of the Historic Resource possessing heritage value are hereafter referred to as the Regulated Portions (the “Regulated Portions”). The Regulated Portions are identified in the attached Schedule “B”.

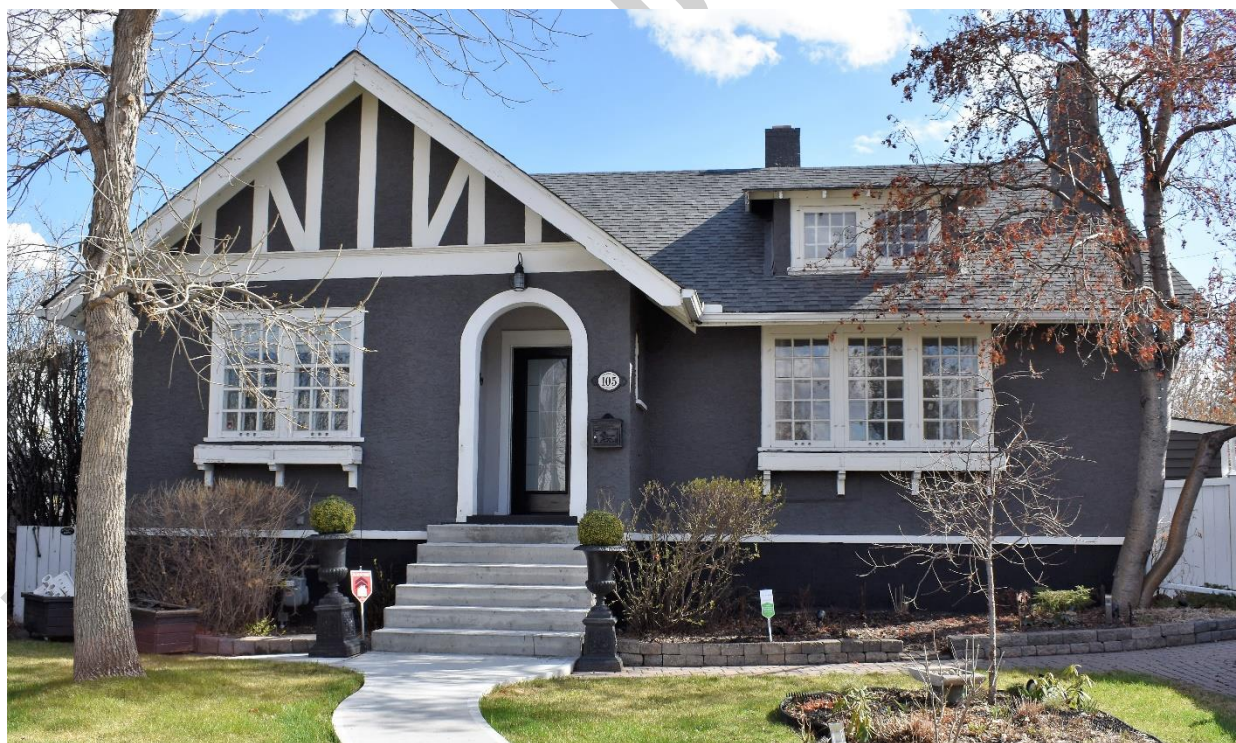
(Image 2.1: North façade)

- a) One and one-half story massing; rectangular plan; stucco cladding on main floor and upper level; mock half-timbering on north gable; wood water table above concrete foundation (Images 2.1 – 2.7);

- b) Medium pitched side-gabled roof; north-facing gable; north-facing dormer with shed roof; moulded wood verges; wood tongue-and-groove soffits; projecting open eaves; exposed rafters tails (Images 2.1 – 2.7);

- c) Front entry recessed behind wood rounded arch offset under north-facing gable; box bay window with shed roof, exposed rafter tails (Image 2.1 – 2.2 and 2.8 – 2.9); and

- d) Original fenestration including: twinned and triple multi-pane single-hung window assemblies; twinned and triple one-over-one single-hung window assemblies, multi-pane casement windows; fixed semi-circular multi-paned window; wood sashes and frames; wood lug sills (Images 2.1 – 2.5, 2.7 – 2.8 and 2.10 – 2.14).

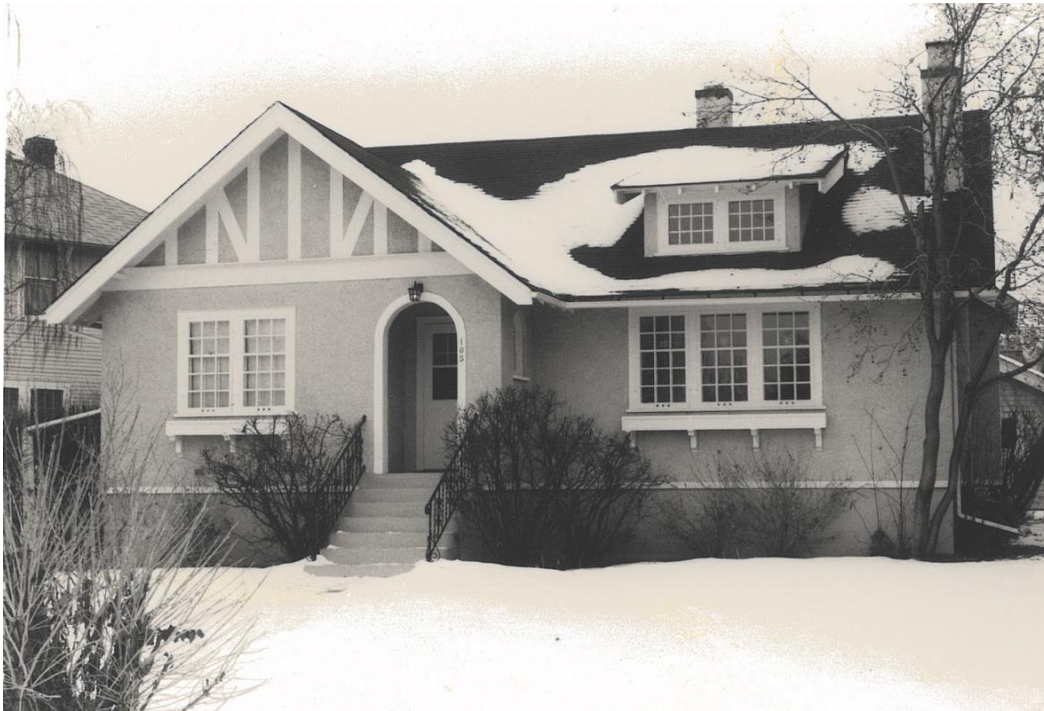
(Image 2.2: North façade ca. 1984, Alberta Heritage Survey Program HS 70869)

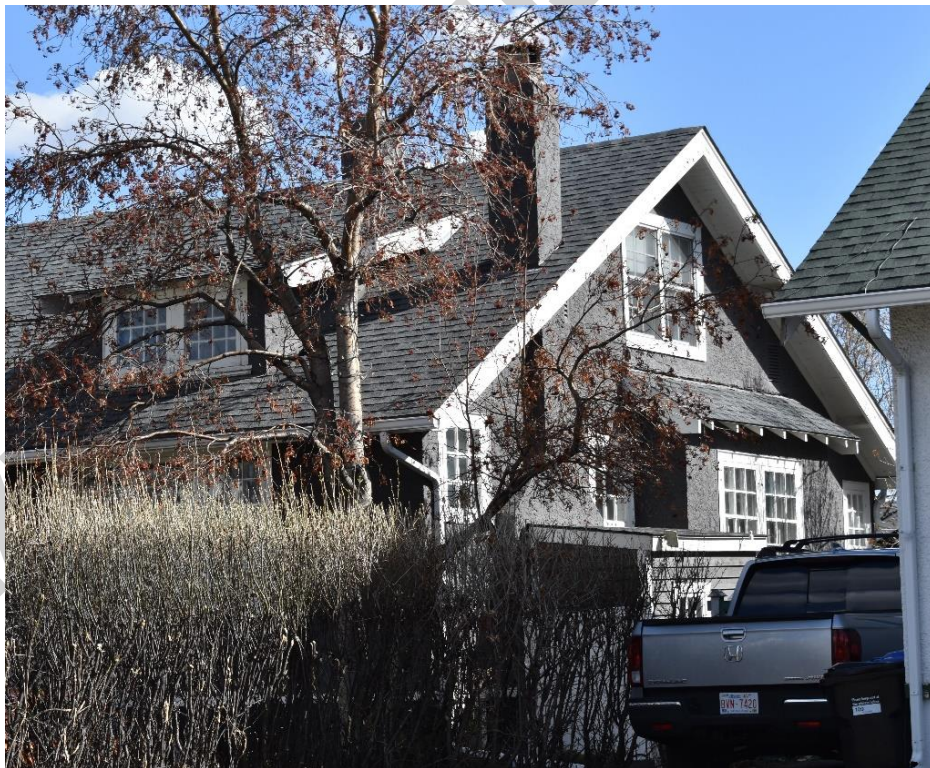
(Image 2.3: West façade)

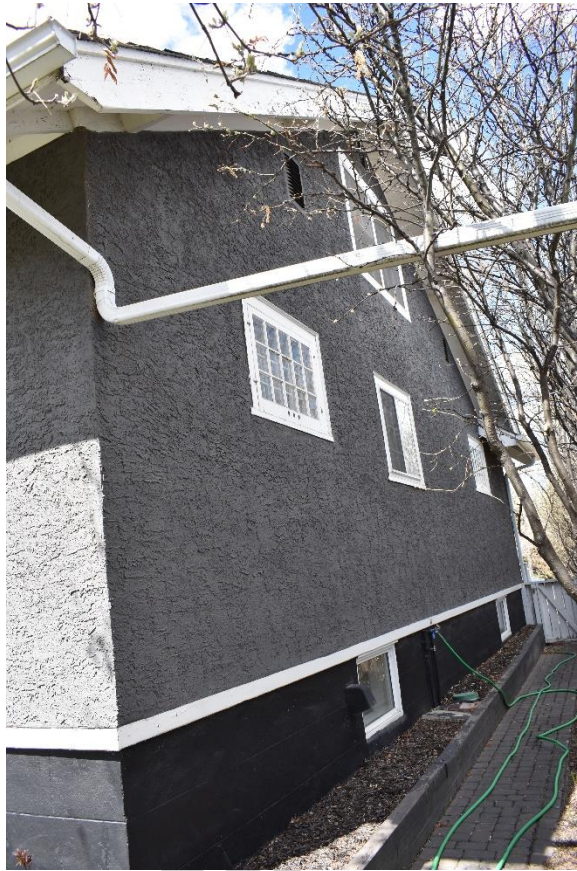
(Image 2.4: East façade)

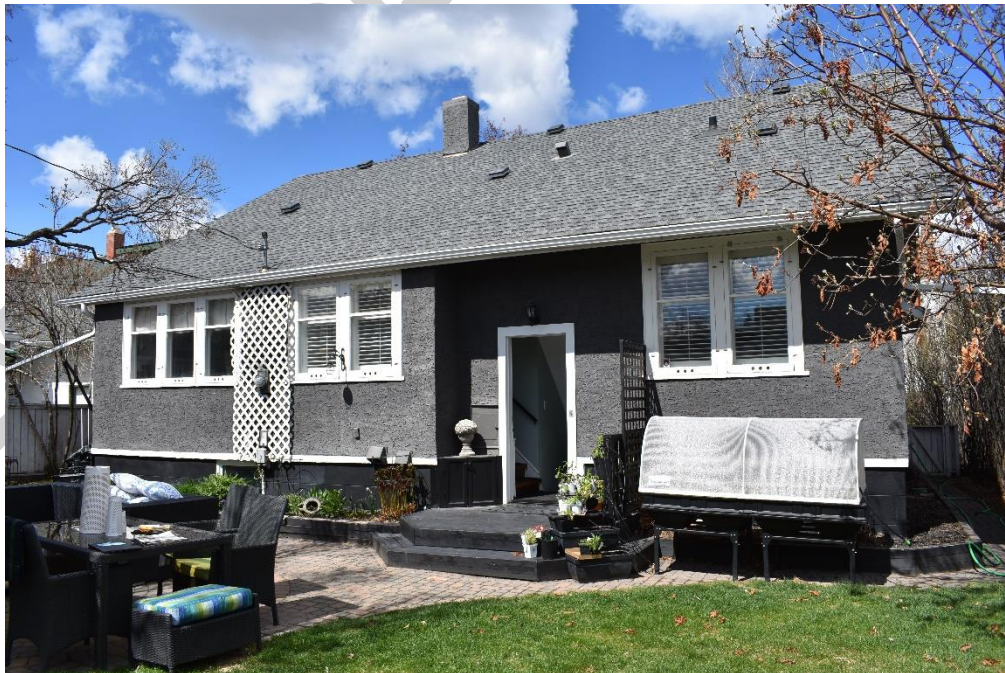
(Image 2.5: South façade)

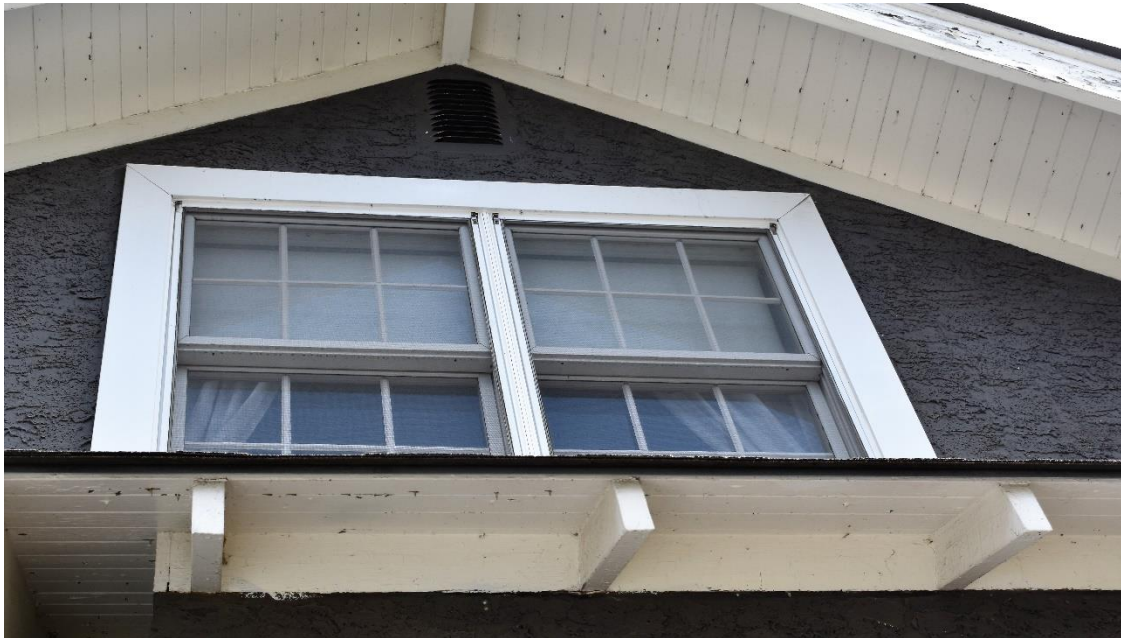
(Image 2.6: Detail of wood tongue-and-groove soffits and exposed rafter tails)

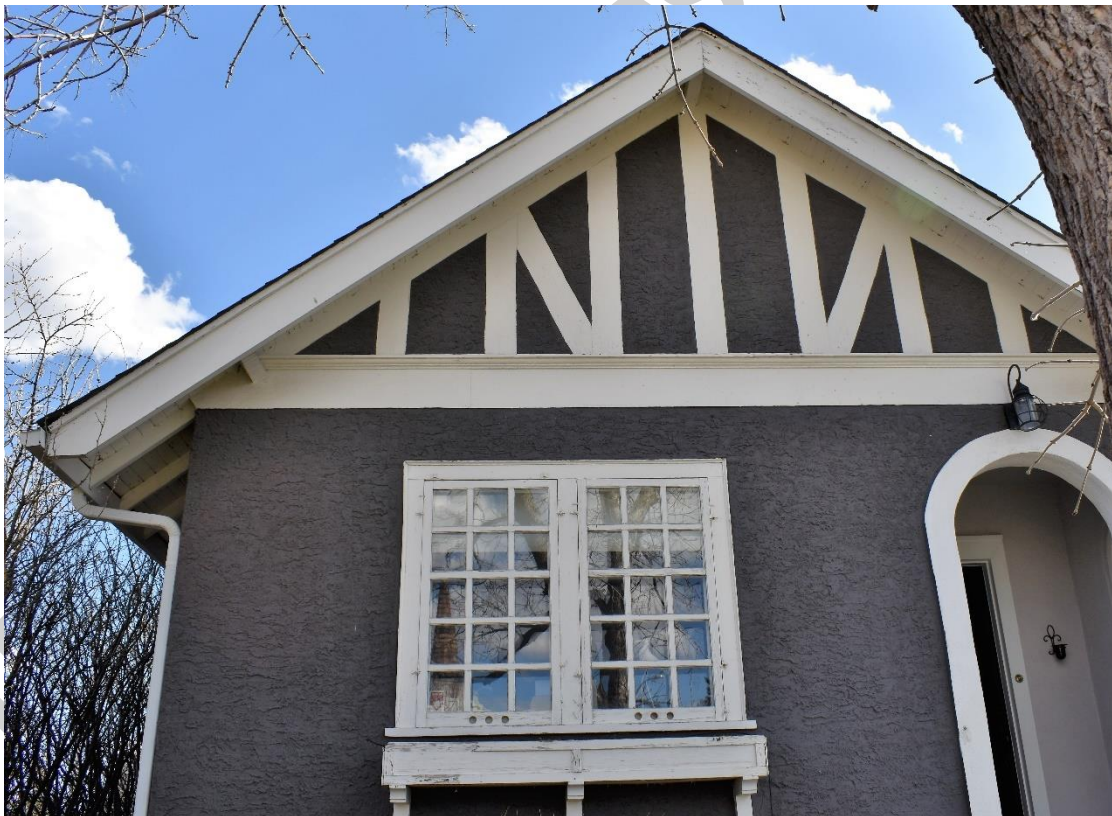
(Image 2.7: Detail of moulded wood verge and mock half-timbering on north gable)

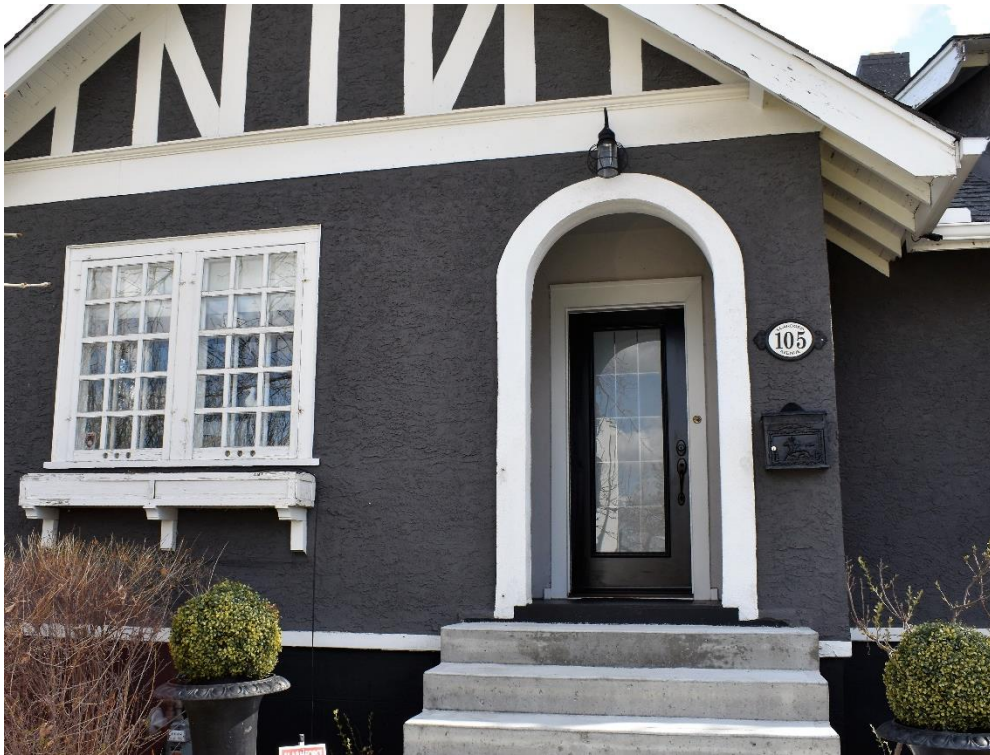
(Image 2.8: Detail of front entry recessed behind wood rounded arch offset under north gable)

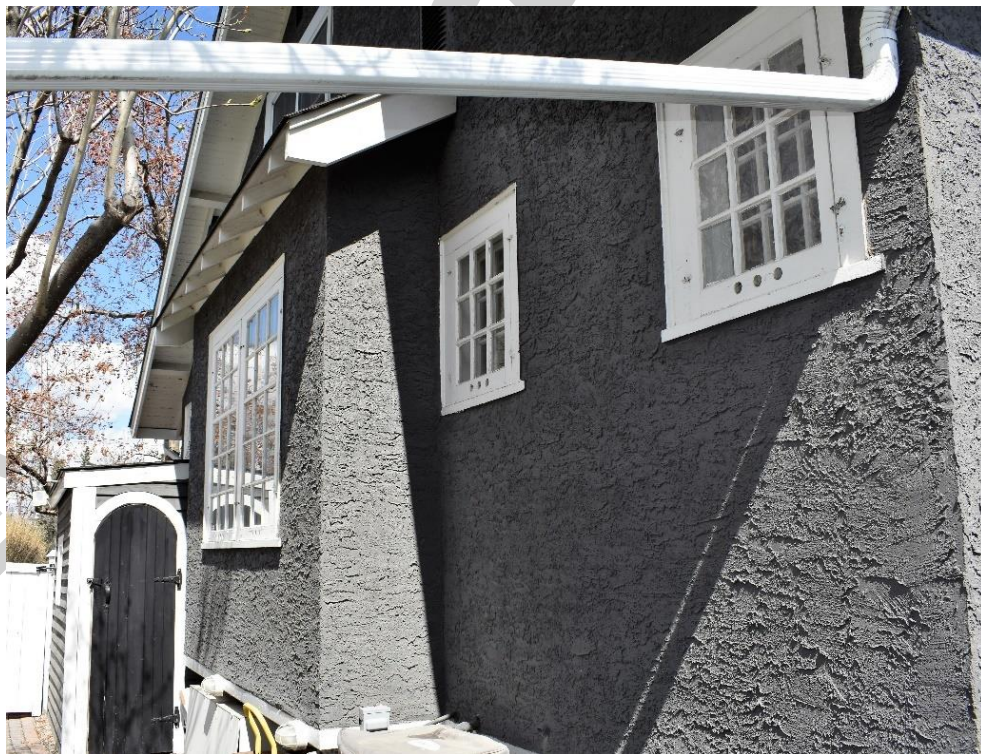
(Image 2.9: Box bay window with shed roof and exposed rafter tails on west façade)

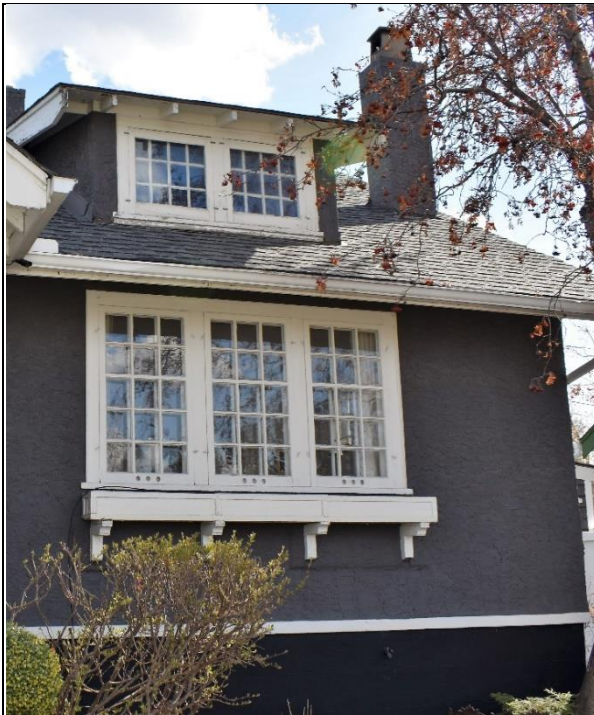
Image 2.10: Typical twinned and triple multi-pane single-hung window assemblies

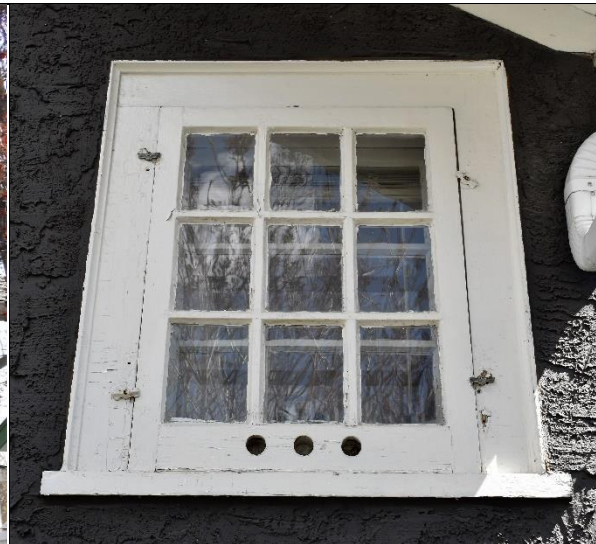
Image 2.11: Typical multi-light casement window.

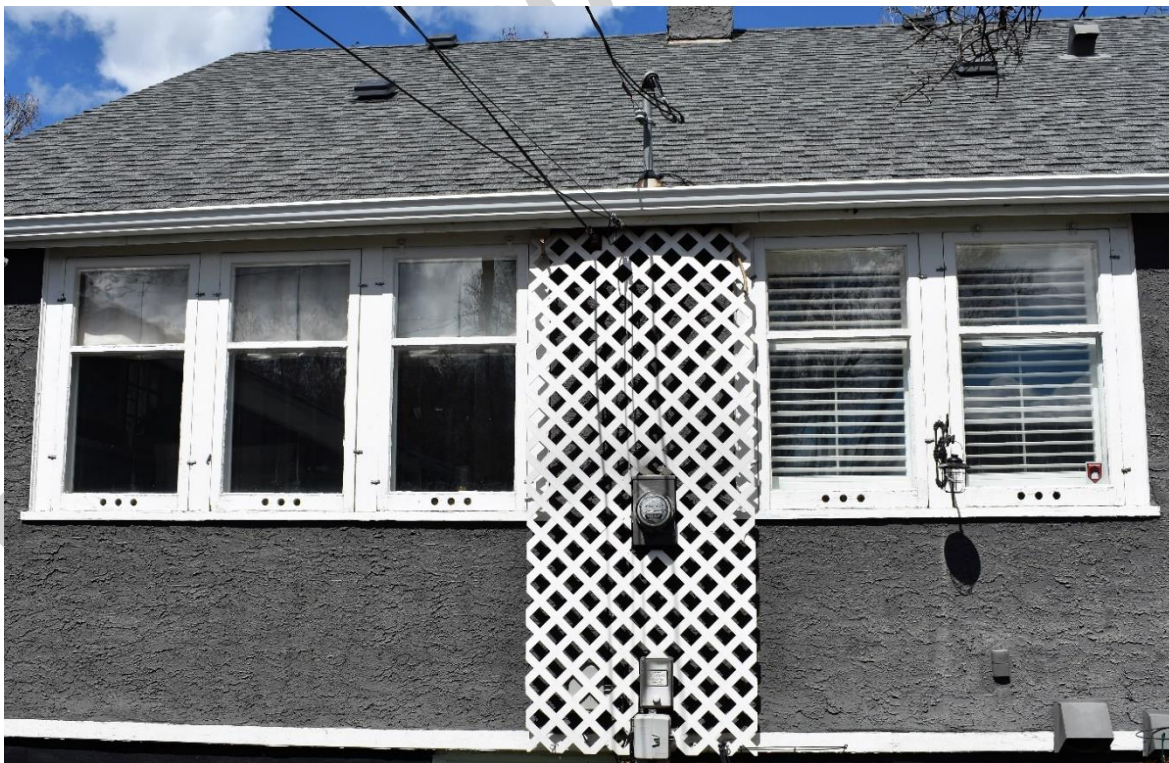
(Image 2.12: Triple and twinned one-over-one, single-hung window assemblies)

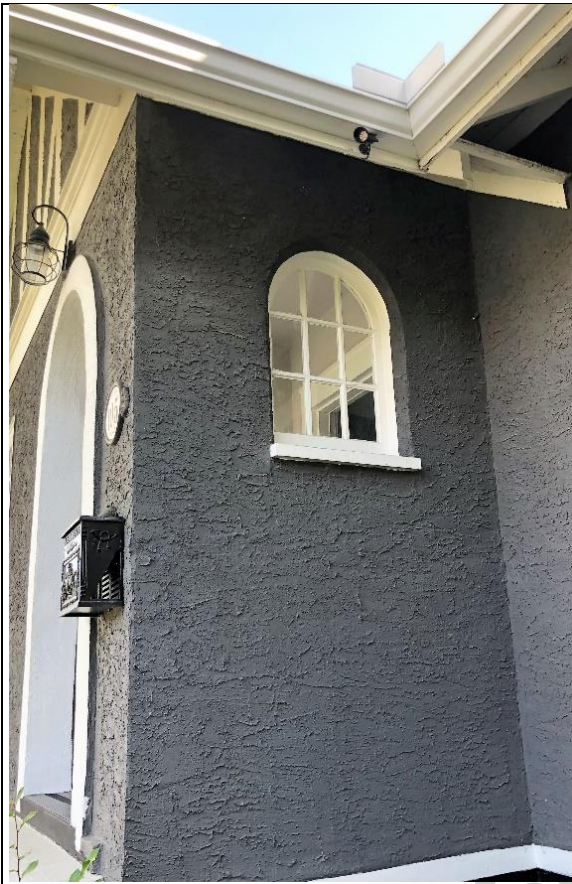
Image 2.13: Fixed semi-circular multi-paned window on west side of covered arched front entry.

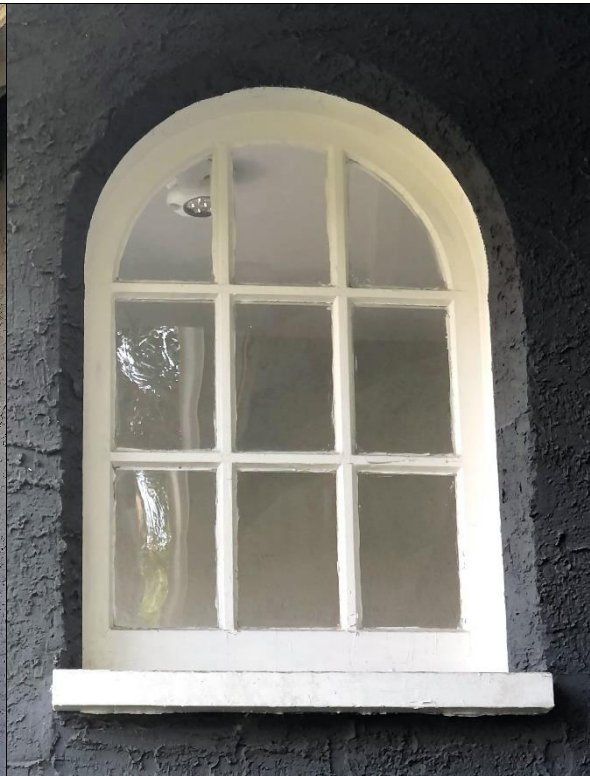
Image 2.14: Detail of fixed semi-circular multi-paned window.
