## BYLAW NUMBER 42M2022

### BEING A BYLAW OF THE CITY OF CALGARY TO DESIGNATE THE BARRON BUILDING AS A MUNICIPAL HISTORIC RESOURCE

**IP2022-1255  
ATTACHMENT 2**

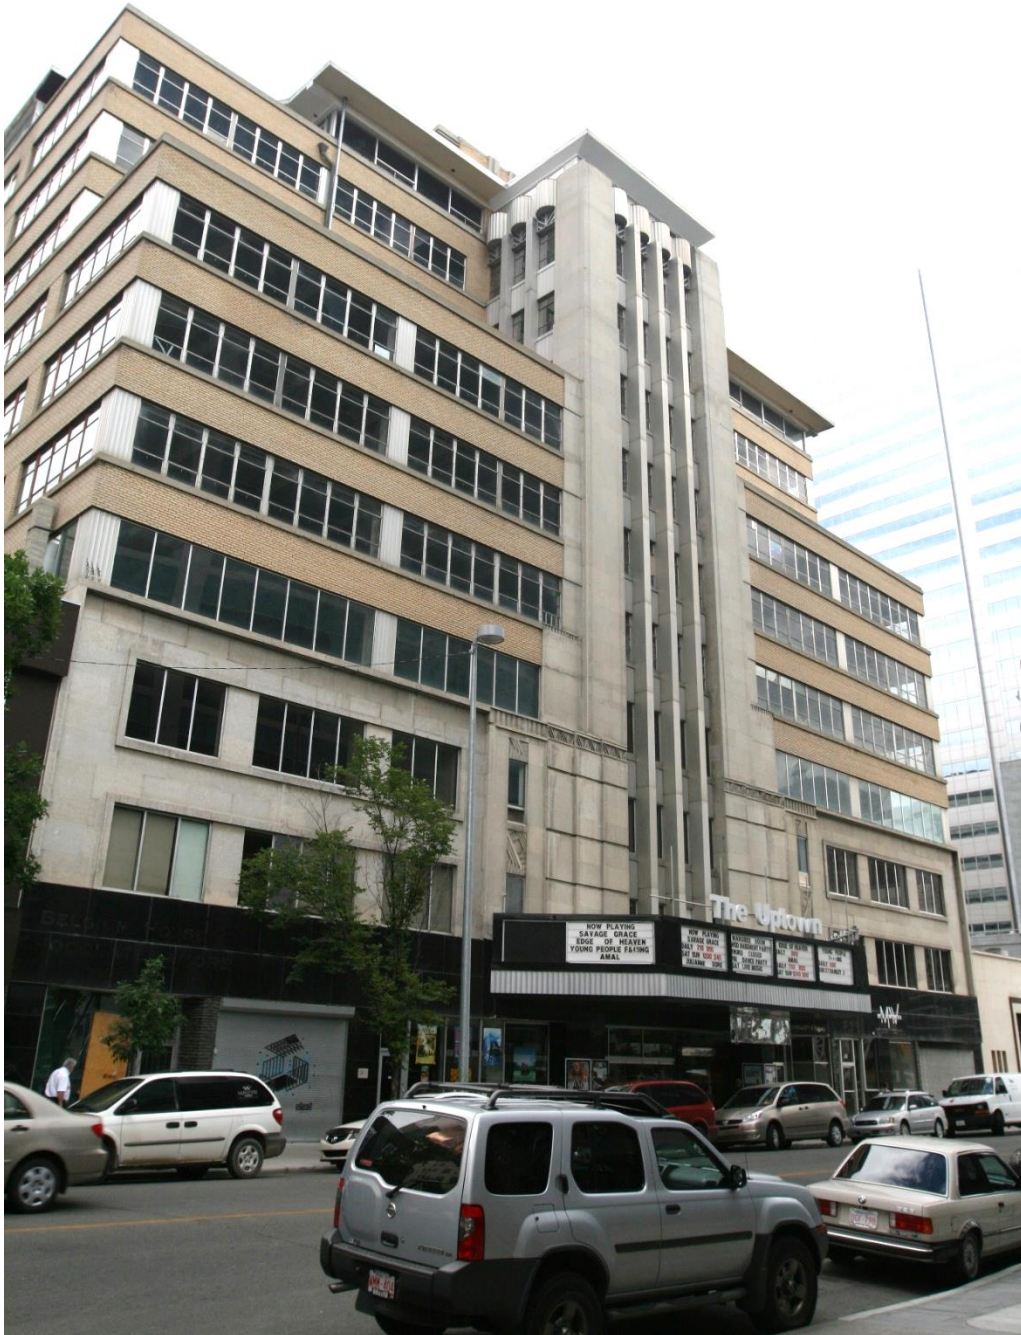
(Image 1.1: Oblique view of south façade showing black granite tile sheet cladding framing the first storey with angled storefronts, concrete tile cladding framing the second and third storeys, buff-colored brick spandrels framing with scalloped sheet aluminum cladding details at corners and in front of the columns from storeys four through ten, with fenestration comprised of ribbon windows from storeys two through eleven)

- a) Stepped-back form and 11-storey massing (eleventh storey form and massing re-created based on historic penthouse massing), and angled storefront configuration on the main floor (Images 1.1 – 1.2, 1.4, 1.6, 1.10 and 1.11);

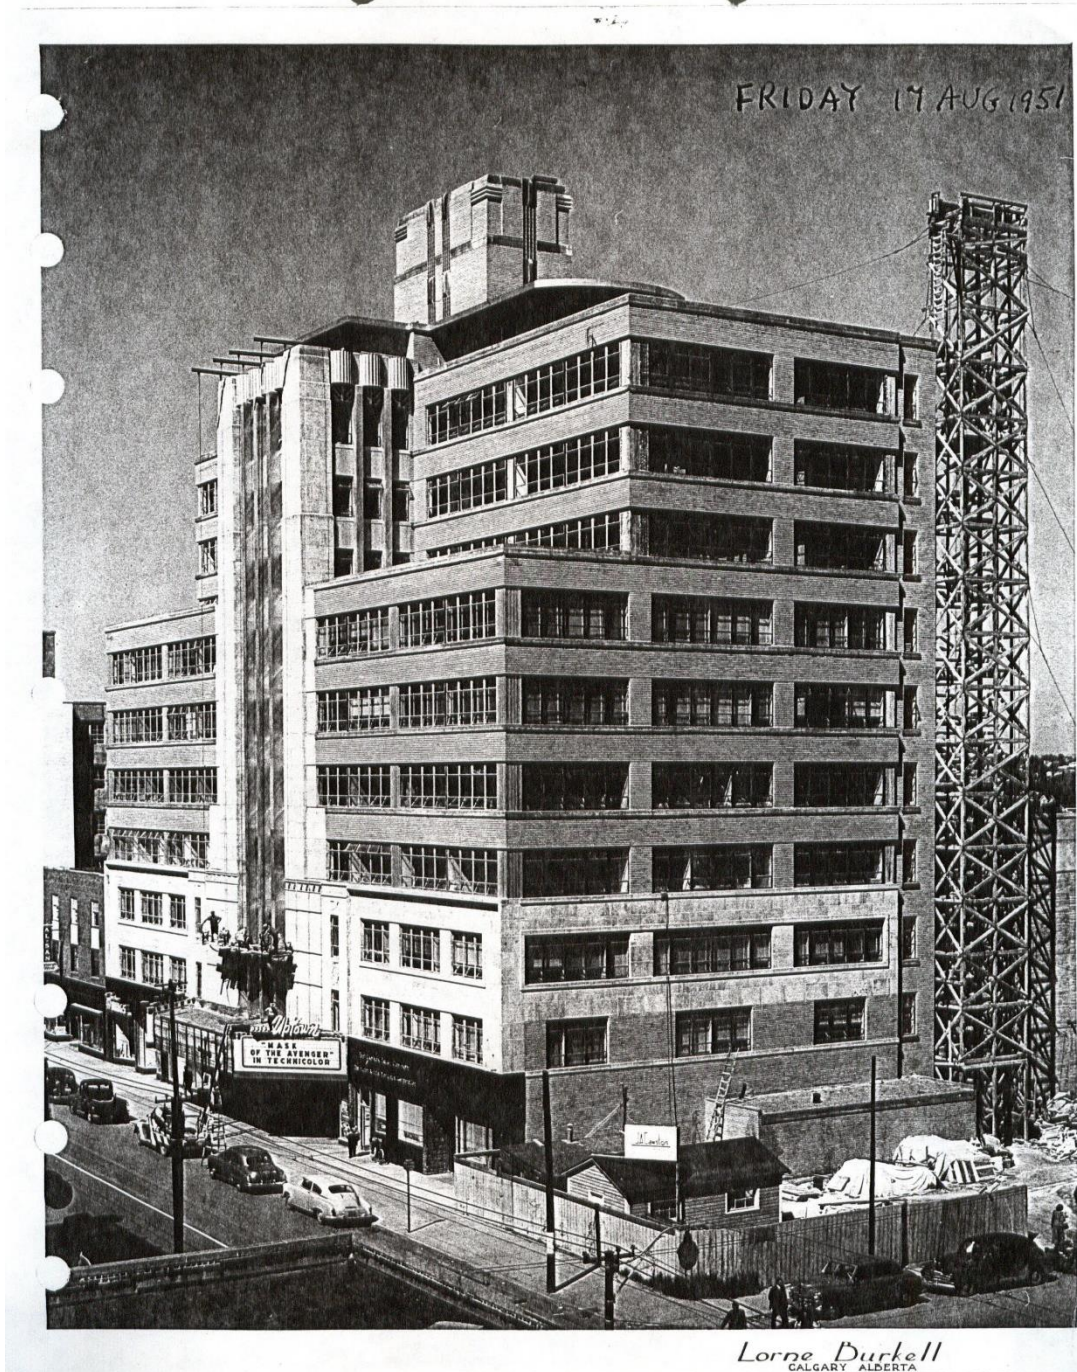
(Image 1.2: 1951 photo showing oblique view of south façade with deep overhanging eaves at the eleventh storey penthouse, and original rooftop mechanical and elevator house forms, geometric-patterned stone banding on elevator house at the rooftop). Photo Credit: Daniel Barron

- c) Reconstructed elevator house and mechanical structures at the rooftop, geometric-patterned stone banding on elevator house (Image 1.2);
- d) Black granite tile sheet cladding framing the first storey (storefronts), concrete tile cladding framing the second and third storey, buff-coloured brick spandrel panels framing with scalloped sheet aluminum cladding details at corners and in front of the columns from storeys four through ten (Images 1.1 – 1.6 and 1.9 – 1.11 and 1.14);

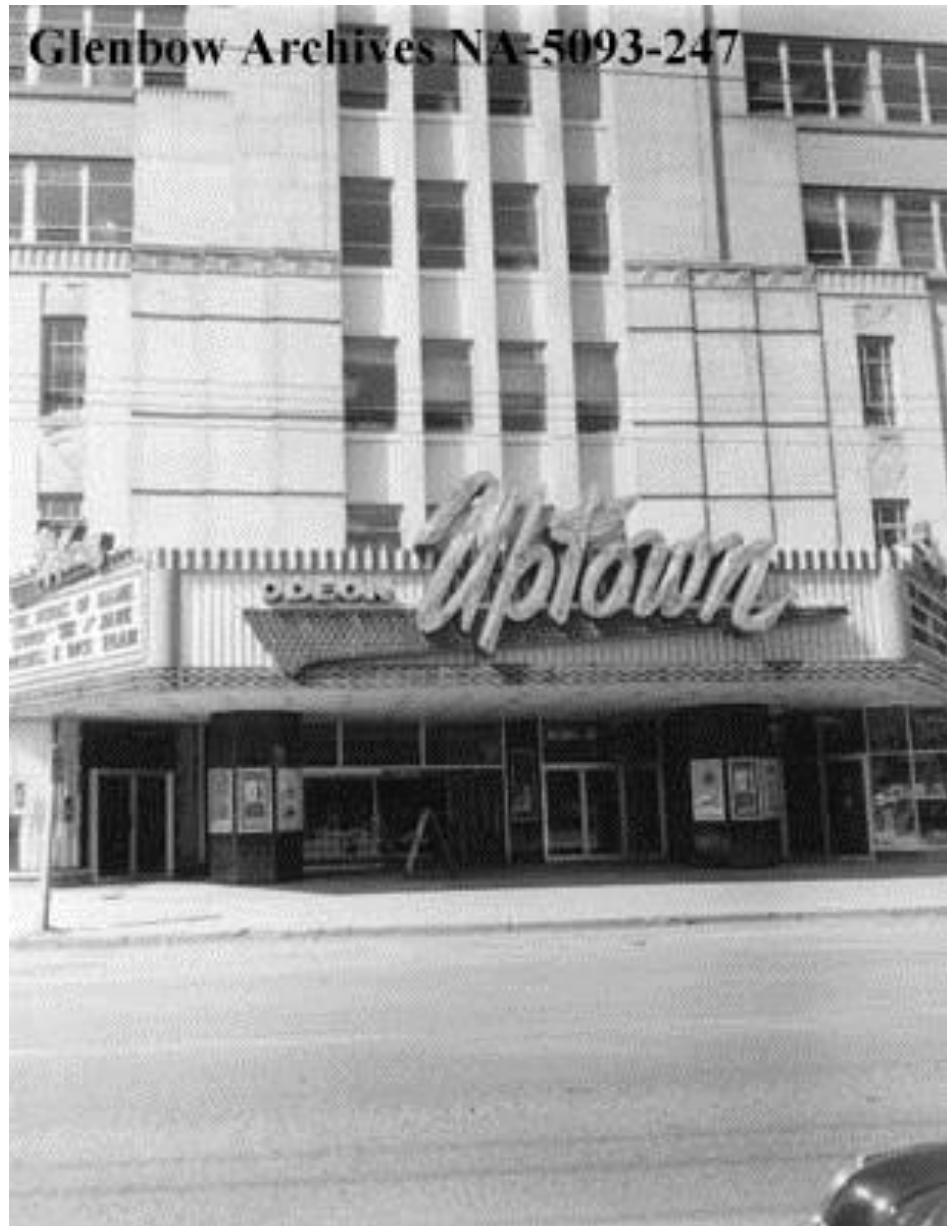
(Image 1.3: 1956 photo showing Black granite tile sheet cladding framing the first storey with angled storefronts, and honed Tyndall limestone windowsills, copings, spandrel panels and ornaments for storeys two through four)

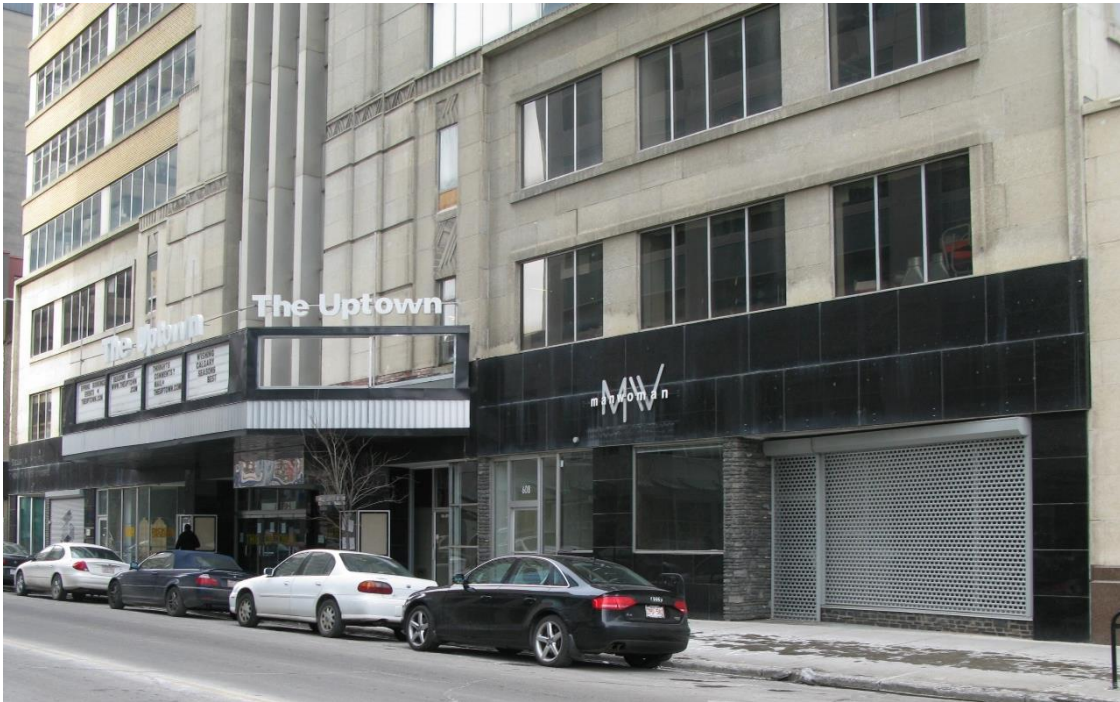
(Image 1.4: Black granite tile sheet cladding framing the first storey with angled storefronts, and honed Tyndall limestone windowsills, copings, spandrel panels and ornaments for storeys two through four)

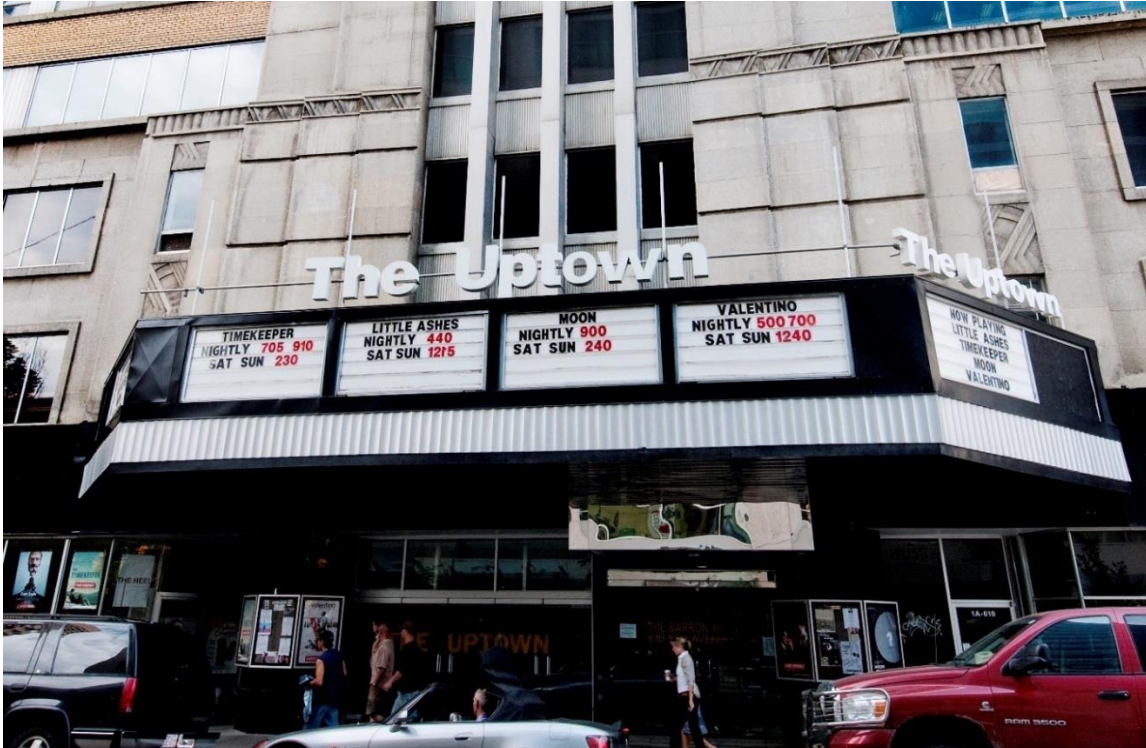
(Image 1.5: Black granite tile sheet cladding framing the first storey, and honed Tyndall limestone windowsills, copings, spandrel panels and ornaments for storeys two through four)

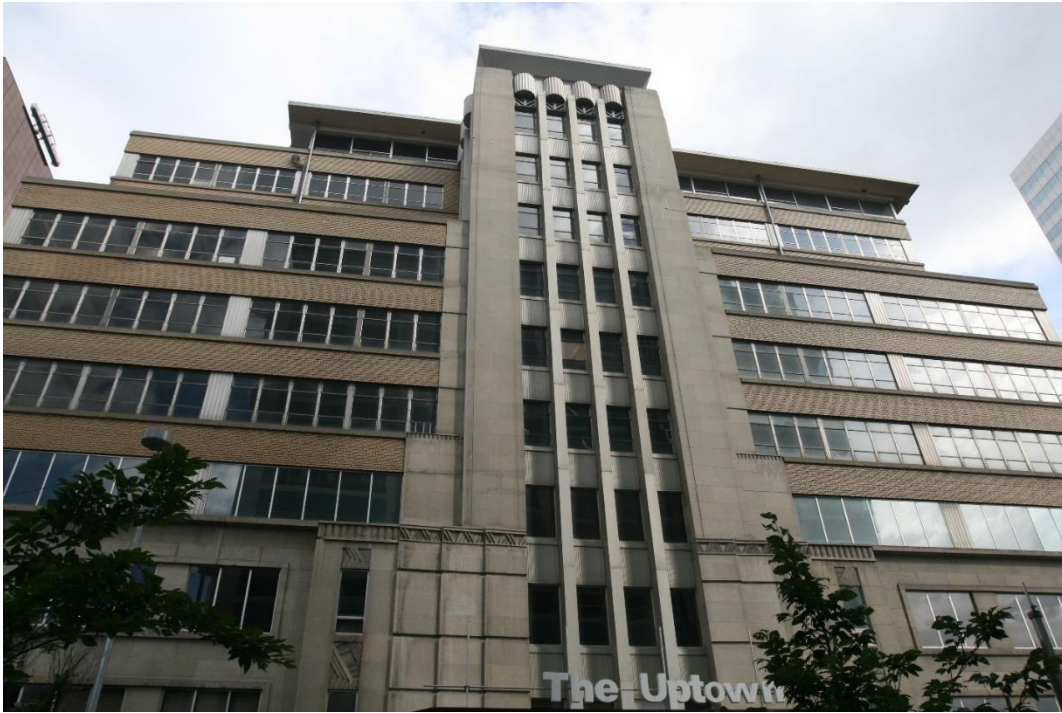
(Image 1.6: South façade photo showing honed Tyndall limestone vertical central frontispiece on storeys two through eleven, scalloped aluminum cladding details at spandrel panels on central frontispiece rising from storeys two through ten, four vertical bands of windows on central frontispiece rising from storey two through ten, stylized aluminum-clad pilasters on central frontispiece from storeys two through ten, curved, stylized aluminum panels curved aluminum panels with scalloped profile and Art-Moderne ornamentation displaying carved, low-relief panels with geometric-patterned stone detail at the eleventh storey)

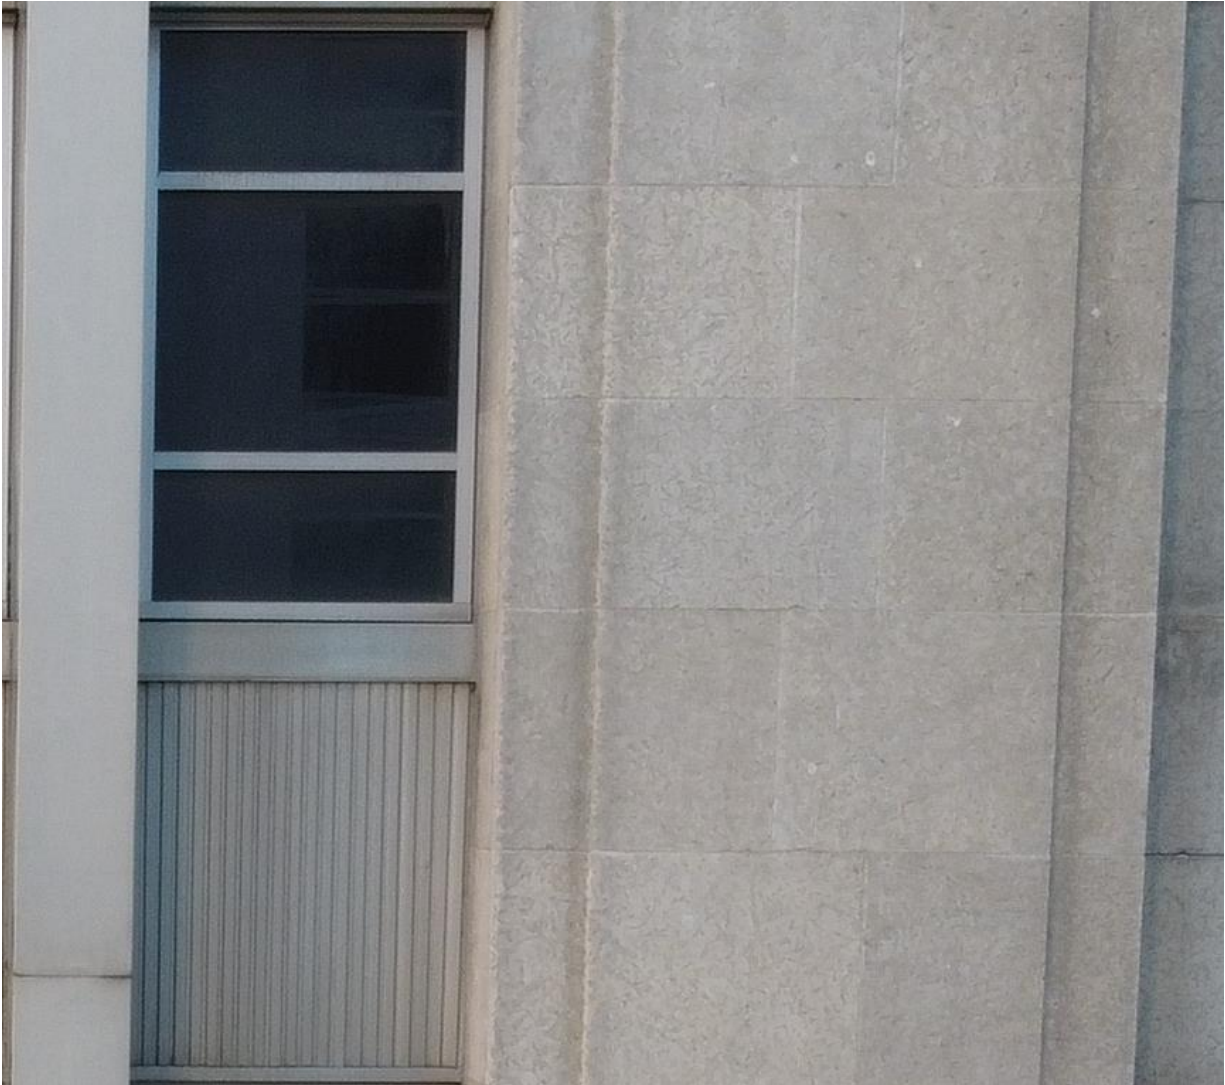
(Image 1.8: Detailed view of central frontispiece's stylized aluminum pilaster on the left, scalloped aluminum cladding details at spandrel panels in the middle and limestone pilaster on the right).

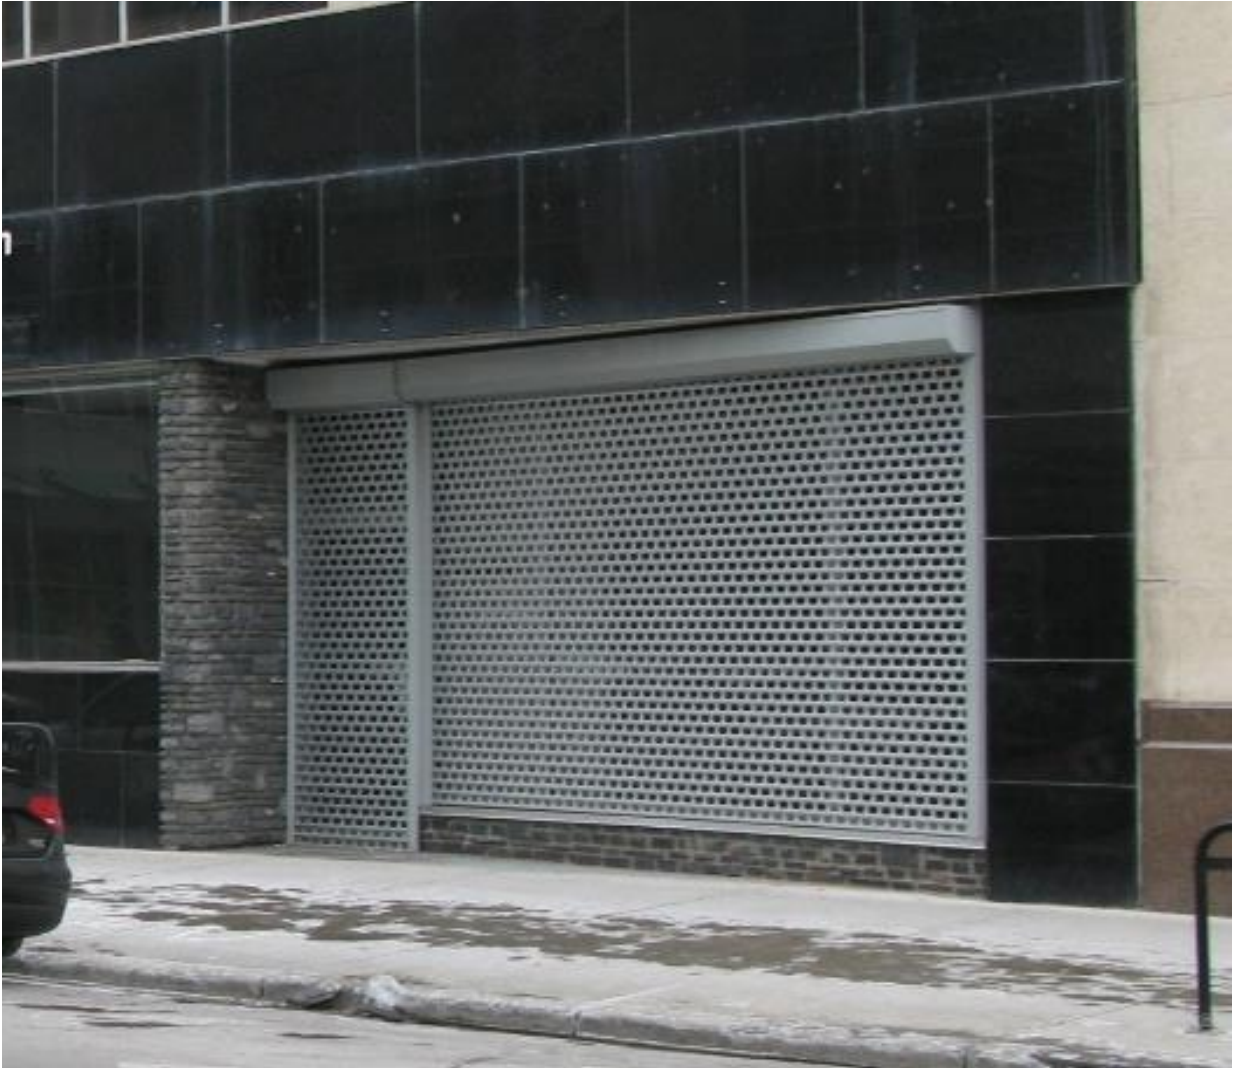
(Image 1.10: Detailed view of black granite cladding on the angled storefront at the southeast façade. View of junction of black granite and Tyndall limestone)

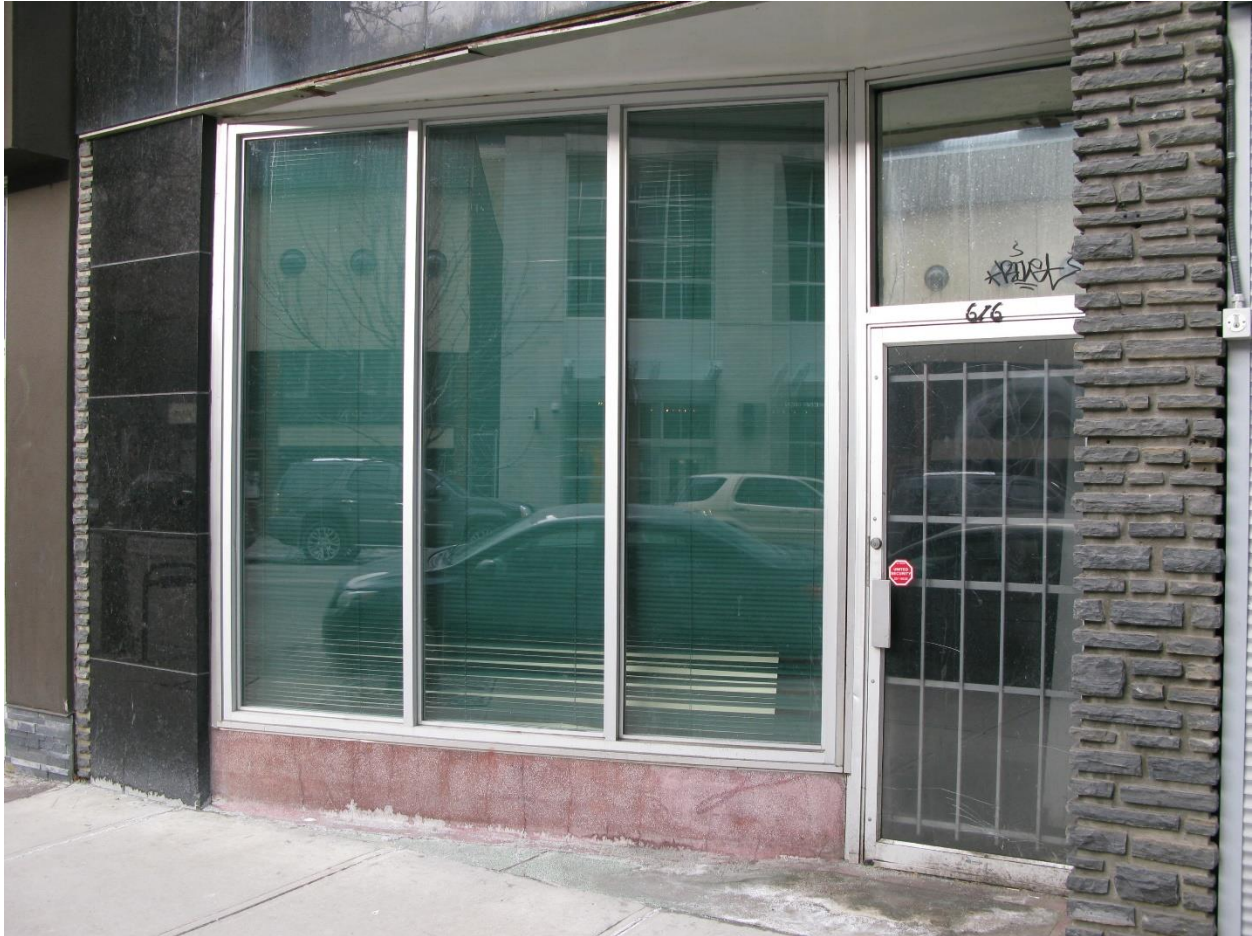
(Image 1.11: Detailed view of black granite cladding on the angled storefront at the southwest façade)

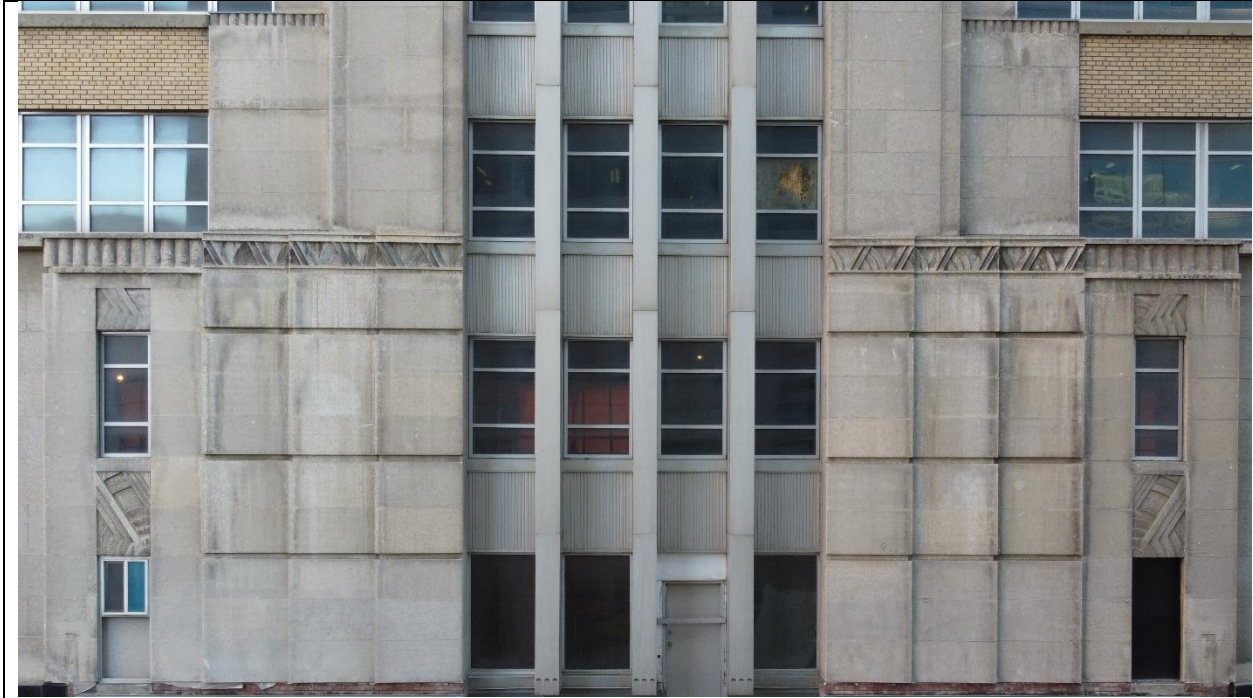
(Image 1.12: Frontal view of carved detail bands and Art Deco motifs on Tyndall limestone)

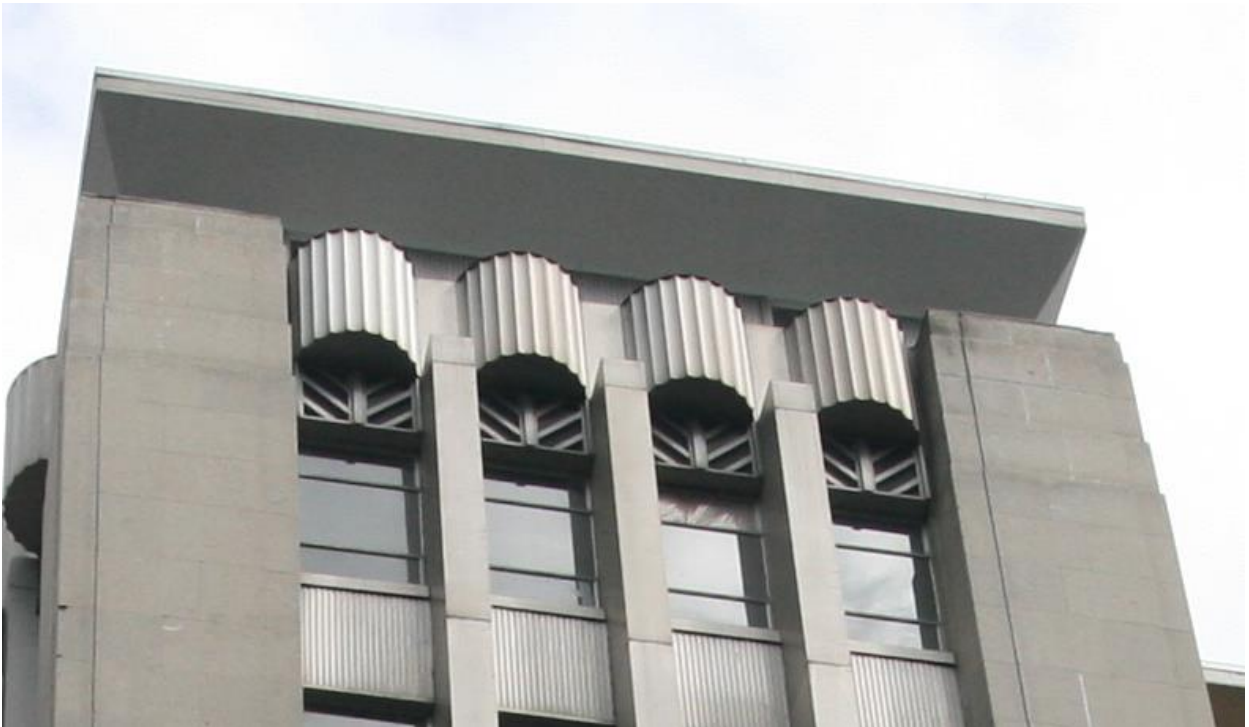
(Image 1.15: curved, stylized aluminum panels with scalloped profile and Art-Moderne ornamentation displaying carved, low-relief panels with geometric-patterned stone detail at the eleventh storey, with deep overhanging eaves)

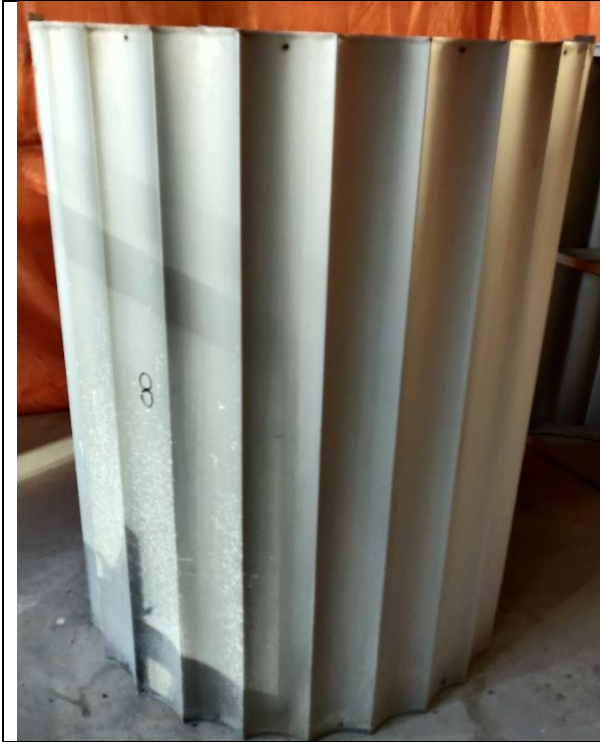
(Image 1.16: 2022 close-up photo of curved, stylized aluminum panel with scalloped profile. Deconstructed from its original placement, it will be returned to its original location and configuration)

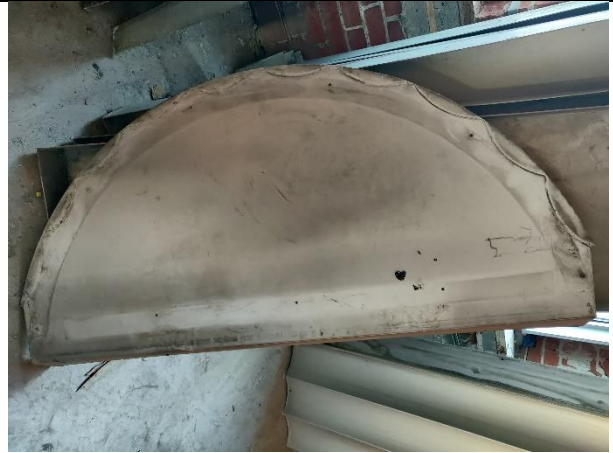
(Image 1.17: 2022 close-up photo of top cap for curved, stylized aluminum panel. Deconstructed from its original placement, it will be returned to its original location and configuration)

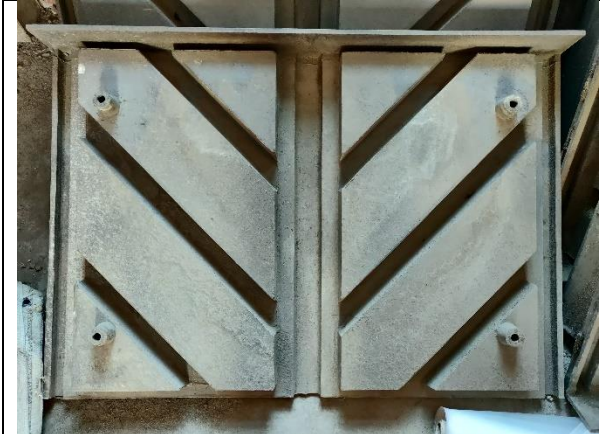
(Image 1.18: 2022 close-up photo of low-relief panel with geometric-patterned stone. Deconstructed from its original placement, it will be returned to its original location and configuration)

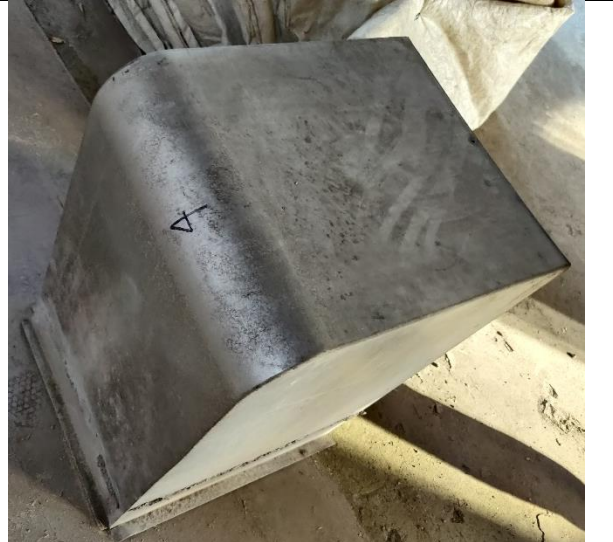
(Image 1.19: 2022 close-up photo of top cap for aluminum pilaster. Deconstructed from its original placement, it will be returned to its original location and configuration)

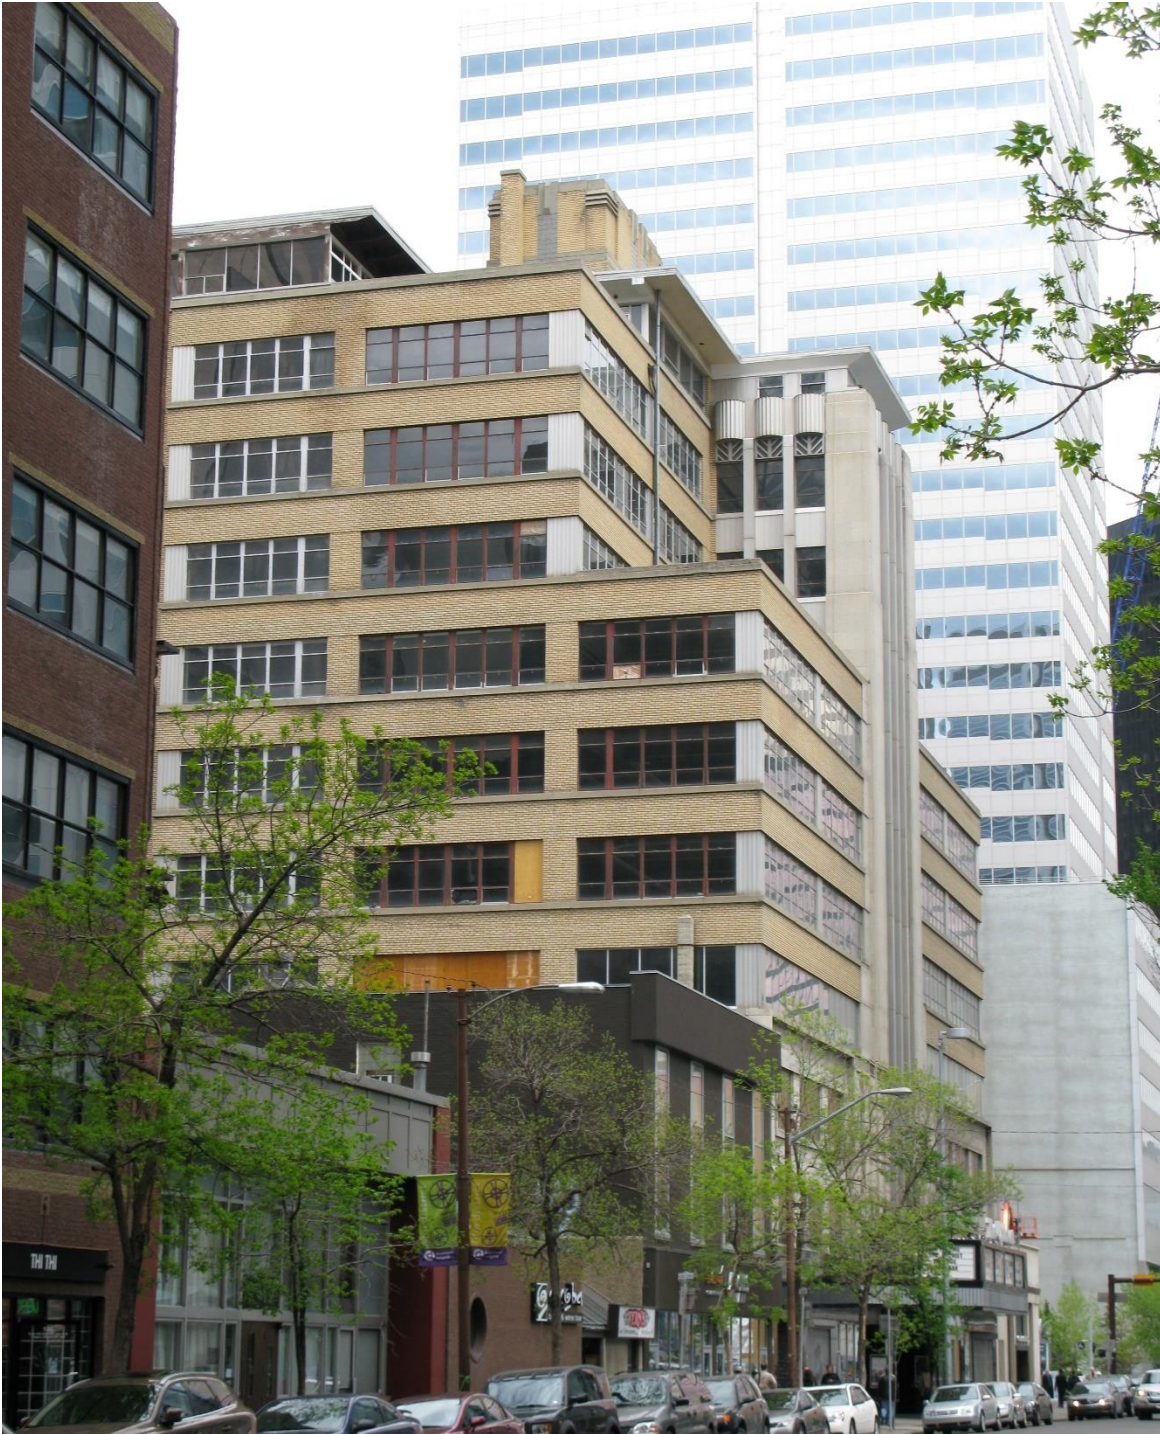
(Image 2.1: Oblique view of the west and south façade showing building stepback at the eighth and eleventh storey, with deep overhanging eaves at the eleventh storey penthouse, and original rooftop mechanical and elevator house forms, fenestration comprised of ribbon windows with scalloped aluminum-panel corners with buff-coloured brick spandrel panels framing storeys four through ten. Curved and stylized aluminum panels with scalloped profile and Art-Moderne ornamentation displaying carved, low relief spandrel panels with geometric-patterned stone detail on the eleventh storey of central frontispiece)

- a) Stepped-back form and 11-storey massing (eleventh storey form and massing re-created based on historic penthouse massing) (Images 2.1 and 2.2);
- b) Flat roofs (terraces) where the building steps back at the eighth and eleventh storeys, deep overhanging eaves on penthouse (Images 2.1 and 2.2);

- c) Reconstructed elevator house and mechanical structures at the rooftop, geometric-patterned stone banding on elevator house (Images 2.1 and 2.2);
- d) Buff-coloured brick spandrel panels framing storeys four through ten (Image 2.1);

- e) Honed Tyndall limestone vertical central frontispiece on storeys eight through eleven (Images 2.1 and 2.2) ,
- f) Fenestration comprised of ribbon windows with scalloped aluminum-panel corners from storeys four to ten, concrete windowsills on the façade of storeys four through eleven, and three vertical bands of windows with scalloped sheet aluminum cladding details at spandrel panels and aluminum-clad pilasters on central frontispiece rising from storeys eight to ten, and curved and stylized aluminum panels and Art-Moderne ornamentation displaying carved, low relief spandrel panels with geometric-patterned stone detail on the eleventh storey of central frontispiece (Image 2.1 and 2.2);

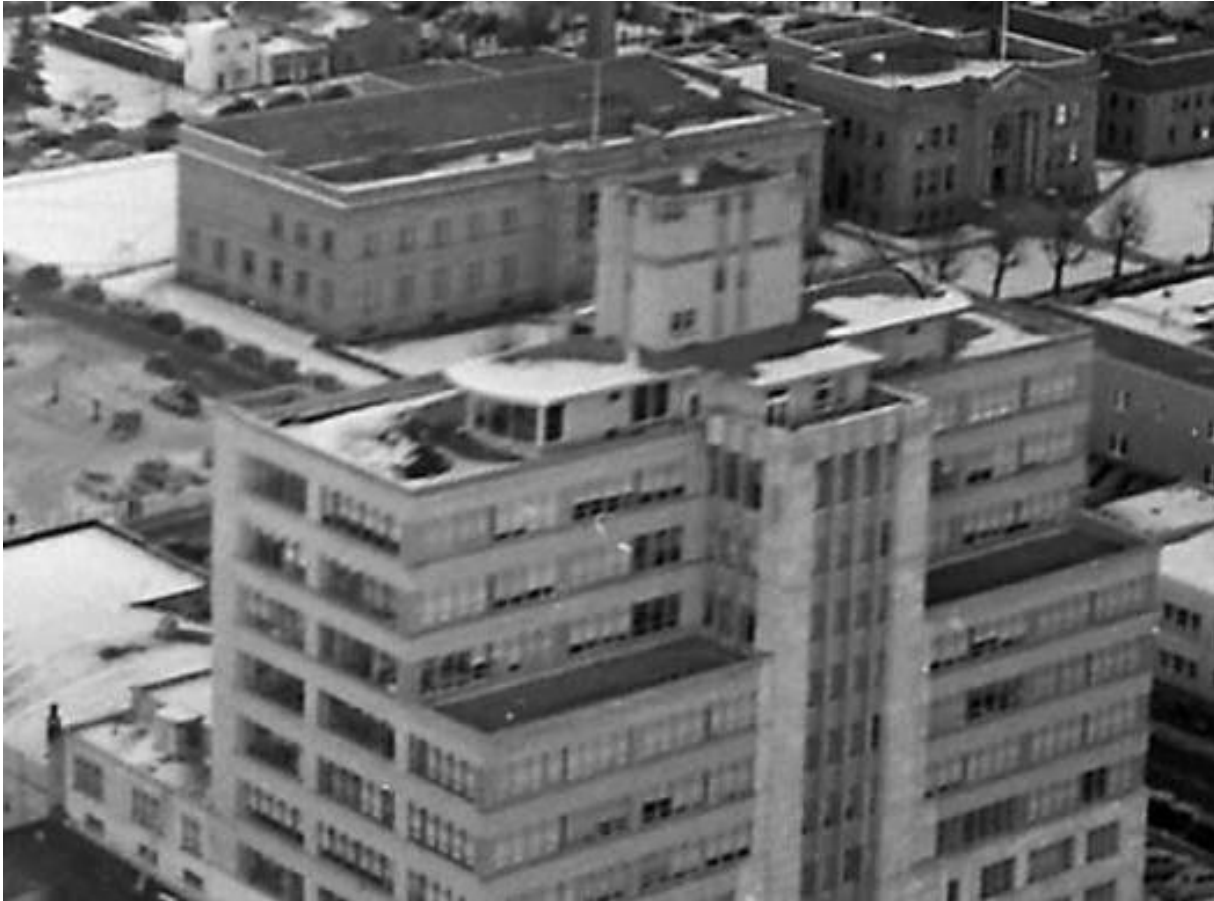
(Image 2.2: 1951 photo showing aerial view of Barron Building from southwest corner showing building stepback at the eighth and eleventh storey with deep overhanging eaves at the eleventh storey penthouse, and original rooftop mechanical and elevator house forms).  
Photo Credit: Daniel Barron

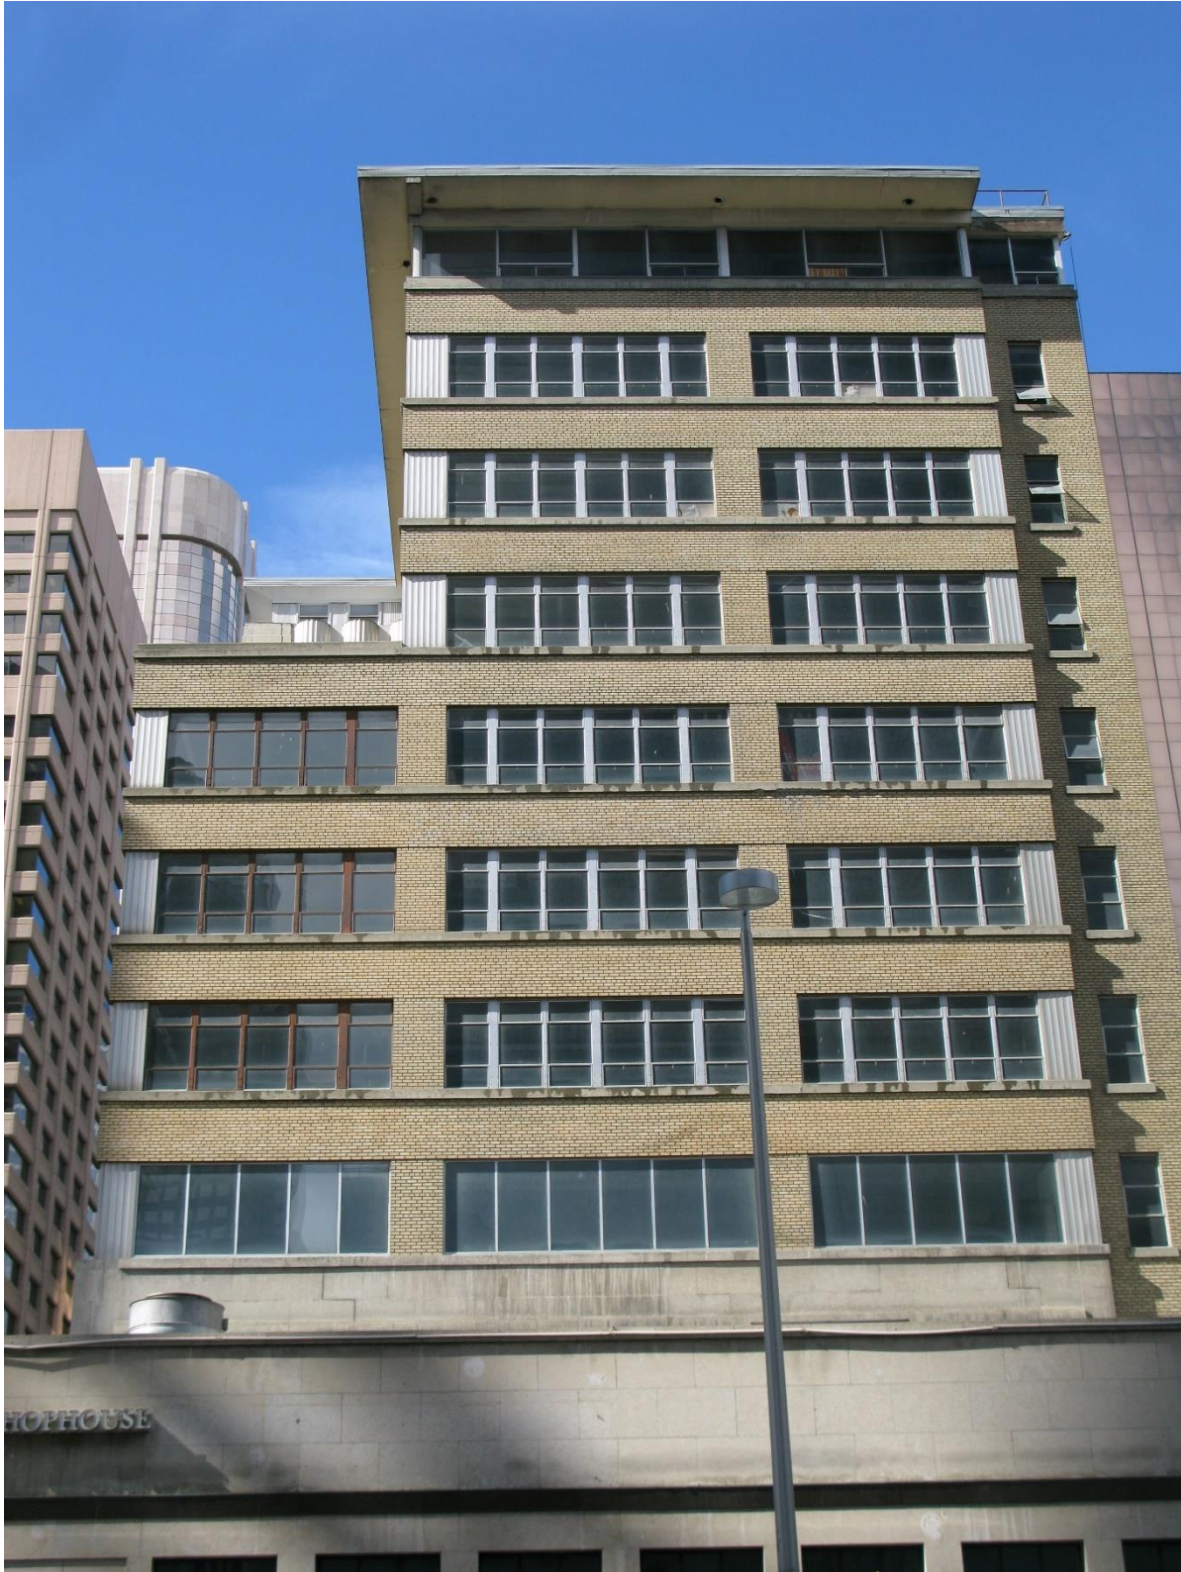
(Image 3.1: View of east façade flat roofs (terraces) where the building steps back at the eighth and eleventh storeys, with deep overhanging eaves at the eleventh storey penthouse, and original rooftop mechanical and elevator house forms, buff-coloured brick spandrel panels framing storeys four through eight)

- a) Stepped-back form and 11-storey massing (eleventh storey form and massing re-created based on historic penthouse massing) (Images 3.1 – 3.4);
- b) Flat roofs (terraces) where the building steps back at the eighth and eleventh storeys, deep overhanging eaves on penthouse (Images 3.1 – 3.4);

- c) Reconstructed elevator house and mechanical structures at the rooftop, geometric-patterned stone banding on elevator house (Images 3.1 – 3.4);
- d) Buff-coloured brick spandrel panels framing storeys four through ten (Images 3.1 and 3.2);

- e) Honed Tyndall limestone vertical central frontispiece on storeys eight through eleven (Image 3.2);
- f) Fenestration comprised of ribbon windows with scalloped aluminum-panel corners from storeys four to ten, concrete windowsills on the façade of storeys five through eleven, honed Tyndall limestone windowsills, copings and ornaments on storeys three and four, three vertical bands of windows with scalloped sheet aluminum cladding details at spandrel panels and aluminum-clad pilasters on central frontispiece rising from storeys eight to ten, and curved and stylized aluminum panels and Art-Moderne ornamentation displaying carved, low relief spandrel panels with geometric-patterned stone detail on the eleventh storey of central frontispiece (Images 3.1 – 3.4);

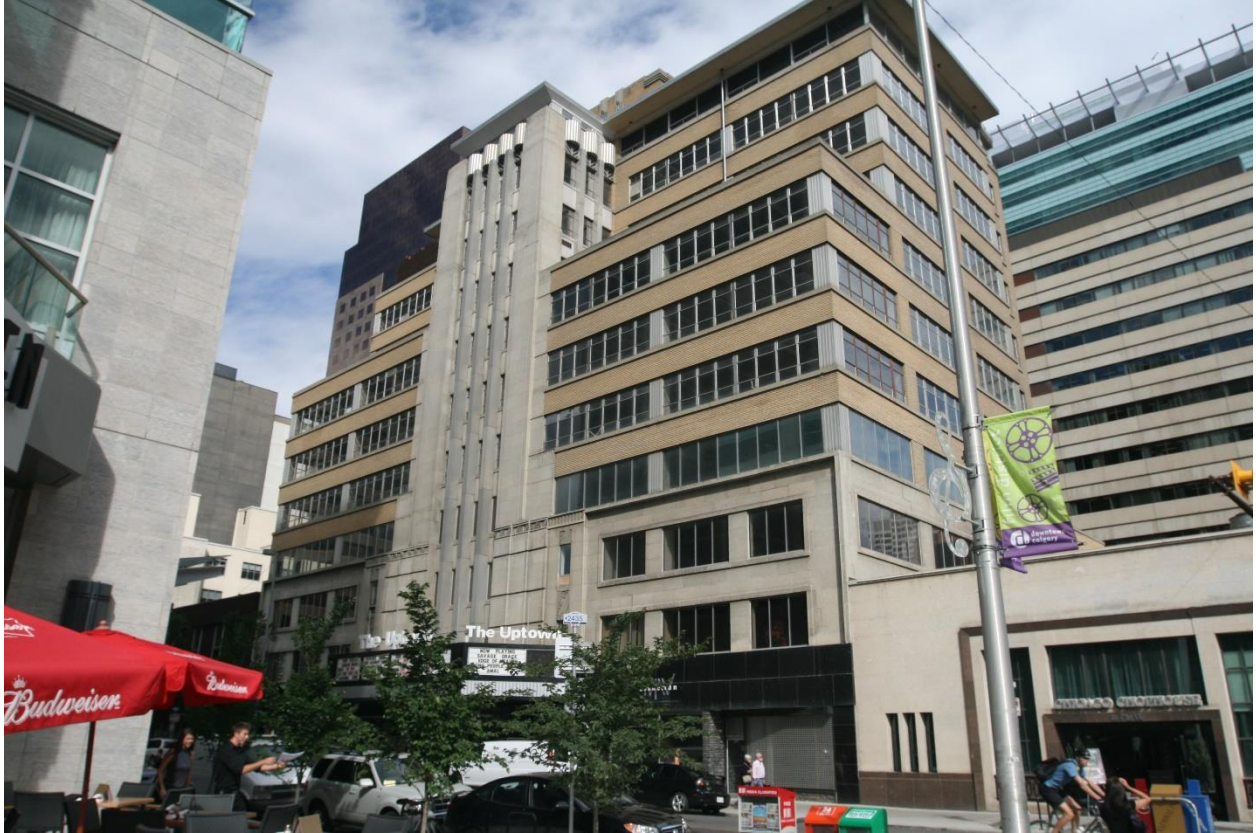
(Image 3.2: View of east façade flat roofs (terraces) where the building steps back at the eighth and eleventh storeys, with deep overhanging eaves at the eleventh storey penthouse, and original rooftop mechanical and elevator house forms, buff-coloured brick spandrel panels framing storeys four through eight)

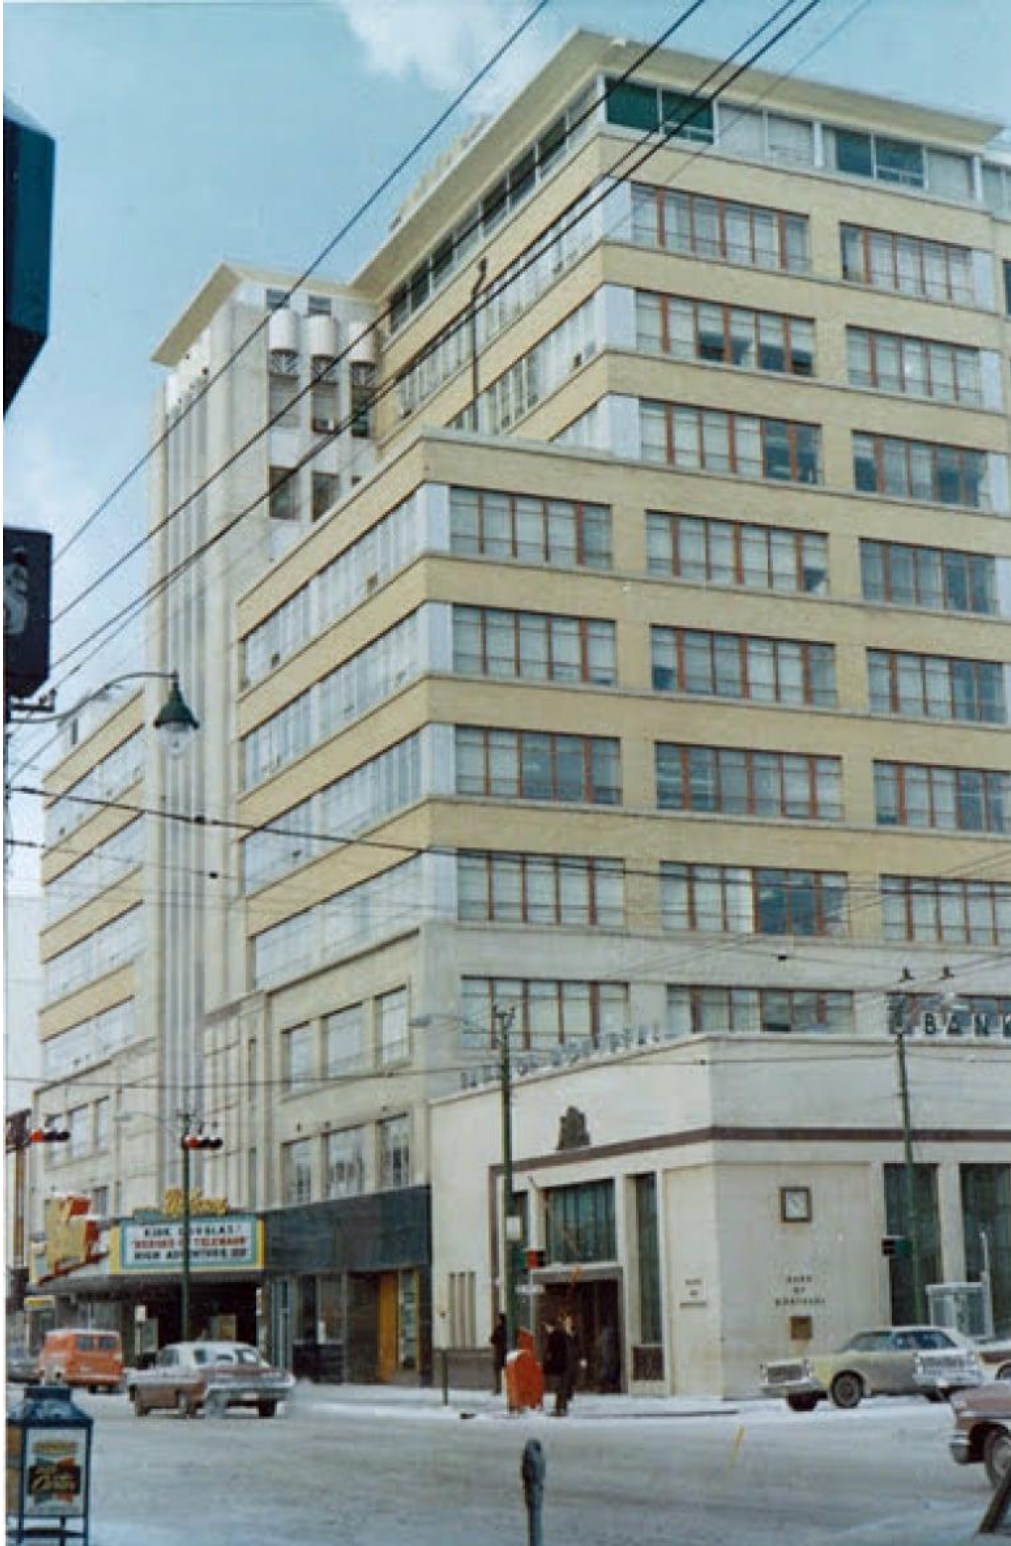
(Image 3.4: 1966 photo showing oblique view of Barron Building from southeast corner showing building stepback at the eighth and eleventh storey with deep overhanging eaves at the historic eleventh storey penthouse, expanded from original 1952 form and massing) Photo Credit: Daniel Barron
