## BYLAW NUMBER 42M2022

### BEING A BYLAW OF THE CITY OF CALGARY TO DESIGNATE THE BARRON BUILDING AS A MUNICIPAL HISTORIC RESOURCE

**IP2022-1255  
ATTACHMENT 2**

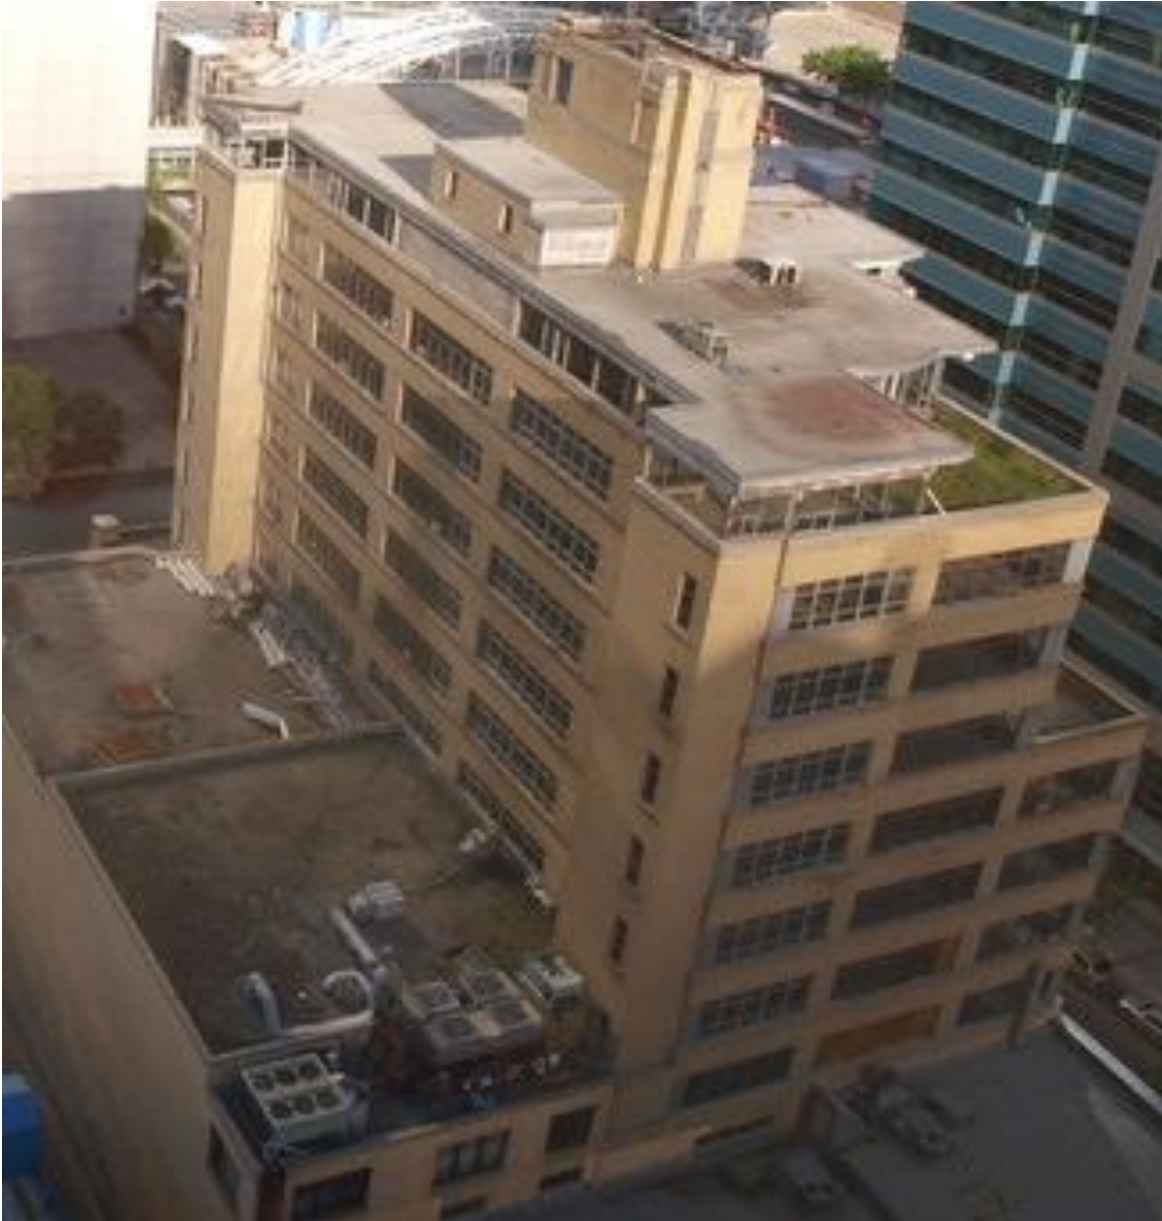
(Image 4.1: Aerial view Barron Building from northwest corner showing building stepback at the eighth and eleventh storey with deep overhanging eaves at the eleventh storey penthouse, and original rooftop mechanical and elevator house forms)

- a) Visual upper form of the original rooftop mechanical and elevator house with geometric-patterned stone banding (Image 4.1).

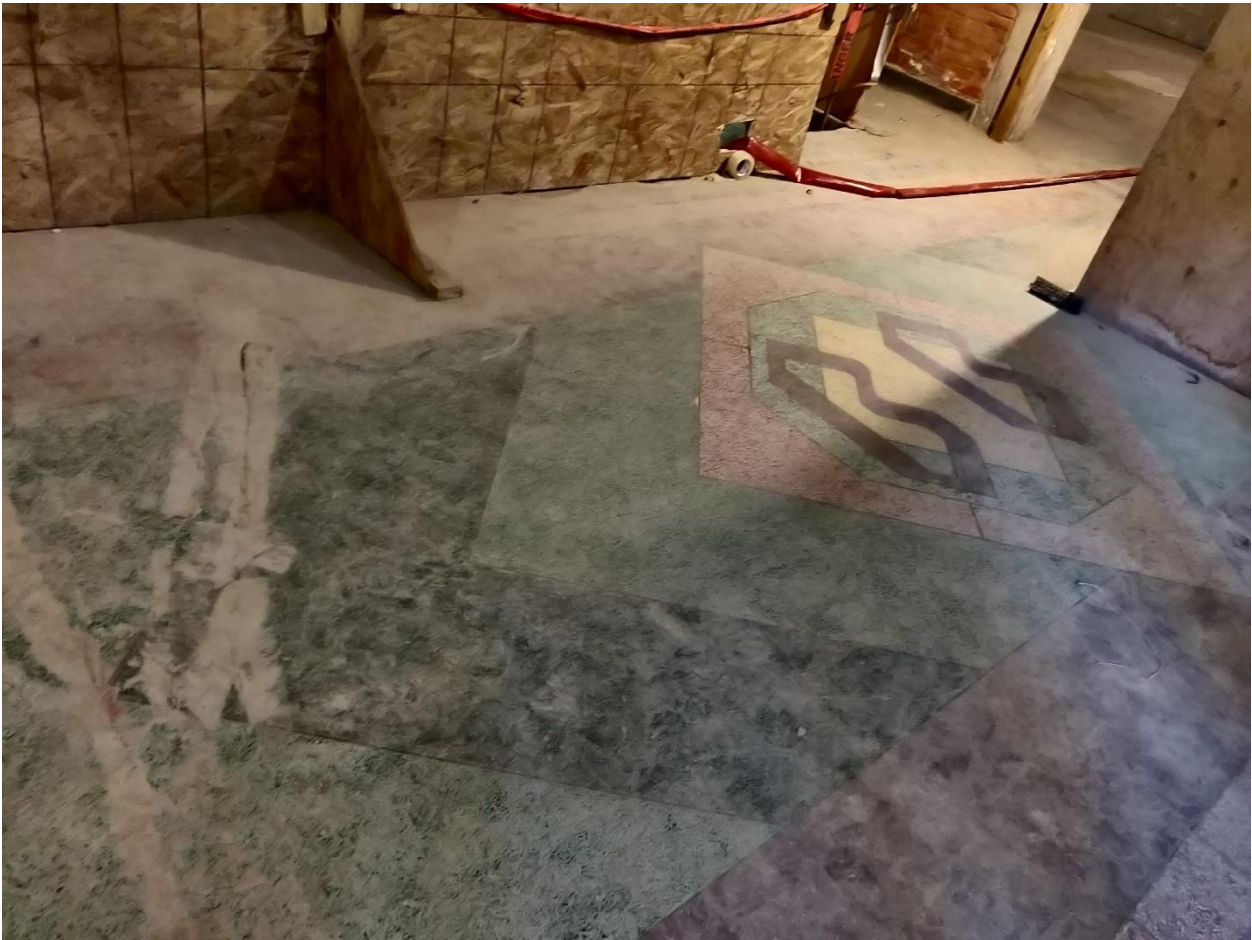
(Image 5.1: View of main floor lobby with ‘BB’ cast into terrazzo flooring)

- a) Coloured terrazzo floors of the elevator core landings from storeys one through five and seven through ten (including re-created sixth storey terrazzo floor), inlaid with “BB” initials on the main floor and “B” initials from floors two through ten (Images 5.1 to 5.3).

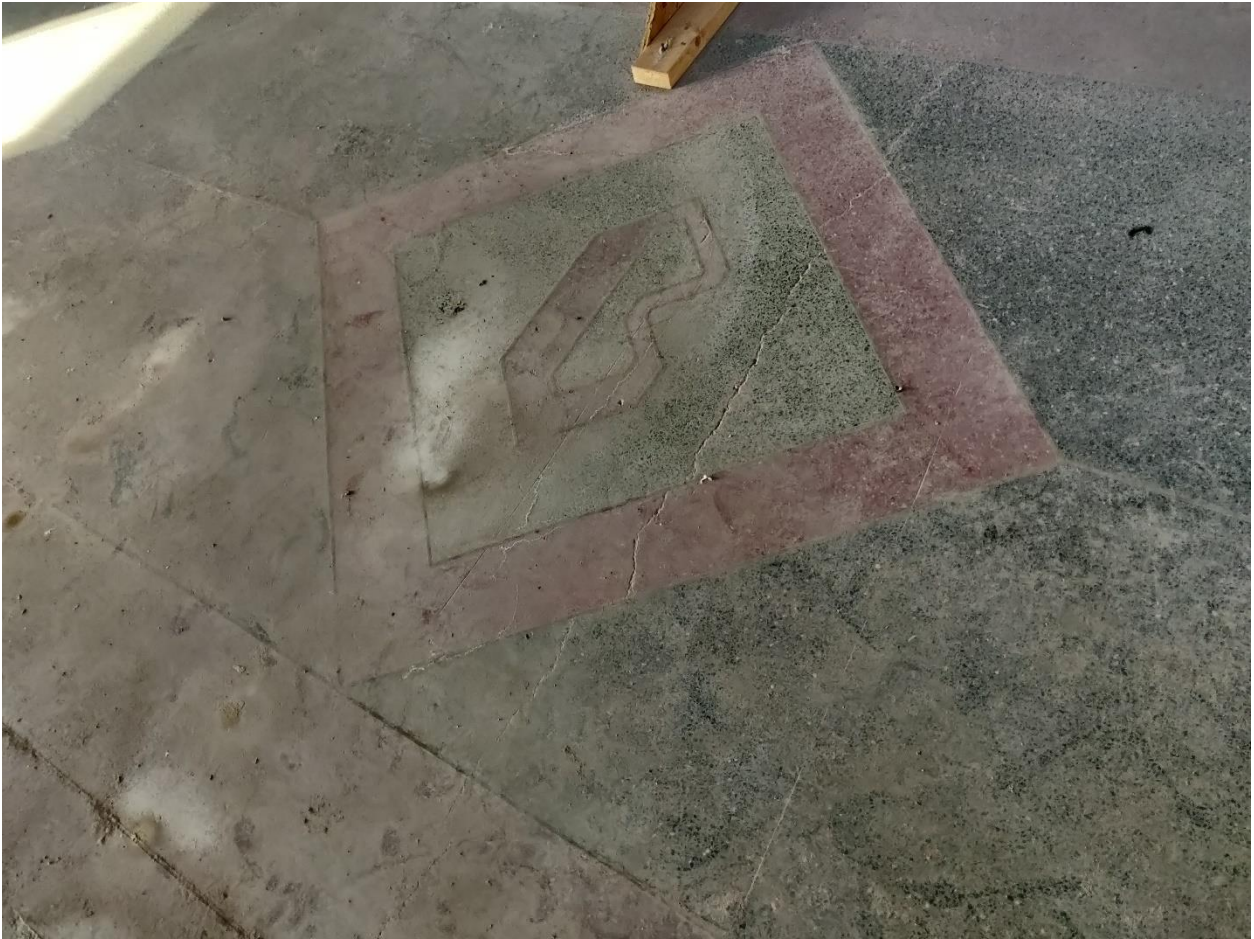
(Image 5.2: Detailed view of terrazzo flooring with brass inlay and 'B' formed in the centre of elevator lobbies from floors two through five, and seven through ten, including re-created sixth storey terrazzo floor )

**Notes:** A return to original configuration and/or appearance of the terrazzo flooring at the sixth floor elevator landing, as shown in Images 5.2 and 5.3, may be permitted.

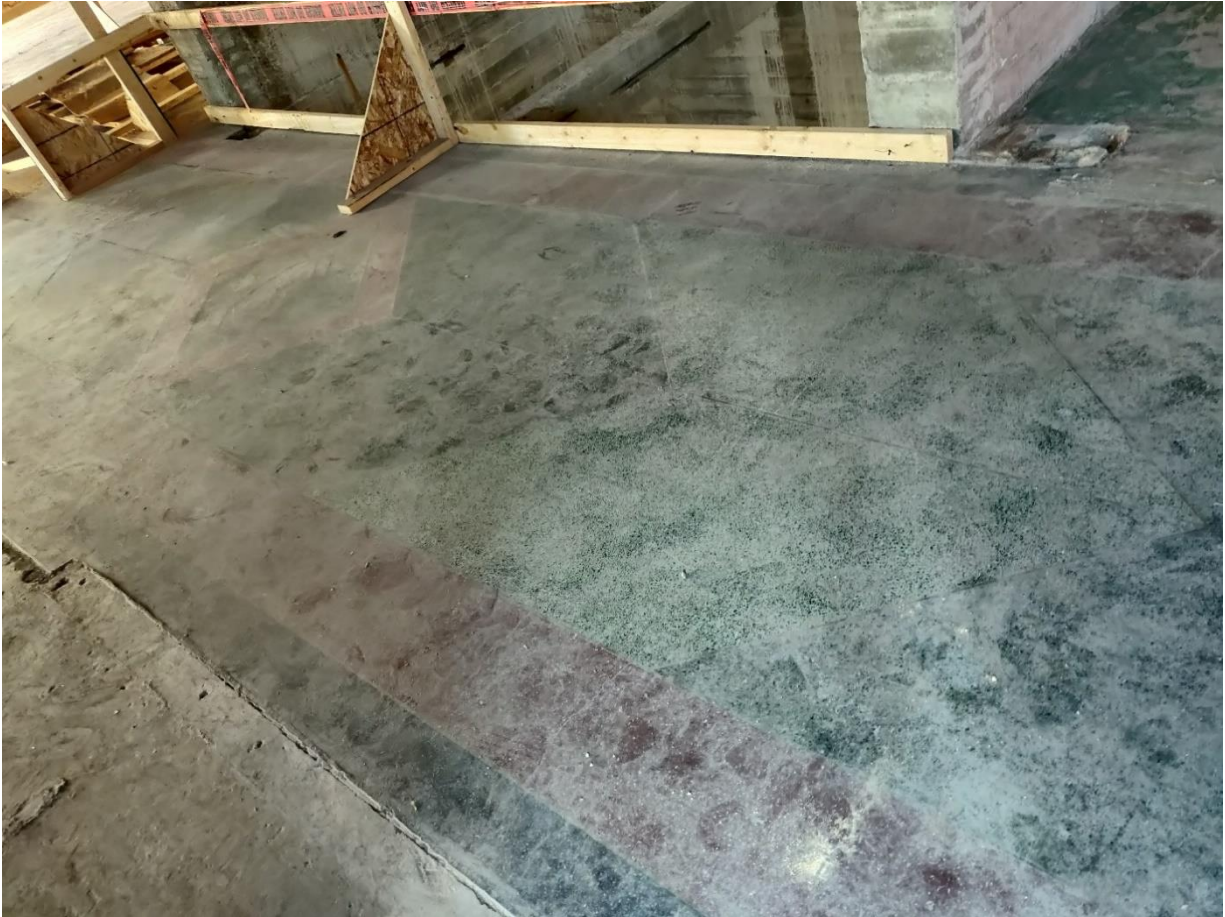
(Image 5.3: View of typical elevator lobby with terrazzo flooring with brass inlay and 'B' formed in the centre of elevator lobbies from floors two through five, and seven through ten, including re-created sixth storey terrazzo floor)
