BYLAW NUMBER 45M2024

BEING A BYLAW OF THE CITY OF CALGARY TO DESIGNATE THE WALTER HARGRAVE RESIDENCE AS A MUNICIPAL HISTORIC RESOURCE

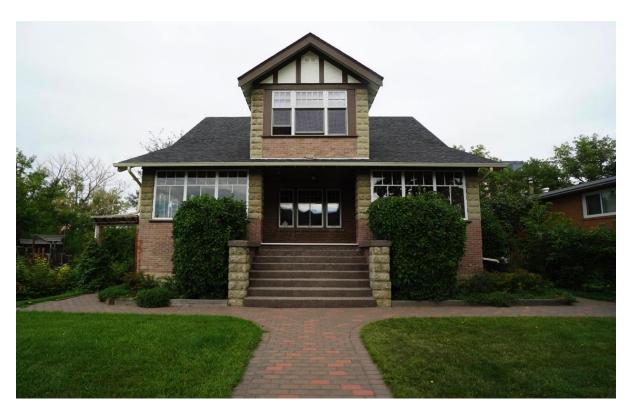
(Image 1.1: South façade)

- a) Stretcher bond concrete brick cladding; continuous hollow rock-faced concrete block band (three rows) (Images 1.1 1.3);
- b) Wraparound verandah with hollow rock-faced concrete block support pillars terminating under painted wooden frieze board; wooden tongue-and-groove ceiling; arched drainage openings with keystone decoration (Images 1.4 1.5);

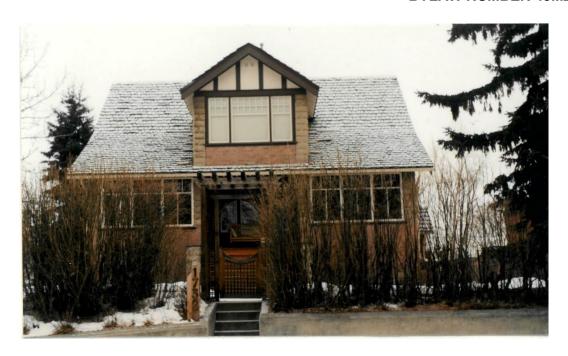
(Image 1.2: ca. 1996 photo showing south façade with original window assembly on second storey)

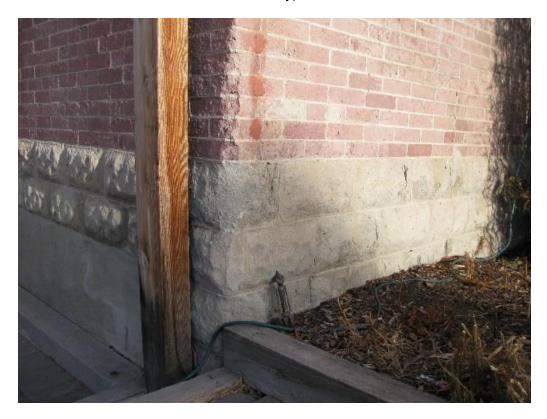
(Image 1.3 Stretcher bond concrete brick cladding; continuous hollow rock-faced concrete block band (three rows in south-facing façade, transitioning to two rows)

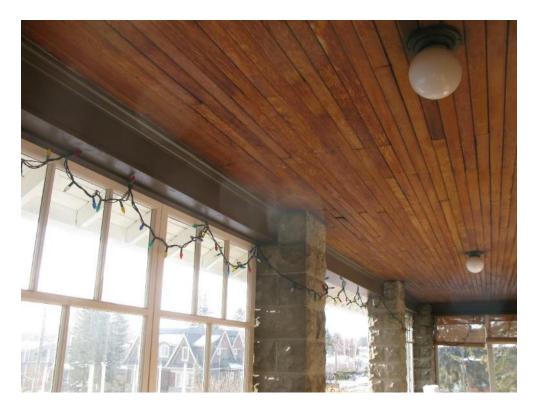
(Image 1.4 Enclosed portion of verandah: tongue-and-groove ceiling, hollow rock-faced concrete block clad support pillars, wood header)

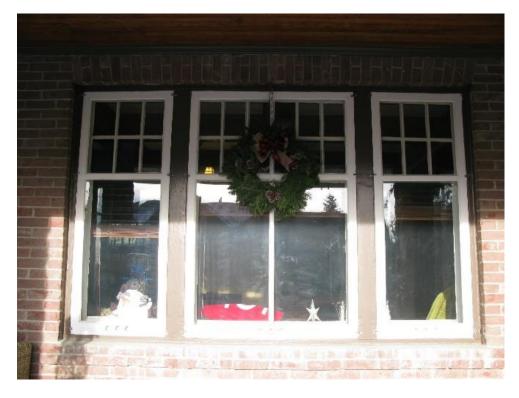
(Image 1.5: triple assembly consisting of a 12-over-1 flanked by 6-over-1 wood windows with sill and flat gauge lintel in concrete brick)

- d) Original fenestration (window patterns and openings); a triple assembly consisting of a 12-over-1 flanked by 6-over-1 wood windows with sill and flat gauge lintel in concrete brick; doorway with flat gauge lintel in concrete brick (Images 1.5 and 1.7); and

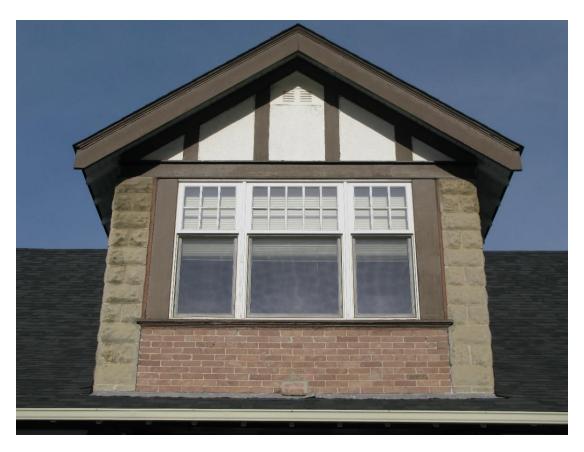
(Image 1.6: detail of second storey porch extension, stretcher bond concrete brick cladding with hollow rock-faced concrete block corner columns; stucco and wood mock half-timbering)

- c) Second storey porch extension; stretcher bond concrete brick cladding with hollow rock-faced concrete block corner columns; stucco and wood mock half-timbering (Image 1.6);

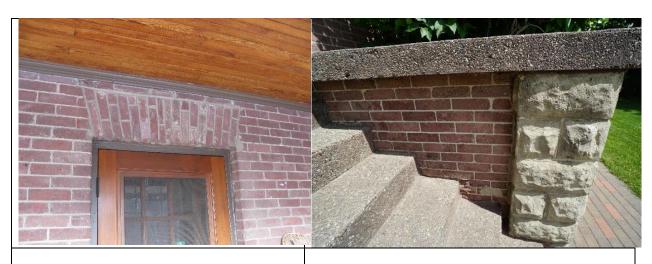
(Image 1.7: doorway with flat gauge lintel in concrete brick)

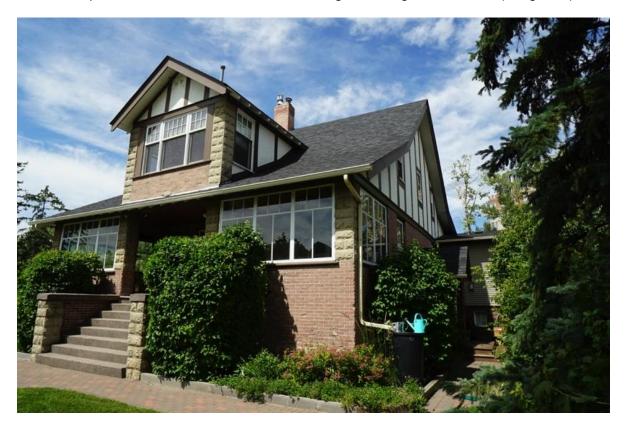
(Image 2.1: View of house from southeast)

- a) Stretcher bond concrete brick cladding; stucco and wood mock half-timbering; continuous hollow rock-faced concrete block band (two rows); continuous wood band with decorative trim (Images 1.3 and 2.1 2.3); and
- b) Original fenestration (window patterns and openings); two 15-pane wood windows with concrete sills (main storey); three 6-over-1 wood hung windows with flat window heads and painted wood trim (Images 2.2 2.5).

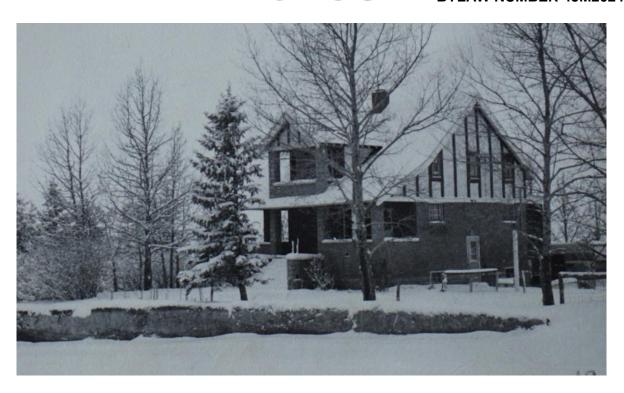
(Image 2.2: Historic photo ca.1959, view of house from southeast)

Note: The east side single-storey projecting vestibule built between 1959 and 1986, while sympathetically designed, is not regulated and a return to original configuration/appearance would not be precluded where documentation of original configuration exists (Image 2.2).

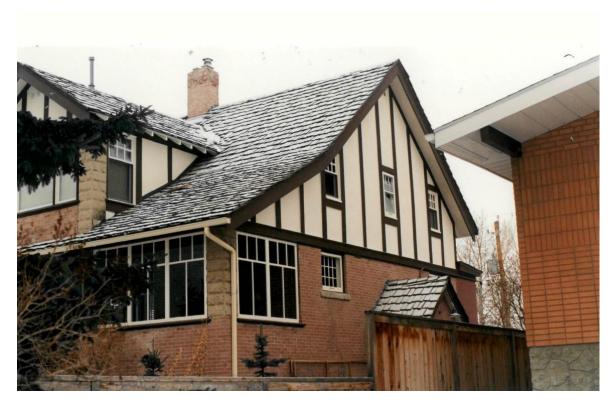
(Image 2.3: photo ca.1996, view of house from southeast)

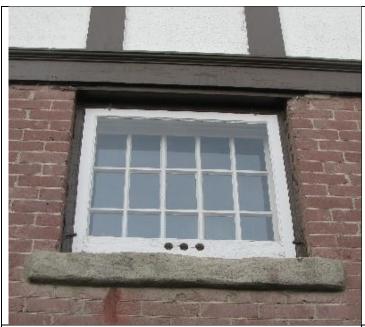
(Image 2.4: example of one of two 15-pane wood windows with concrete sills; continuous wood band with decorative trim)

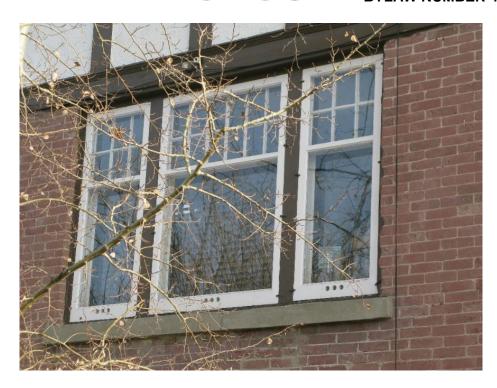
(Image 3.2: triple assembly consisting of a 12-over-1 flanked by 6-over-1 wood windows, with concrete sill; continuous wood band with decorative trim)

- a) Stretcher bond concrete brick cladding; stucco and wood mock half-timbering; continuous hollow rock-faced concrete block band (two rows); continuous wood band with decorative trim (Images 1.3 and 3.1);
- b) Wraparound front verandah with hollow rock-faced concrete block support pillars terminating under painted wooden frieze board; wooden tongue-and-groove ceiling (Images 1.4 and 3.1); and
- c) Original fenestration (window patterns and openings); a triple assembly consisting of a 12-over-1 flanked by 6-over-1 wood windows, with concrete sill; a 12-over-1 wood window with sill and flat gauge lintel in concrete brick; two double assemblies of 6-over-1 wood windows with flat heads and painted wood trim (Images 3.2 3.4).

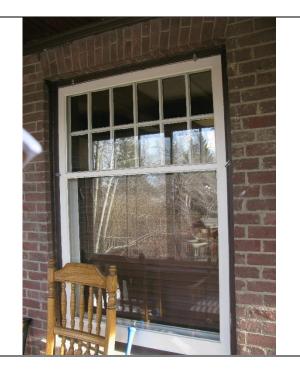
(Image 3.3: a 12-over-1 wood window with sill and flat gauge lintel in concrete brick, located within wraparound verandah)

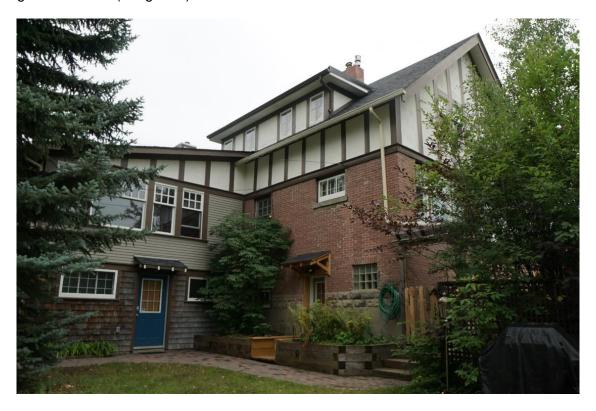
(Image 4.1: North façade)

- a) Stretcher bond concrete brick cladding; stucco and wood mock half-timbering; continuous hollow rock-faced concrete block band (two rows); continuous wood band with decorative trim (Images 1.3 and 4.1 4.2);and
- b) Original fenestration (window patterns and openings); a 6-over-1 wood window and a 12-pane wood window, both with concrete sills; four multi-pane wood windows (shed dormer) (Images 4.1 4.4).

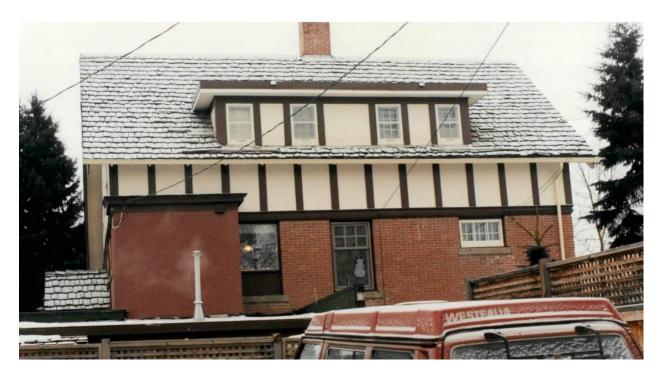
(Image 4.2: Photo ca. 1996 of rear façade)

Note: The north extension, while sympathetically designed, is not regulated and a return to original configuration/appearance would not be precluded where documentation of original configuration exists (Image 4.2)

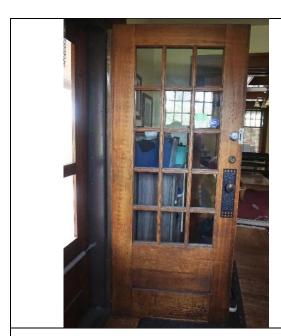
(Image 7.1 Main entry 15-pane Douglas fir door)

- a) Original Douglas fir main door assembly with panels topped by 15 glass panes and plain wooden trim (Image 7.1);
- b) Original Douglas fir second storey porch exterior wood door with panels topped by 12 glass panes and plain wooden trim (Image 7.2);
- c) Extant original main floor Douglas Fir woodwork including baseboards, window and door casings, pocket door, crown moulding and ceiling beams (living and dining rooms) (Images 7.3 7.7);
- d) Quarter-turn closed staircase to second storey with Douglas fir stair rail, newel, and ballustrade (Image 7.7)

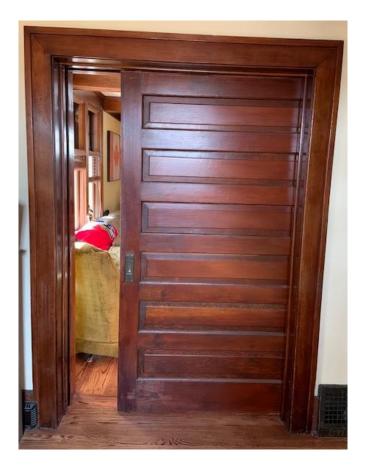
(Image 7.5 Pocket door and example of typical door casing)

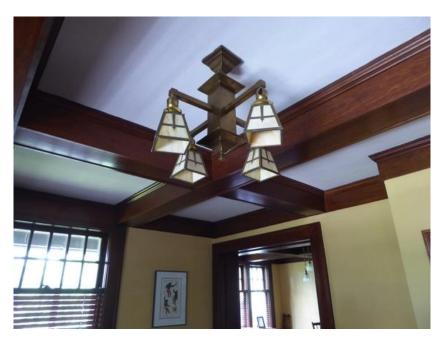
(Image 7.6 Example of extant original Douglas Fir crown moulding and ceiling beams in living and dining rooms)
