Structural Collapse Model

Truss 'A' & 'B' – Structural Upgrades

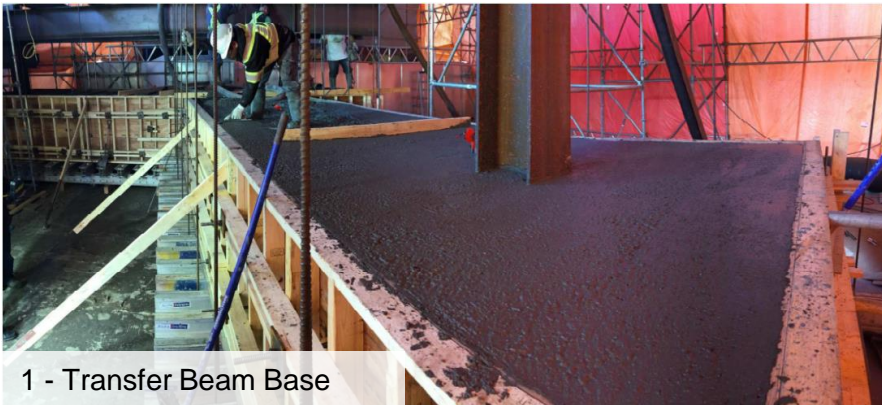
Structural Shoring - Transfer Beam

The new transfer beam distributes the shoring tower load from Truss 'A' to three existing columns of the Administration Building, with one of the existing columns of the Administration Building further reinforced to carry the shoring loads.

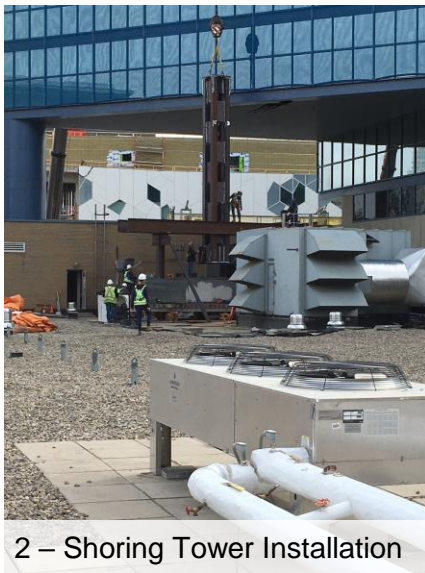
1 - Transfer Beam Base

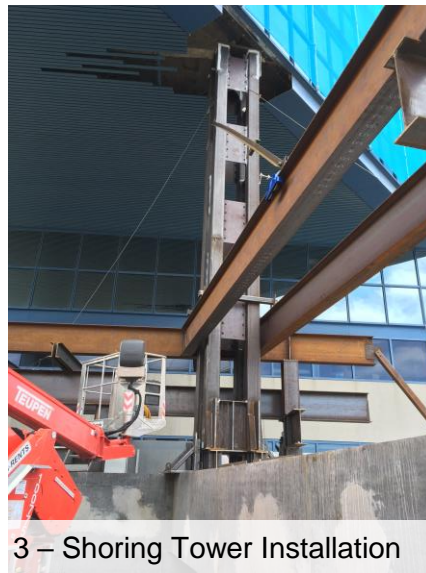
2 - Shoring Tower Installation

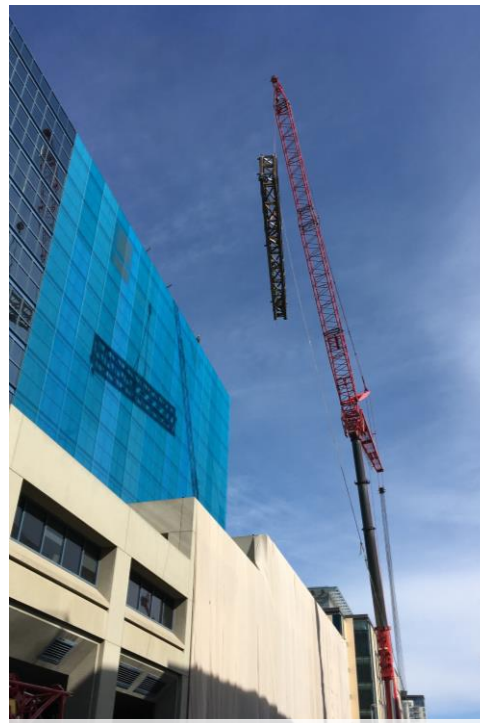
Box Truss Installation

The temporary box truss is located on the roof of the Municipal building to support Truss 'B' remediation efforts. A controlled jacking process was then used to transfer the weight of Truss 'B' onto the temporary box truss assembly.

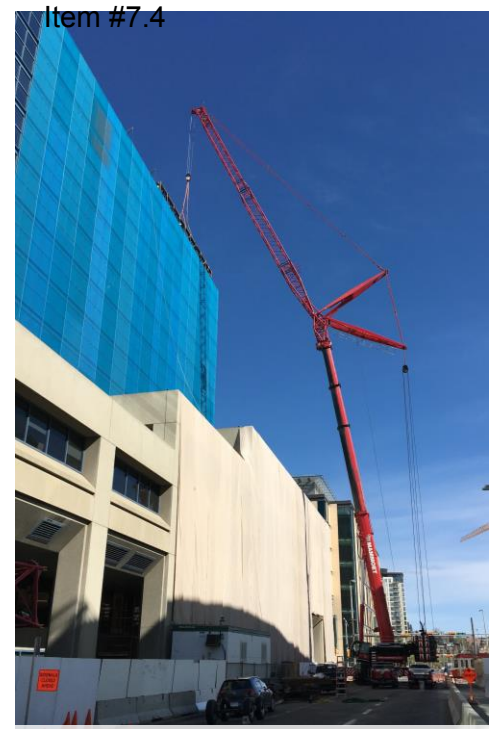
Box Truss Installation

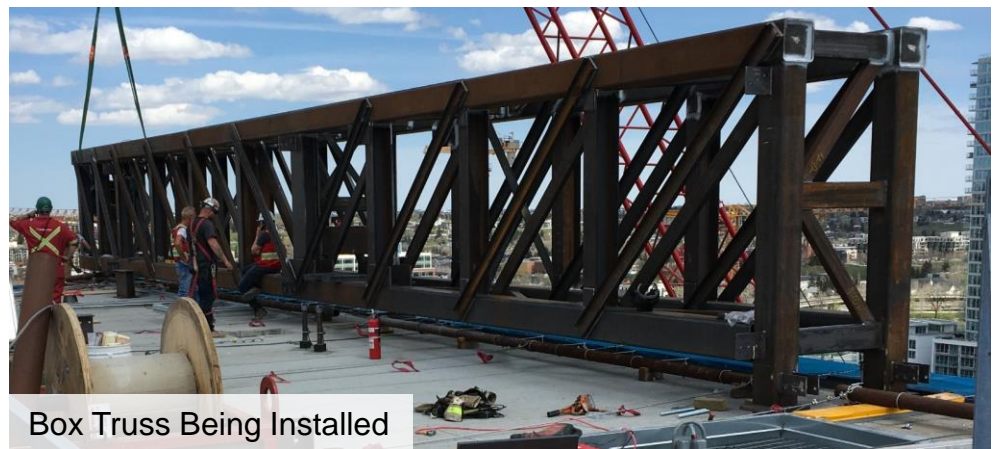
Box Truss Being Installed

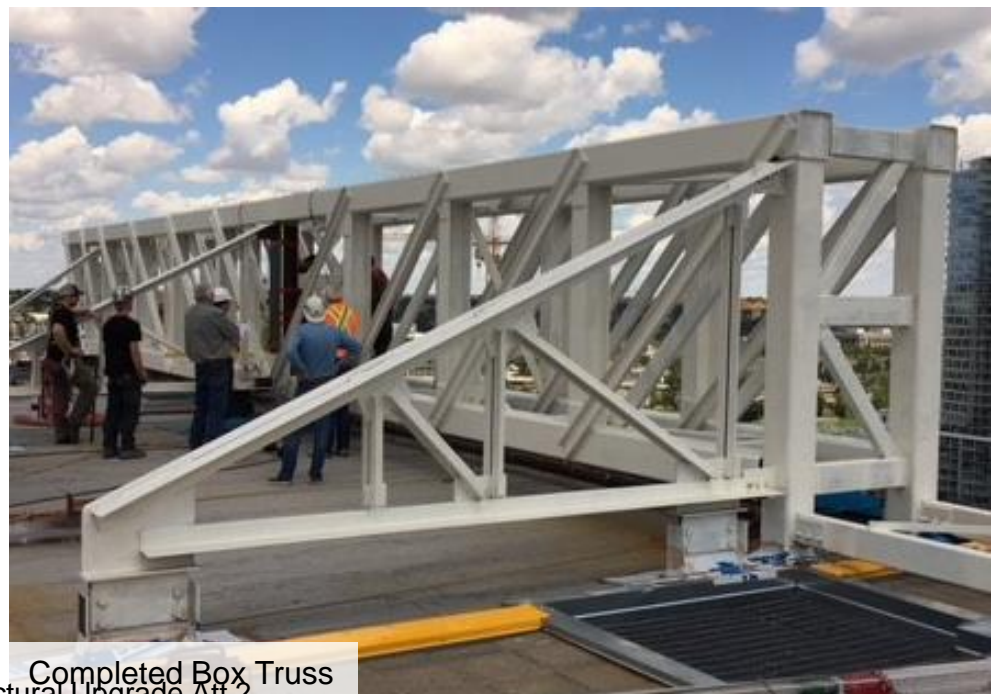
Completed Box Truss

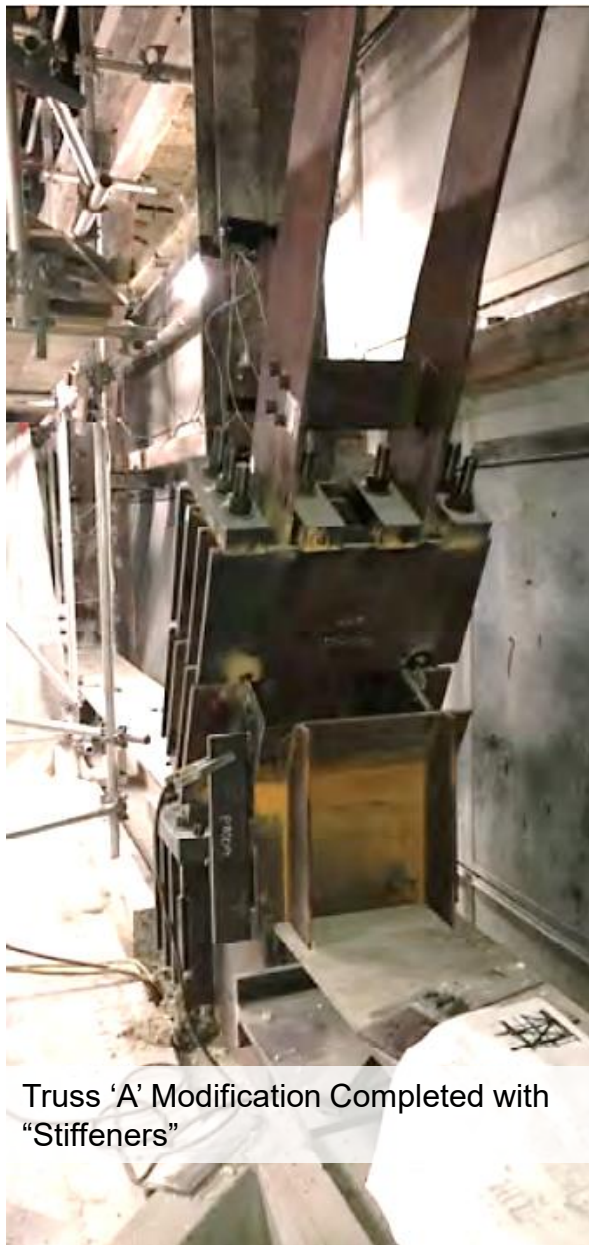
Truss 'A' Modification Completed with “Stiffeners”

To upgrade the structural integrity of Truss 'A' and 'B' a significant number of additional steel plates, or “stiffeners”, were welded into place to support the connections between the truss and surrounding structure. For Truss A, 61 “stiffeners” have now been welded into place supporting eight joints. For Truss B, 80 “stiffeners” of varying sizes and shapes have been welded into place on nine separate joints ensuring enhanced structural stability and safety code compliance.

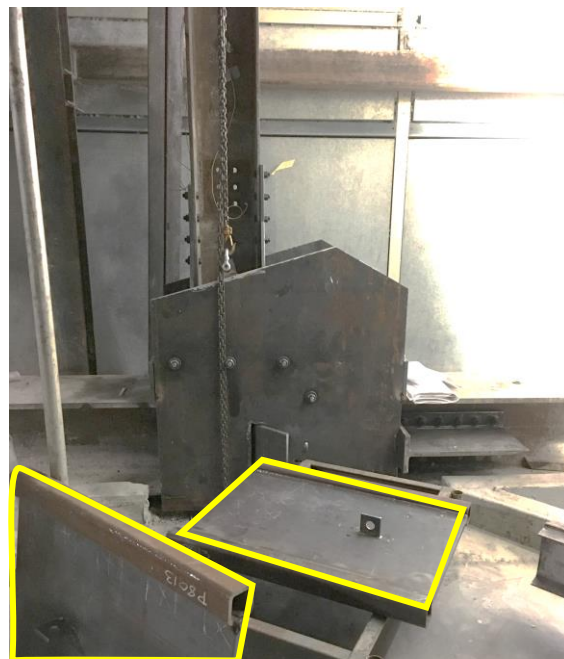
Example of Steel plates prior to installation; “Stiffeners”
