BYLAW NUMBER 60M2018

BEING A BYLAW OF THE CITY OF CALGARY TO DESIGNATE THE RIVERIA APARTMENTS AS A MUNICIPAL HISTORIC RESOURCE

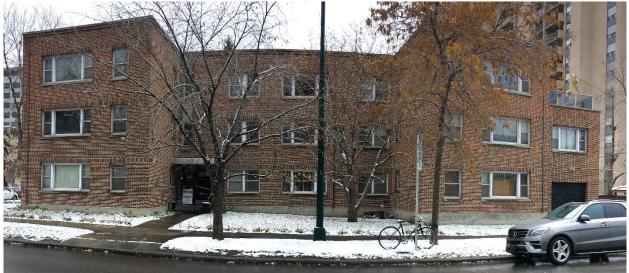
(Image 1.1: west façade)

- a) Red/ brown vertical scored brick exterior wall in running bond; cement parged foundation base (Images 1.1, 1.2);
- b) Brick details including solider course band above windows at all storeys; stacked bond surrounding stairwell window and on garage wing (Images 1.1, 1.2, 1.3);
- c) Fenestration comprising single and double-assembly wooden frame windows with one-overone profiles; triple assembly wooden frame windows with one-over-one profiles flanking a fixed sash; concrete window sills (Images 1.1, 1.2, 1.7, 1.8, 1.9); and
- d) The main central entrance with wood doorway assembly, sidelight and overhang (Images 1.1, 1.10).

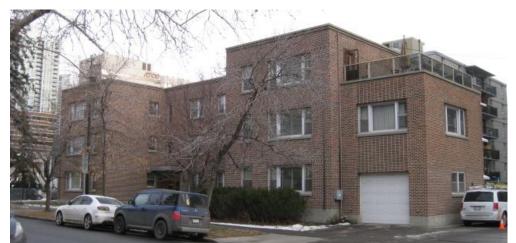
(Image 1.2: oblique from of west façade)

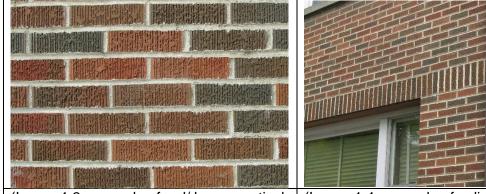
(Image 1.3: example of red/ brown vertical scored brick exterior wall in running bond)

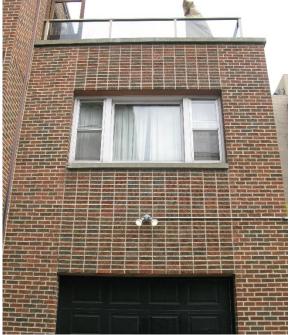
(Image 1.6: stacked bond brick detail on garage wing)

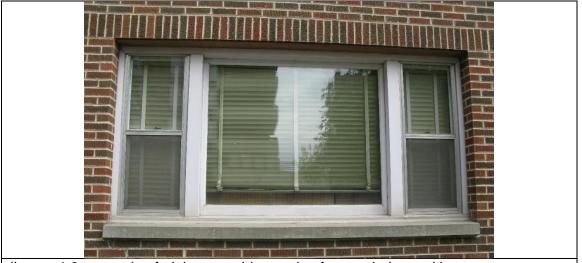
(Image 1.9: example of triple assembly wooden frame windows with one-over-one profiles flanking a fixed sash; concrete window sill)

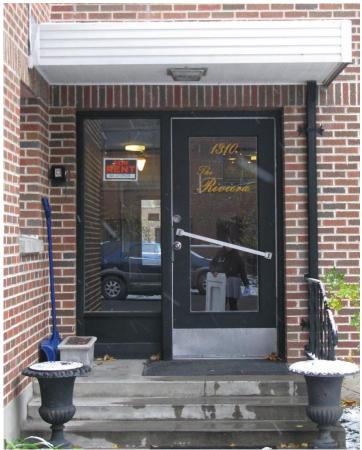
(Image 1.10: the main central entrance with wood doorway assembly, sidelight and overhang)

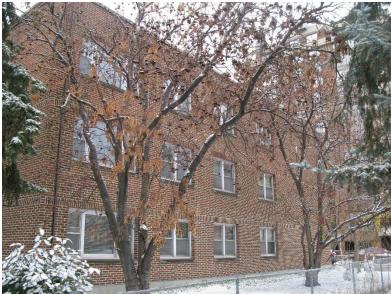
(Image 2.1: oblique view of the north façade)

- a) Red/ brown vertical scored brick exterior wall in running bond; cement parged foundation base (Images 2.1, 2.2);
- b) Brick details including soldier course band above windows at all storeys (Images 1.3, 2.1, 2.2); and
- c) Fenestration comprising double-assembly wooden frame windows with one-over-one profiles; triple assembly wooden frame windows with one-over-one profiles flanking a fixed sash; concrete window sills (Images 2.1, 2.2, 1.8, 1.9).

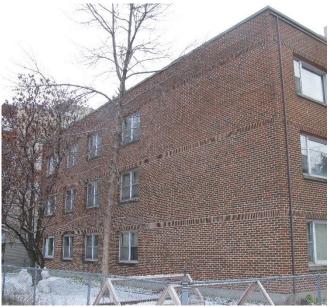
(Image 2.2: oblique view of the north façade)

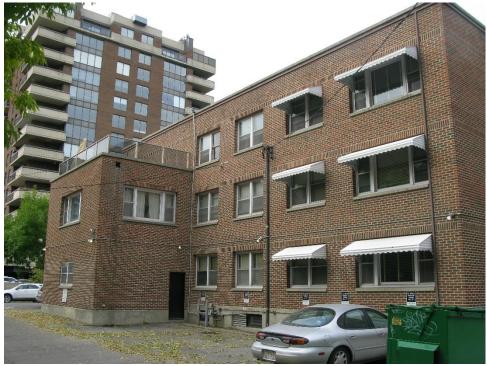
(Image 3.1: south façade)

- a) Red/ brown vertical scored brick exterior wall in running bond; cement parged foundation base (Images 3.1, 1.3);
- b) Brick details including soldier course band above windows at all storeys; soldier lintel on garage wing windows (Images 3.1, 1.4);
- c) Fenestration comprising double-assembly wooden frame windows with one-over-one profiles; triple assembly wooden frame windows with one-over-one profiles flanking a fixed sash; concrete window sills (Images 3.1, 1.8, 1.9); and
- d) Third storey rooftop deck over the garage wing (Image 3.1).

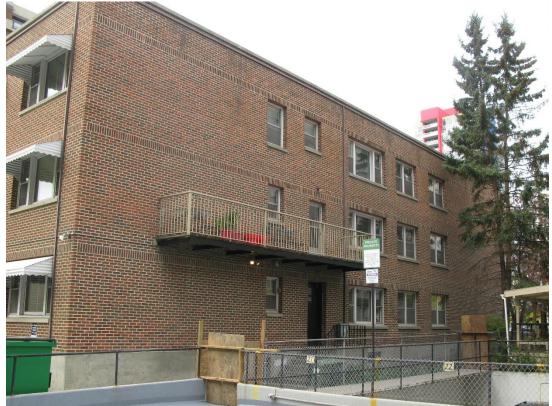
(Image 4.1: east façade)

- a) Red/ brown vertical scored brick exterior wall in running bond; cement parged foundation base (Images 4.1, 1.3);
- b) Brick details including soldier course band above windows at all storeys (Images 4.1, 1.4);
- c) Fenestration comprising single and double-assembly wooden frame windows with one-overone profiles; triple assembly wooden frame windows with one-over-one profiles flanking a fixed sash; concrete window sills (Images 4.1, 1.7, 1.8, 1.9); and
- d) Second storey open balcony (Image 4.1).

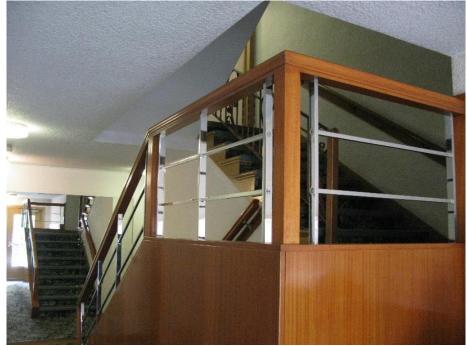
(Image 7.1: lobby main staircase)

a) Ground floor foyer layout including open staircase with wood handrail and posts, decorative cast iron newels and balusters, and varnished wood panelled base (Images 7.1, 7.2).

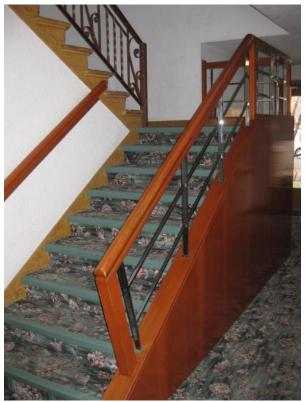
(Image 7.2 lobby main staircase)
